WCAP-15429-NP (Non-Proprietary)
Revision 0
September 2004

Structural Integrity Evaluation of Reactor Vessel Upper Head Penetrations to Support Continued Operation: Diablo Canyon Units 1 and 2

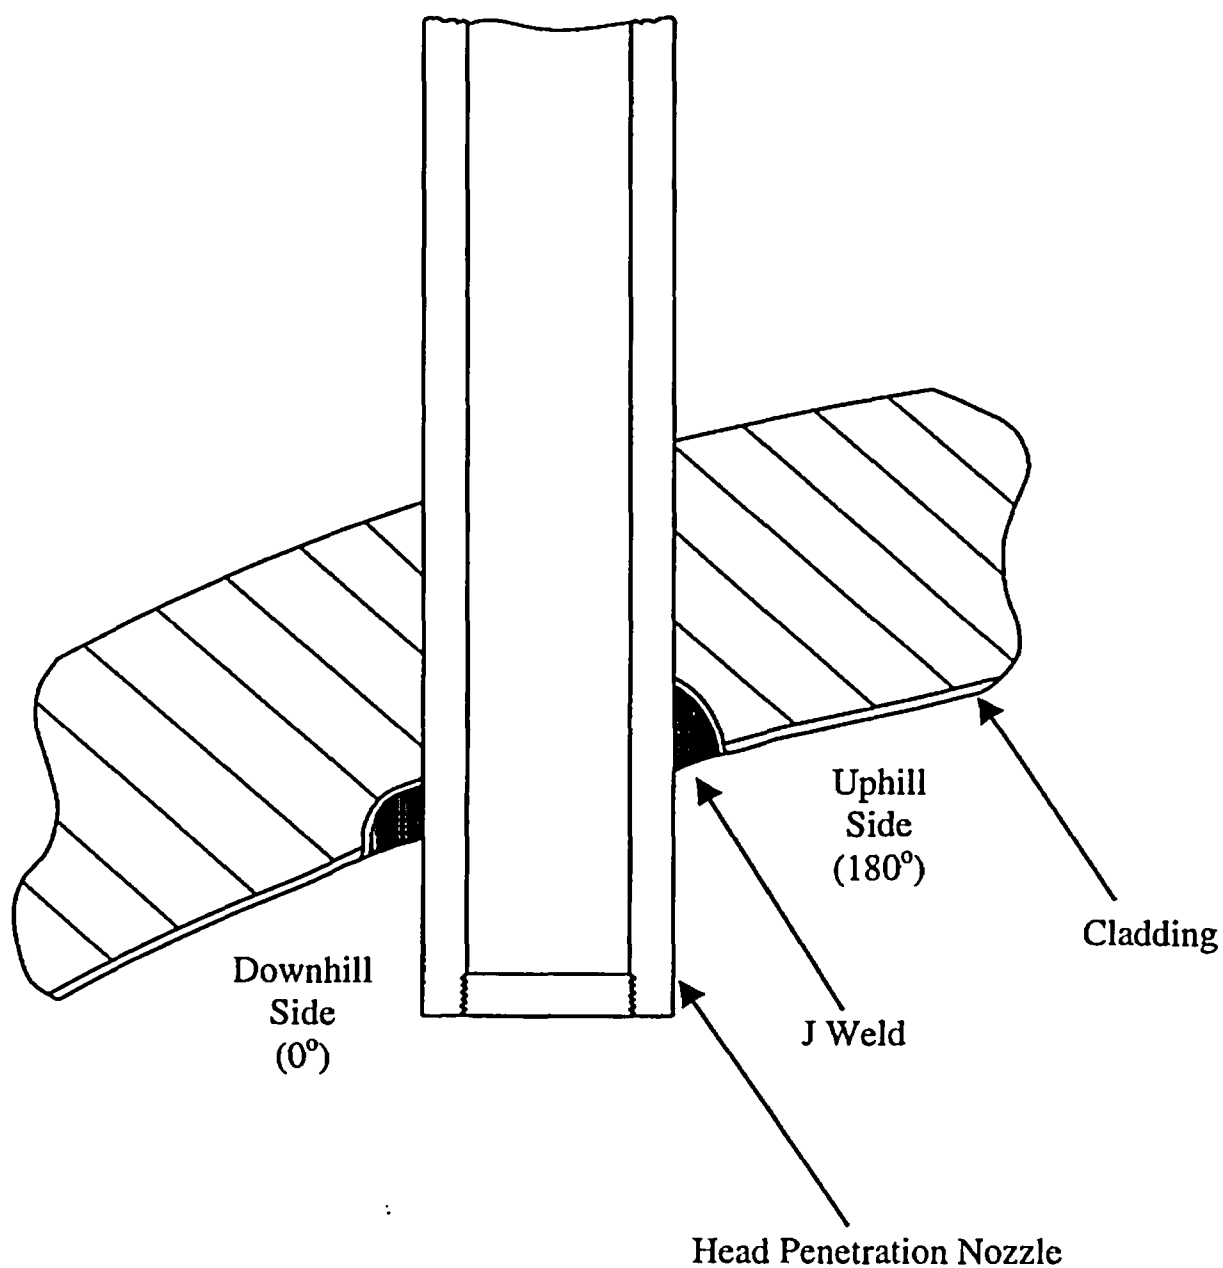
Figure 1-1 Typical Reactor Vessel Control Rod Drive Mechanism (CRDM) Penetration

Thus far, the cracking in reactor vessel heads not designed by Babcock and Wilcox (B&W) has been consistent in both its location and extent. All cracks discovered by nondestructive examination have been oriented axially, and have been located in the bottom portion of the penetration in the vicinity of the partial penetration attachment weld to the vessel head as shown schematically in Figure 1-1.

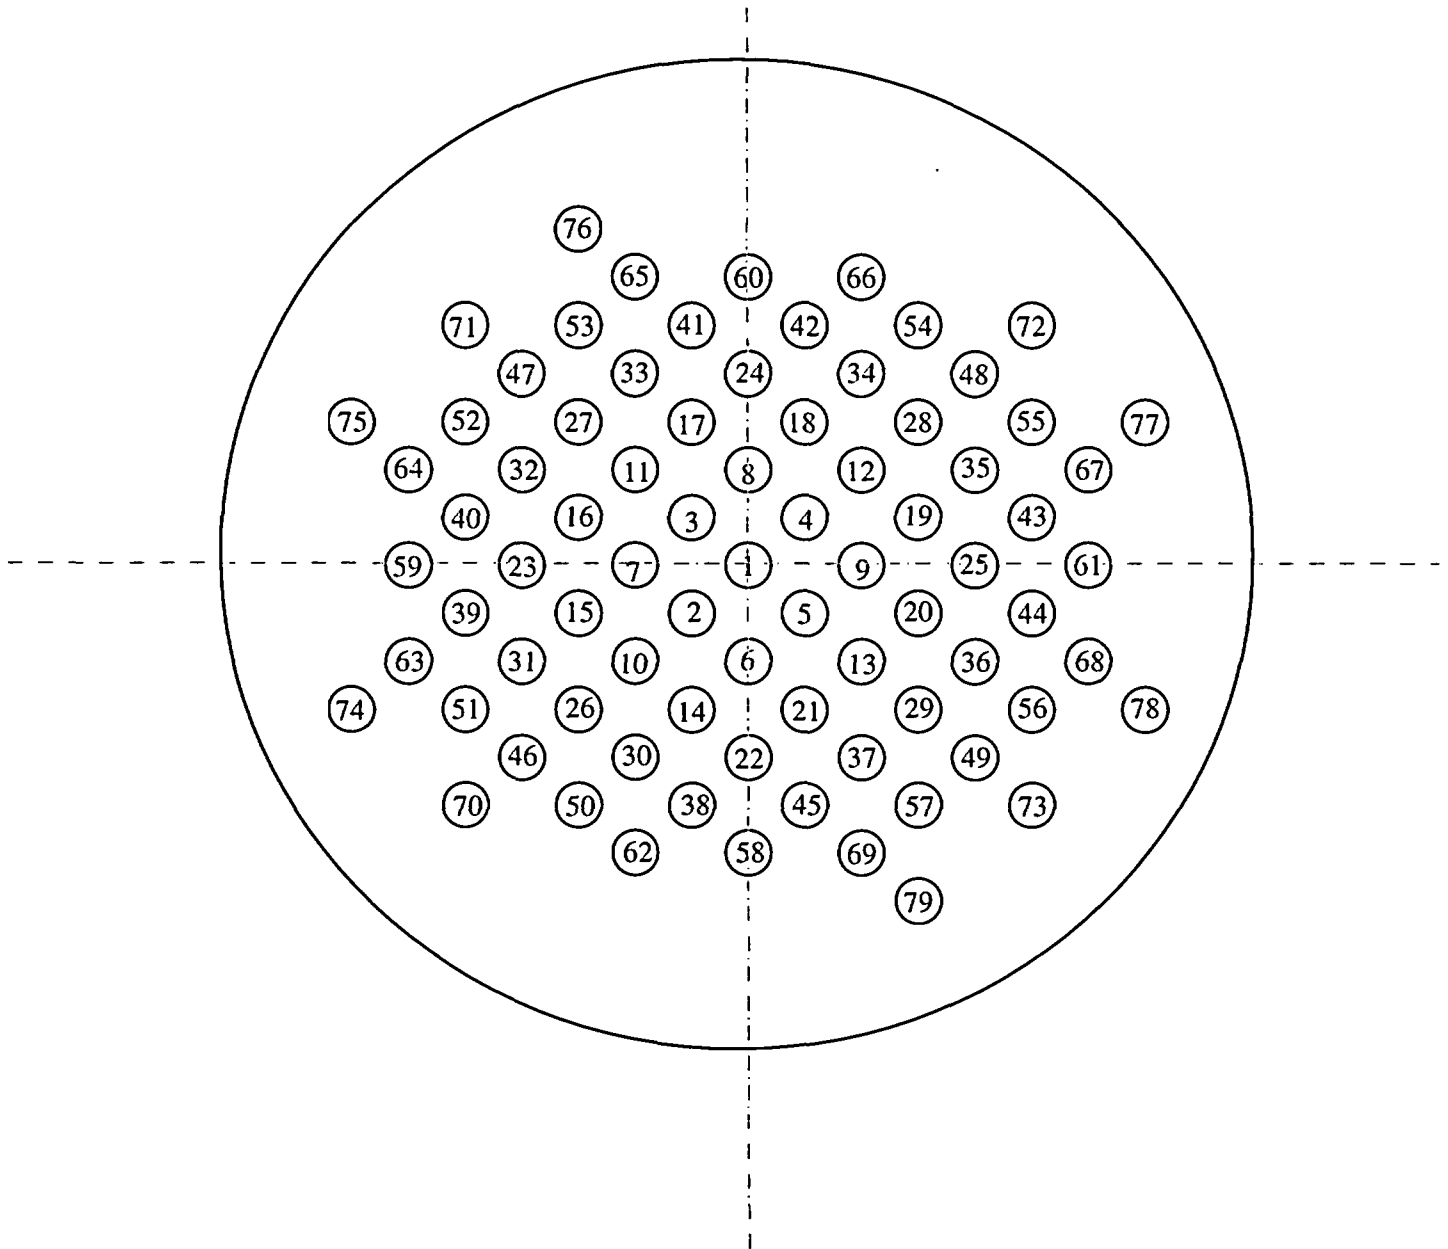
Figure 1-2 Location of Head Penetrations for Diablo Canyon Unit 1 [1A]

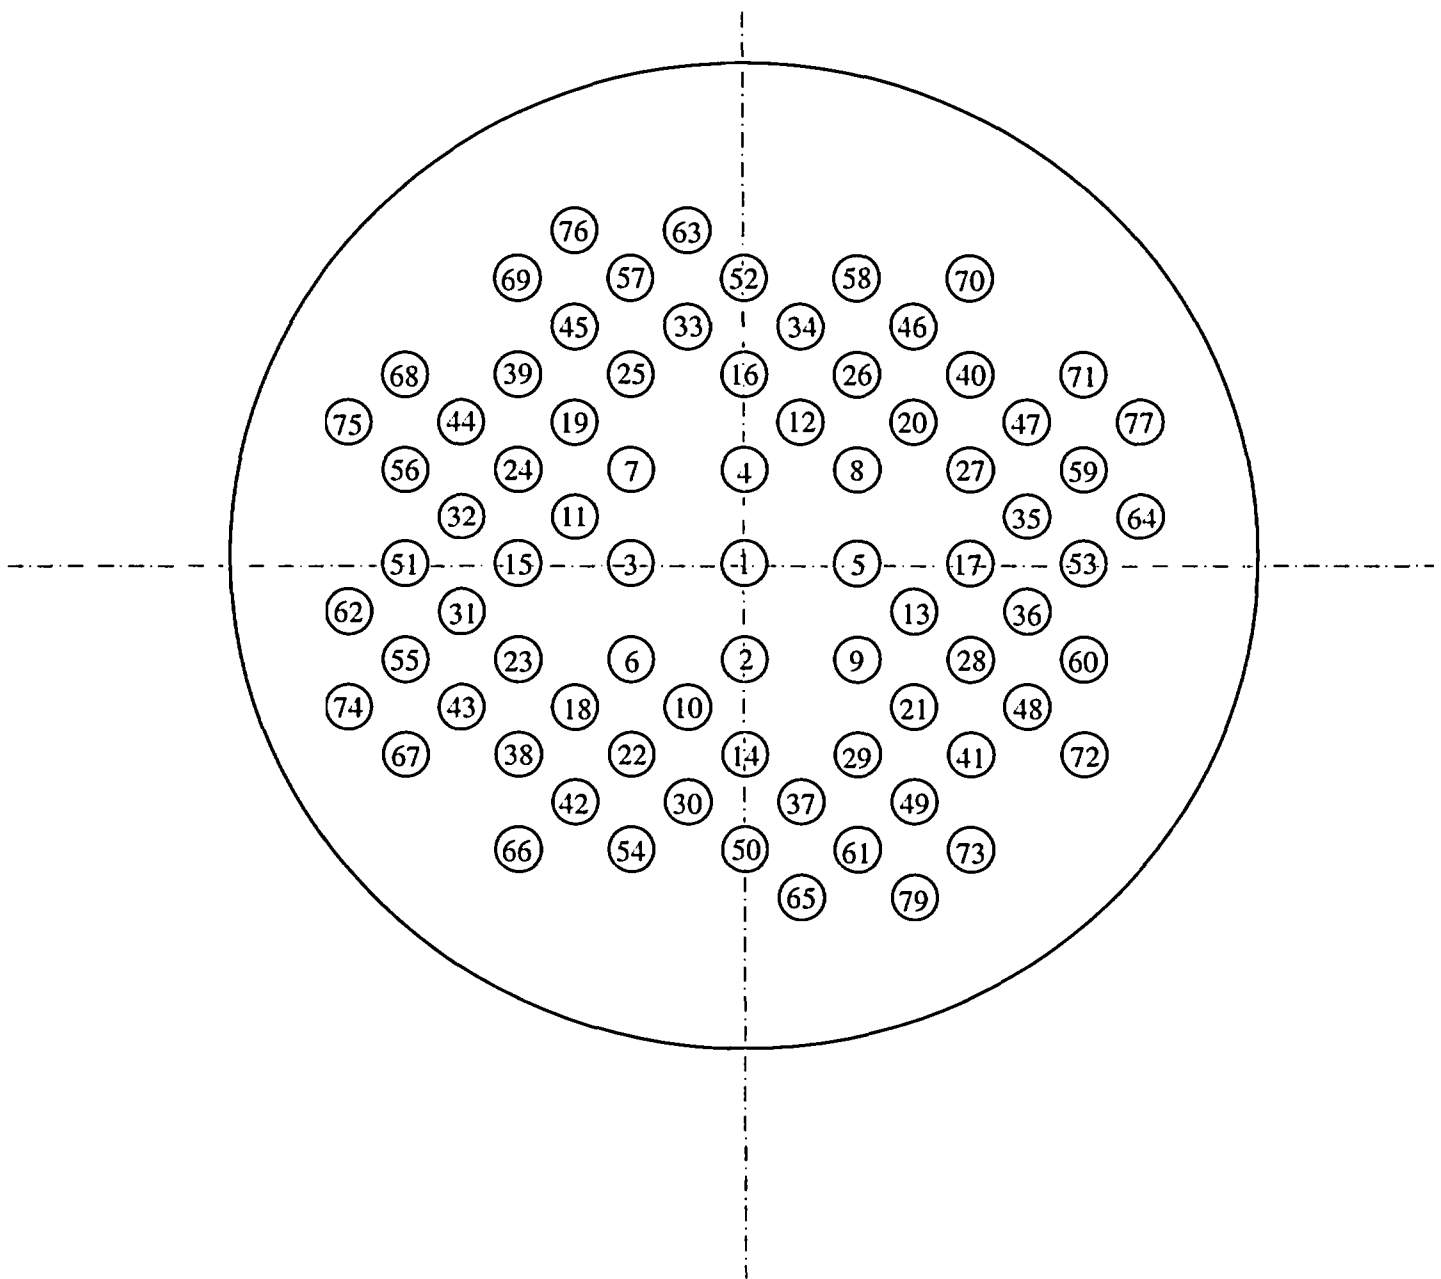
Figure 1-3 Location of Head Penetrations for Diablo Canyon Unit 2 [2A]

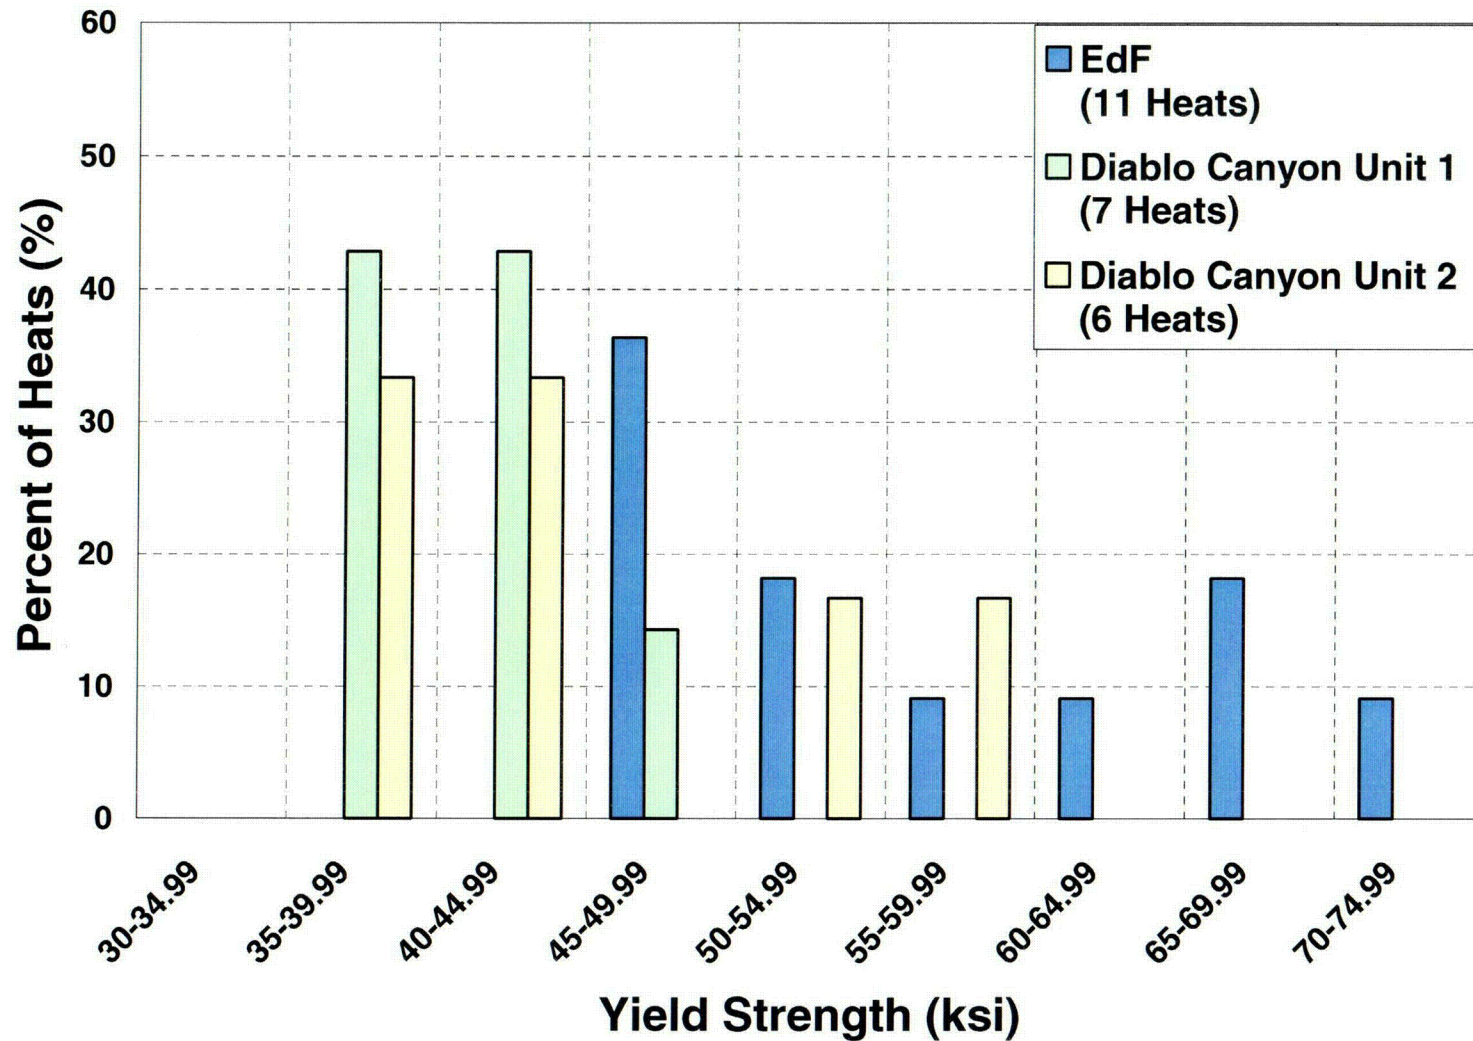
Figure 4-1 Yield Strength of the Various Heats of Alloy 600 Used in Fabricating the Diablo Canyon Units 1 and 2 and French Head Penetrations

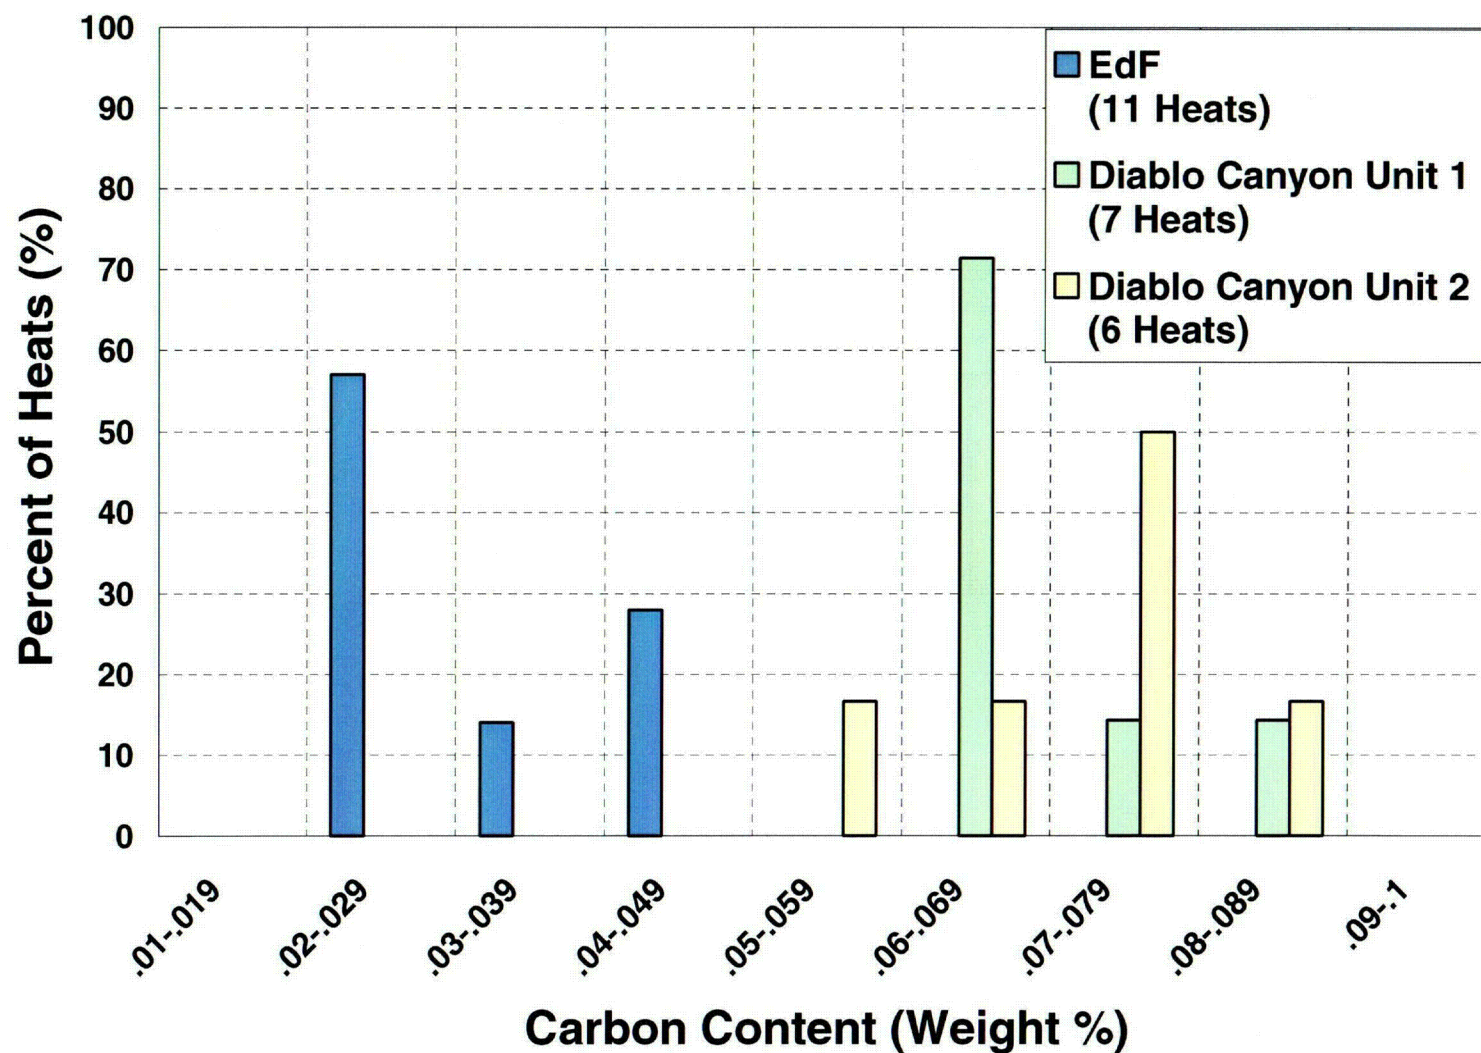
Figure 4-2 Carbon Content of the Various Heats of Alloy 600 Used in Fabricating the Diablo Canyon Units 1 and 2 and French Head Penetration

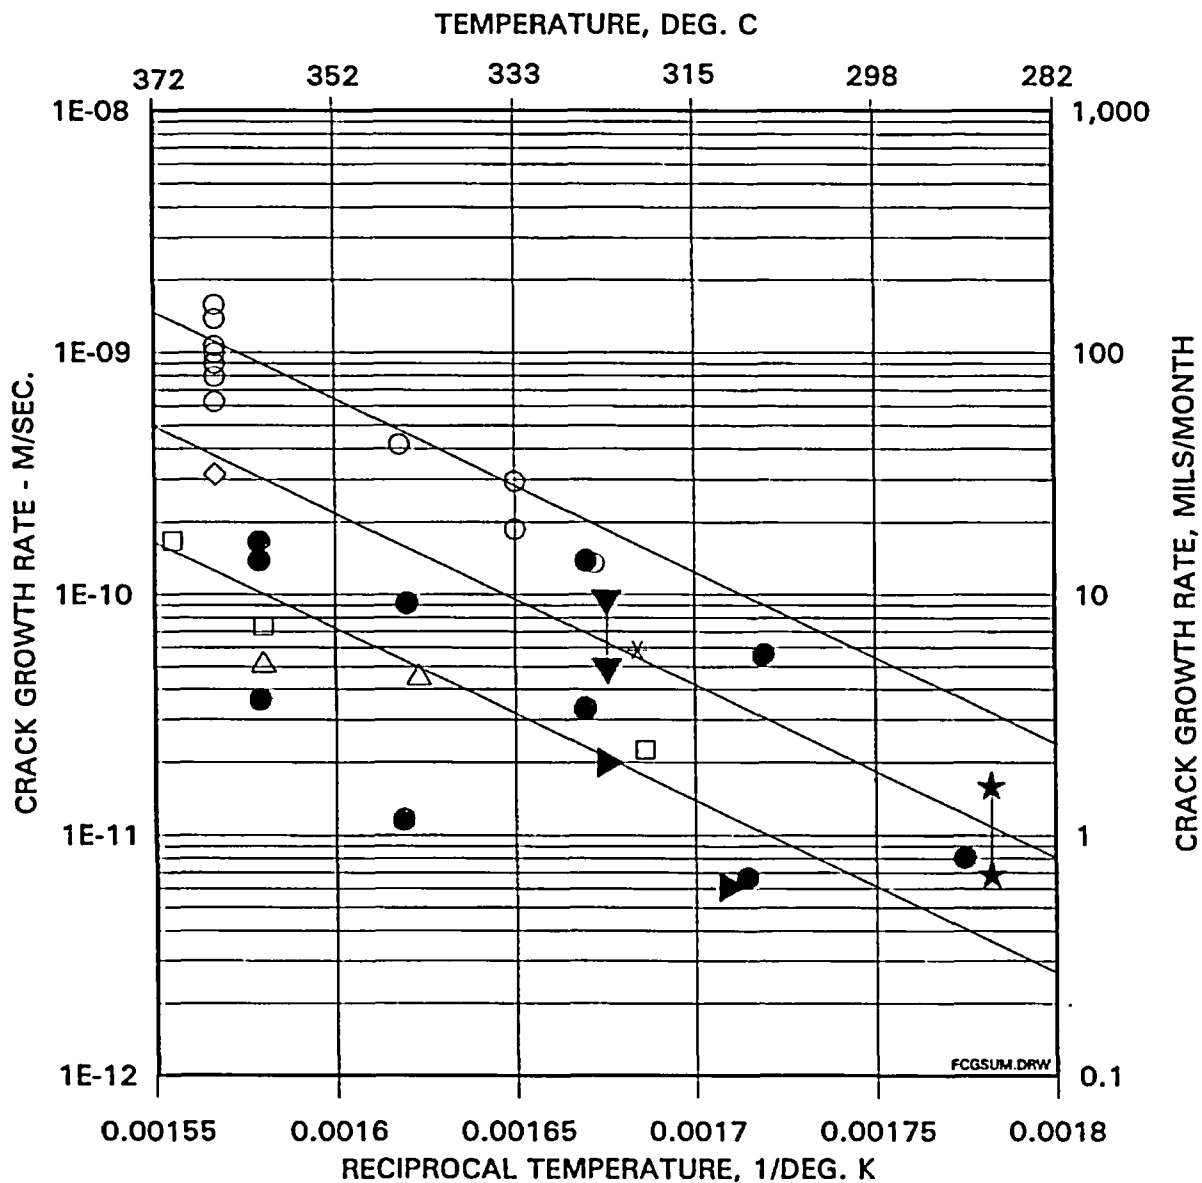
Note: All symbols are for steam generator materials, except the solid circles, which are head penetration laboratory data.

Figure 4-5 Summary of Temperature Effects on PWSCC Growth Rates for Alloy 600 in Primary Water

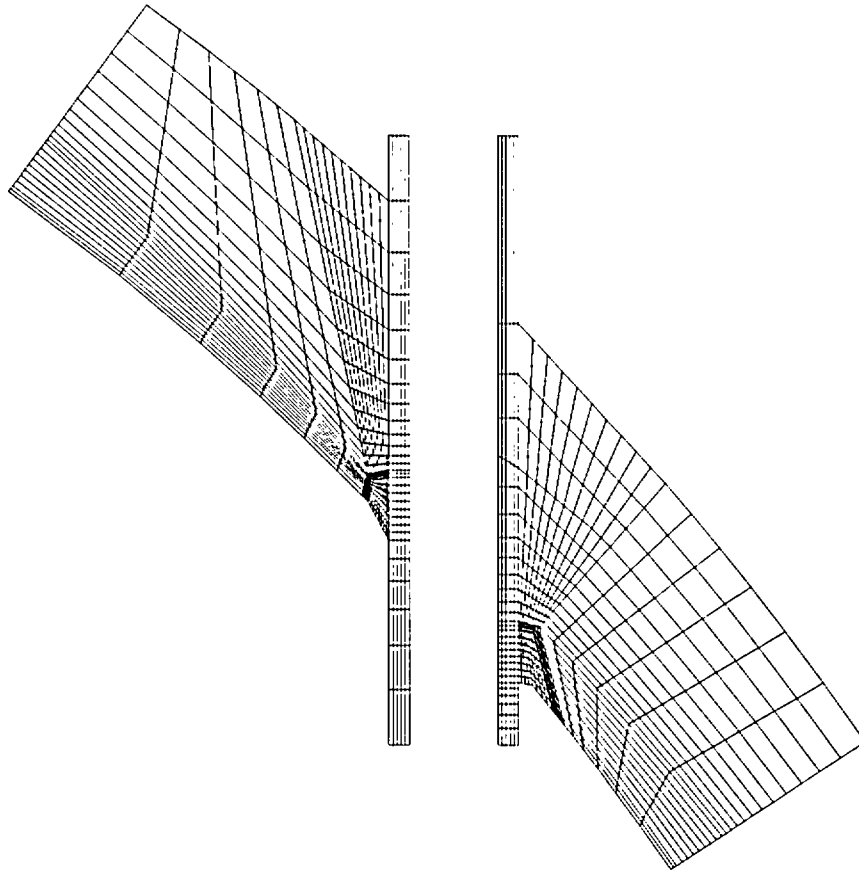
Figure 5-1 Finite Element Model of CRDM Penetration

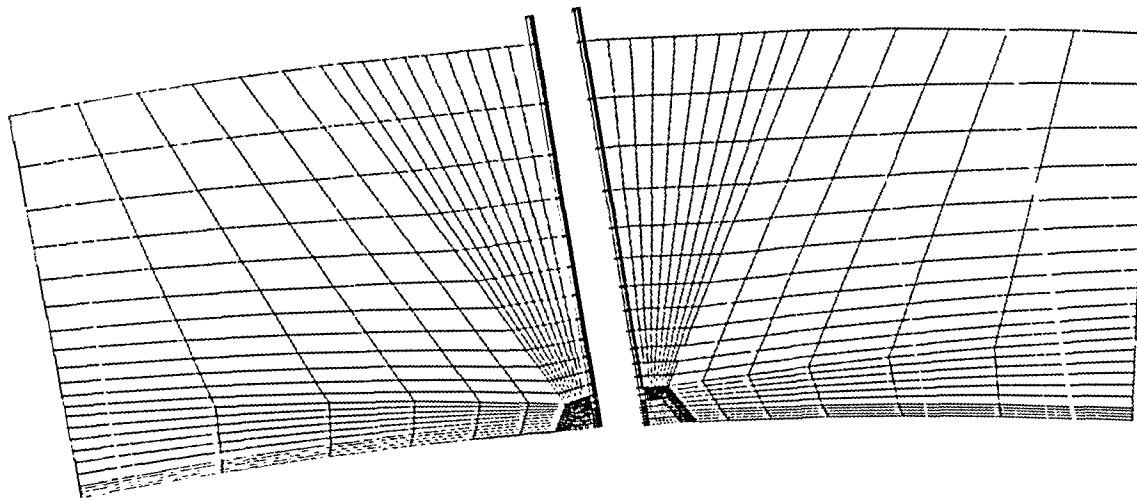
Figure 5-2 Vent Pipe Finite Element Model

The head vent nozzle is a smaller penetration than the CRDM head penetration, but is also constructed of Alloy 600 material, with a partial penetration weld at the inside of the reactor vessel head. The head vent was evaluated using a three-dimensional finite element model as shown in Figure 5-2.

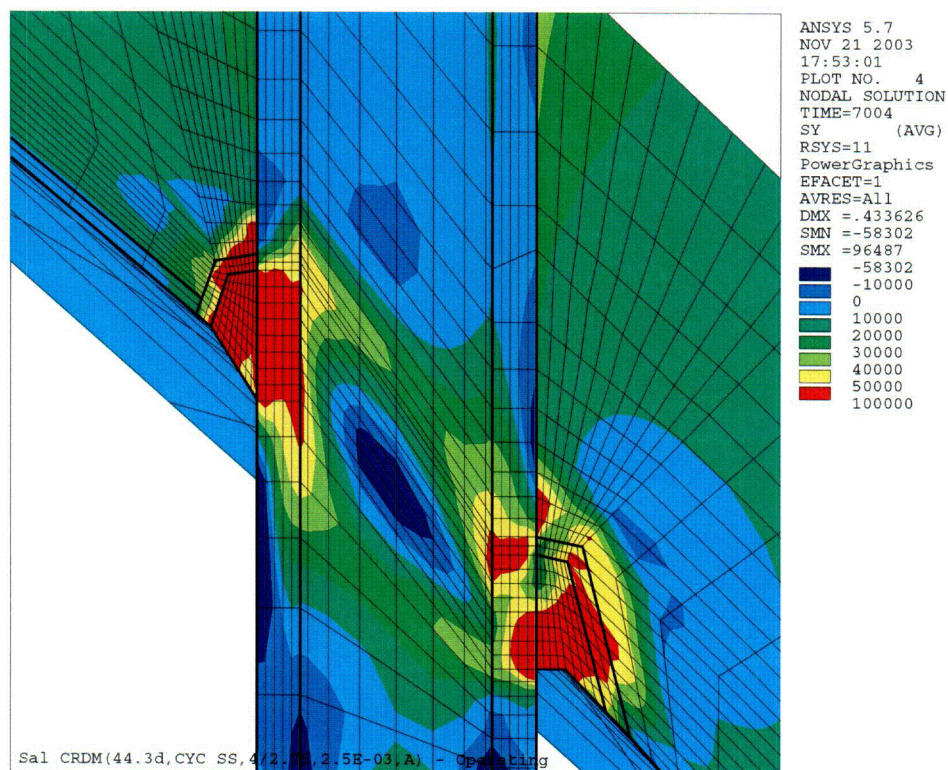
Figure 5-5 Stress Distribution at Steady State Conditions for the 44.3 Degrees CRDM Penetration (Hoop Stress is the Top Figure; Axial Stress is the Bottom Figure)

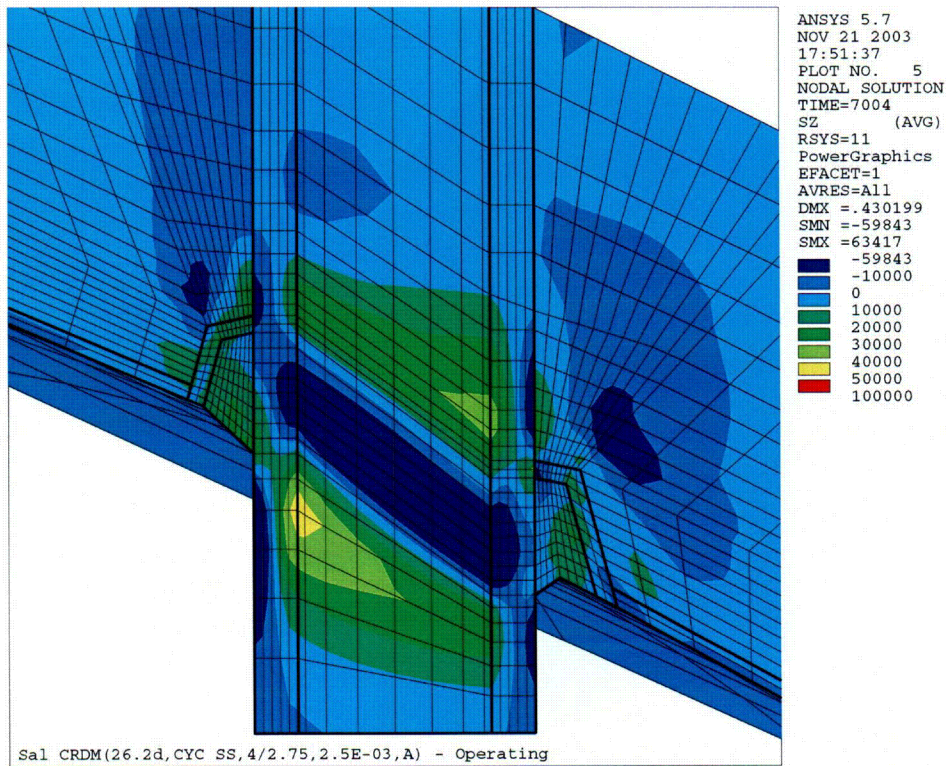
Figure 5-6 Stress Distribution at Steady State Conditions for the 26.2 Degree CRDM Penetration (Hoop Stress is the Top Figure; Axial Stress is the Bottom Figure)

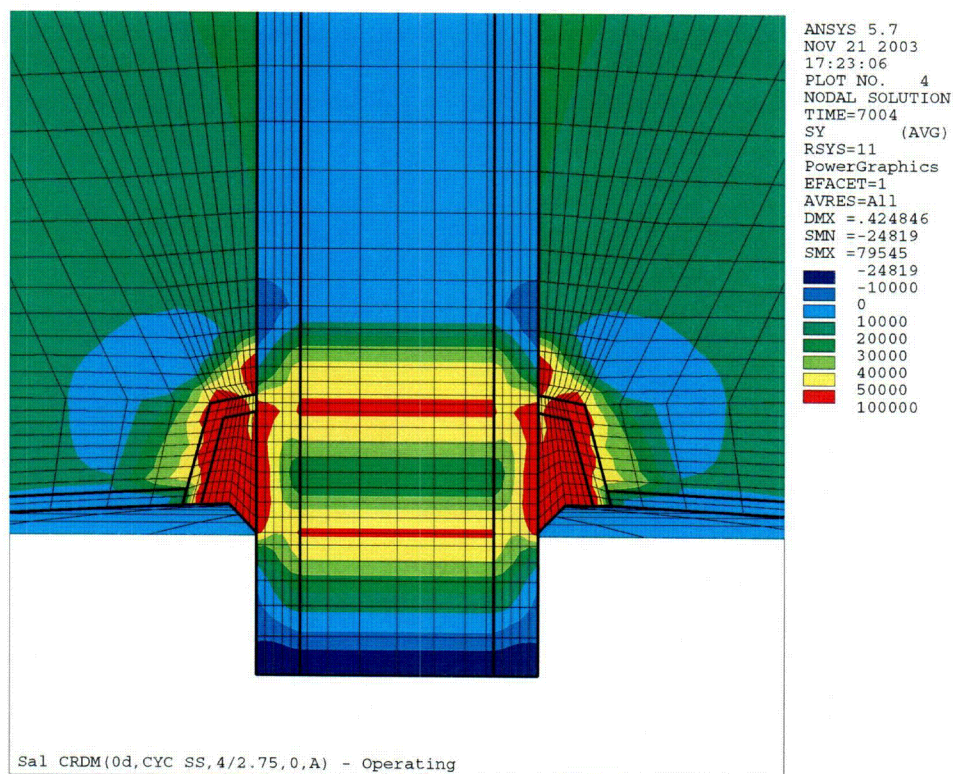
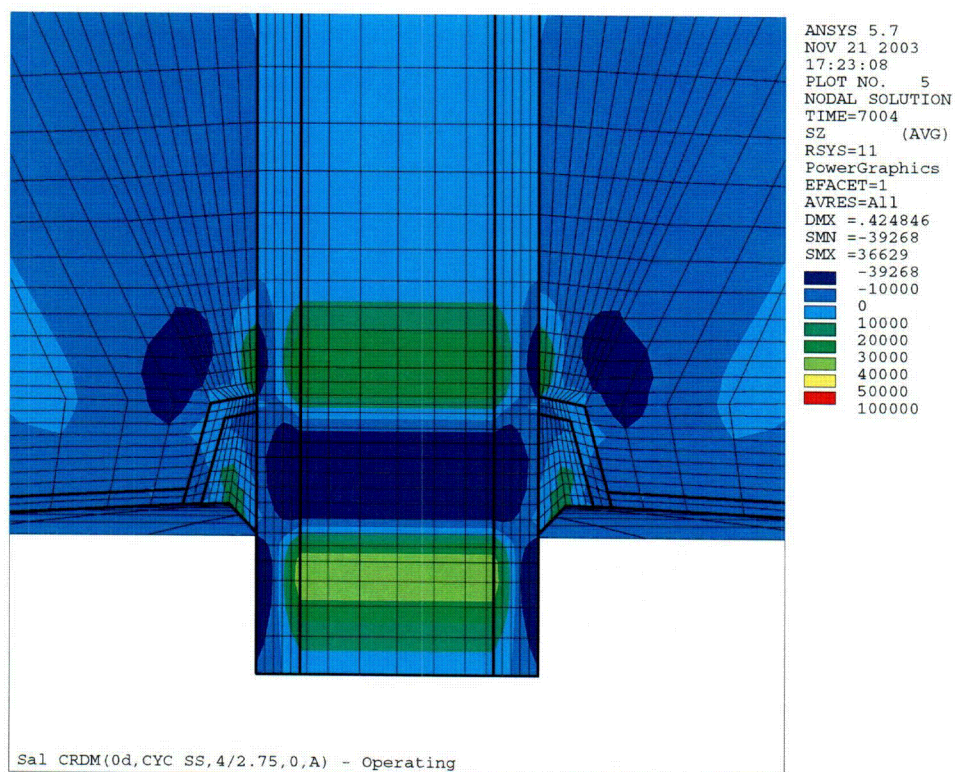
Figure 5-7 Stress Distribution at Steady State Conditions for the Center CRDM Penetration (Hoop Stress is the Top Figure; Axial Stress is the Bottom Figure)

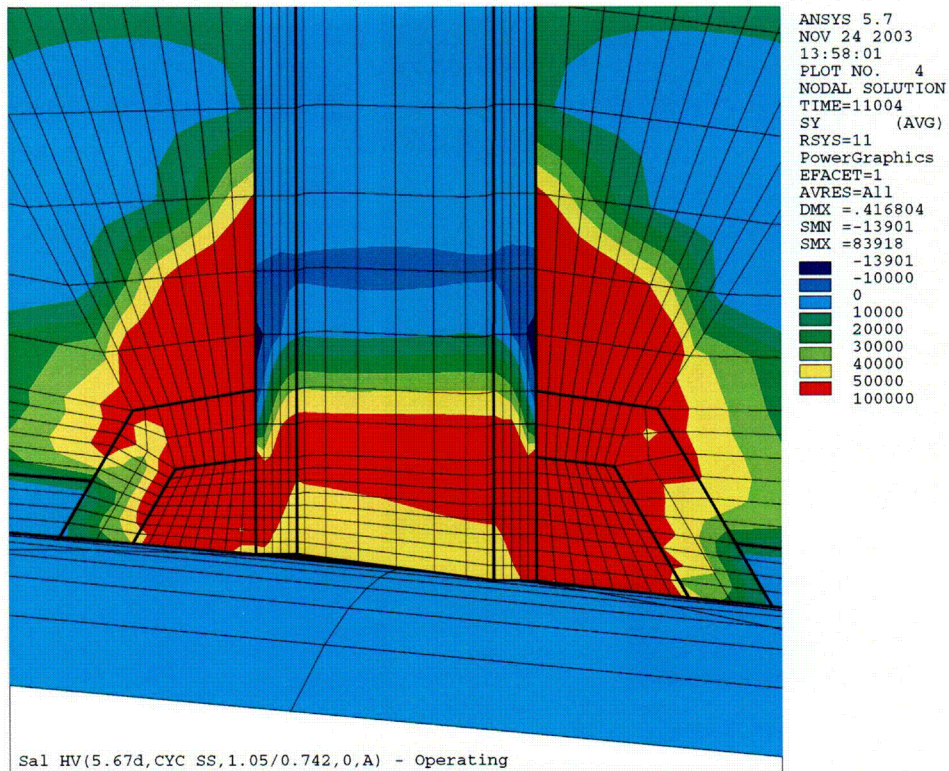
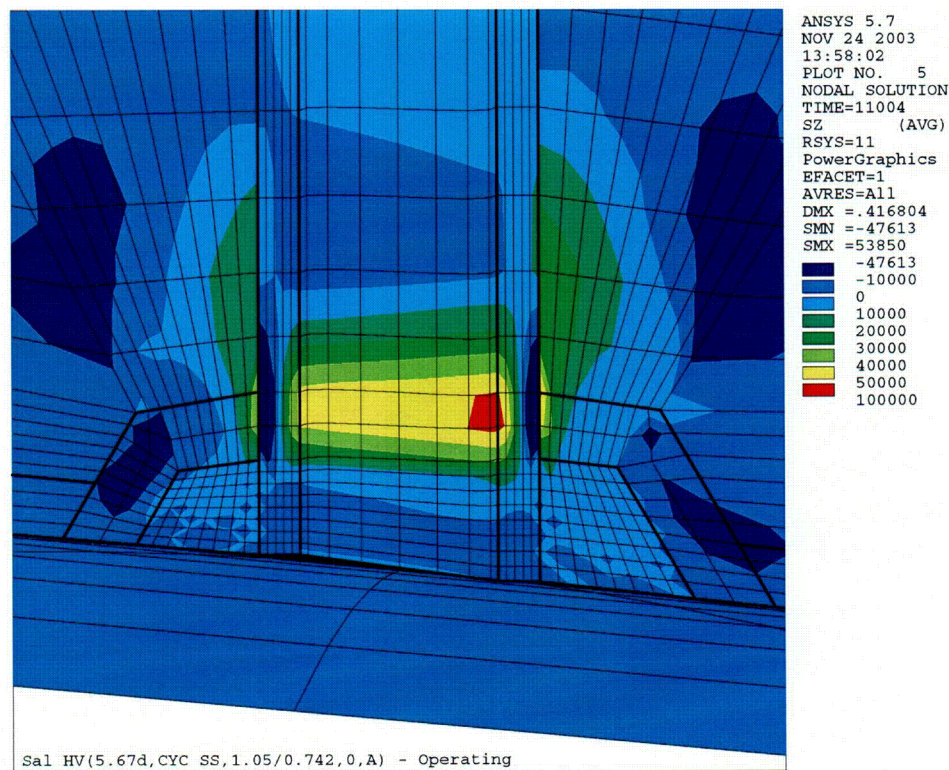
Figure 5-8 Stress Contours in the Head Vent Nozzle as a Result of Residual Stresses and Operating Pressure (Hoop Stress is the Top Figure; Axial Stress is the Bottom Figure)

The critical stress location in the head vent is in the vicinity of the attachment weld, where residual and pressure stresses have the most impact. As with the CRDM penetrations, the residual stresses dominate. Also similar to the CRDM head penetrations, the stresses in the pipe decrease quickly as a function of distance up the pipe away from the weld. The hoop and axial stresses are shown as contours in Figure 5-8.

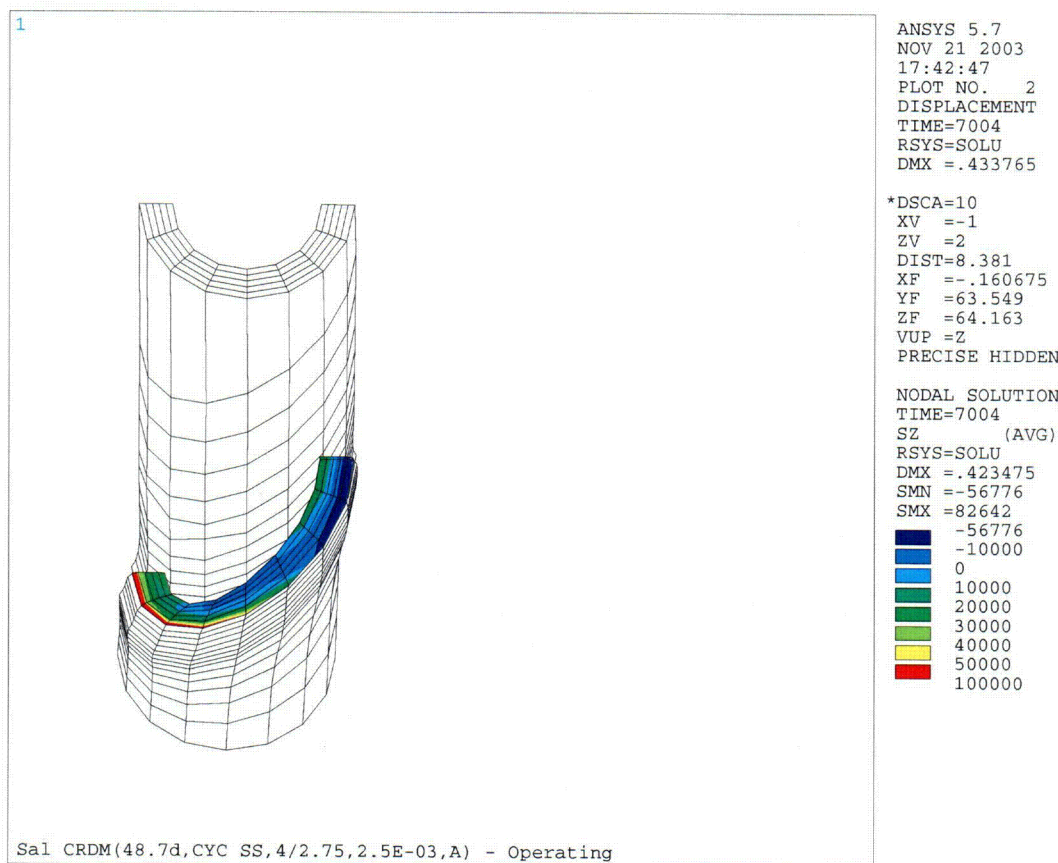
Figure 5-9 Axial Stress Distribution at Steady State Conditions for the Outermost CRDM Penetration (48.7 Degrees), Along a Plane Oriented Parallel to, and Just Above, the Attachment Weld

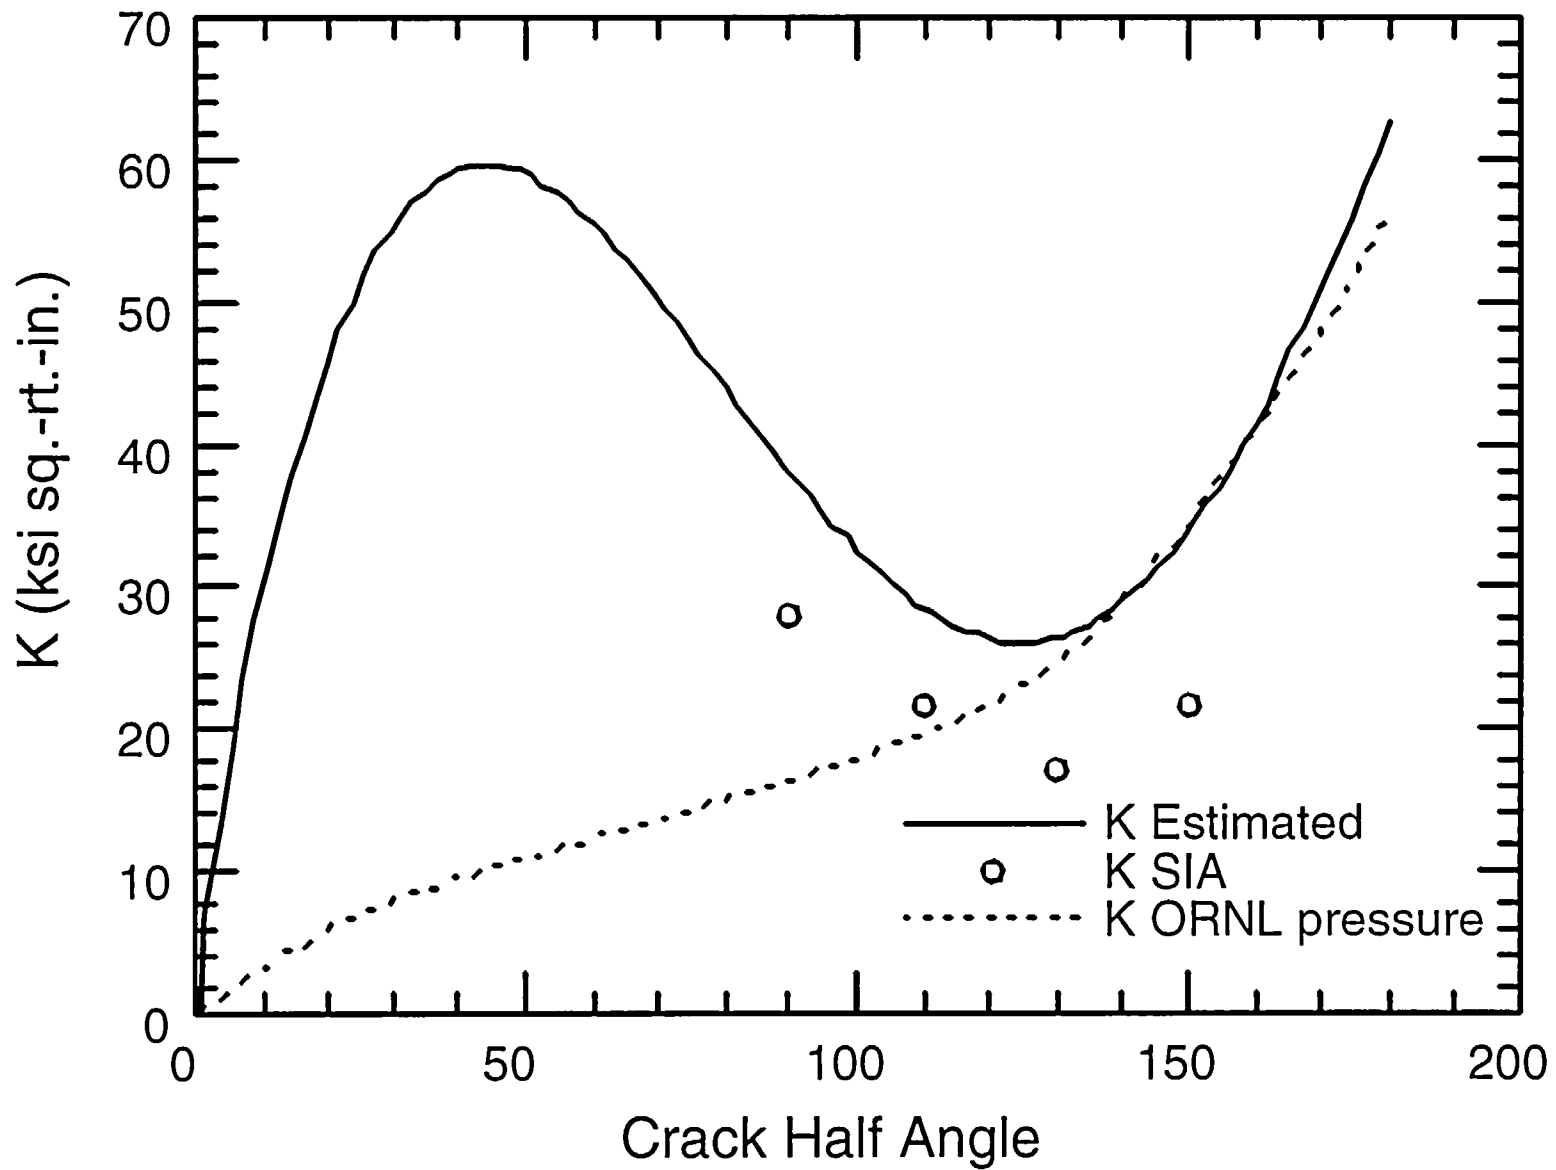
Figure 6-1 Stress Intensity Factor for a Through-Wall Circumferential Flaw in a Head Penetration

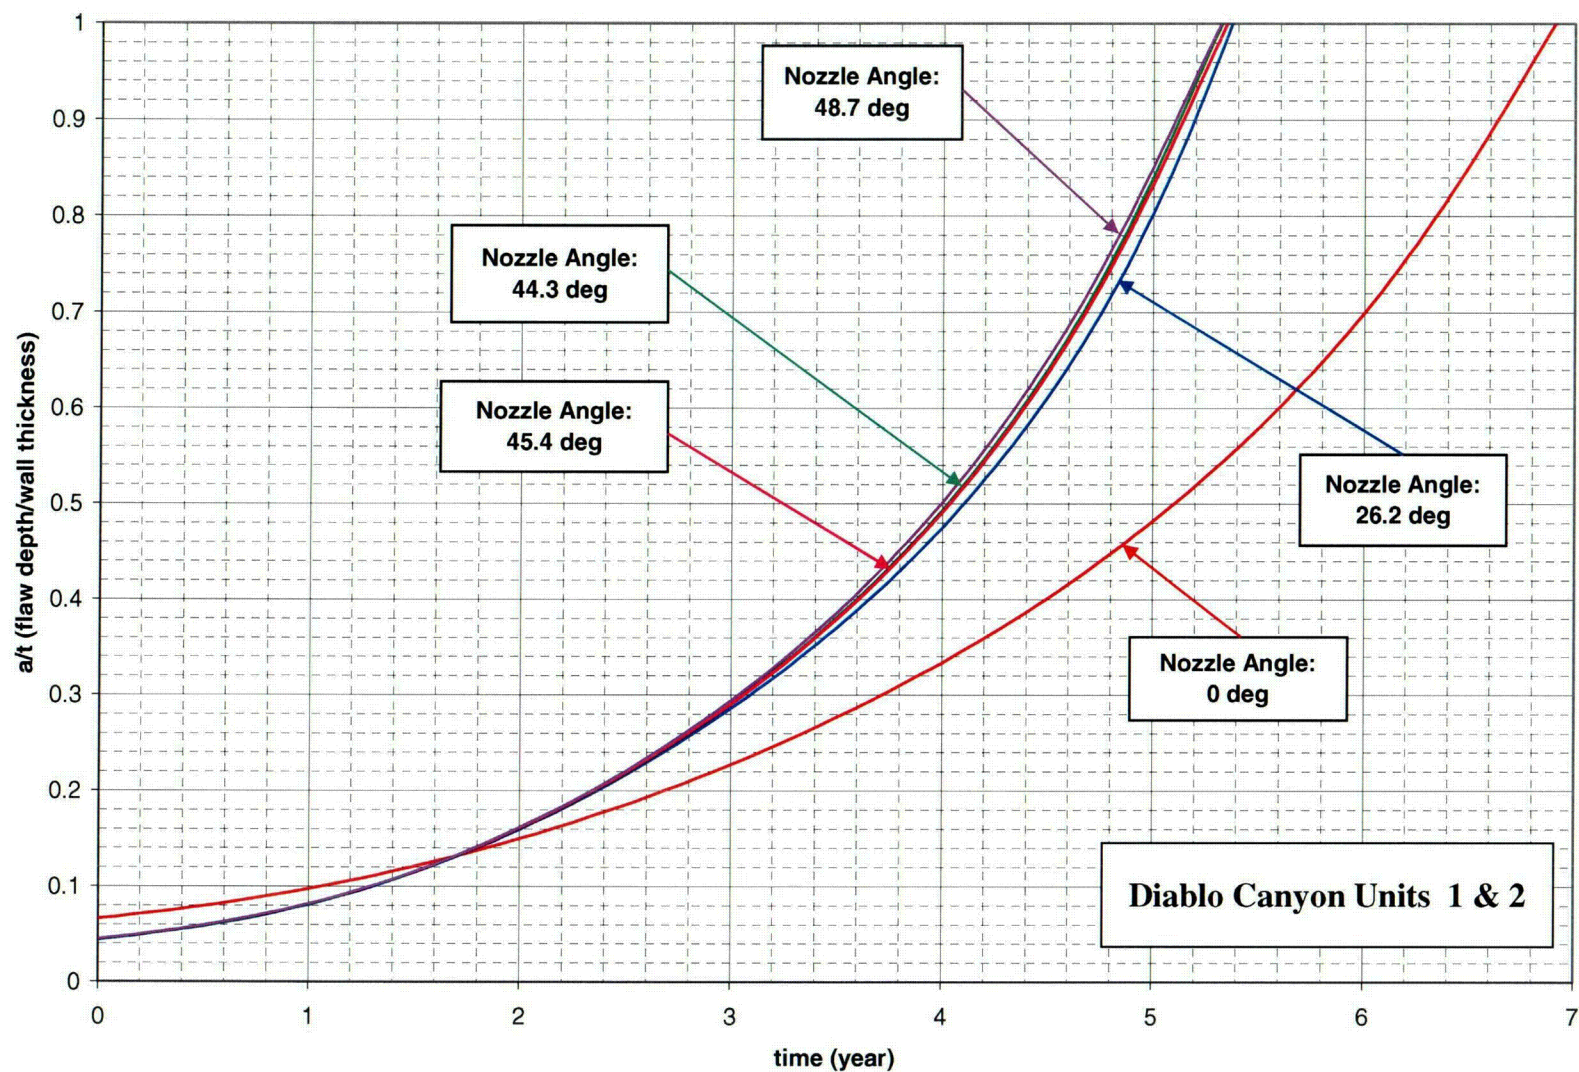
Figure 6-2 Inside, Axial Surface Flaws, .5" Below the Attachment Weld, Nozzle Uphill Side - Crack Growth Predictions for Diablo Canyon Units 1 and 2

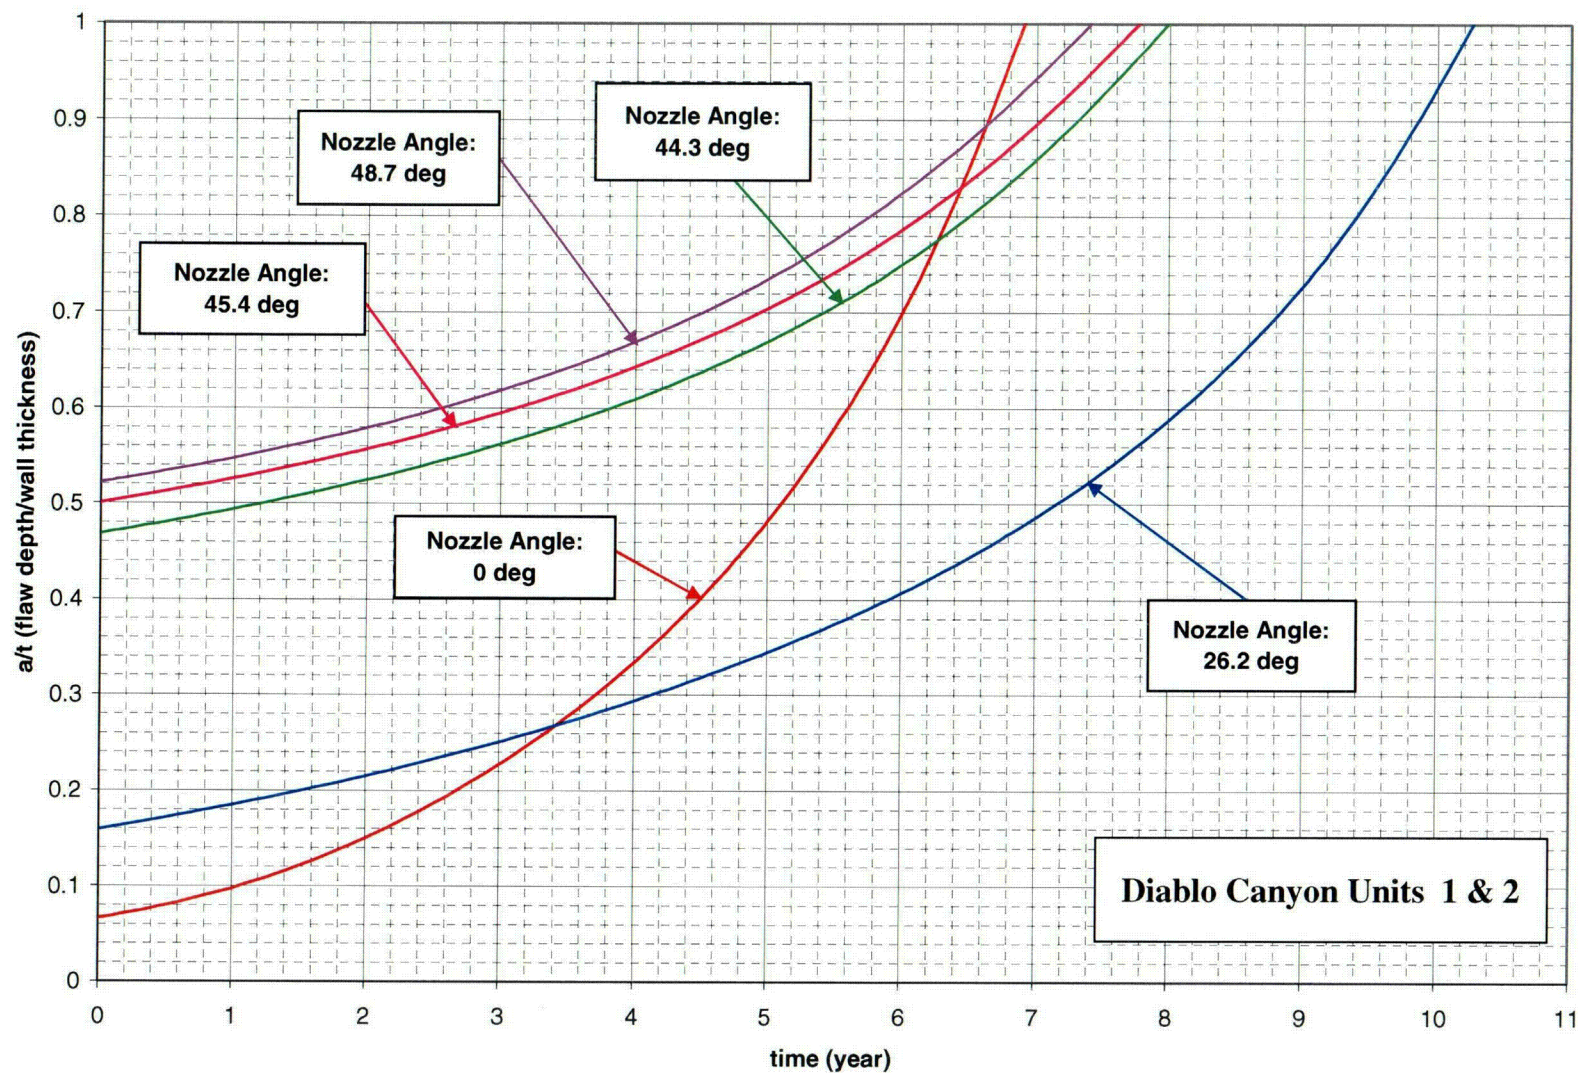
Figure 6-3 Inside, Axial Surface Flaws, .5" Below the Attachment Weld, Nozzle Downhill Side - Crack Growth Predictions for Diablo Canyon Units 1 and 2
