WCAP-15429-NP (Non-Proprietary)
Revision 0
September 2004

Structural Integrity Evaluation of Reactor Vessel Upper Head Penetrations to Support Continued Operation: Diablo Canyon Units 1 and 2

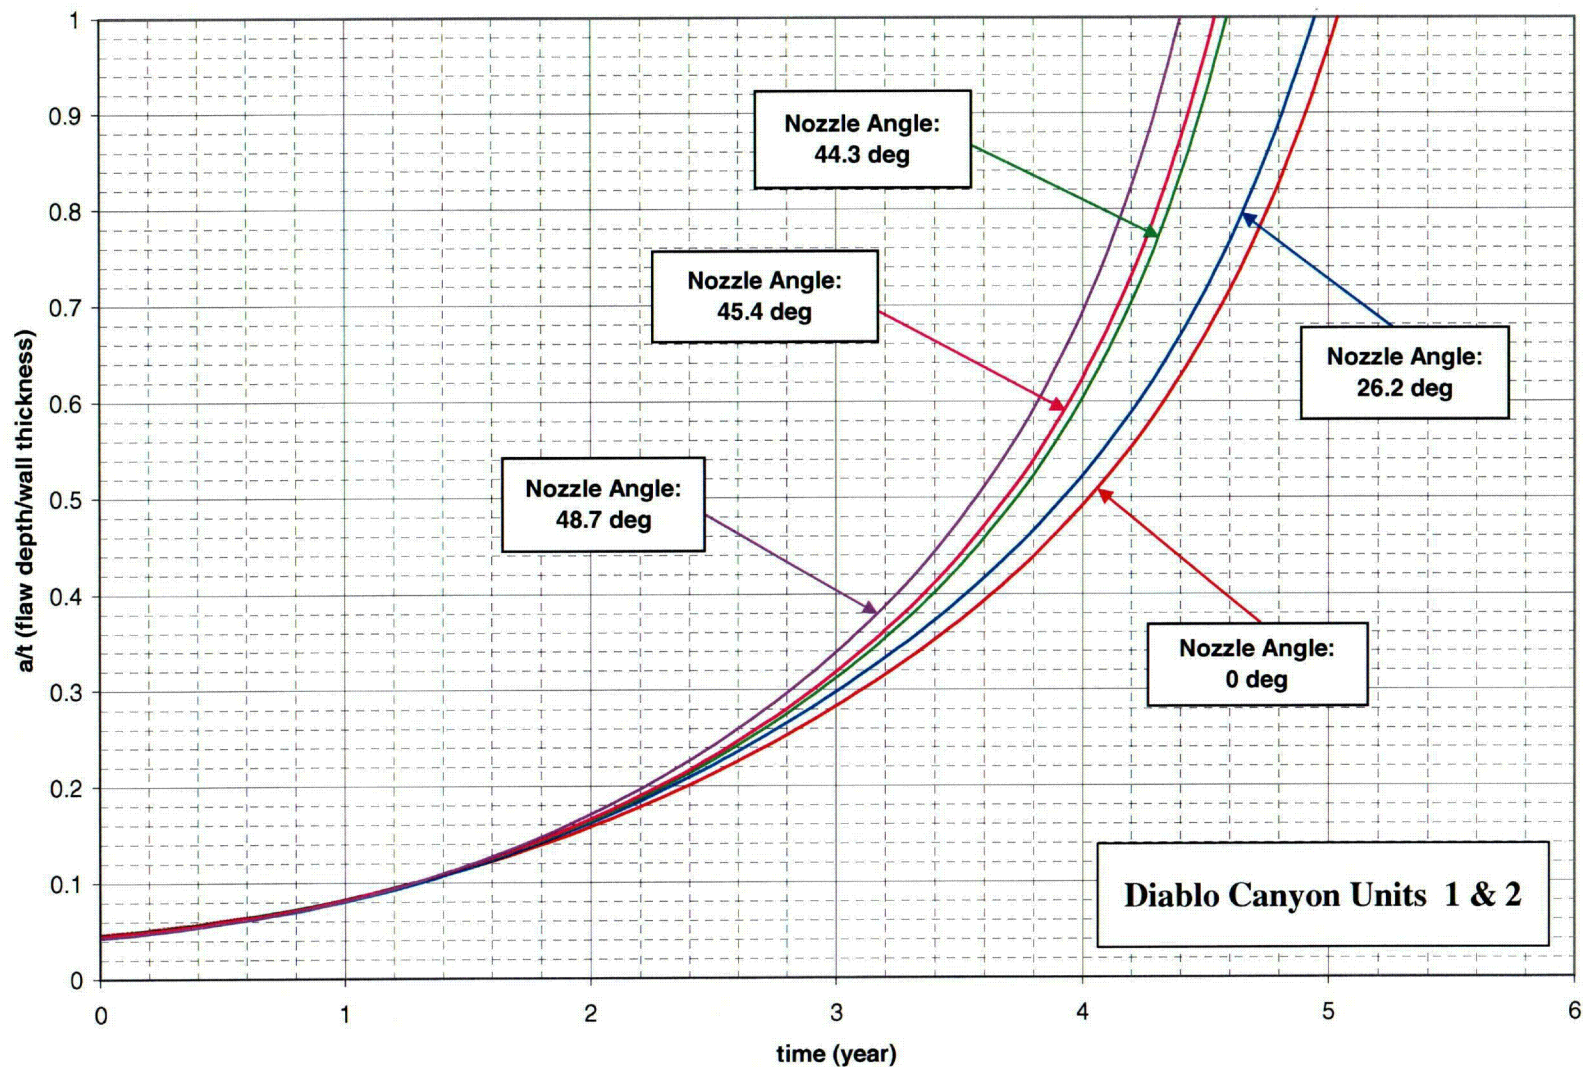
Figure 6-4 Inside, Axial Surface Flaws, At the Attachment Weld, Nozzle Uphill Side - Crack Growth Predictions for Diablo Canyon Units 1 and 2

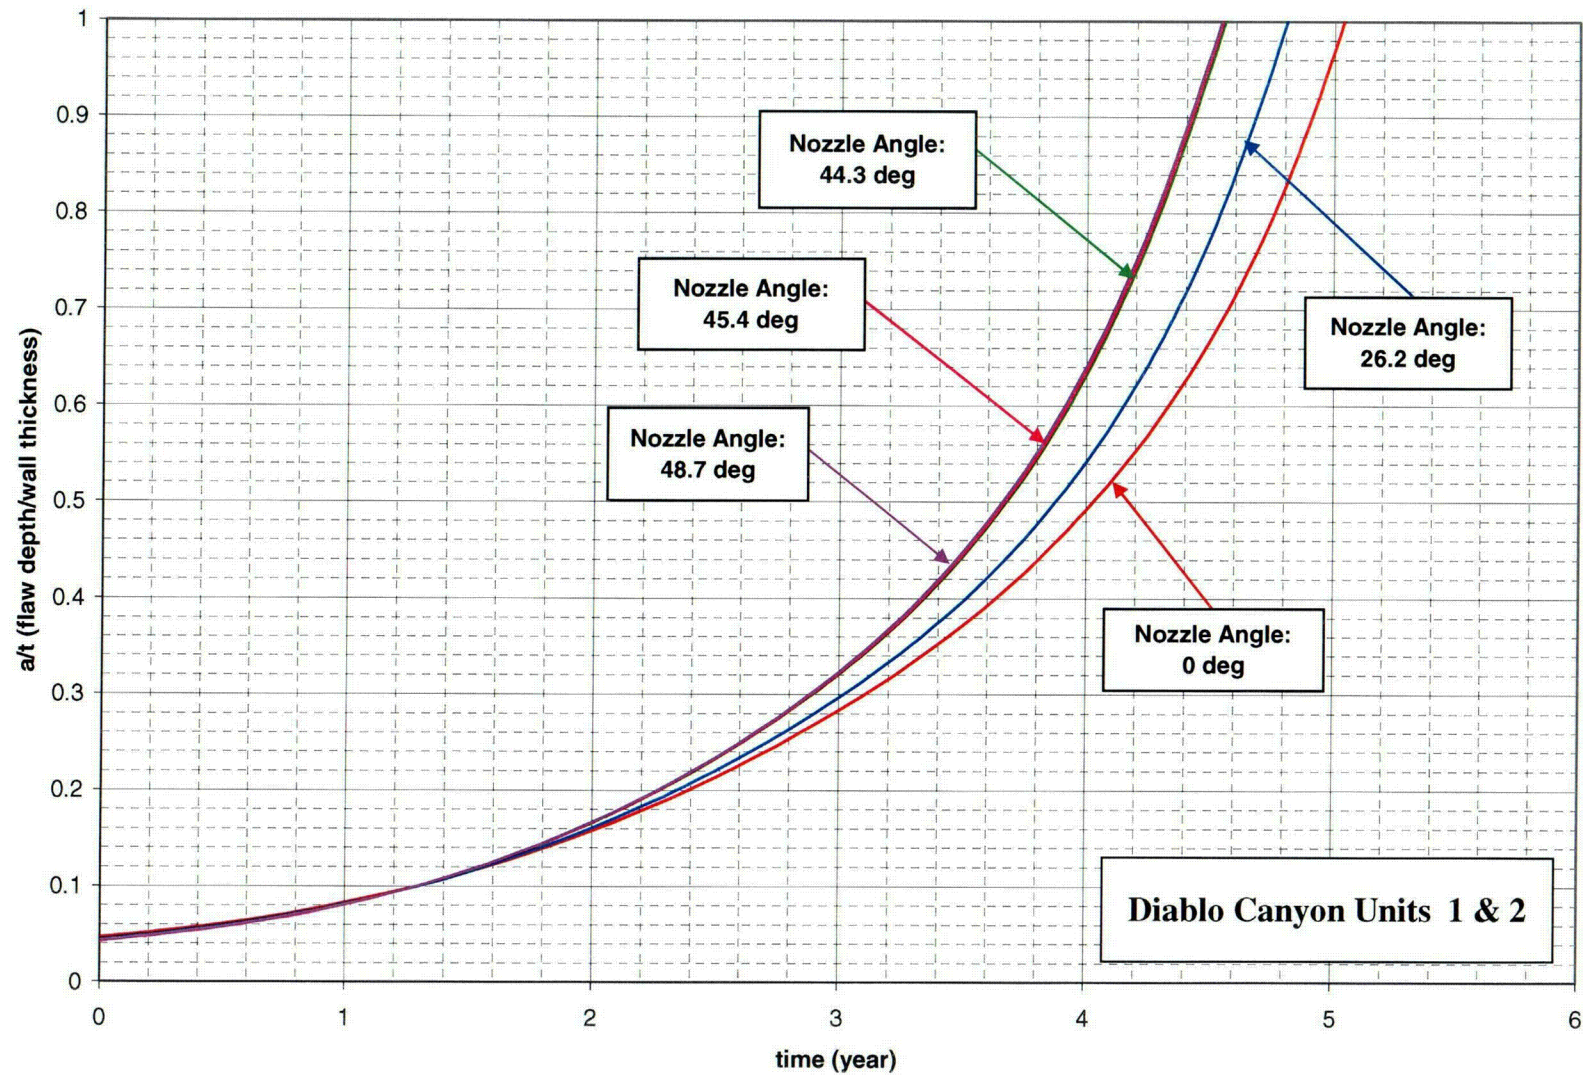
Figure 6-5 Inside, Axial Surface Flaws, At the Attachment Weld, Nozzle Downhill Side - Crack Growth Predictions for Diablo Canyon Units 1 and 2

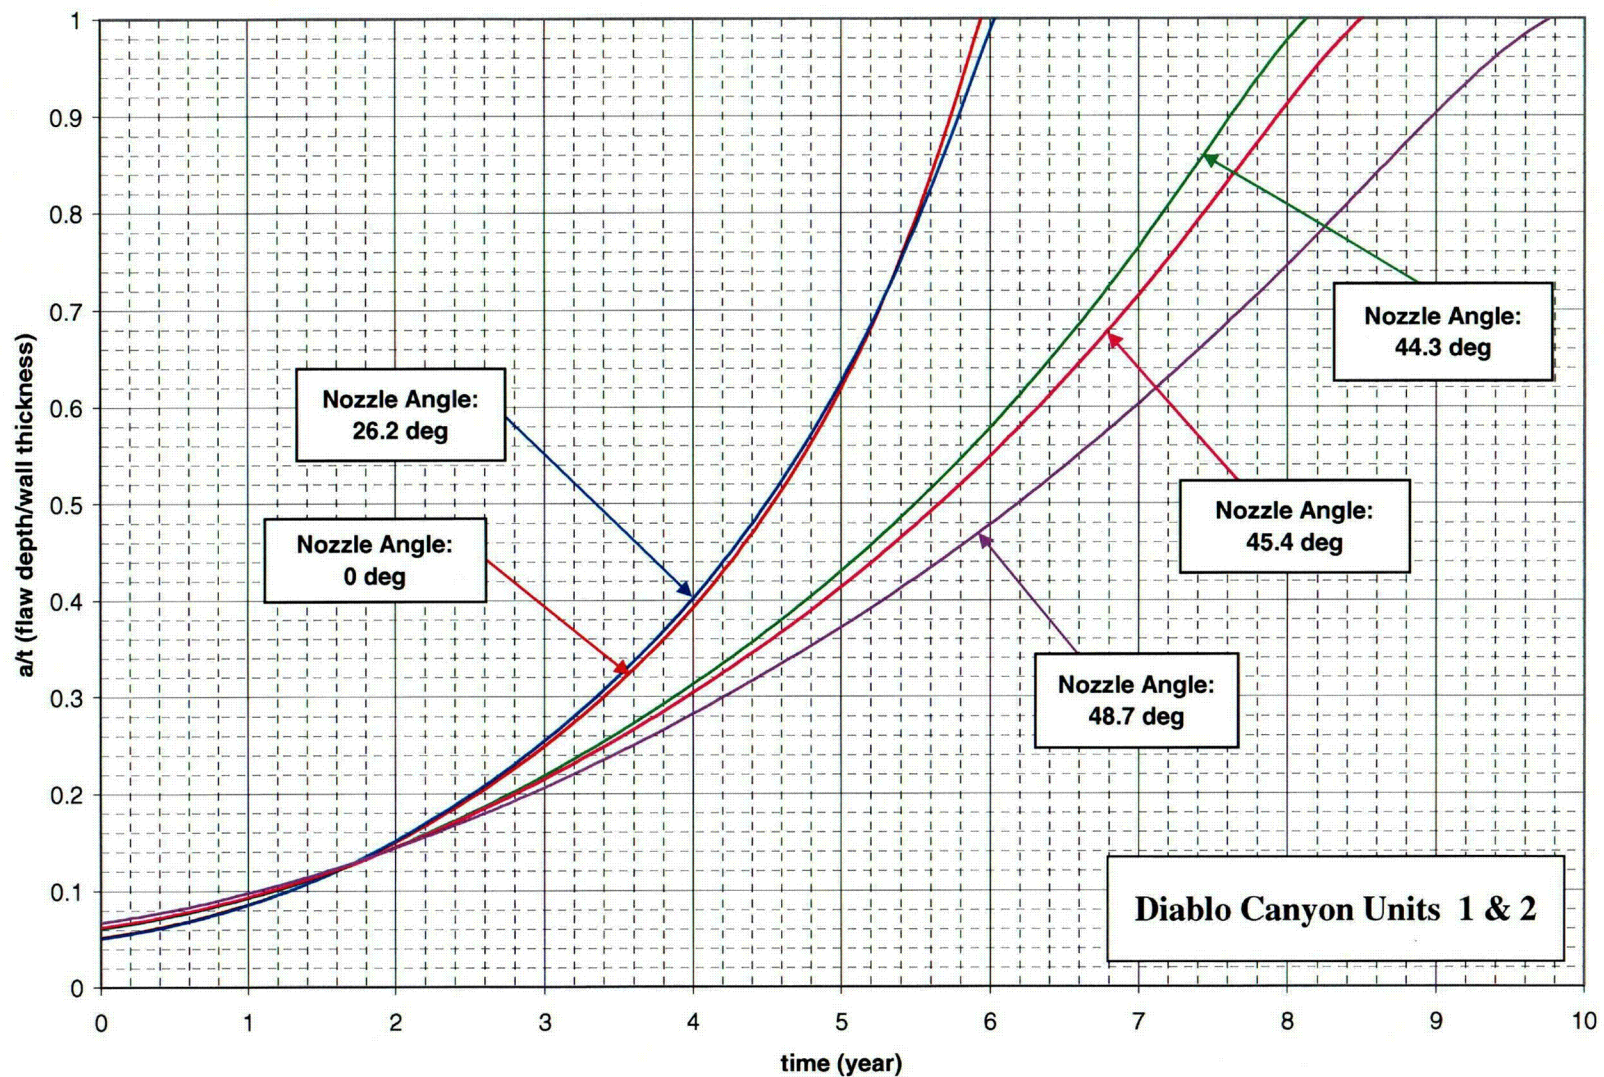
Figure 6-6 Inside, Axial Surface Flaws, .5" Above the Attachment Weld, Nozzle Uphill Side - Crack Growth Predictions for Diablo Canyon Units 1 and 2

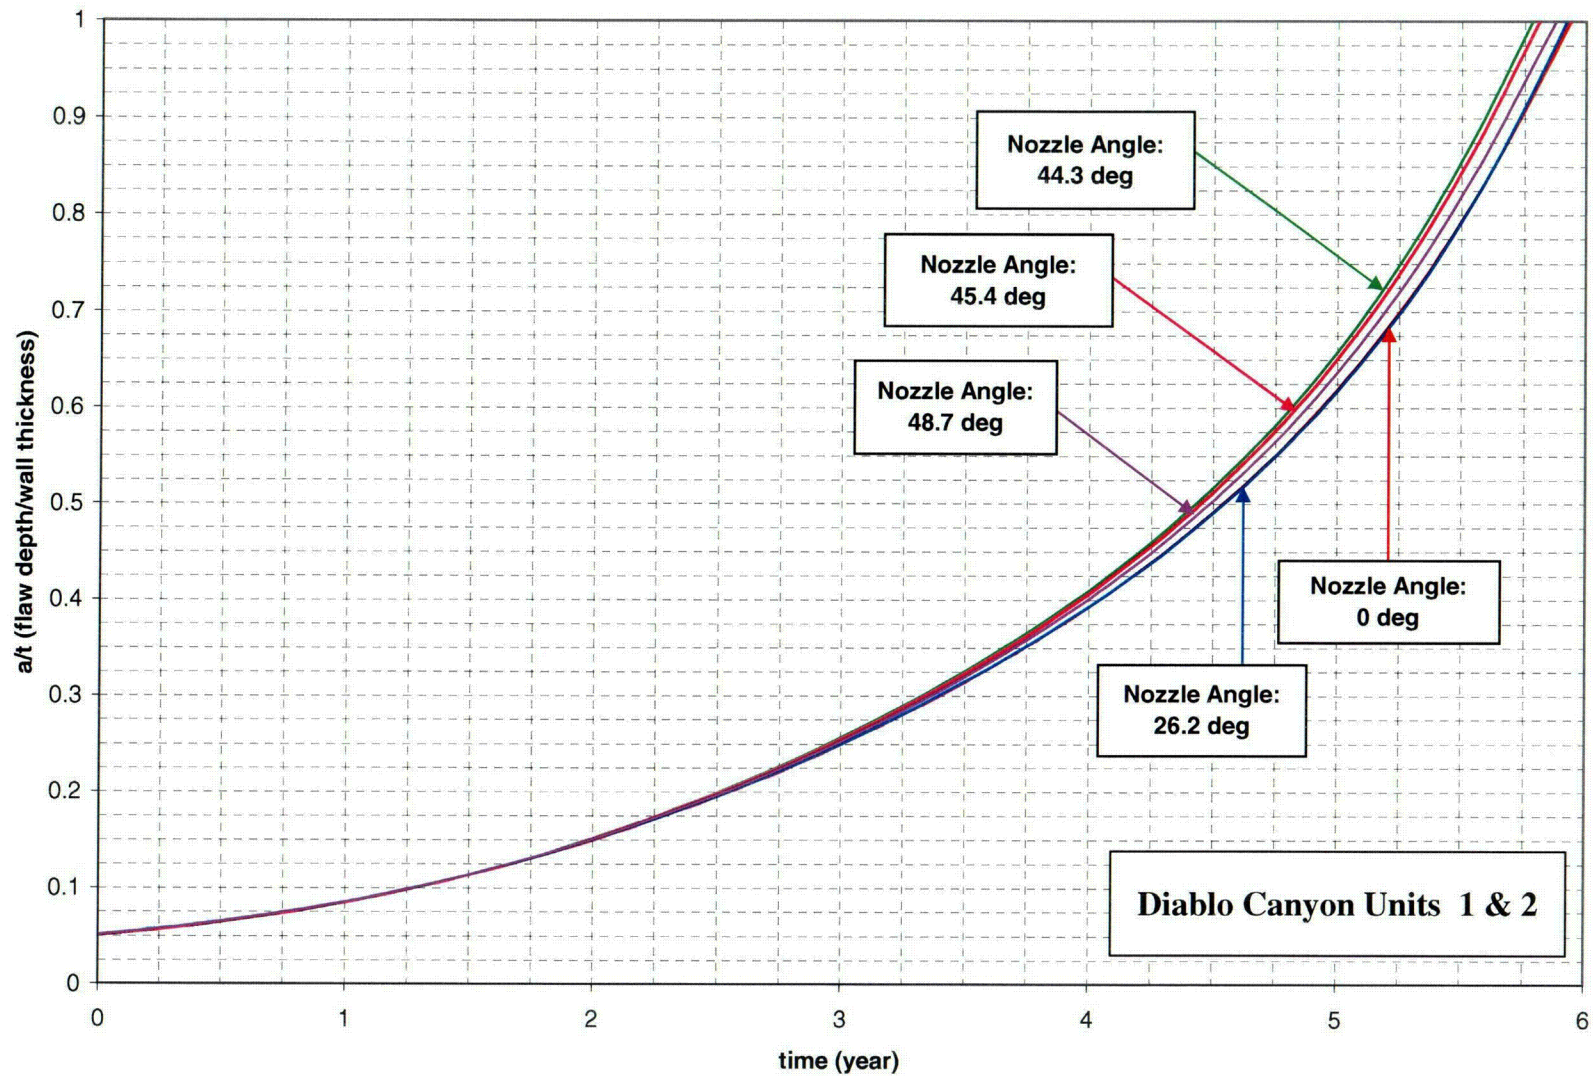
Figure 6-7 Inside, Axial Surface Flaws, .5" Above the Attachment Weld, Nozzle Downhill Side - Crack Growth Predictions for Diablo Canyon Units 1 and 2

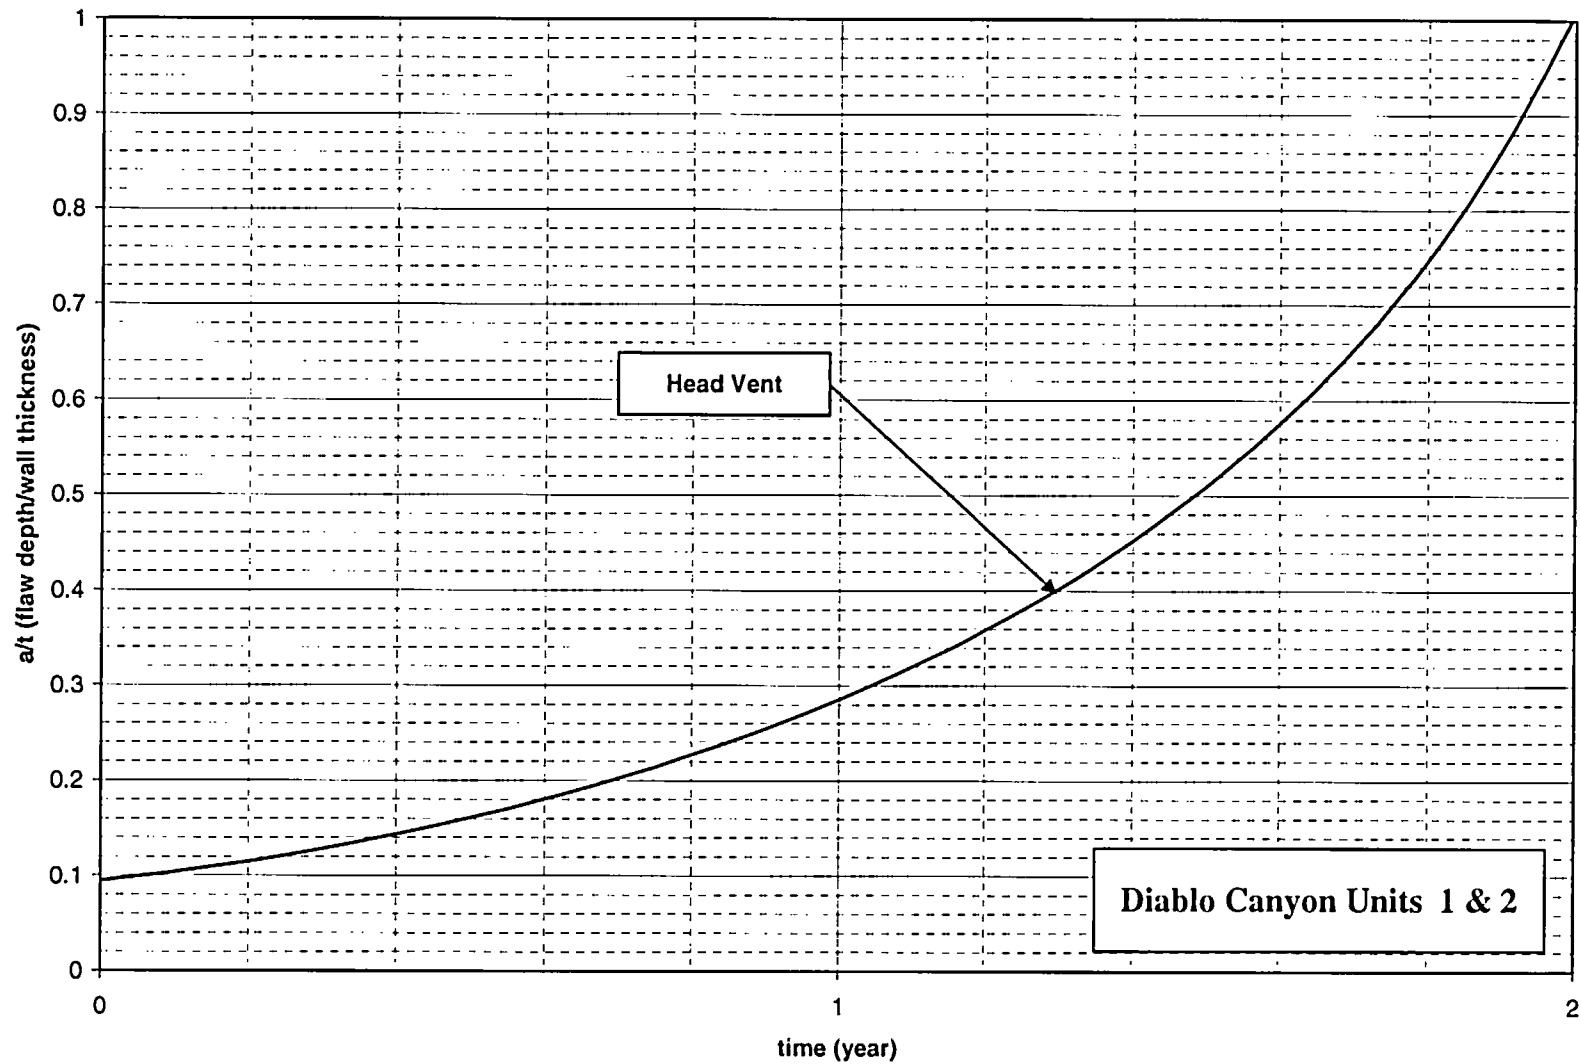
Figure 6-8 Inside, Axial Surface Flaws, At the Attachment Weld, Head Vent- Crack Growth Predictions for Diablo Canyon Units 1 and 2

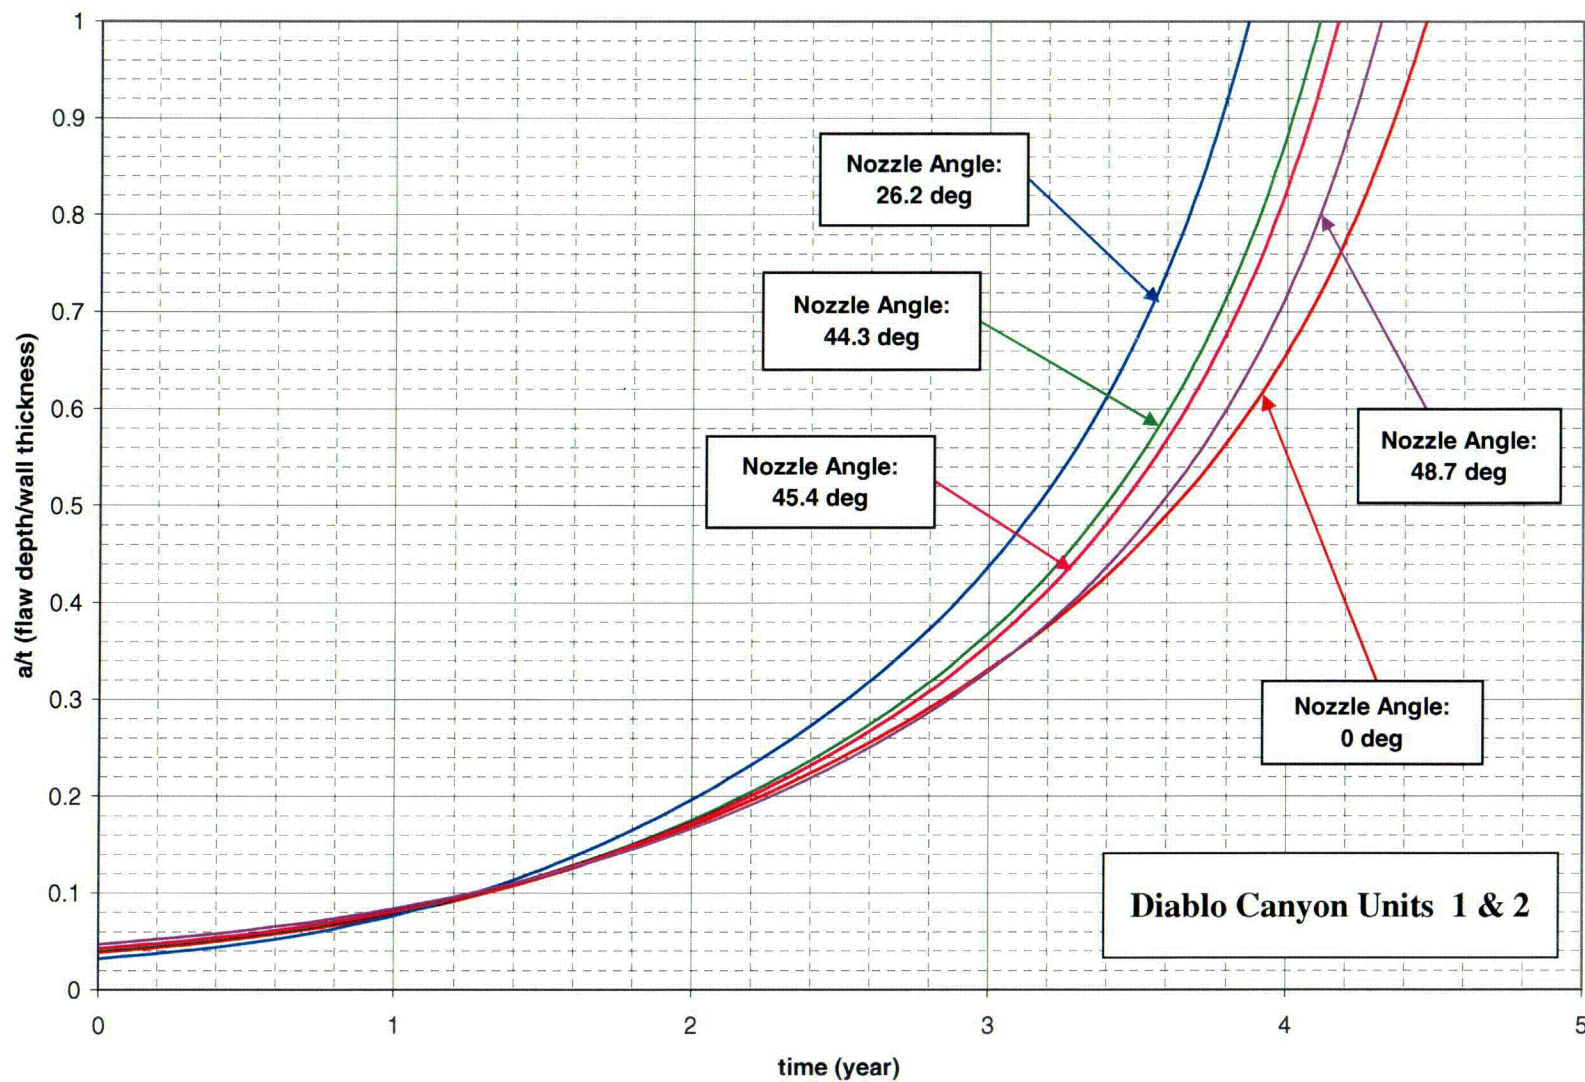
Figure 6-9 Outside, Axial Surface Flaws, Below the Attachment Weld, Nozzle Uphill Side - Crack Growth Predictions for Diablo Canyon Units 1 and 2

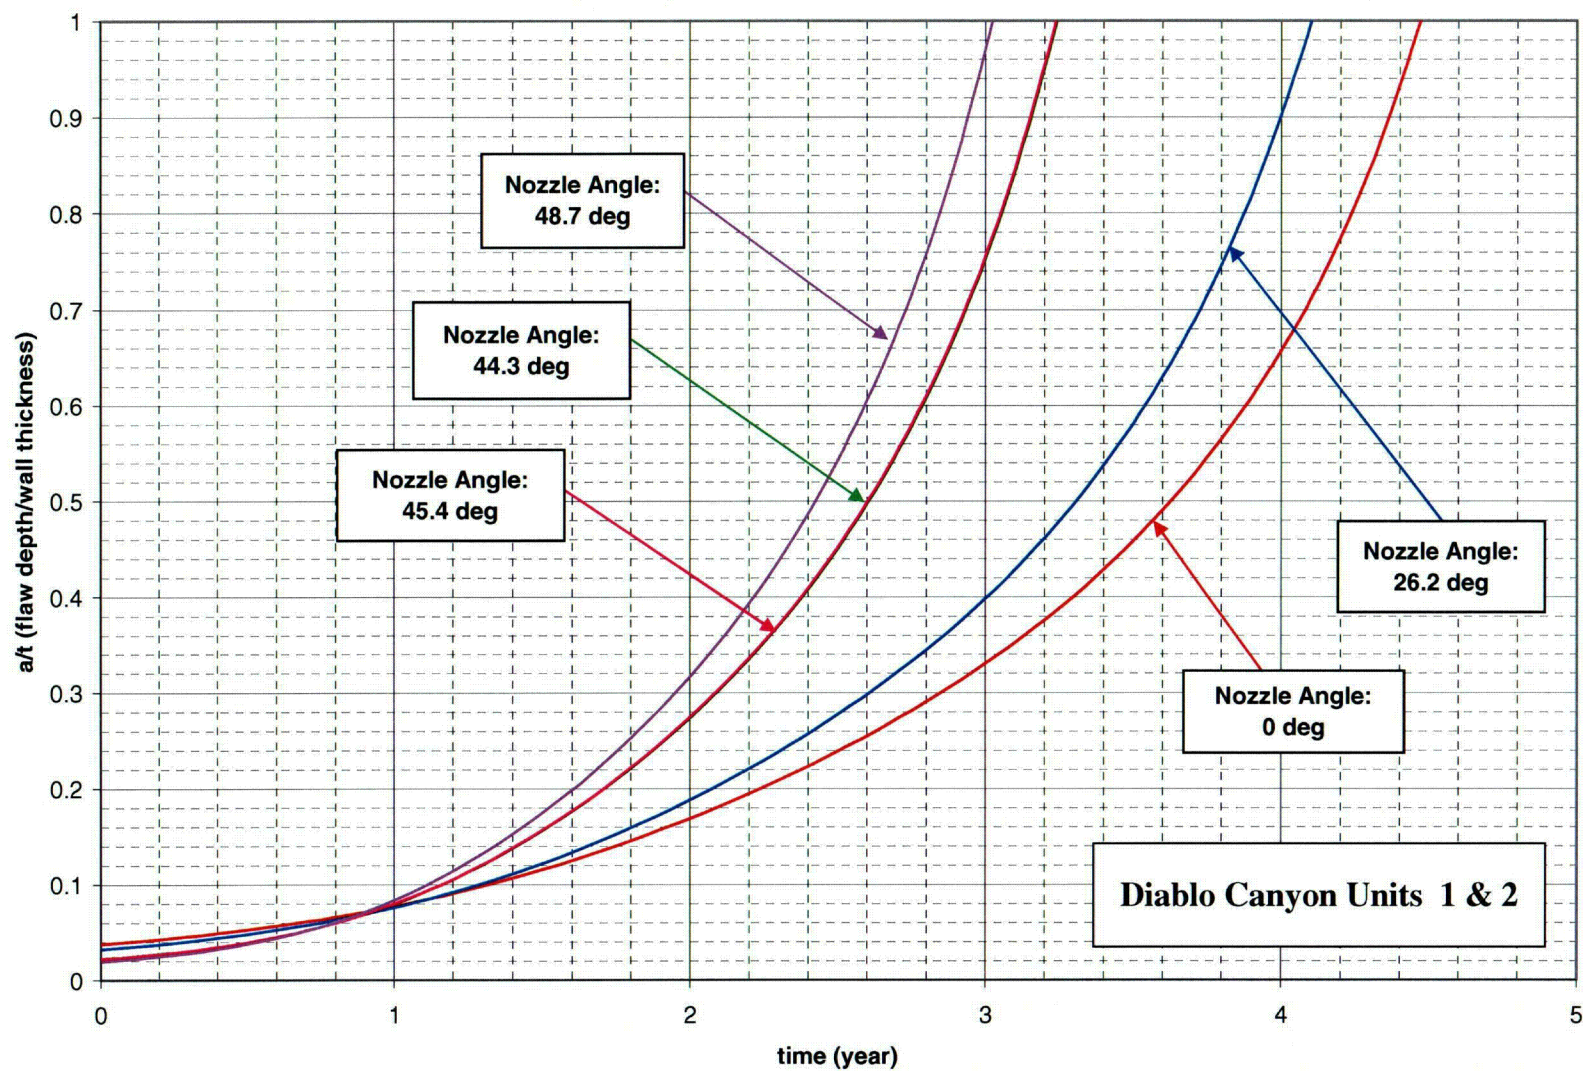
Figure 6-10 Outside, Axial Surface Flaws, Below the Attachment Weld, Nozzle Downhill Side - Crack Growth Predictions for Diablo Canyon Units 1 and 2

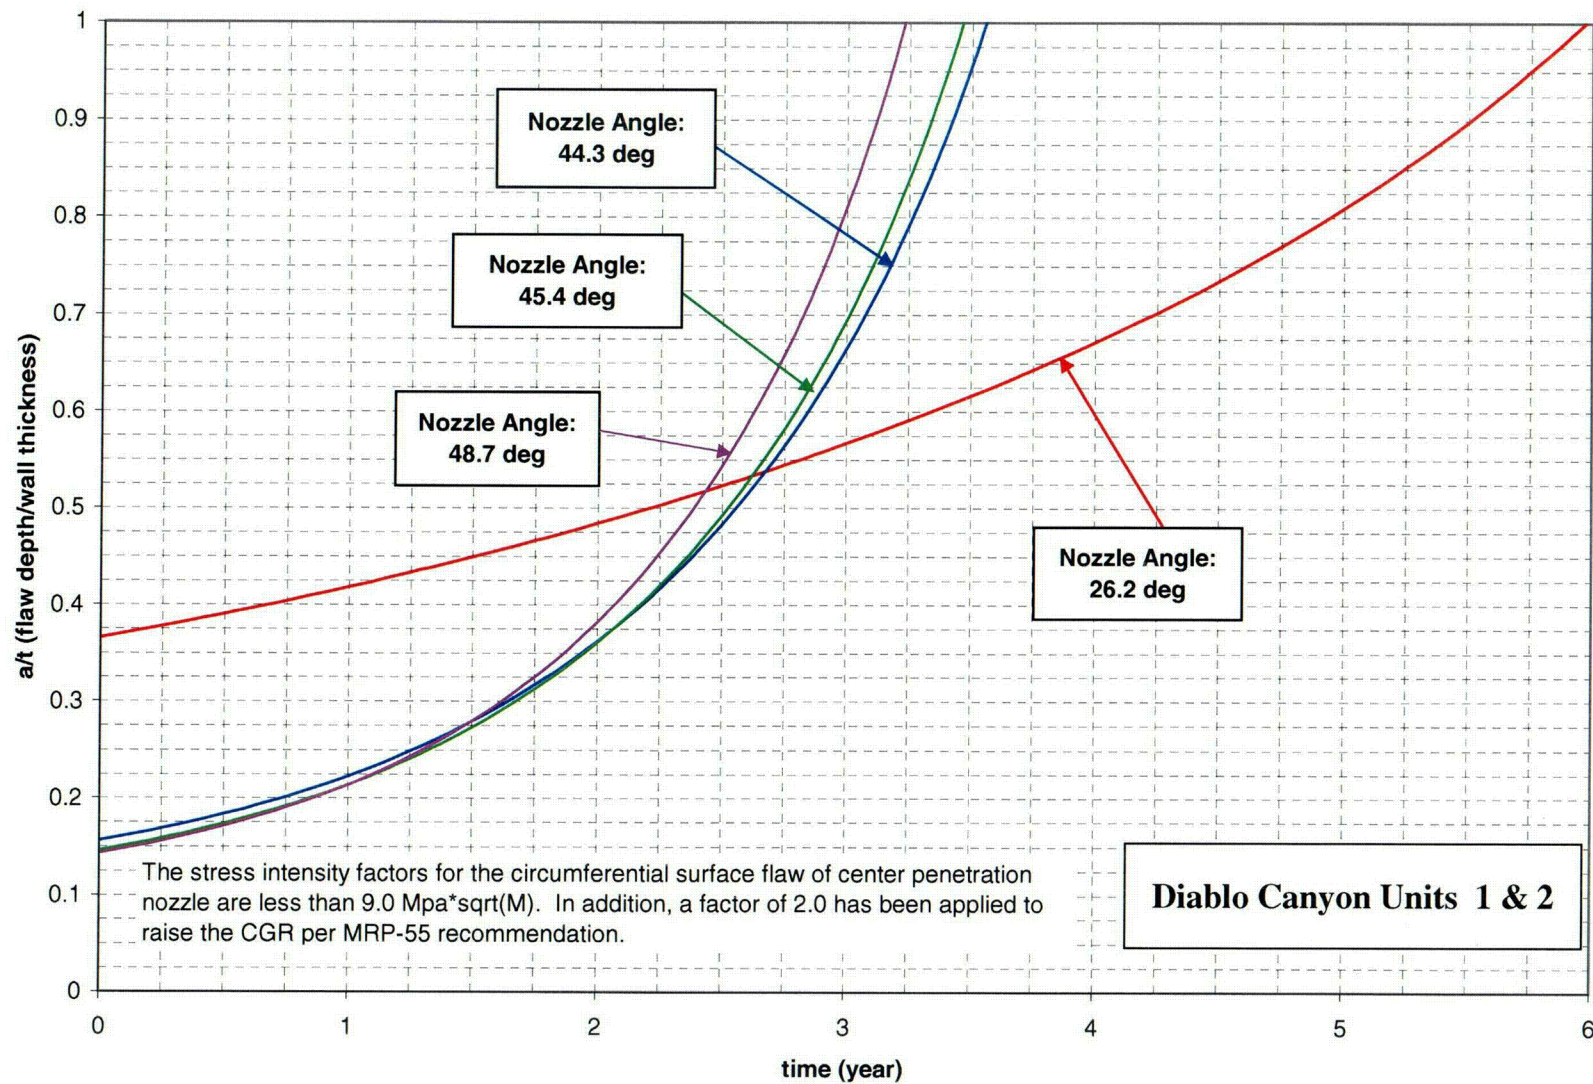
Figure 6-11 Outside, Circumferential Surface Flaws, Along the Top of the Attachment Weld - Crack Growth Predictions for Diablo Canyon Units 1 and 2 (MRP Factor of 2.0 Included)

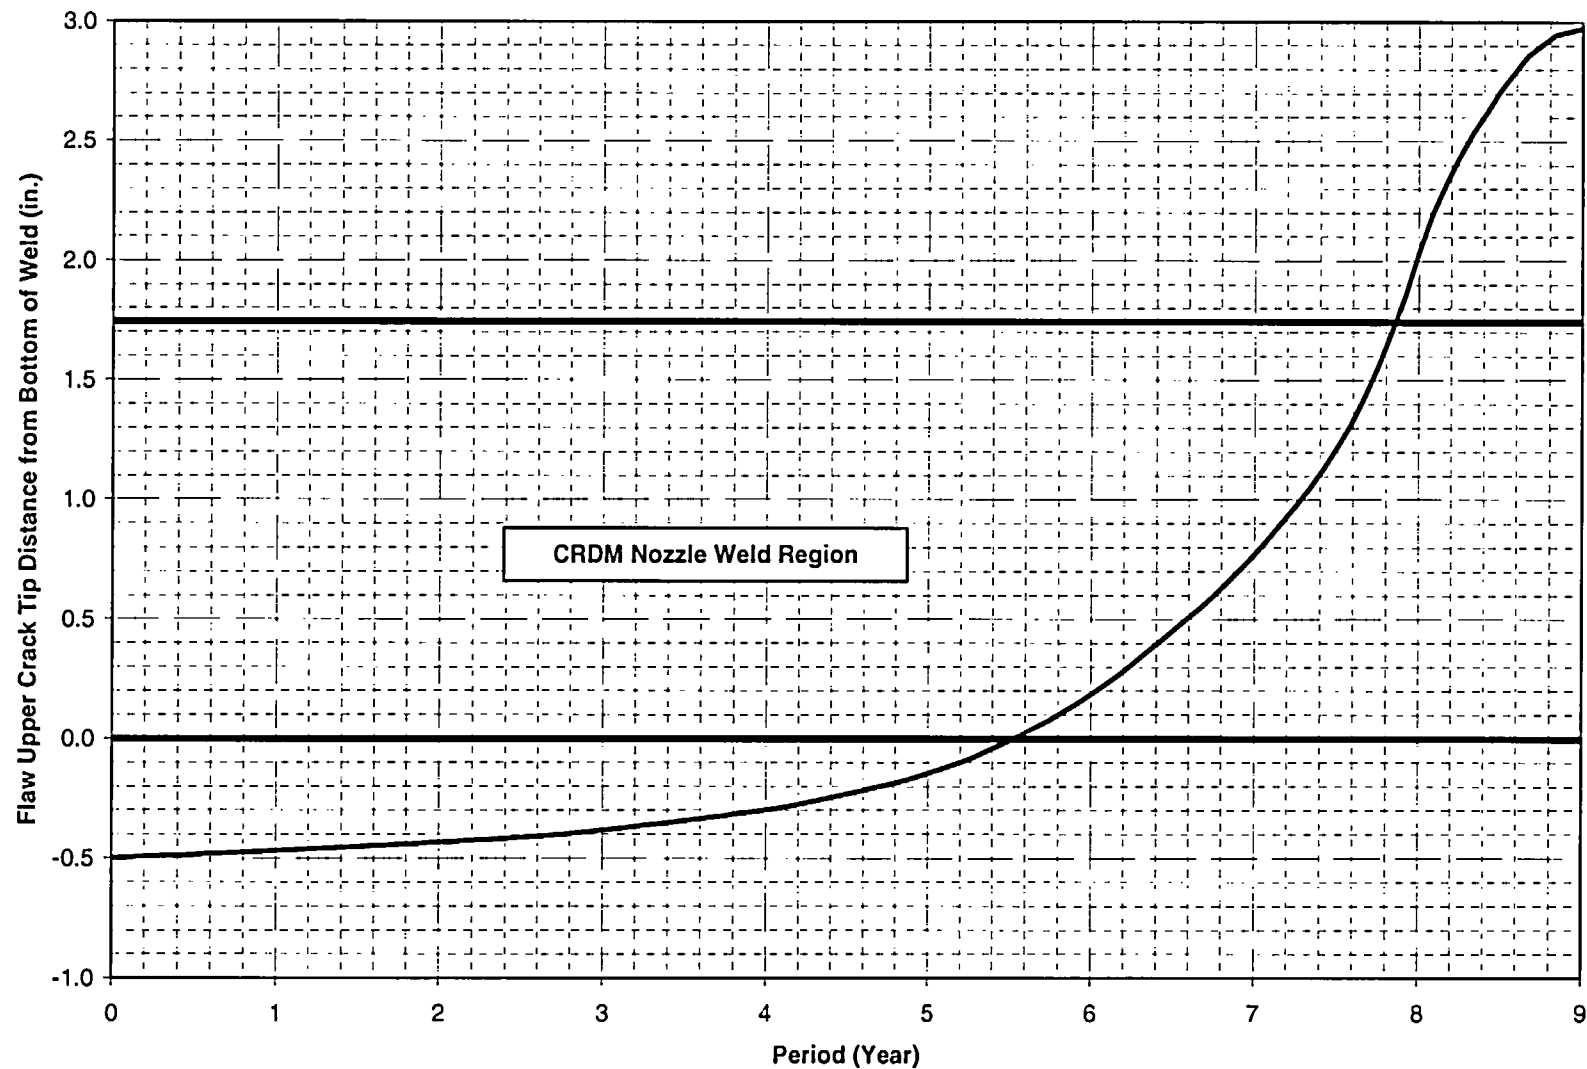
Figure 6-12 Through-Wall Axial Flaws Located in the Center CRDM (0.0 Degrees) Penetration - Crack Growth Predictions for Diablo Canyon Units 1 and 2

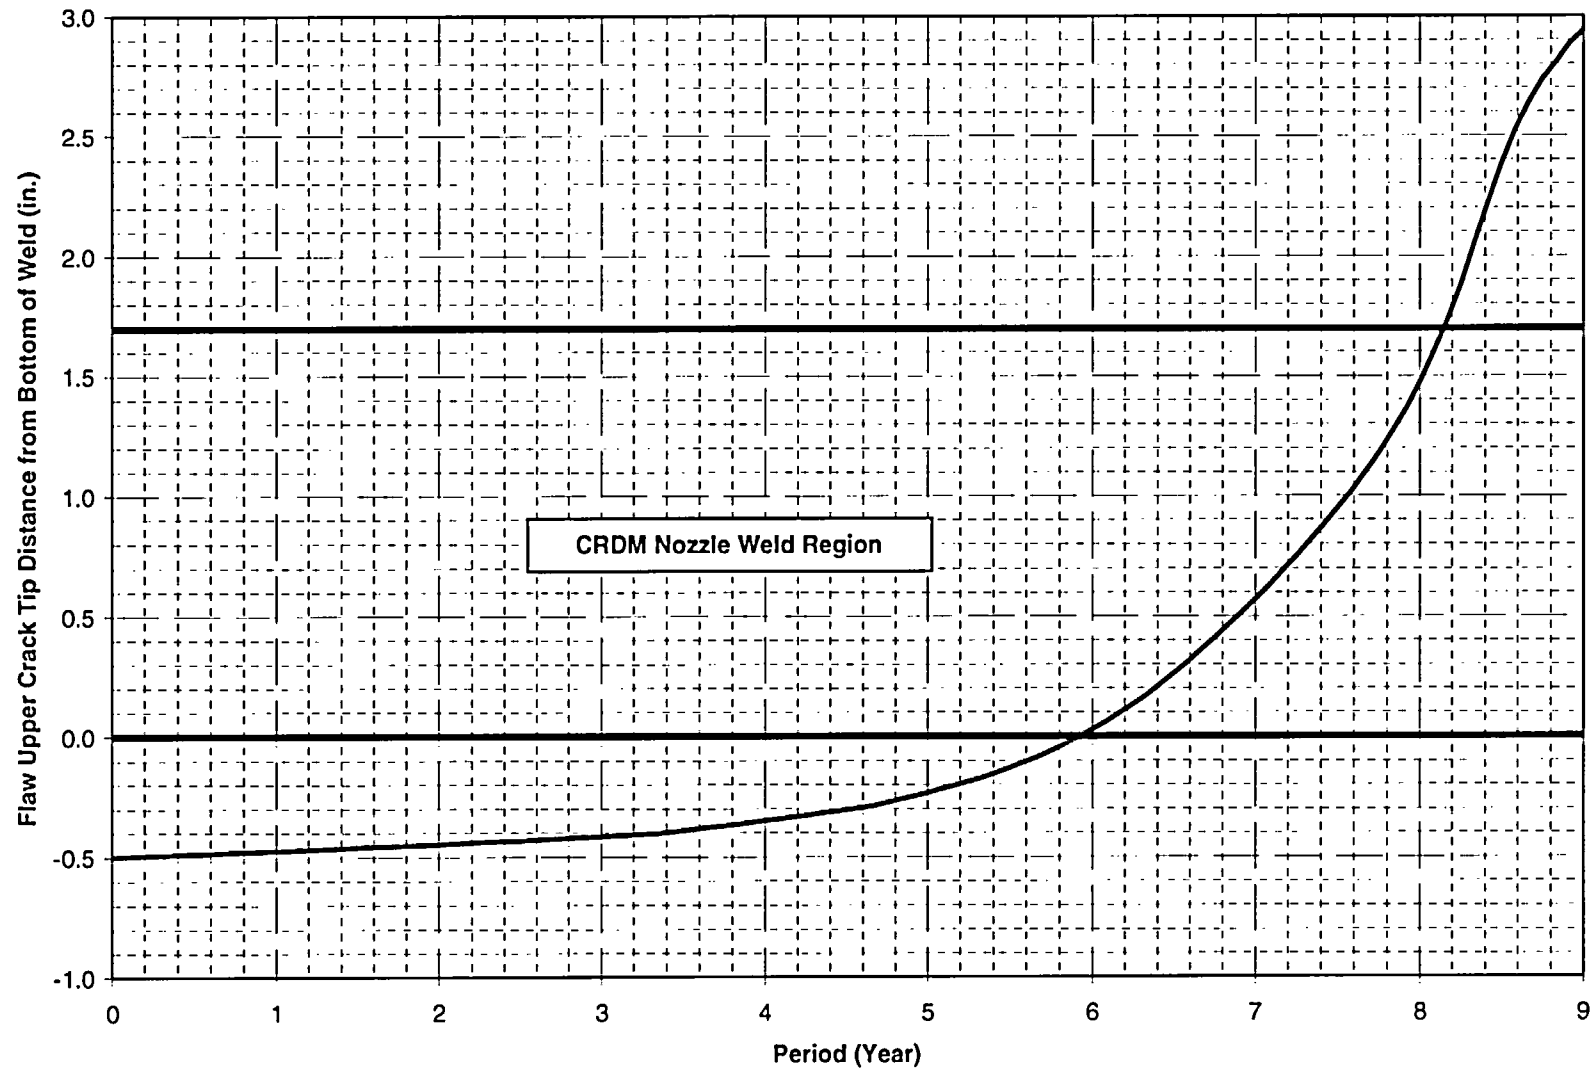
Figure 6-13 Through-Wall Axial Flaws Located in the 26.2 Degrees CRDM Row of Penetrations, Downhill Side - Crack Growth Predictions for Diablo Canyon Units 1 and 2

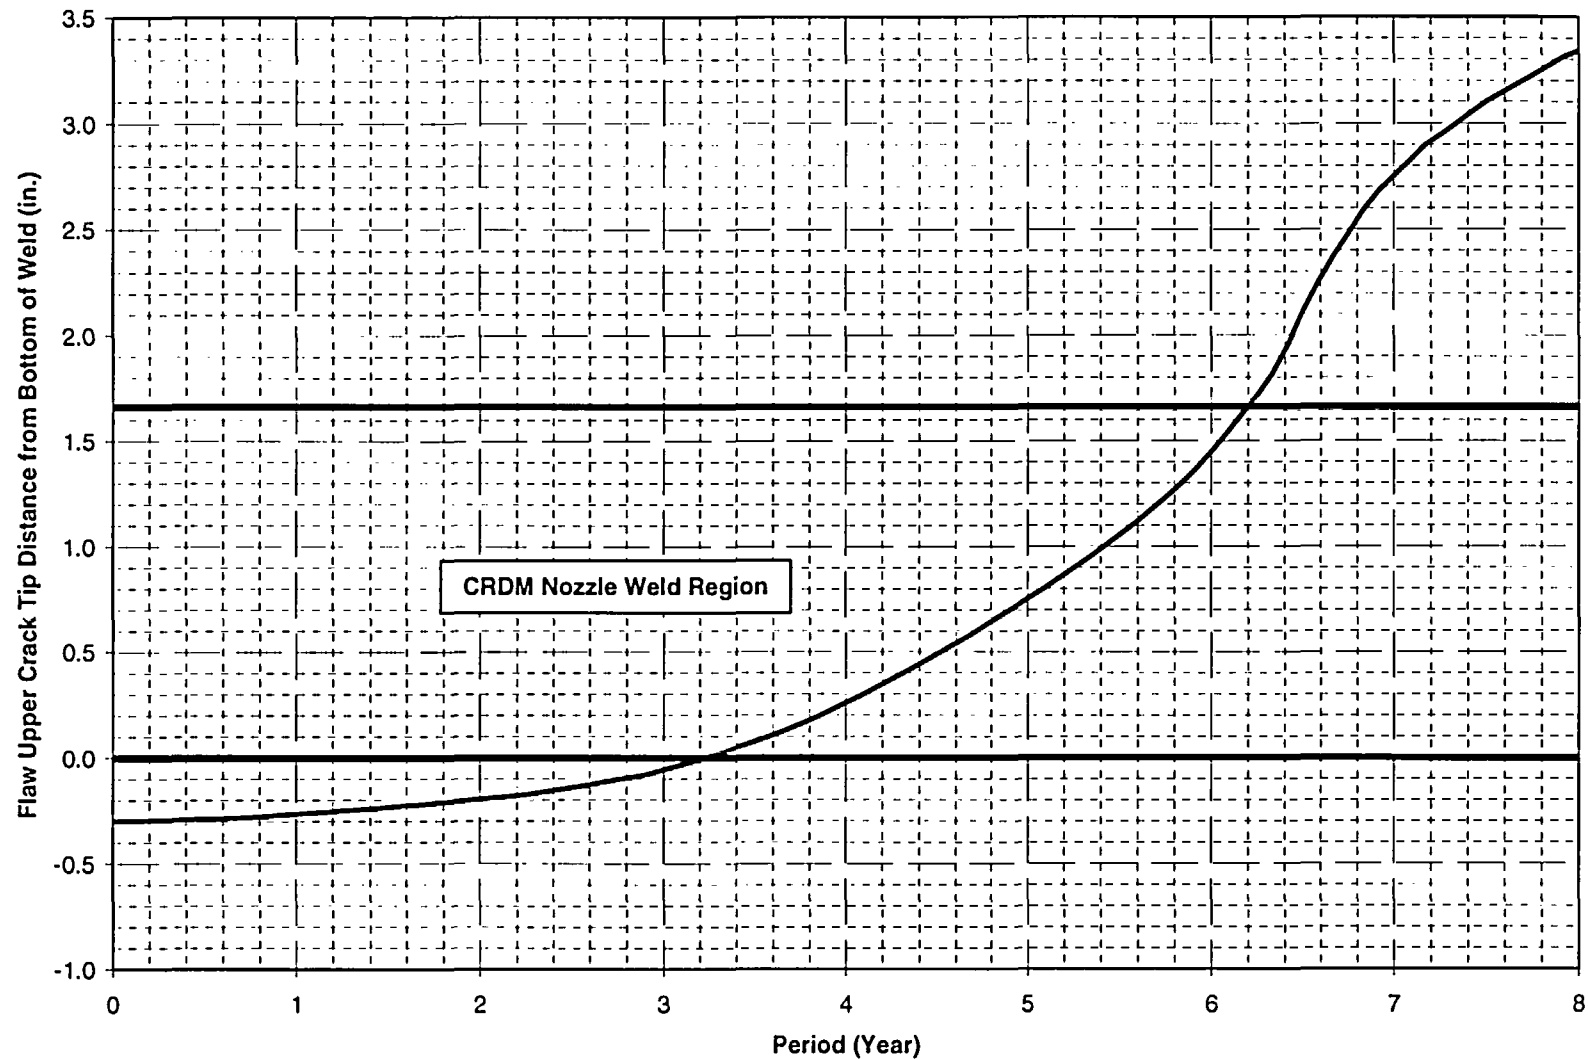
Figure 6-14 Through-Wall Axial Flaws Located in the 44.3 Degrees CRDM Row of Penetrations, Downhill Side - Crack Growth Predictions for Diablo Canyon Units 1 and 2

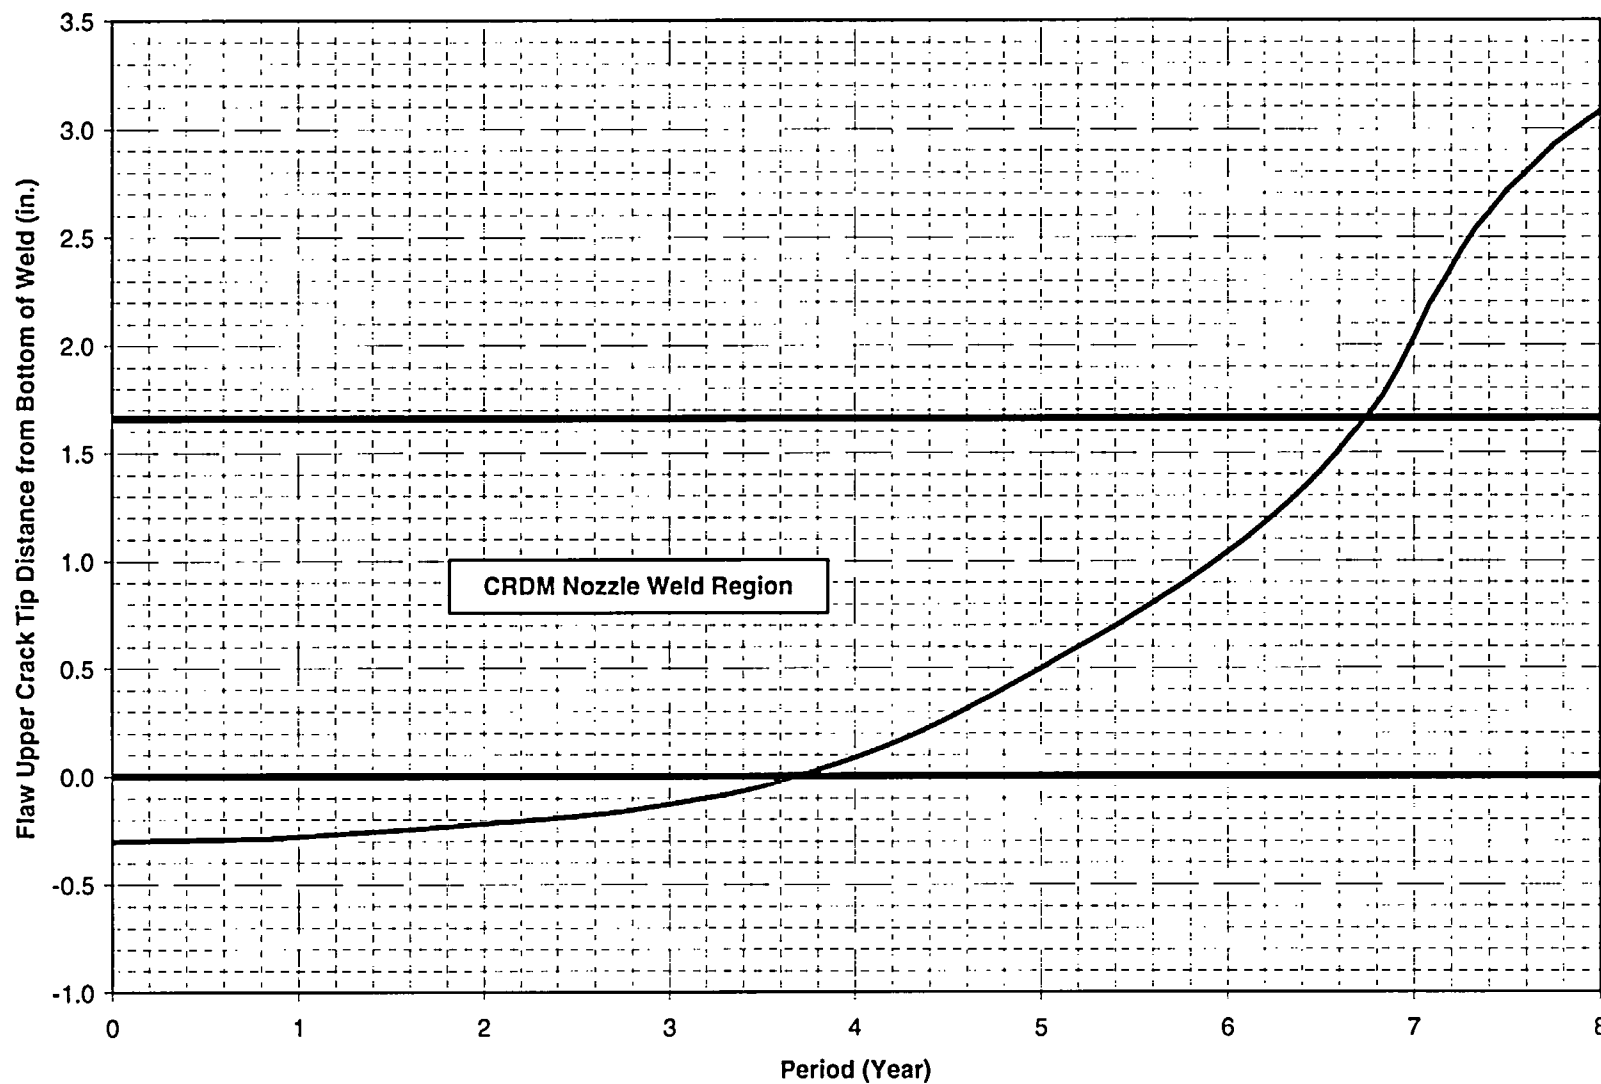
Figure 6-15 Through-Wall Axial Flaws Located in the 45.4 Degrees CRDM Row of Penetrations, Downhill Side - Crack Growth Predictions for Diablo Canyon Unit 2

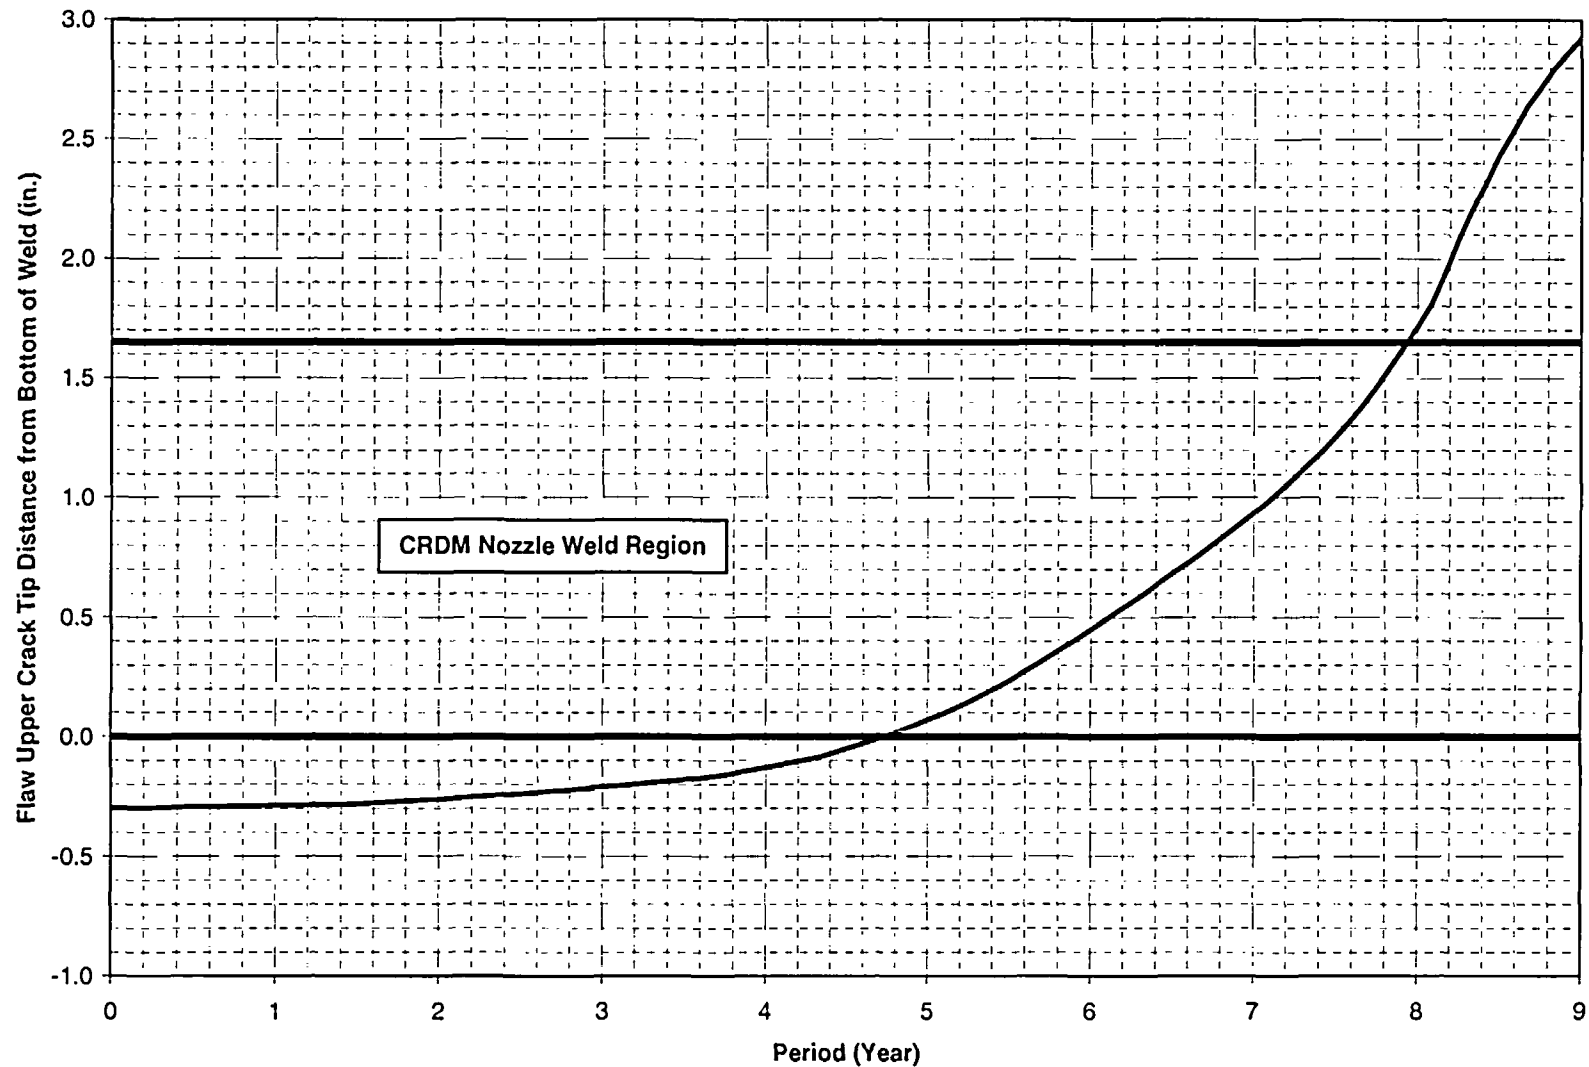
Figure 6-16 Through-Wall Axial Flaws Located in the 48.7 Degrees CRDM Row of Penetrations, Downhill Side - Crack Growth Predictions for Diablo Canyon Units 1 and 2
