WCAP-15429-NP (Non-Proprietary)
Revision 0
September 2004

Structural Integrity Evaluation of Reactor Vessel Upper Head Penetrations to Support Continued Operation: Diablo Canyon Units 1 and 2

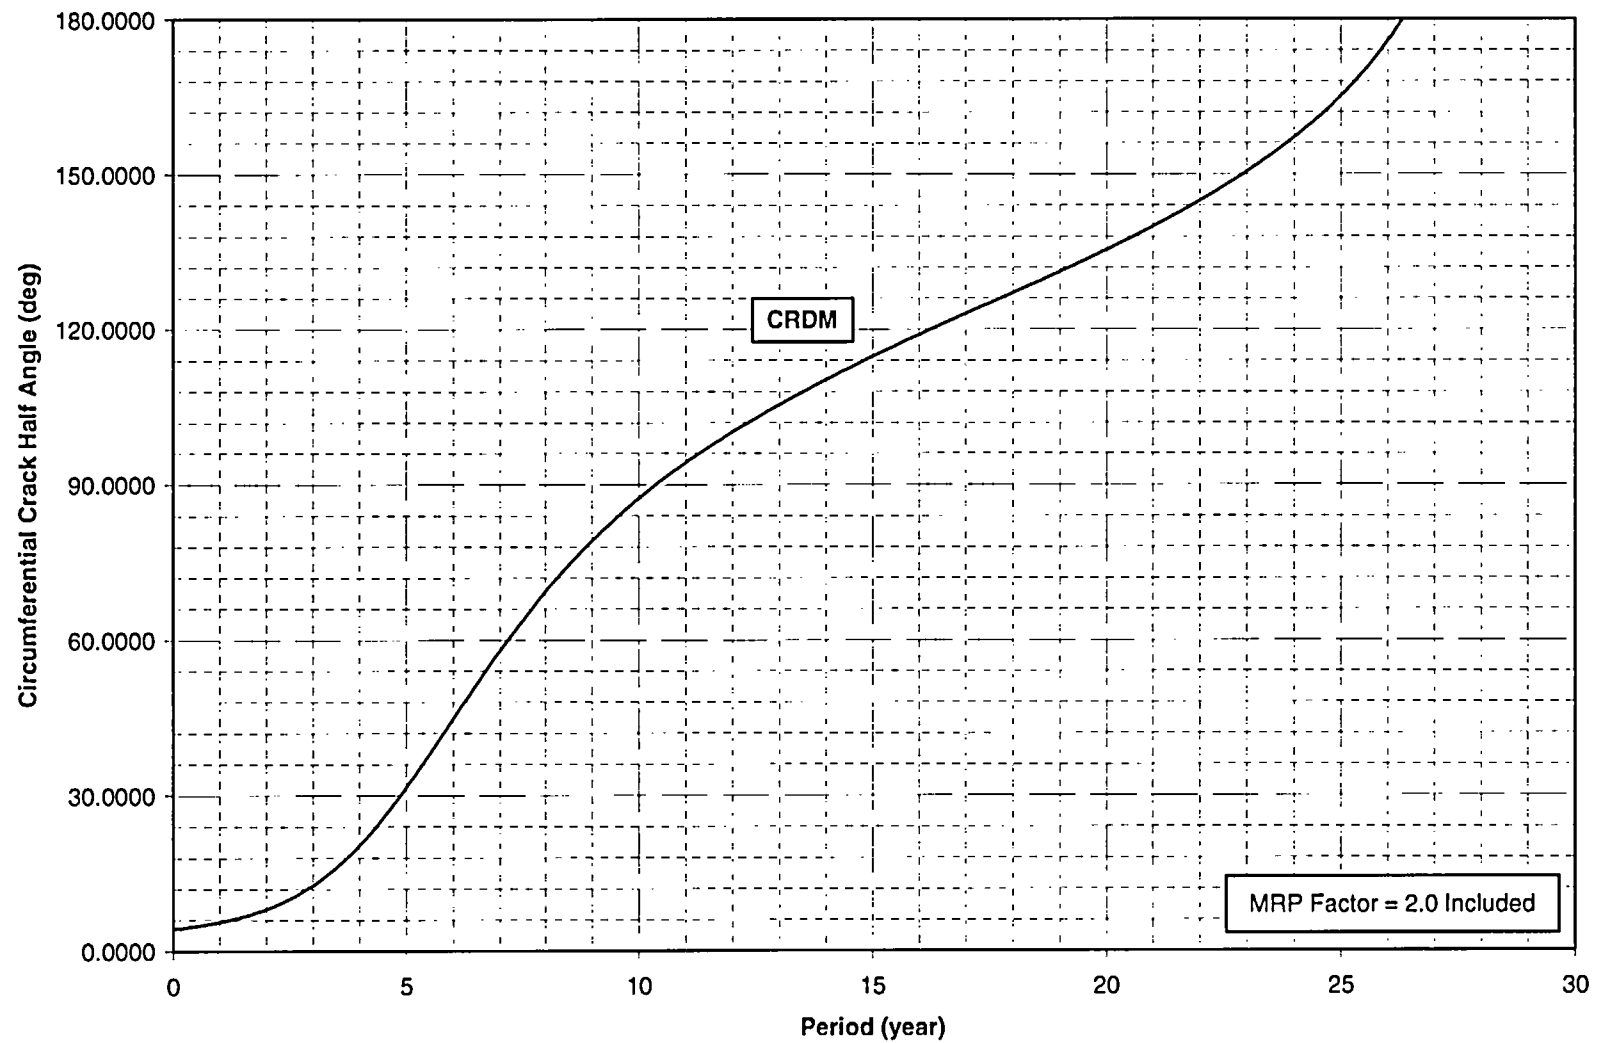
Figure 6-17 Through-Wall Circumferential Flaws Near the Top of the Attachment Weld for CRDM Nozzles - Crack Growth Predictions for Diablo Canyon Units 1 and 2 (MRP Factor of 2.0 Included)

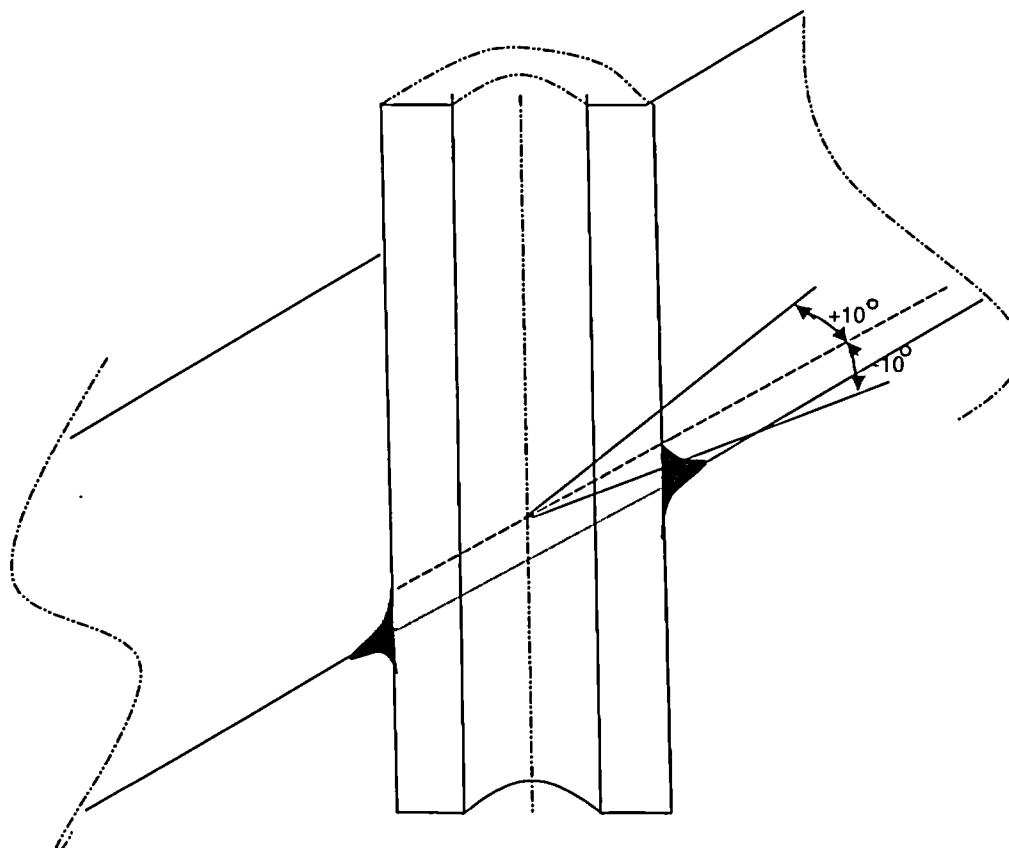
Figure 6-19 Definition of "Circumferential"

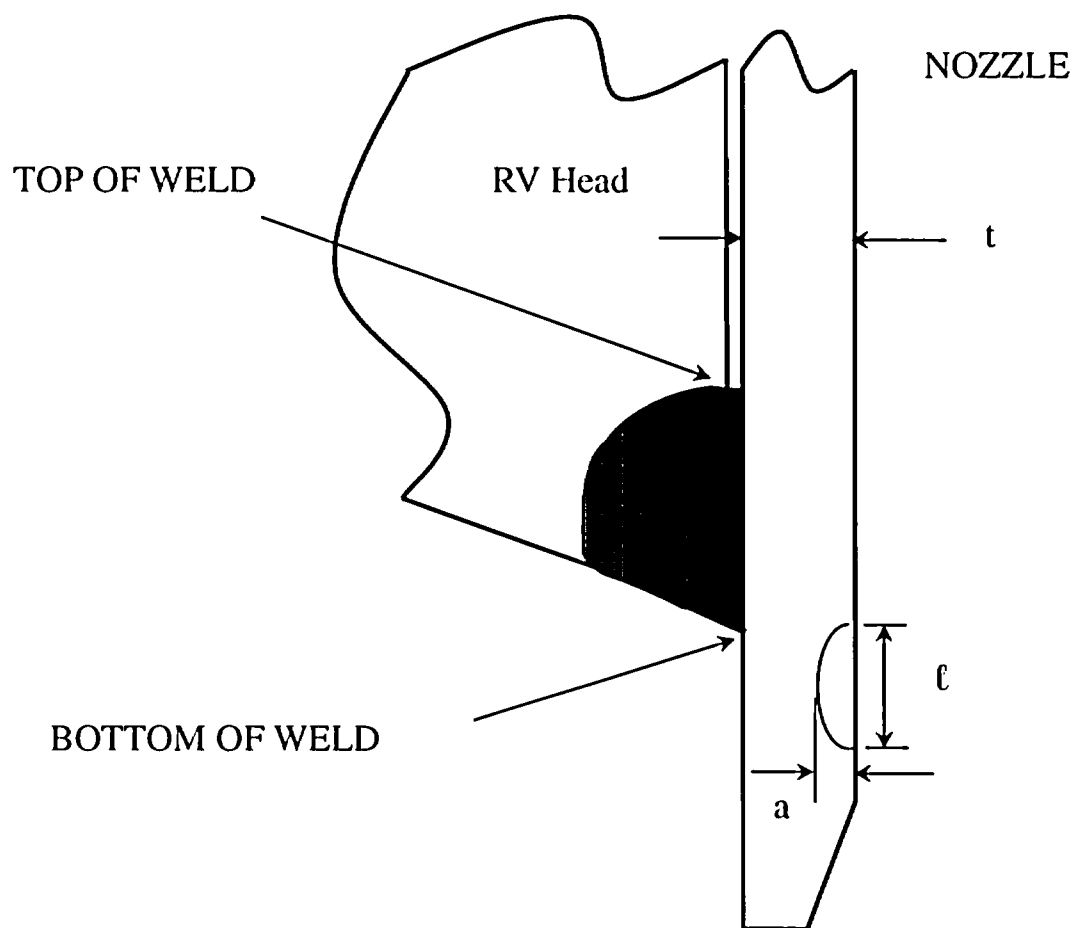
Figure 6-20 Schematic of Head Penetration Geometry

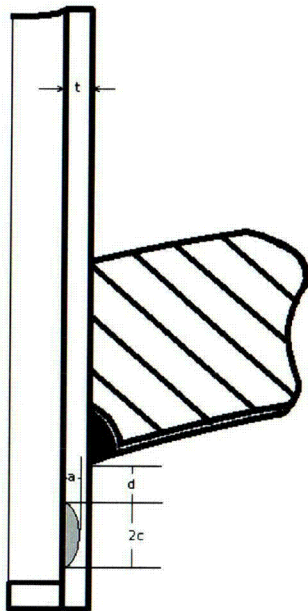
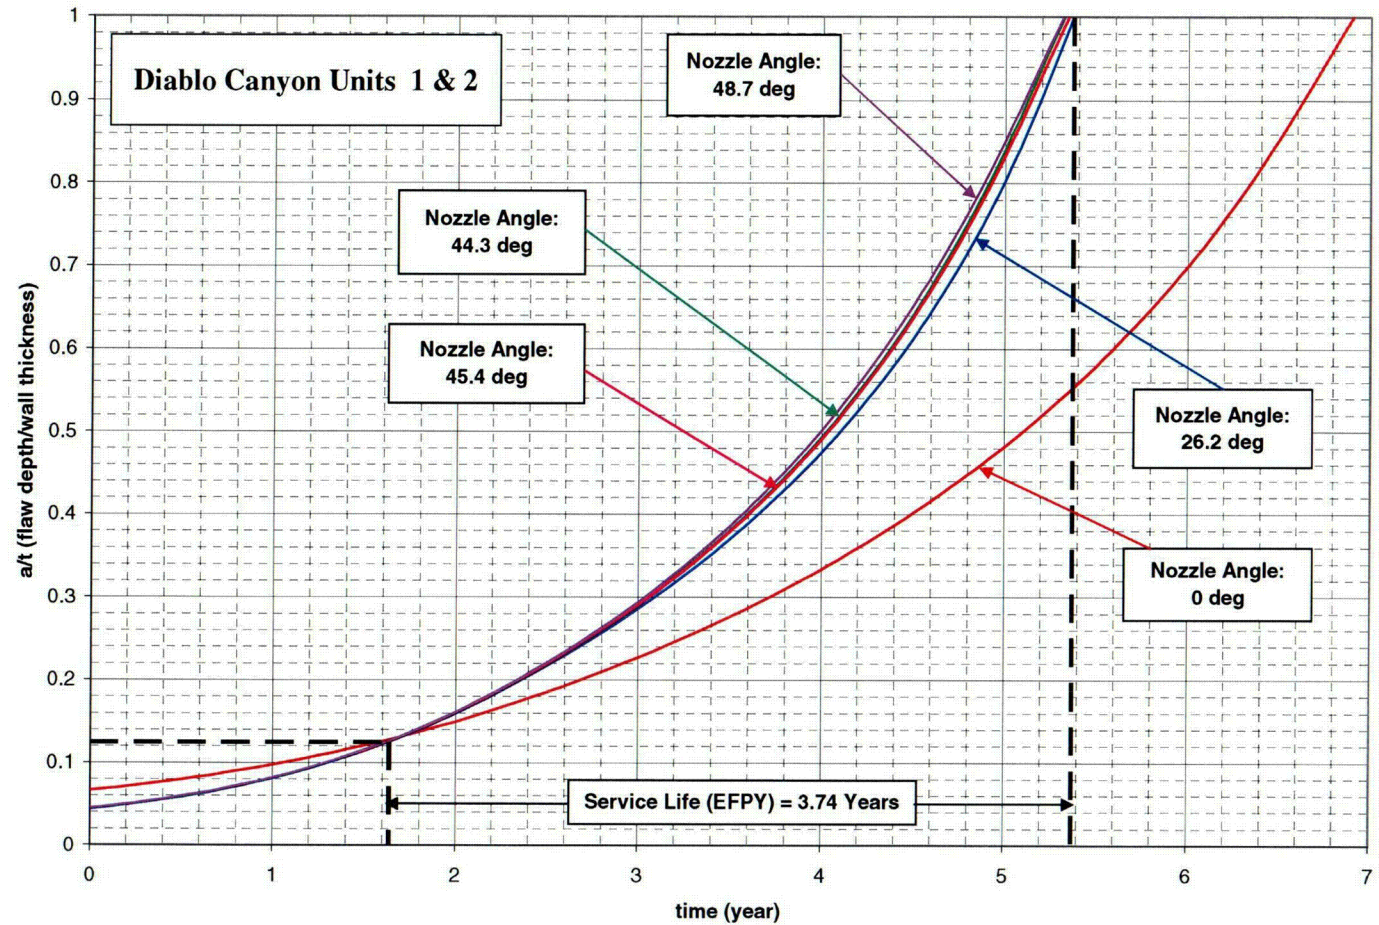
Figure 7-1 Example Problem 1

Example No.	Orientation	Crack Tip Location	Circumferential Location	Penetration Row	Length (2c)	Depth (a)	Wall Thickness	a/t	Penetration No.	Source Figure
2	Axial – Outside Surface	1.25" Below Weld	Downhill	26.2°	0.195"	0.078"	0.625"	0.125	30	6-10

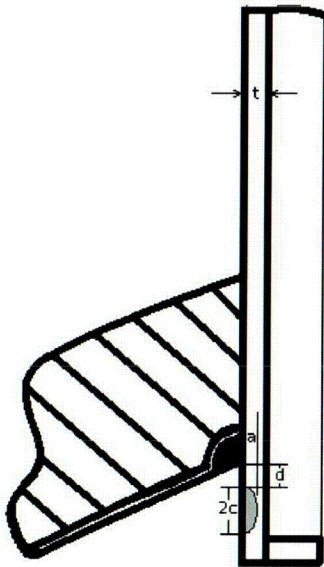
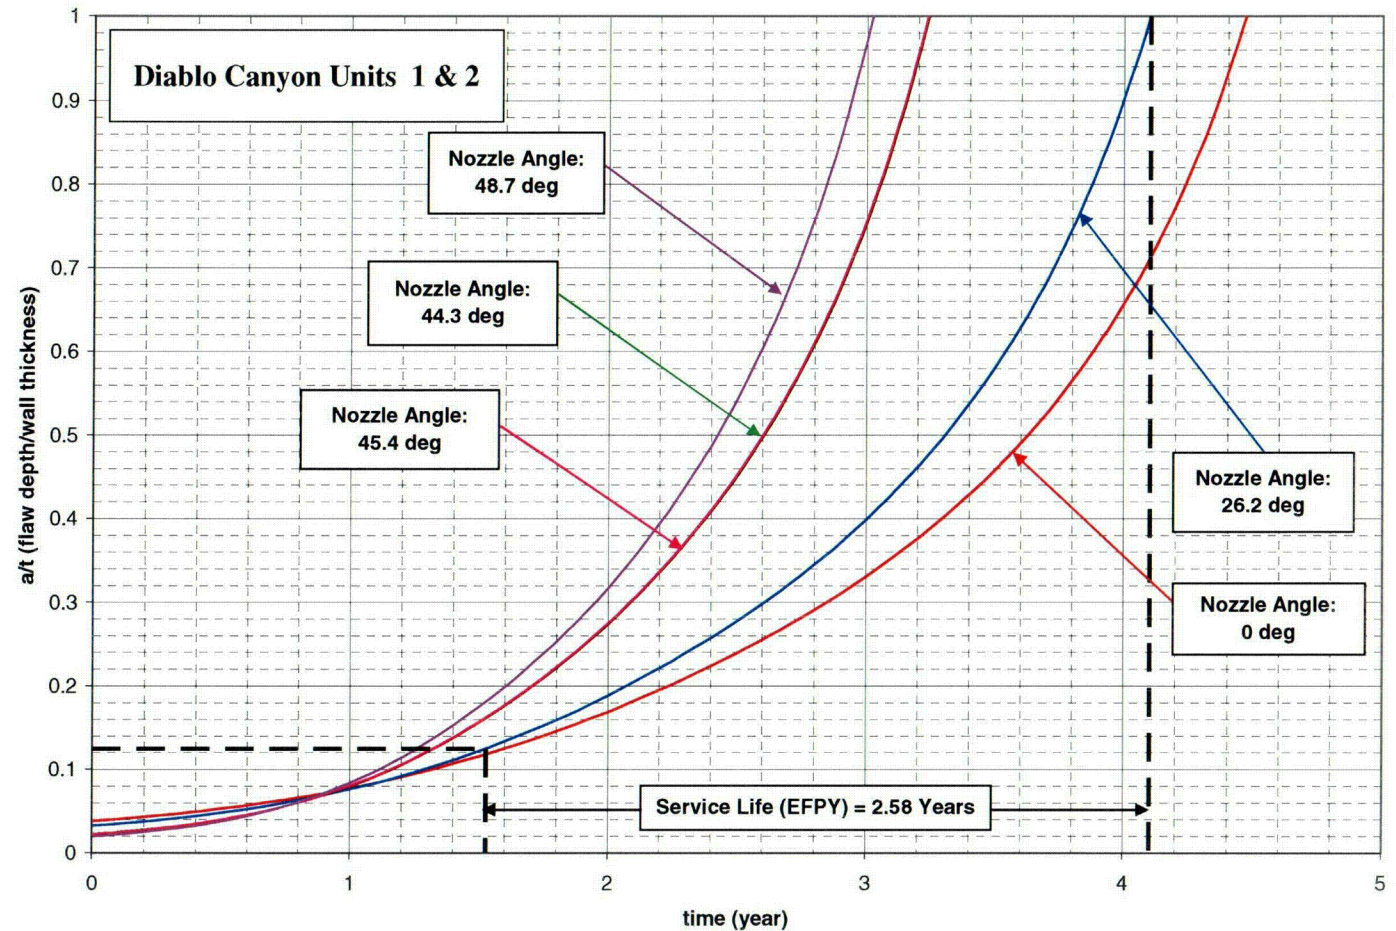
Figure 7-2 Example Problem 2

Example No.	Orientation	Crack Tip Location	Circumferential Location	Penetration Row	Length (2c)	Depth (a)	Wall Thickness	a/t	Penetration No.	Source Figure
3	Axial – Inside Surface	At Weld	Downhill	48.7°	0.250"	0.05"	0.625"	0.08	79	6-5

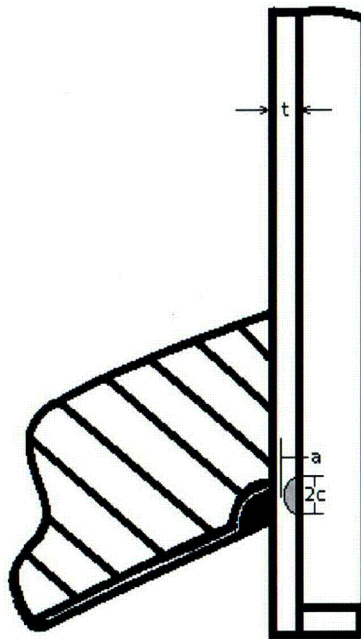
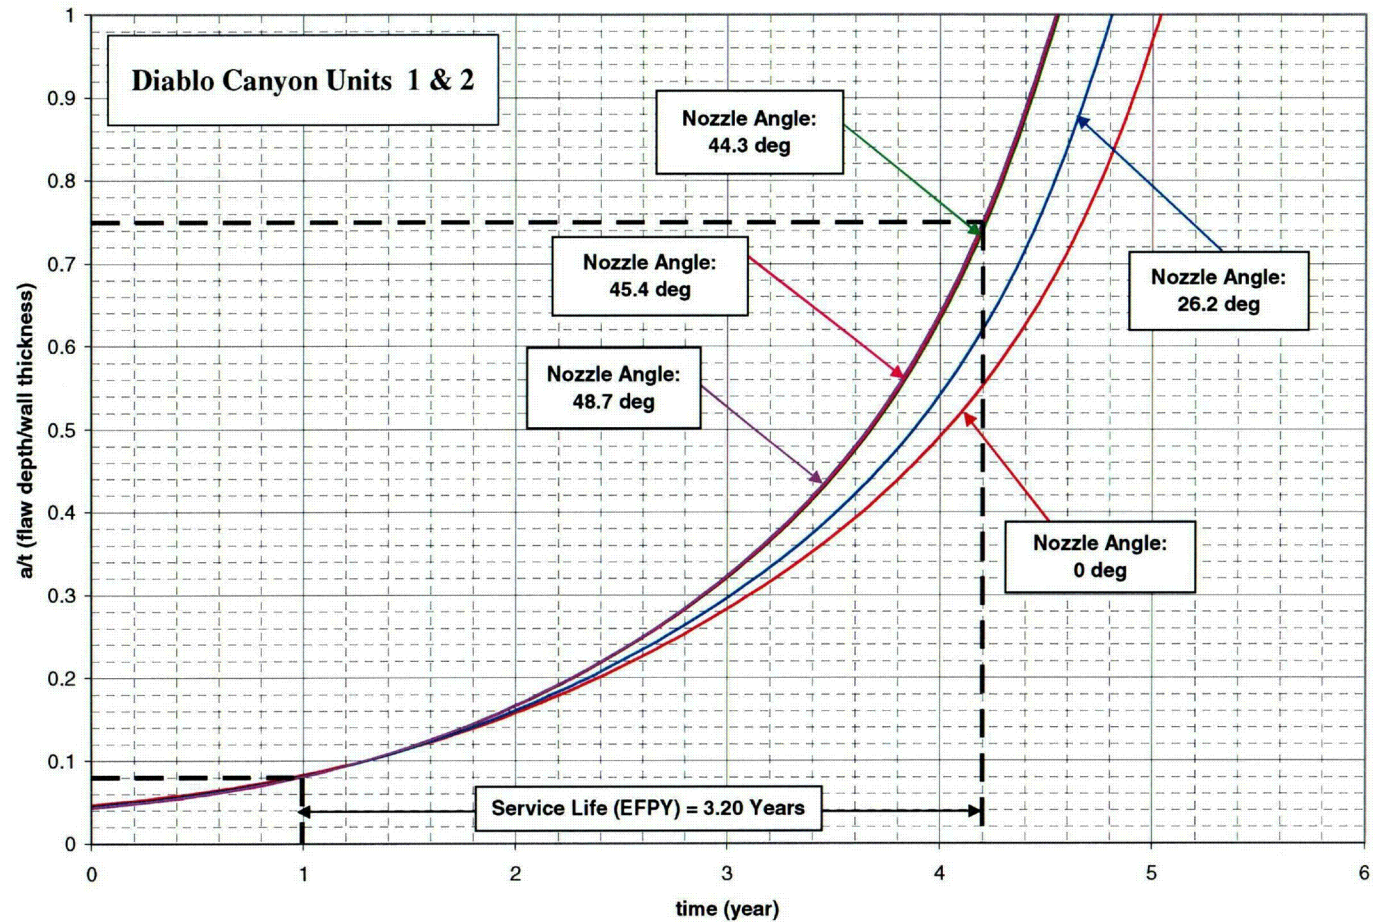
Figure 7-3 Example Problem 3

Example No.	Orientation	Crack Tip Location	Circumferential Location	Penetration Row	Length (2c)	Depth (a)	Wall Thickness	a/t	Penetration No.	Source Figure
4	Axial – Inside Surface	1.00" Below Weld	Uphill	48.7°	0.395"	0.079"	0.625"	0.126	79	6-2, 6-4

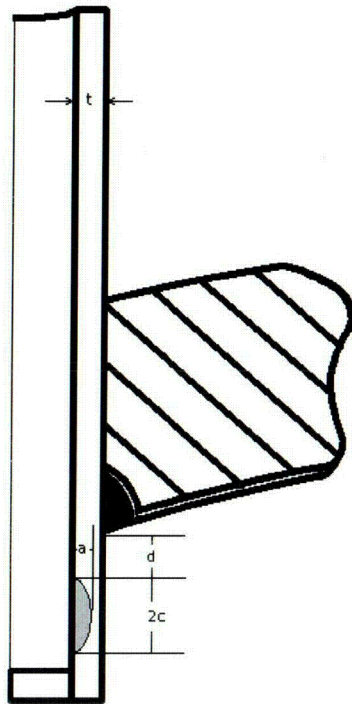
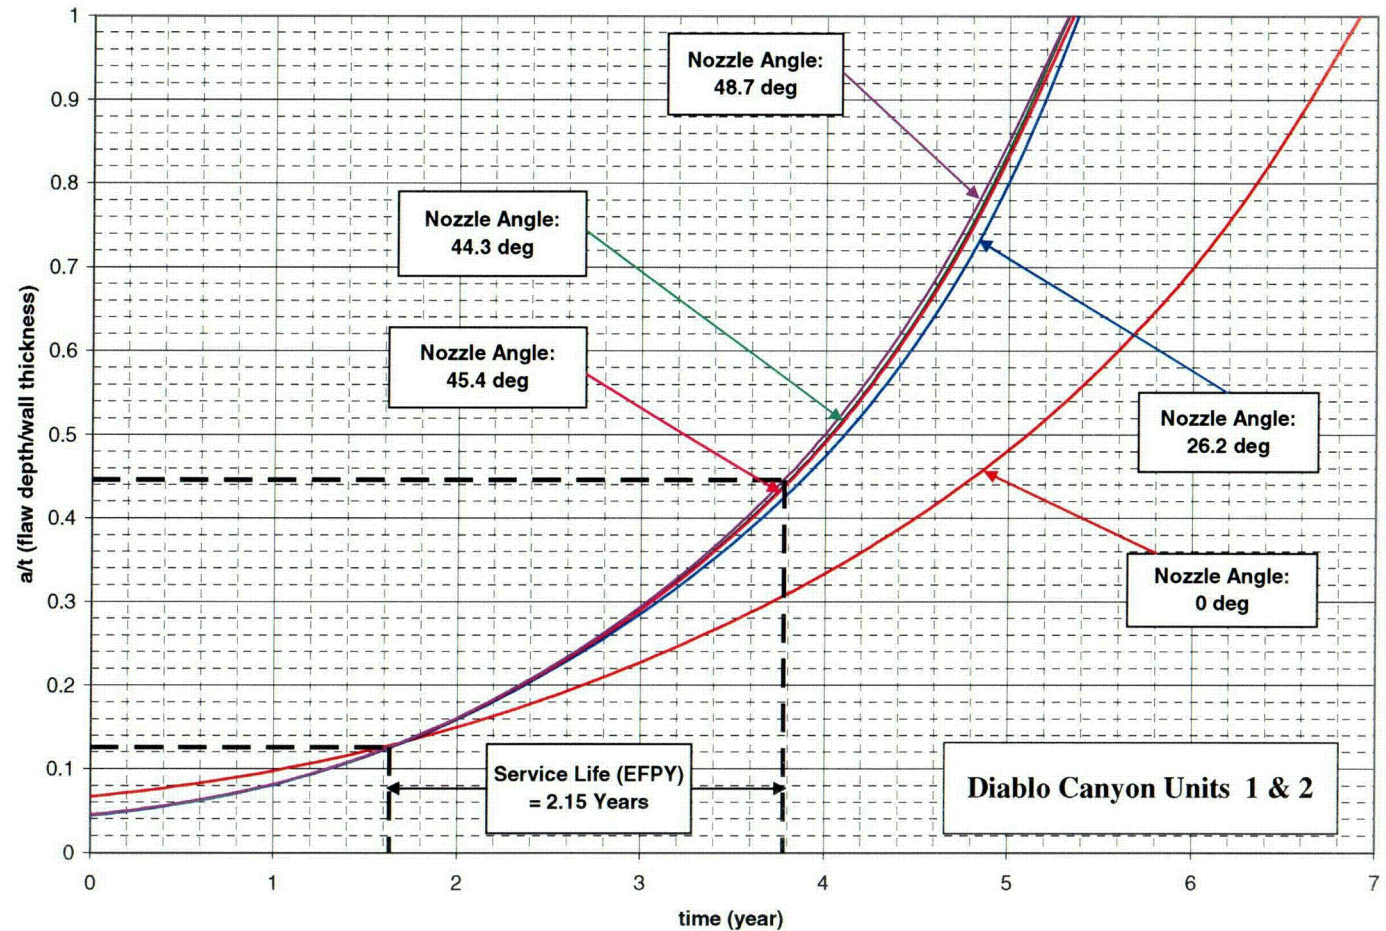
Figure 7-4a Example Problem 4 (See also Figure 7-4b)

Example No.	Orientation	Crack Tip Location	Circumferential Location	Penetration Row	Length (2c)	Depth (a)	Wall Thickness	a/t	Penetration No.	Source Figure
4	Axial – Inside Surface	1.00" Below Weld	Uphill	48.7°	0.395"	0.079"	0.625"	0.126	79	6-2, 6-4

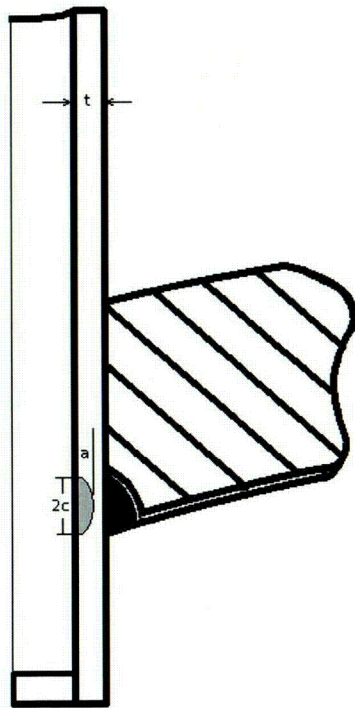
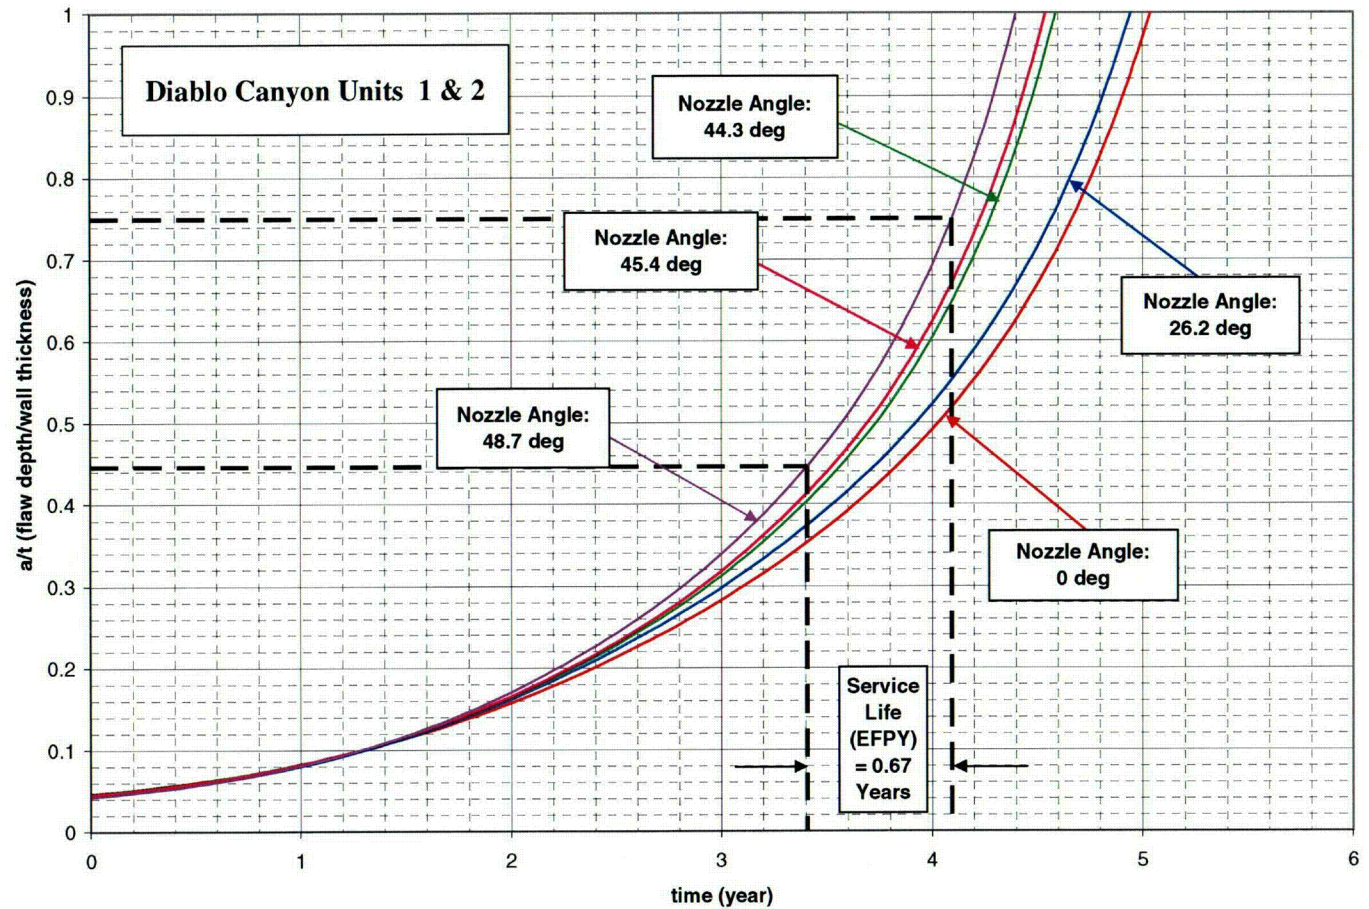
Figure 7-4b Example Problem 4 (See also Figure 7-4a)

Example No.	Orientation	Crack Tip Location	Circumferential Location	Penetration Row	Length (2c)	Depth (a)	Wall Thickness	a/t	Penetration No.	Source Figure
5	Axial – Through-Wall	0.4" Below Weld	Downhill	26.2°	N/A	N/A	0.625"	N/A	33	6-13

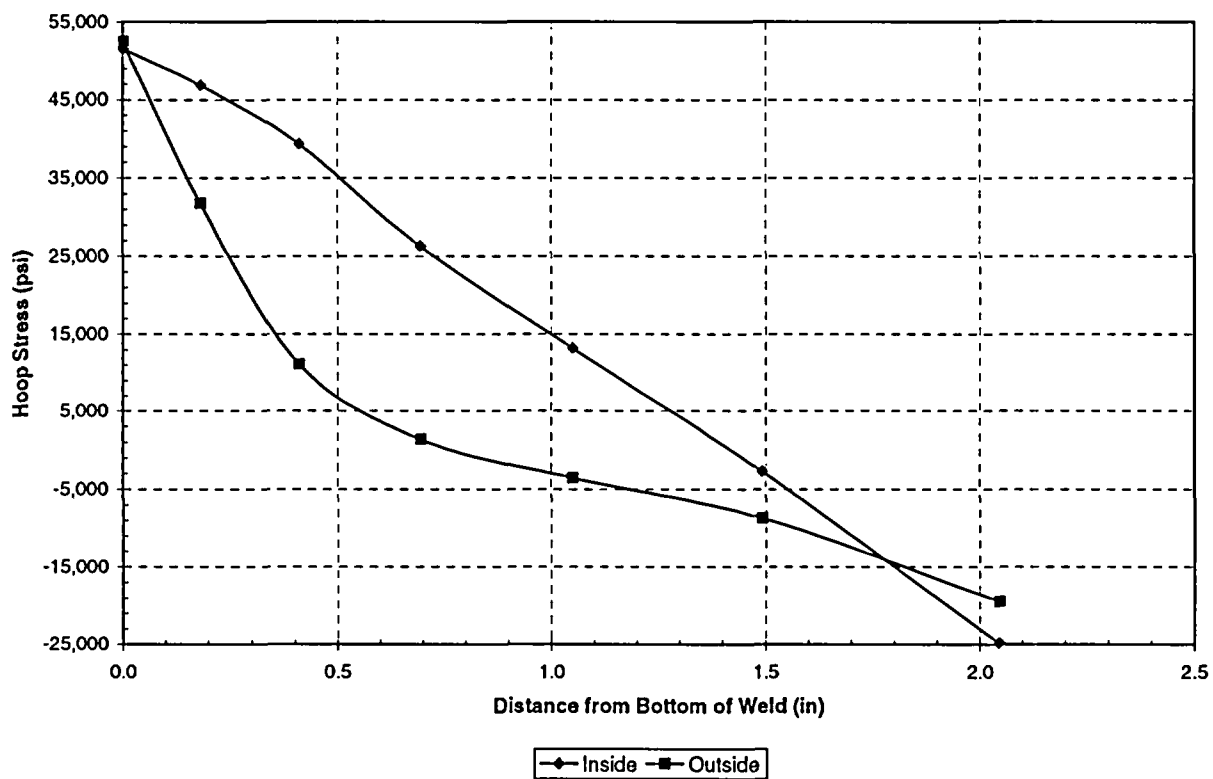
Figure A-1
Hoop Stress Distribution Downhill and Uphill Side
(0° CRDM Penetration Nozzle)

In this section, the CRDM hoop stress distributions below the weld are plotted for the center penetration, 26.2°, 44.3°, 45.4°, and 48.7° penetration rows on both the downhill and uphill sides. The information presented in this Appendix can be used to determine the extent of inspection coverage needed in order to meet the NRC Order EA-03-009 requirements or facilitate the submittal of relaxation requests in the event that the NRC order requirements cannot be met.

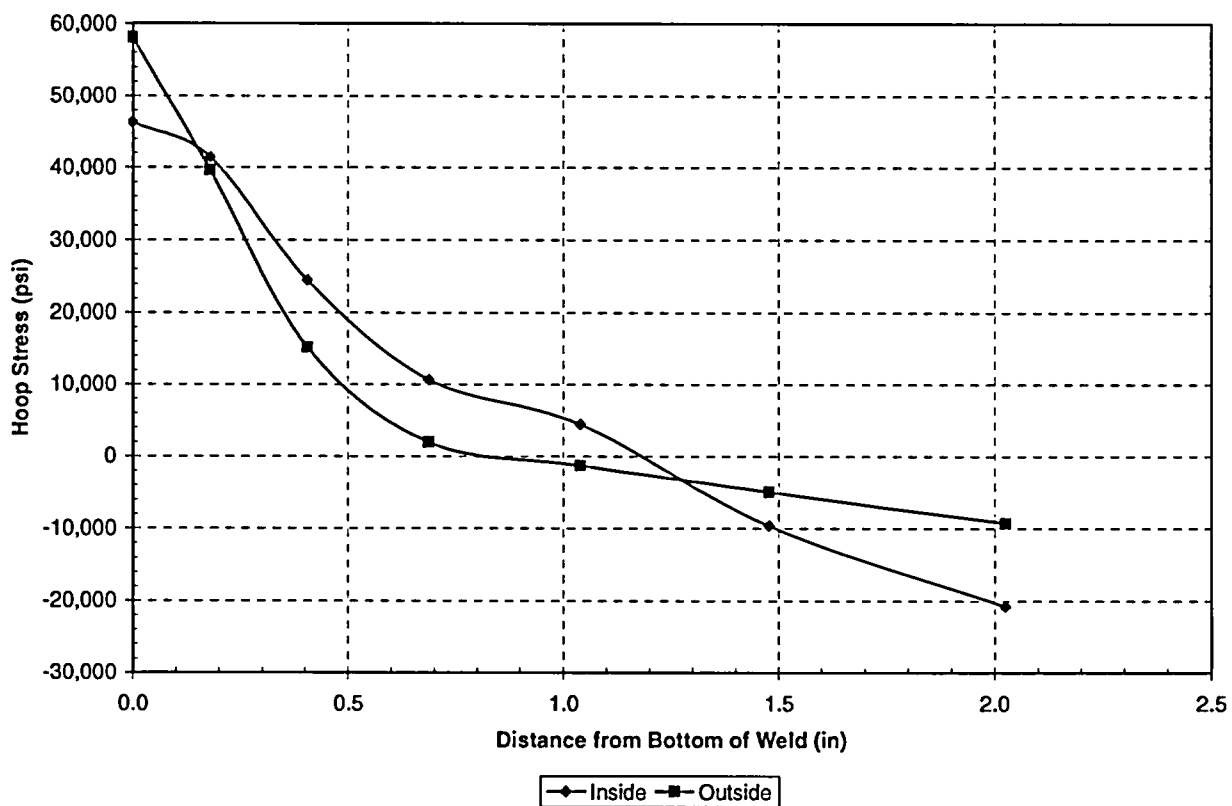
Figure A-2
Hoop Stress Distribution Downhill Side
(26.2° CRDM Penetration Nozzle)

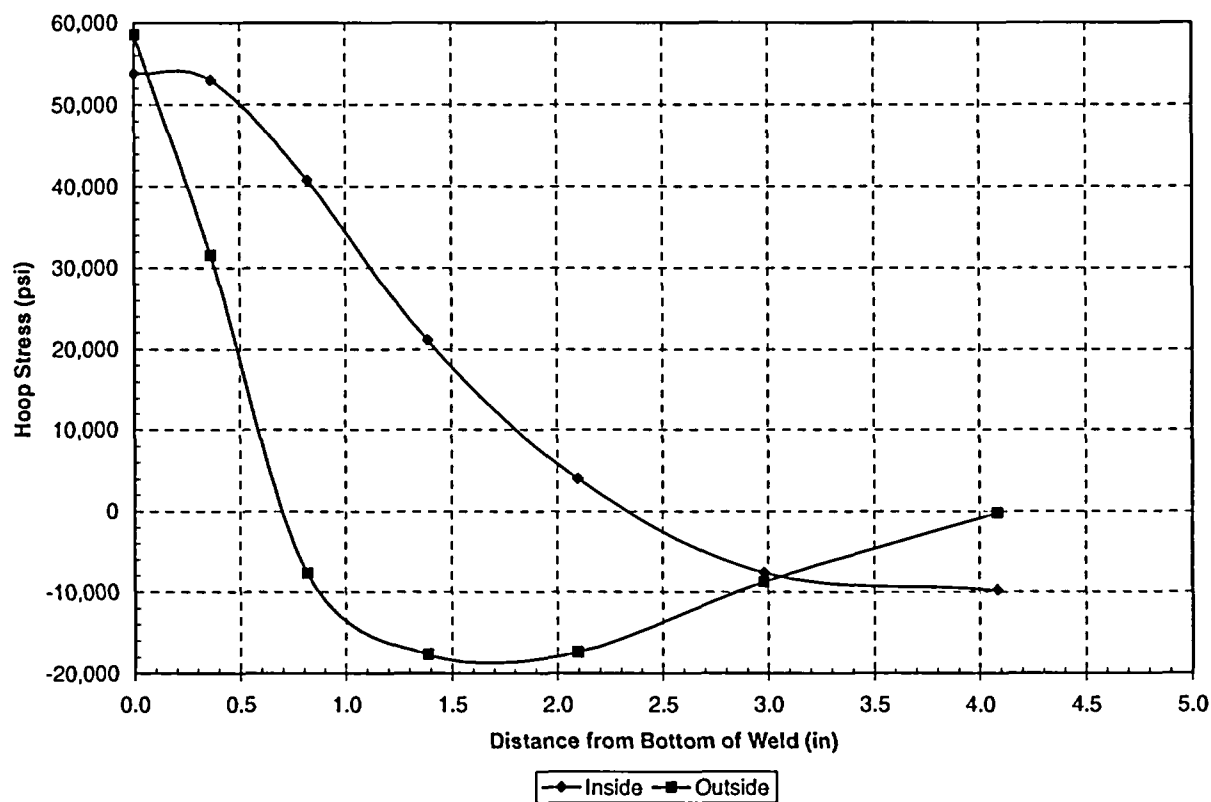
Figure A-3
Hoop Stress Distribution Uphill Side
(26.2° CRDM Penetration Nozzle)

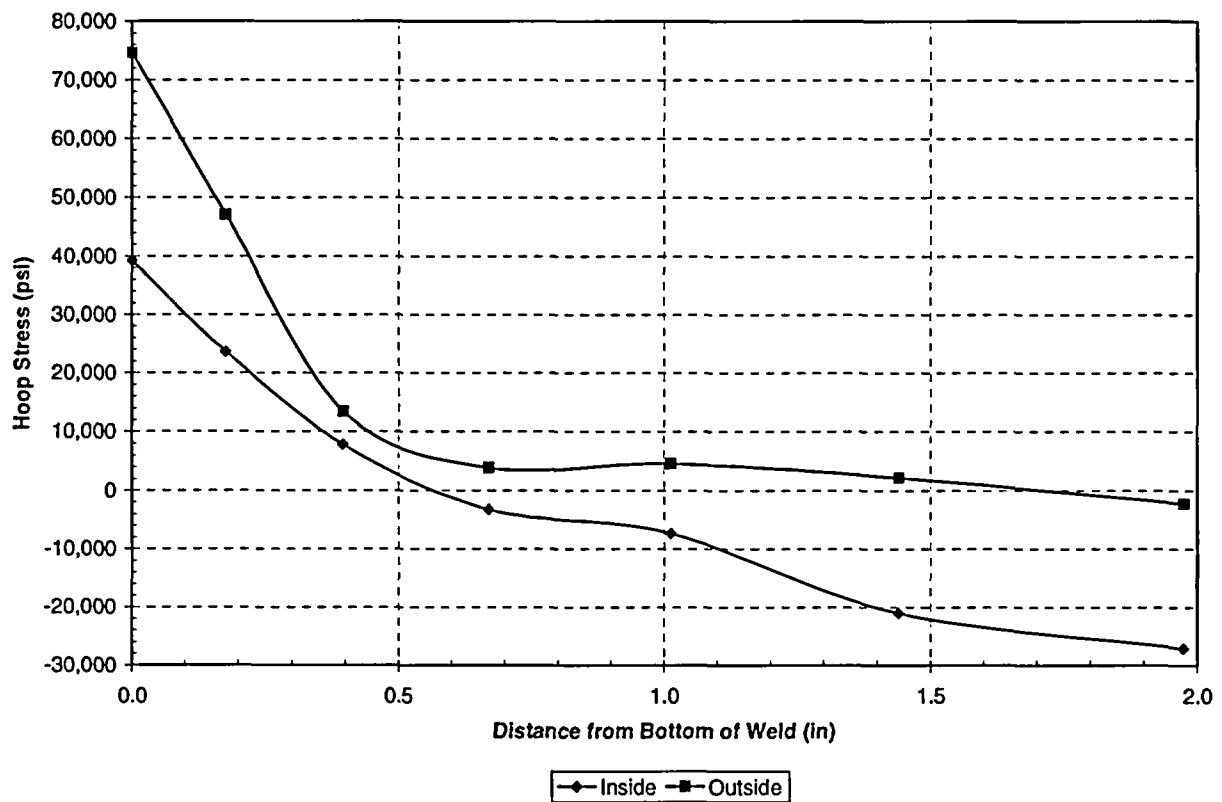
Figure A-4
Hoop Stress Distribution Downhill Side
(44.3° CRDM Penetration Nozzle)

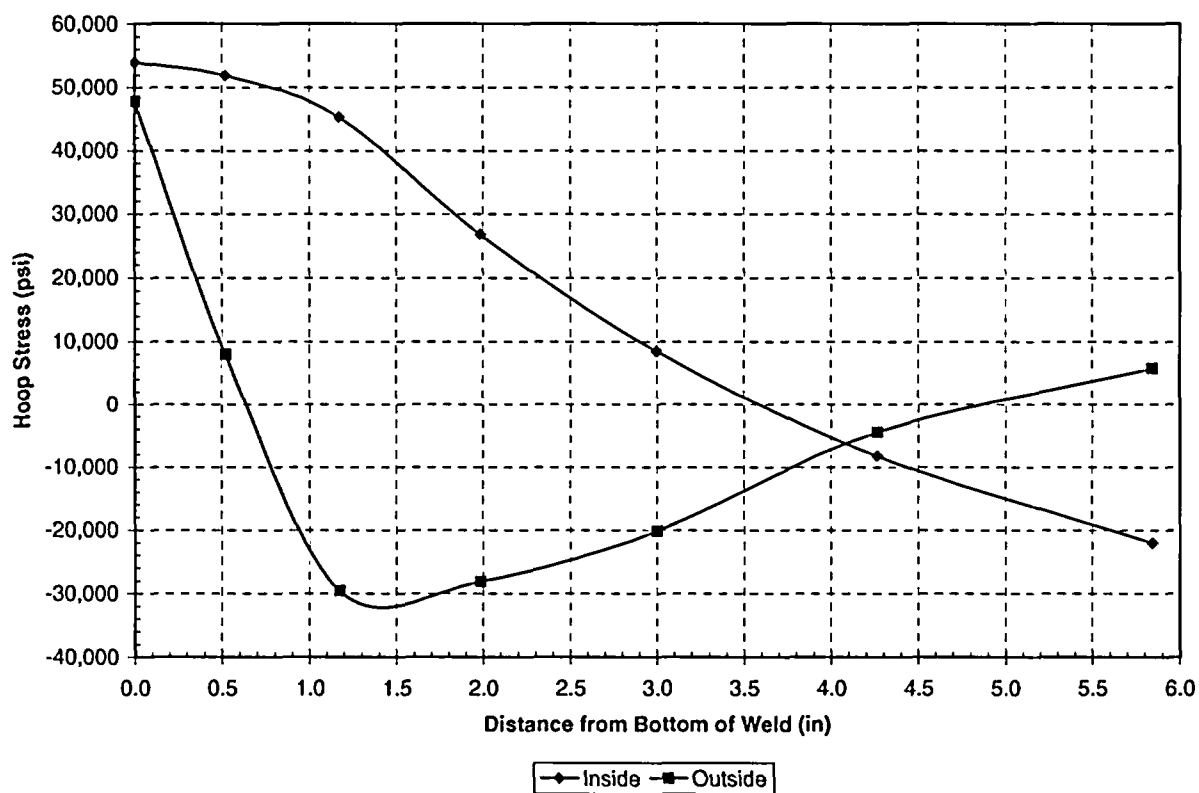
Figure A-5
Hoop Stress Distribution Uphill Side
(44.3° CRDM Penetration Nozzle)

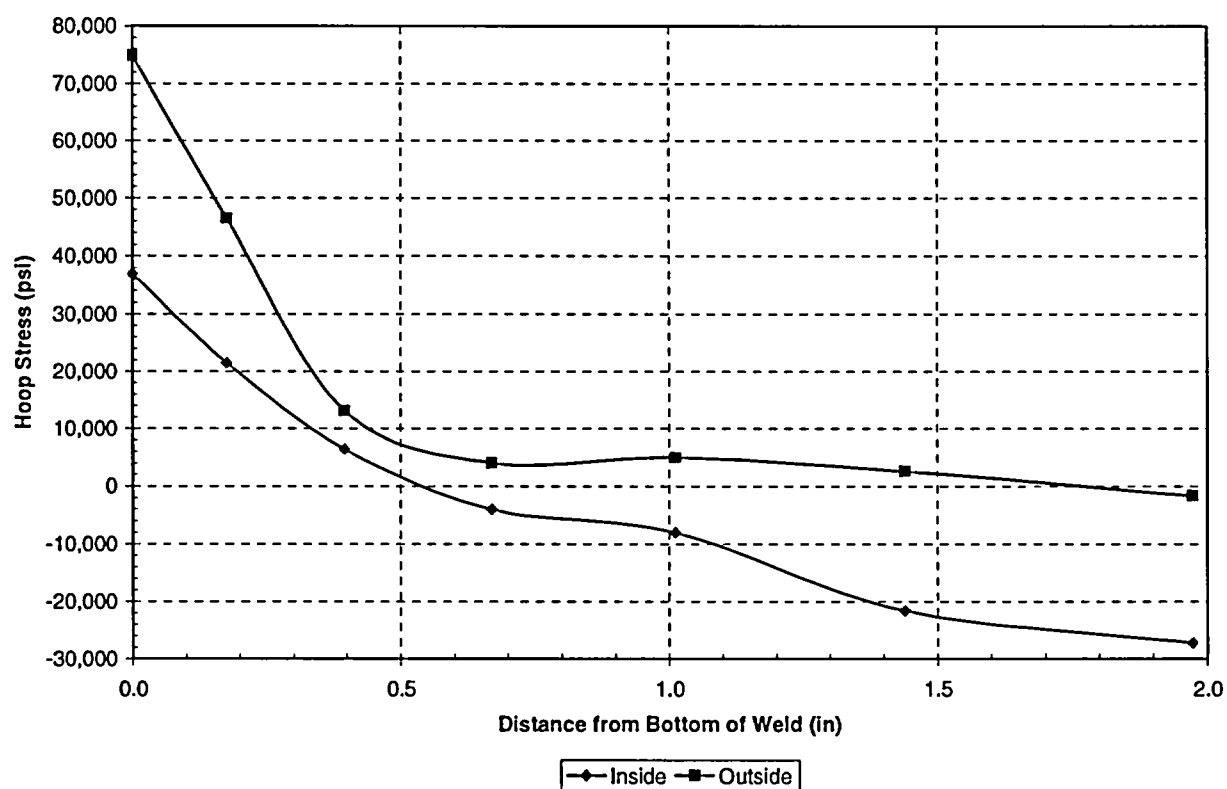
Figure A-6
Hoop Stress Distribution Downhill Side
(45.4° CRDM Penetration Nozzle)

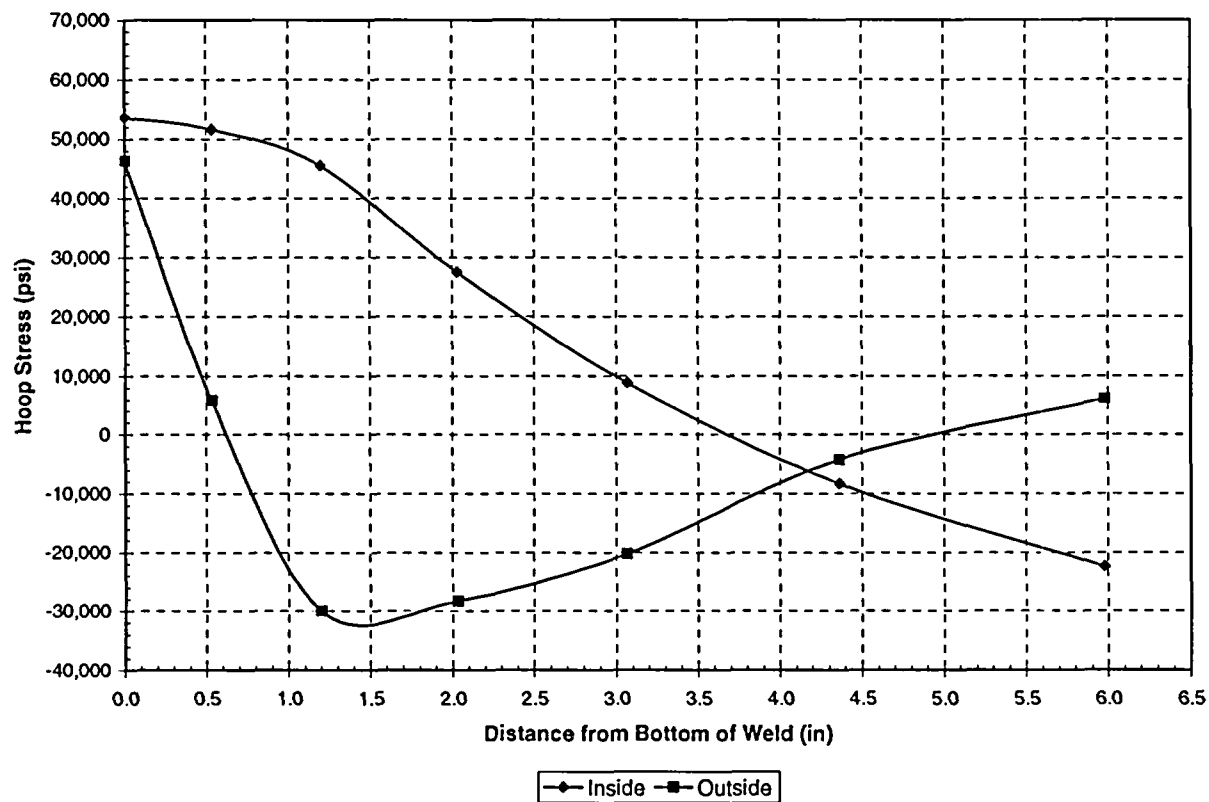
Figure A-7
Hoop Stress Distribution Uphill Side
(45.4° CRDM Penetration Nozzle)

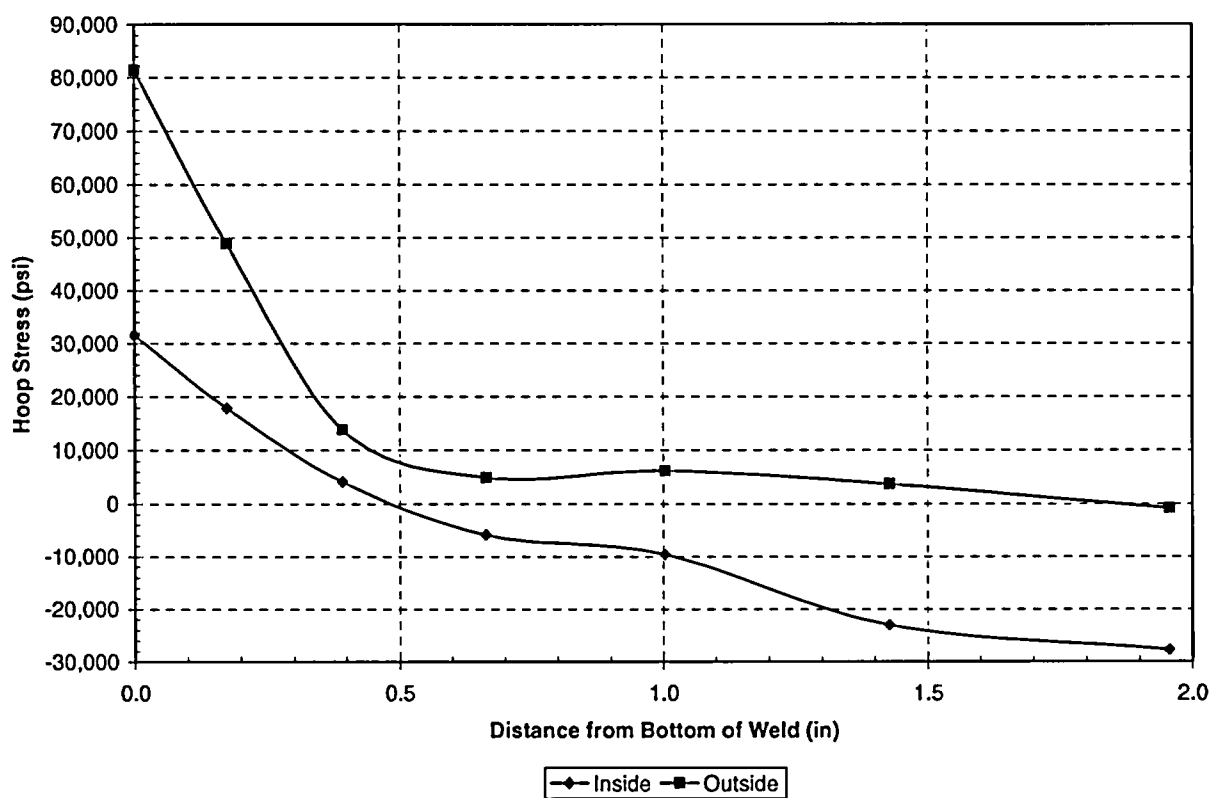
Figure A-8
Hoop Stress Distribution Downhill Side
(48.7° CRDM Penetration Nozzle)

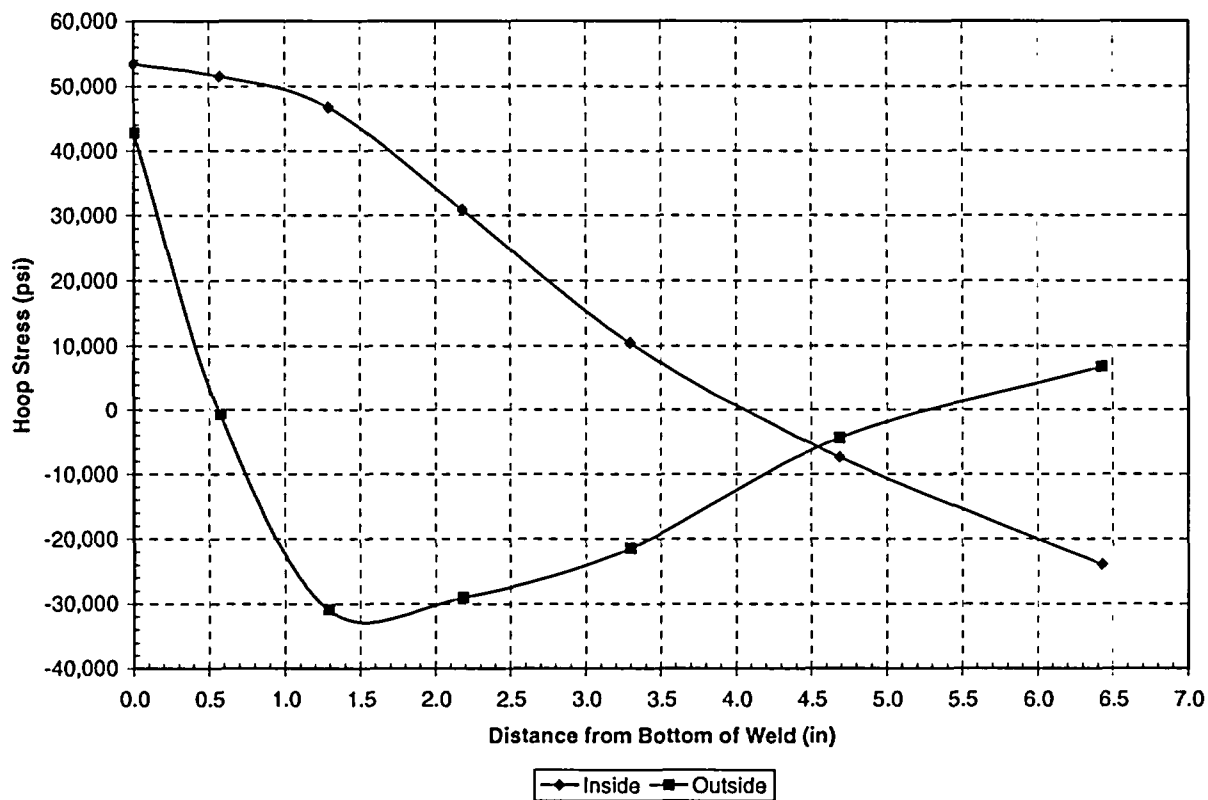
Figure A-9
Hoop Stress Distribution Uphill Side
(48.7° CRDM Penetration Nozzle)
