An Assessment of Visual Testing

Pacific Northwest National Laboratory

**U.S. Nuclear Regulatory Commission
Office of Nuclear Regulatory Research
Washington, DC 20555-0001**

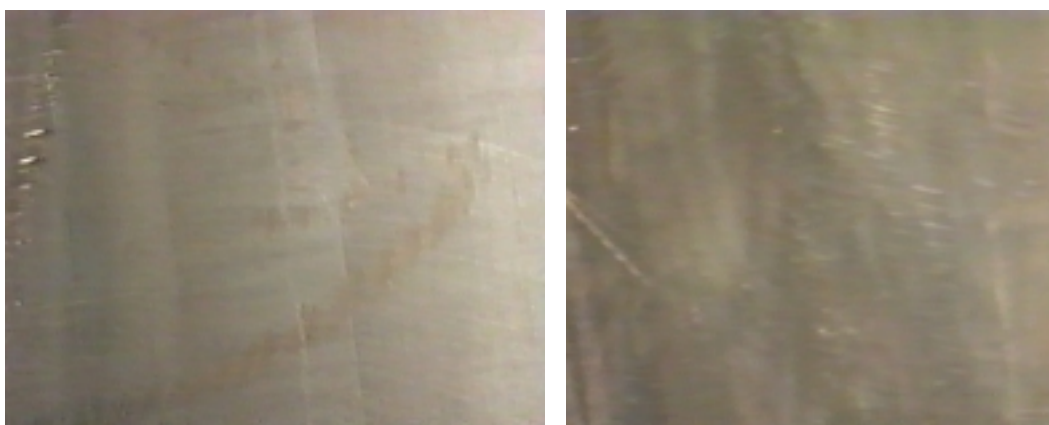
Figure 4.4 Reduction of Visual Acuity During Scanning. Left: a screen capture from when the camera is not moving. The vertical lines are sharp and the picture is relatively clear. Right: a screen capture of different area when the camera is moving. The vertical lines are blurred, as is the rest of the picture.

An example of the loss of visual acuity when a camera is scanning is shown in Figure 4.4. The picture is significantly sharper when the camera is stationary (system normal visual acuity) over a zone as opposed to scanning (system kinetic visual acuity). This lower kinetic visual acuity demonstrates that a system capable of passing a resolution test when not moving can possibly fail when the camera is being scanned.
