### 3.2 Run1ga - Side

The run1ga is a 30-foot impact followed by a crush impact, with the crush plate centered above the CV flange. The run1g 30-foot impact restart file was used and the crush plate was moved during the restart phase so that its centerline was approximately above the CV flange. The 30-foot impact was from time 0.0 to 0.0085 sec. The crush plate translation to center it above the CV flange was from time 0.0085 sec to 0.0086 sec. The run1ga crush occurred from 0.0086 sec to 0.027 sec. Therefore, the 30-foot impact results for this run would be the Section 3.1, 30-foot results for run1g, and the crush results for run 1ga (offset crush) are presented in this section.

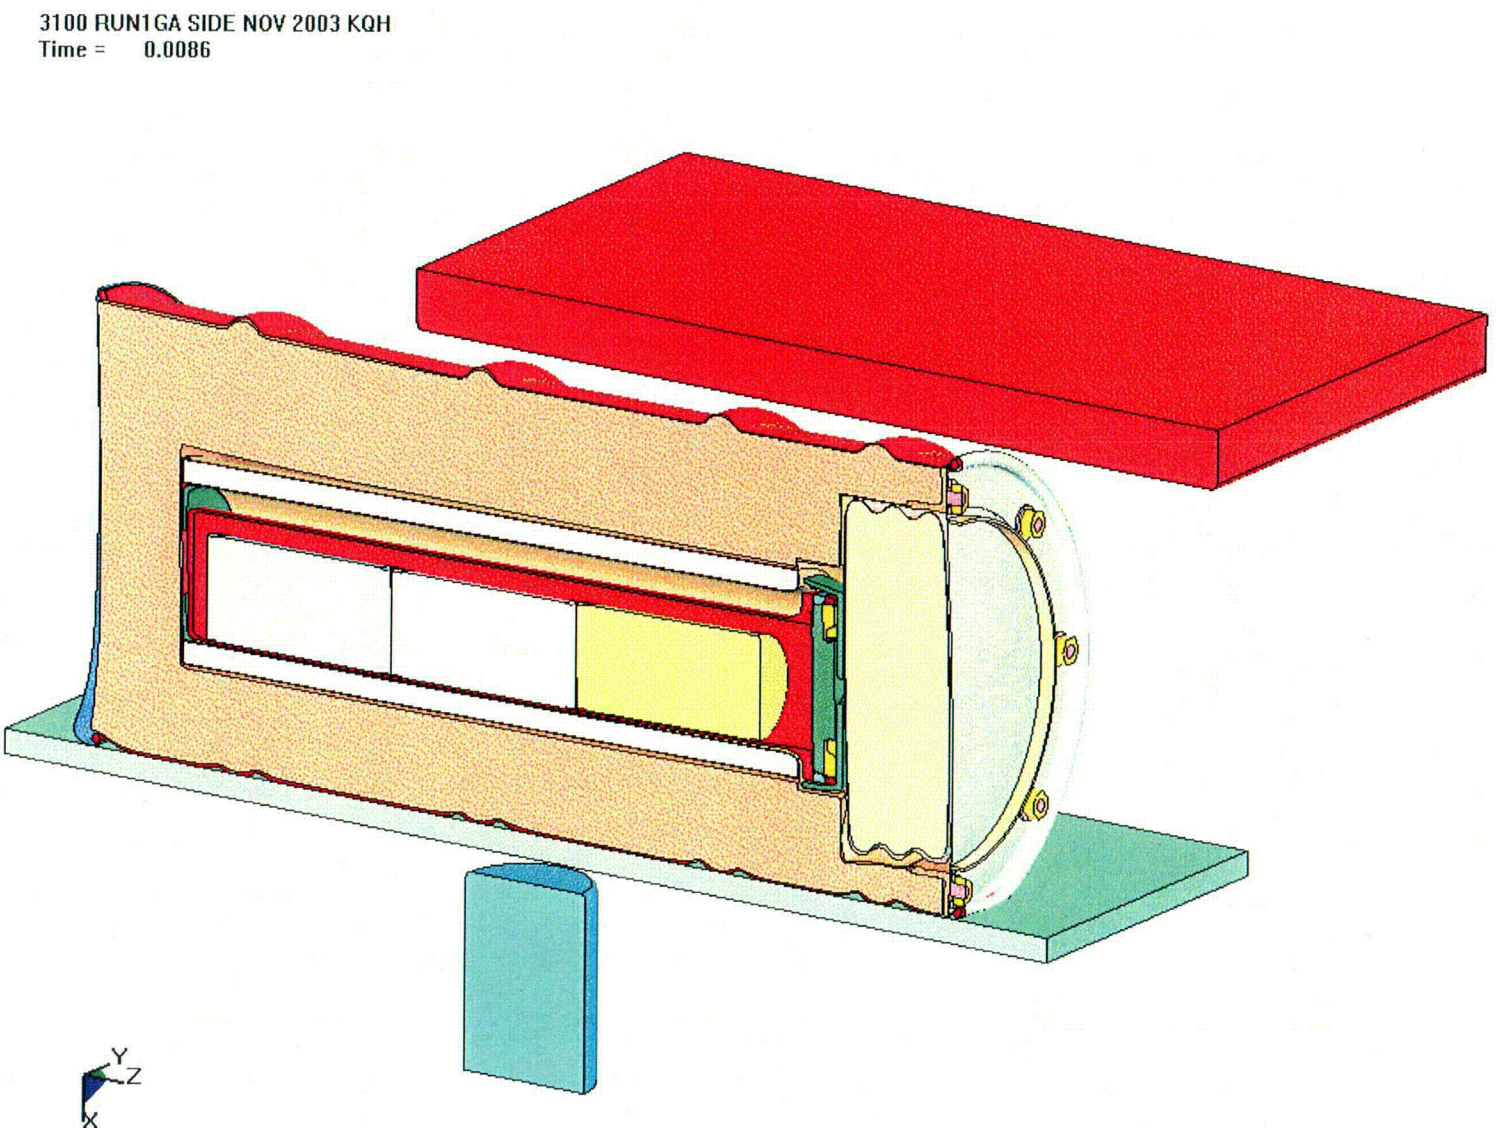
Figure 3.2.1 - Run1ga, Crush Impact, Initial Configuration for the Crush Impact

Figure 3.2.1 shows the configuration of the model after the crush plate was moved above the CV flange (time = 0.0086 sec). Figure 3.2.2 shows the model configuration after the run1ga crush impact. Figure 3.2.3 through Figure 3.2.6 show enlarged views in the lid and bottom regions of the package assembly.

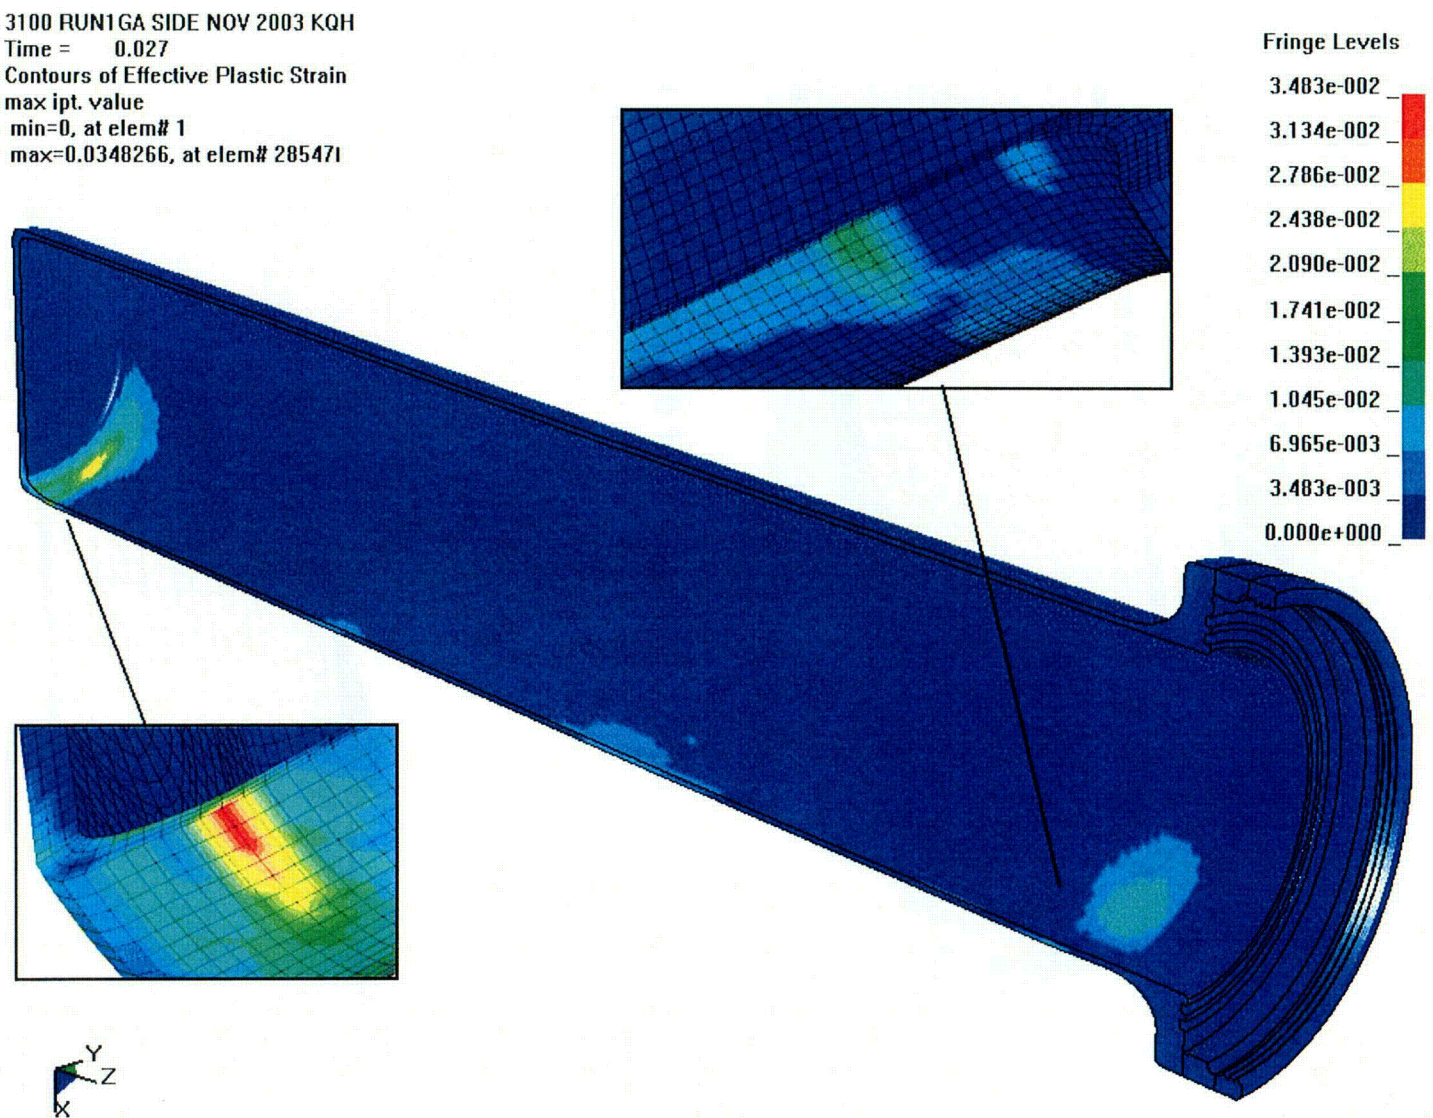
Figure 3.2.7 - Run1ga, Crush Impact, Effective Plastic Strain in the CV Body

Figure 3.2.7 shows that the maximum strain in the CV body for the run1ga crush impact is 0.0348 in/in. The effective plastic strain in the CV lid is 0.0002 in/in and is shown in Figure 3.2.8. The CV nut ring remains elastic for the crush impact of run1ga.

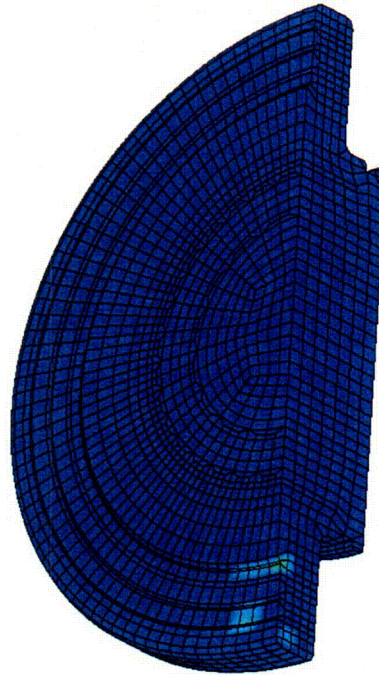
Figure 3.2.8 - Run1ga, Crush Impact, Effective Plastic Strain in the CV Lid

3100 RUN1GA SIDE NOV 2003 KQH  
Time = 0.027  
Contours of Effective Plastic Strain  
max ipt. value  
min=0, at elem# 61157  
max=0.10579, at elem# 679231

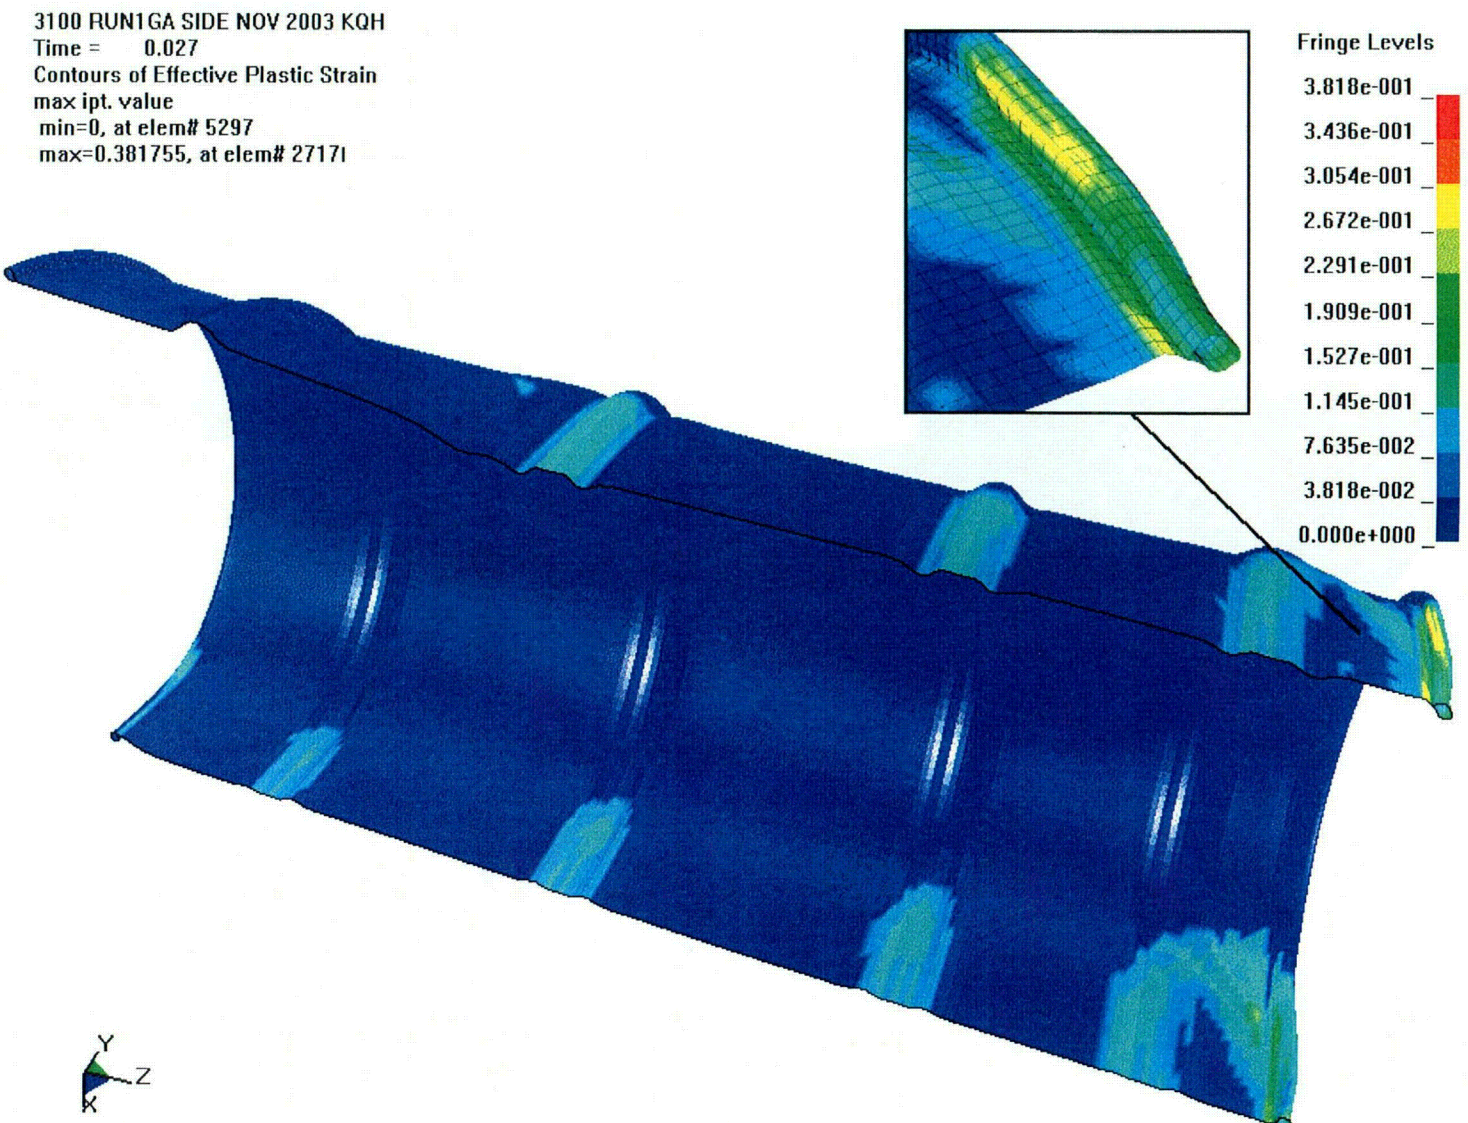
Figure 3.2.10 - Run1ga, Crush Impact, Effective Plastic Strain in the Drum

The maximum effective plastic strain in the drum angle is shown in Figure 3.2.9 to be 0.1058 in/in. The maximum effective plastic strain in the drum is 0.3818 in/in and occurs in the top drum roll near the crush plate (Figure 3.2.10).

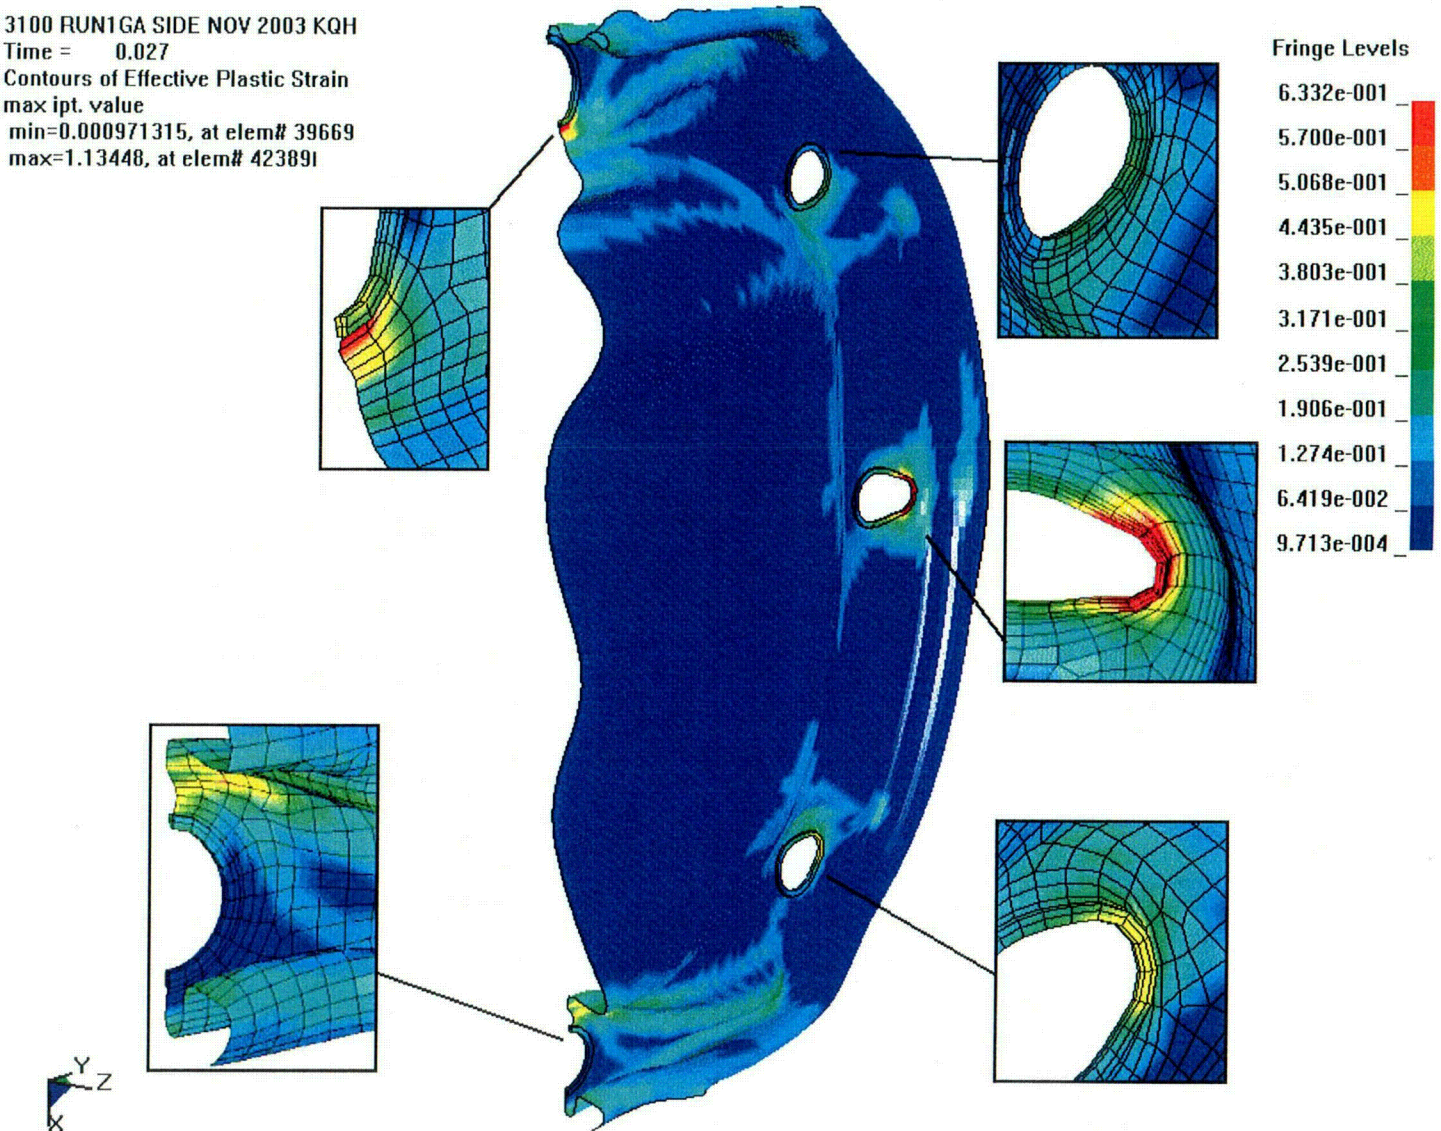
Figure 3.2.11 - Run1ga, Crush Impact, Effective Plastic Strain in the Lid

Figure 3.2.11 gives the maximum effective plastic strain in the lid to be 1.1345 in/in. This is a relatively high strain level and the maximum occurs near the stud hole at the 90° position (initially along Y axis). Another high region of strain is near the upper stud nearest the crush plate. The solid elements (used for contact bearing on the studs) around the stud holes show effective plastic strain maximum of 0.8745 in/in. The membrane effective plastic strain in the shell elements is a maximum of 0.8057 in/in and is highly localized near the stud hole at the 90° position. Some tearing of the lid could occur in the lid hole at the 90° position and at the lid hole nearest the crush plate (180°).

A study of the timing of the elevated effective plastic strain levels in the lid and the drum studs shows that the lid reaches failure magnitudes before the studs. At the stud hole in the drum lid nearest the crush plate (180°), the bending strain crosses the 0.57 in/in

From this timing data, it is shown that the lid would reach failure levels in bending and membrane before the stud effective plastic strain levels become relatively high. Therefore, it would be expected that the lid would locally tear before the bolting reached elevated effective plastic strain levels, thus possibly reducing the loadings on the studs. Due to the extent of the relatively high levels of effective plastic strain in the drum lid, it would be expected that any lid tearing would be localized and that the large washers would restrain the drum lid.

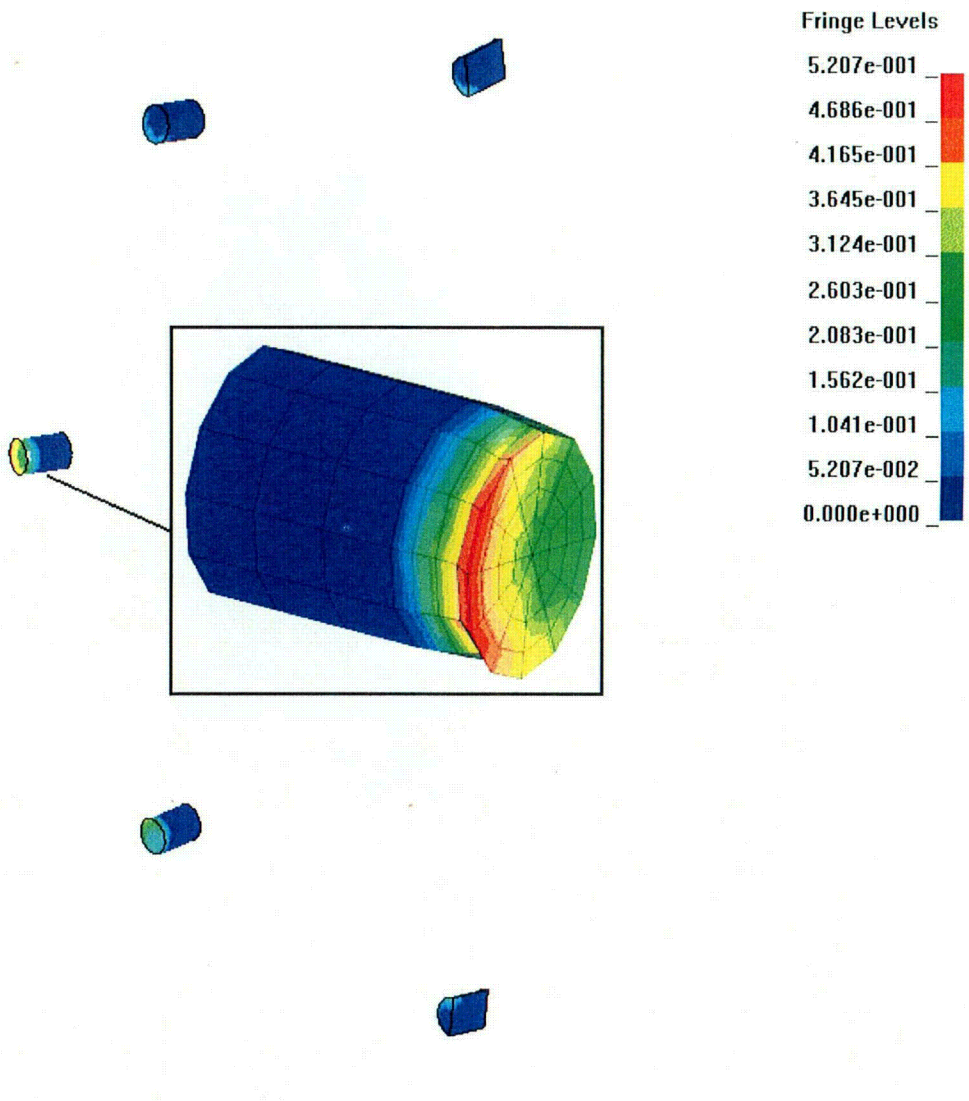
Figure 3.2.12 - Run1ga, Crush Impact, Effective Plastic Strain in the Drum Studs

Figure 3.2.12 shows the effective plastic strain levels in the drum studs. The maximum is shown to be 0.5207 in/in and occurs in the stud at the 90° position. From Figure 3.2.12 it is seen that the elevated strain occurs near the outer extreme of the stud, and that the through thickness strain levels between 0.3170 and 0.3802 in/in exist.

At the 90° position in the lid, the membrane effective plastic strain exceeds the 0.57 in/in level near 0.0164 seconds in the crush impact. The surface maximum effective plastic strain exceeds 0.57 in/in at about 0.0161 seconds, slightly ahead of the membrane. At time 0.0164 seconds, the effective plastic strain levels in the stud at 90° is about 0.35 in/in maximum, with the through thickness levels between 0.104 in/in to 0.136 in/in. Therefore, at the 90° position, the lid reaches the failure level of 0.57 in/in before the stud.

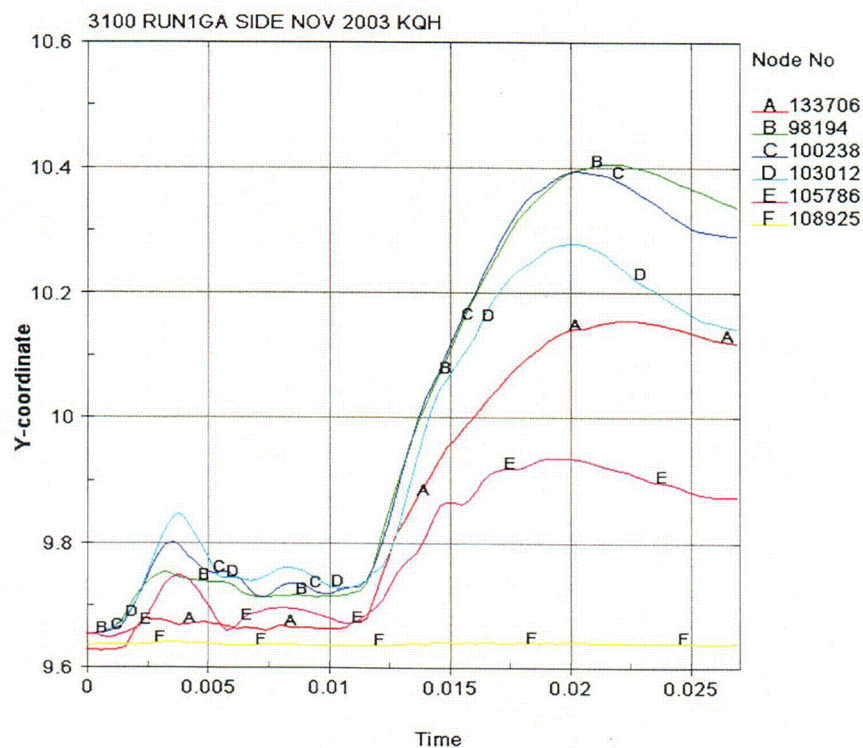
Figure 3.2.18 - Run1ga, Drum Dimension Time History in the Y-Direction

The kaolite thickness time histories for the nodes defined in Figure 3.1.32 are given in Figure 3.2.16 for run1ga. The drum diameter time histories are given in Figures 3.2.17 and 3.2.18. The nodes defining this response are shown in Figure 3.1.34. As shown in Figure 3.2.17, the bottom head and the bottom drum roll remain at, or near 30-foot impact diameters for the crush impact. This response is expected as qualitatively shown in Figure 3.2.2. The response in the Y-direction is shown in Figure 3.2.18.

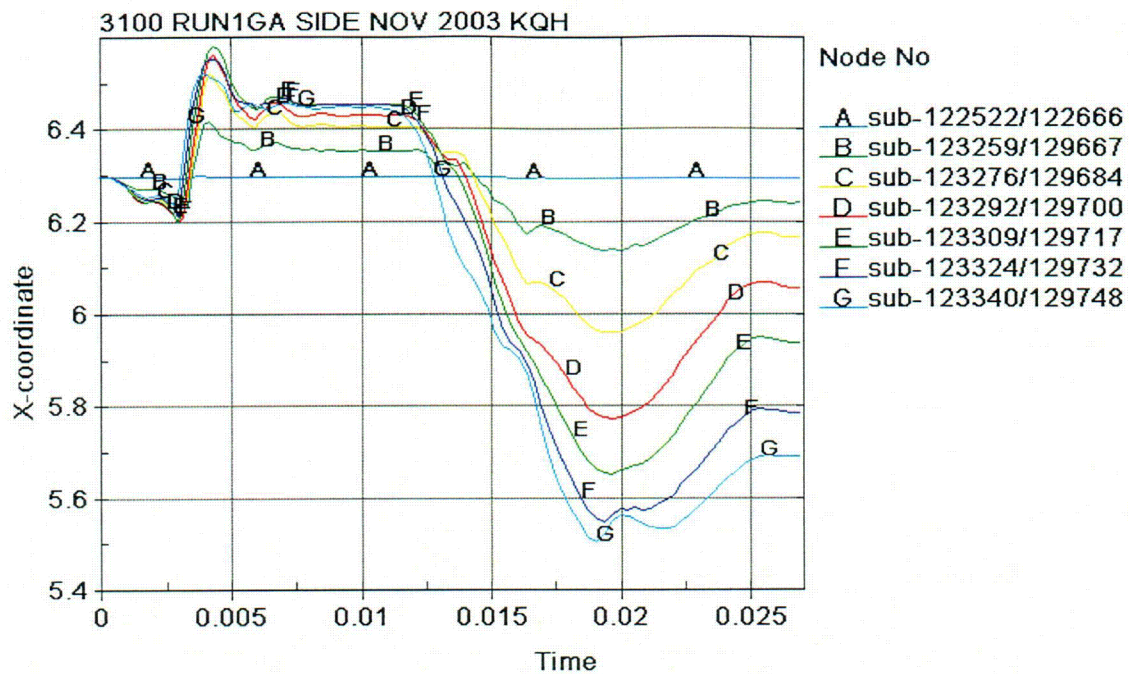
Figure 3.2.19 - Run1ga, Liner Diameter Time History

Figure 3.2.19 shows the diameter time history for various locations along the liner length.

Figure 3.1.37 and Table 3.1.3 define the locations at which the diameters are obtained.

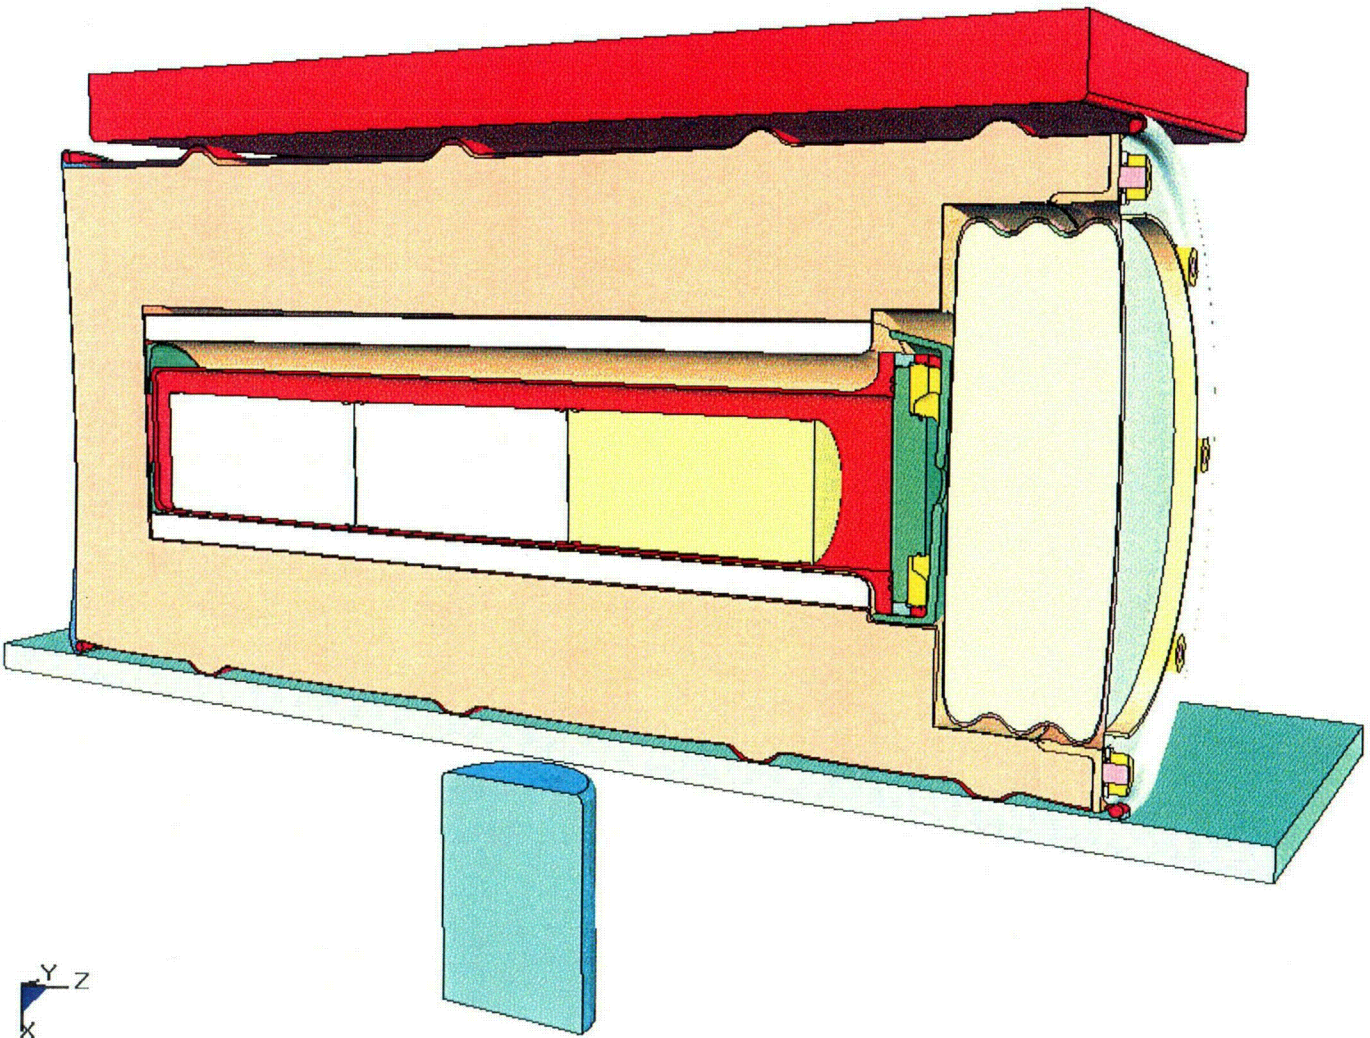
Figure 3.3.1 - Run1hl, 4-Foot Impact, Final Configuration

Run1hl is the lower bounding kaolite run (100°F). It is basically the run1g model, but with kaolite properties of section 2.3.5.2. It is a run with a 4-foot impact (time = 0 to 0.01 seconds), followed by a 30-foot impact (0.01 to 0.02 seconds), followed by a 30-foot crush impact (0.02 to 0.04 seconds), finally followed by a 40-inch punch impact (0.04 to 0.055 seconds). The initial configuration of run1hl is similar to Figure 3.1.1. The configuration after the 4-foot impact is shown in Figure 3.3.1. Figure 3.3.2 and 3.3.3 show the configuration at the extremes of the package.

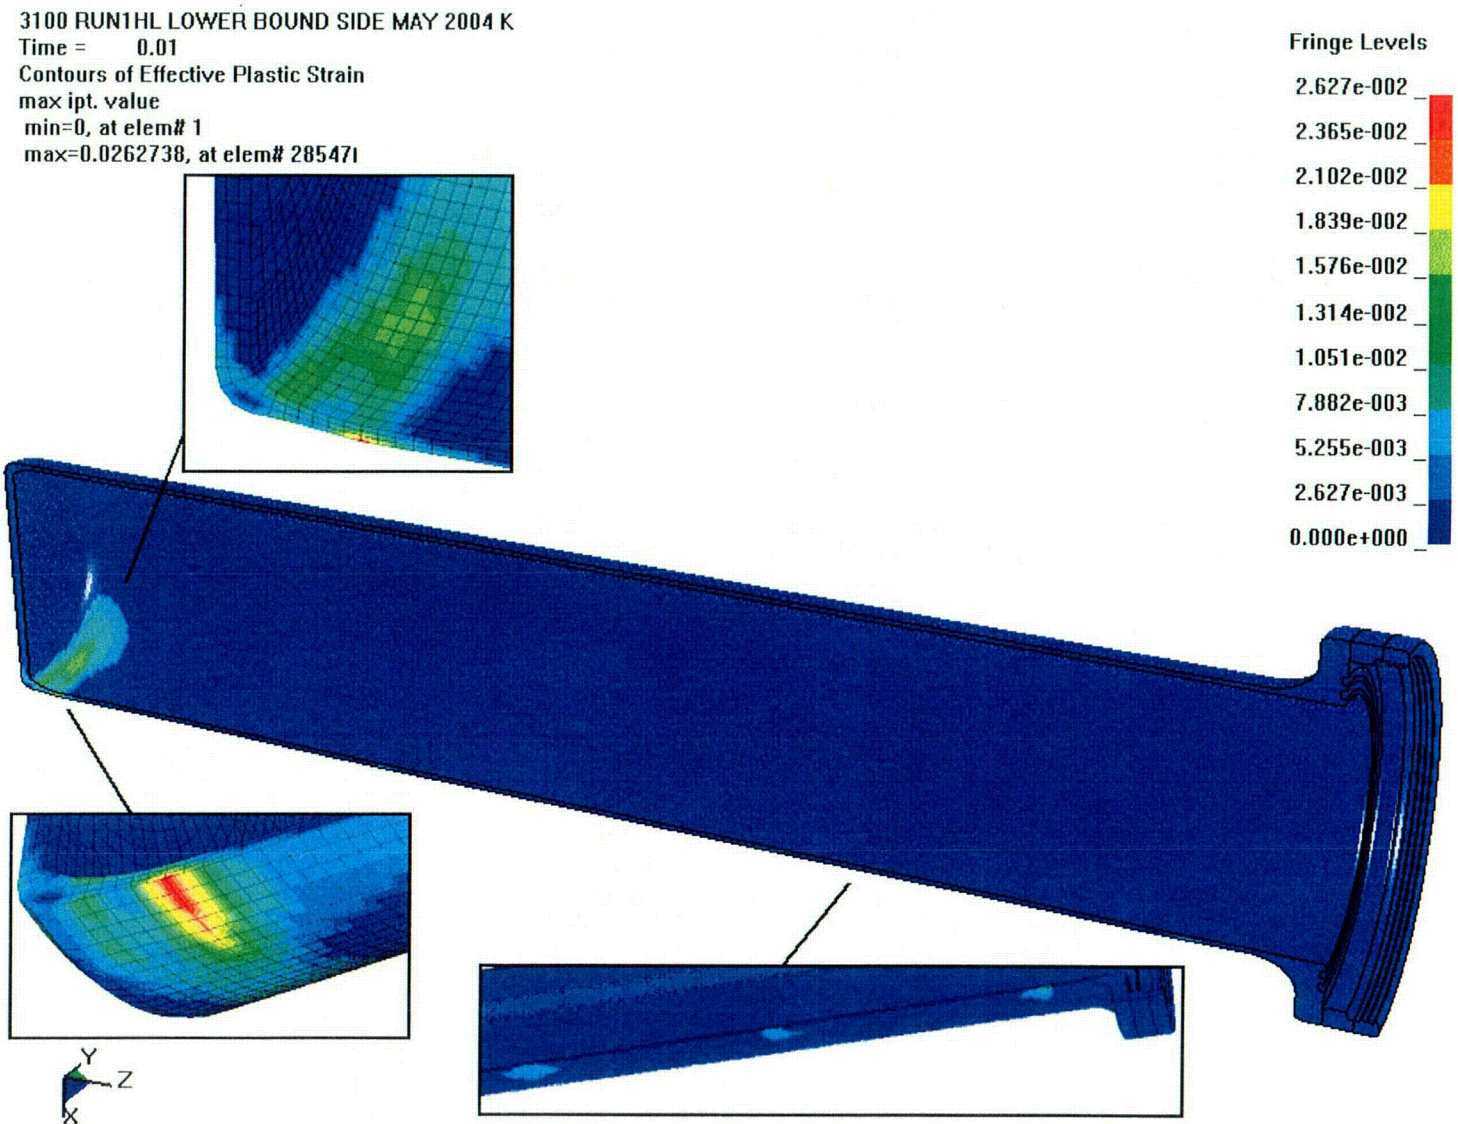
Figure 3.3.4 - Run1hl, 4-Foot Impact, Effective Plastic Strain in the CV Body

The CV body undergoes plastic deformation in the 4-foot impact. The effective plastic strain in the CV body is shown in Figure 3.3.4 to have a maximum of 0.0263 in/in. The elevated plastic strain levels are near the CV bottom head. The CV lid and nut ring remain elastic during the 4-foot impact. The plastic strain in other components for the 4-foot impact are given in Table 3.3.1.

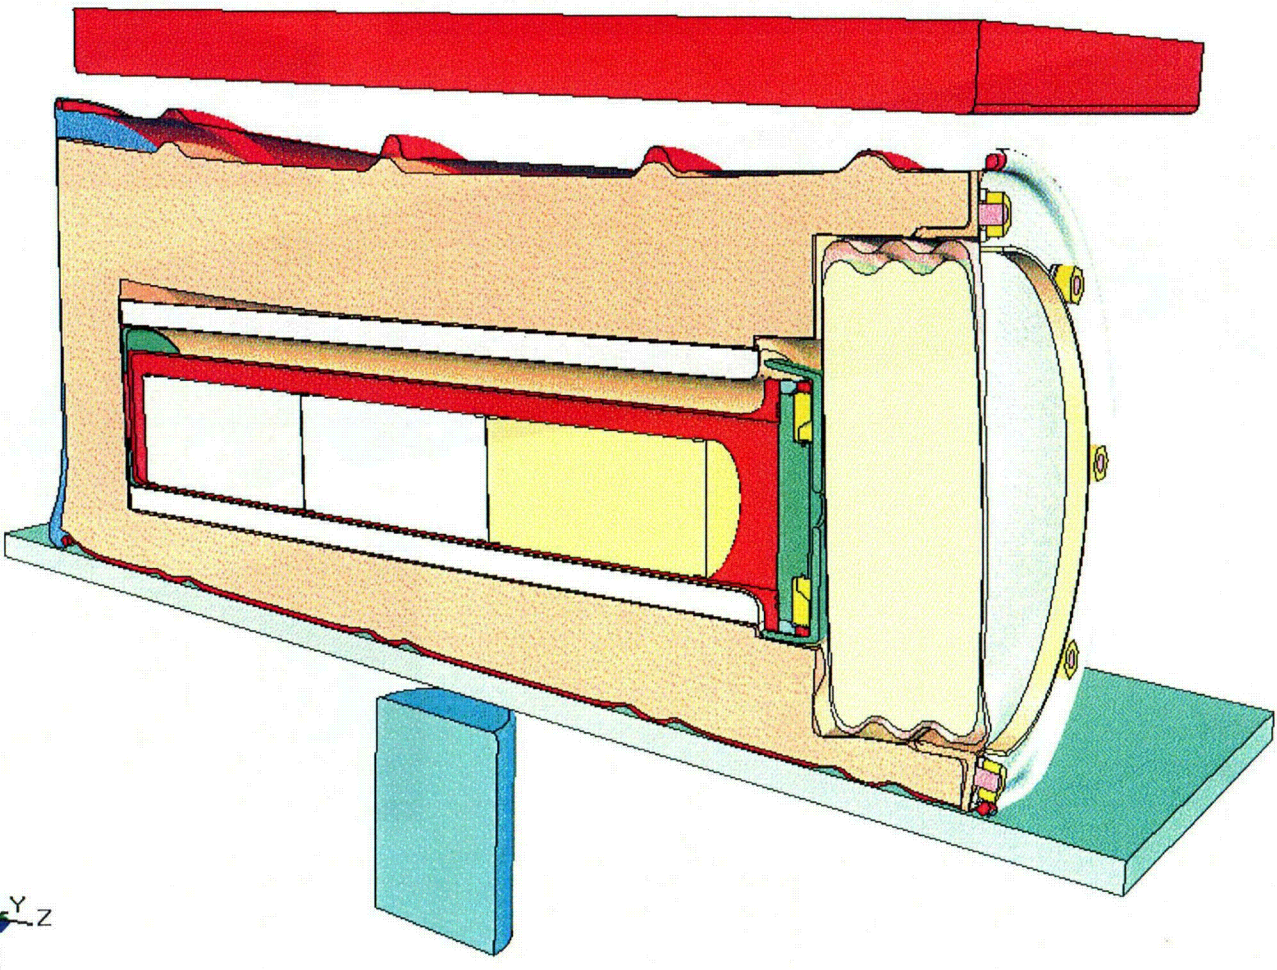
Figure 3.3.5 - Run1hl, 30-Foot Impact, Final Configuration

Figure 3.3.5 shows the final configuration for the run1hl 30-foot impact. Figures 3.3.6 and 3.3.7 show the configurations for the package extremes.

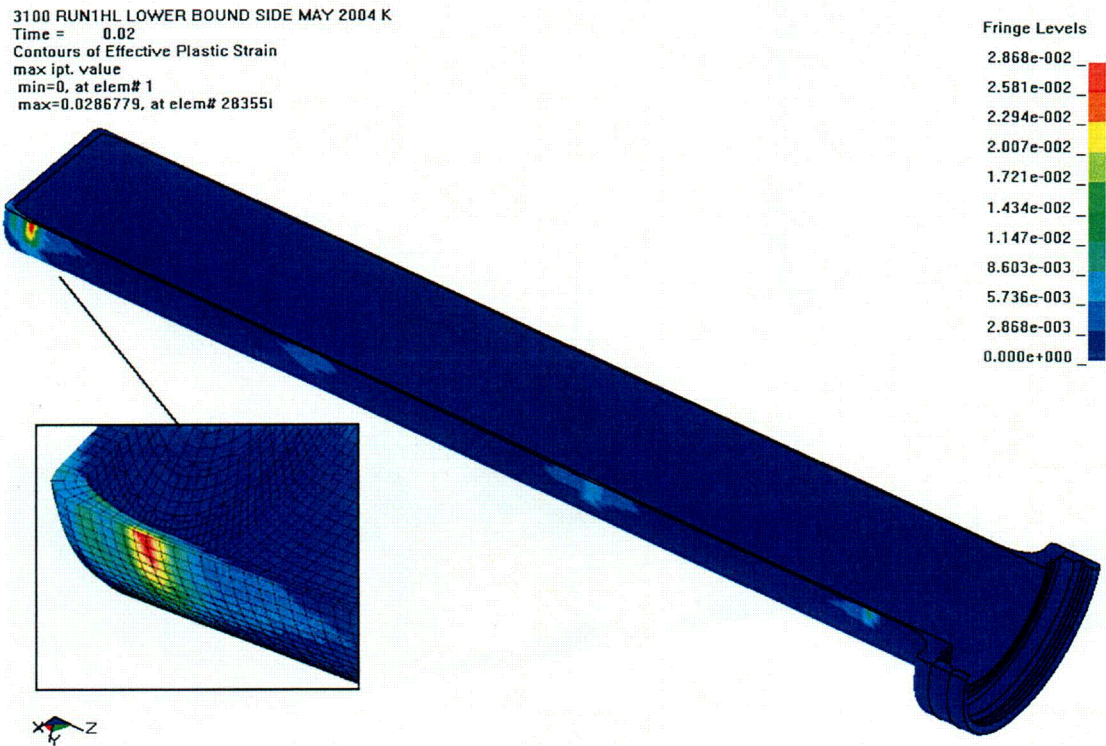
Figure 3.3.8 - Run1hl, 30-Foot Impact, Effective Plastic Strain in the CV

The maximum effective plastic strain due to the 30-foot impact in the CV body is 0.0287 in/in as shown in Figure 3.3.8. The maximum effective plastic strain in the drum lid

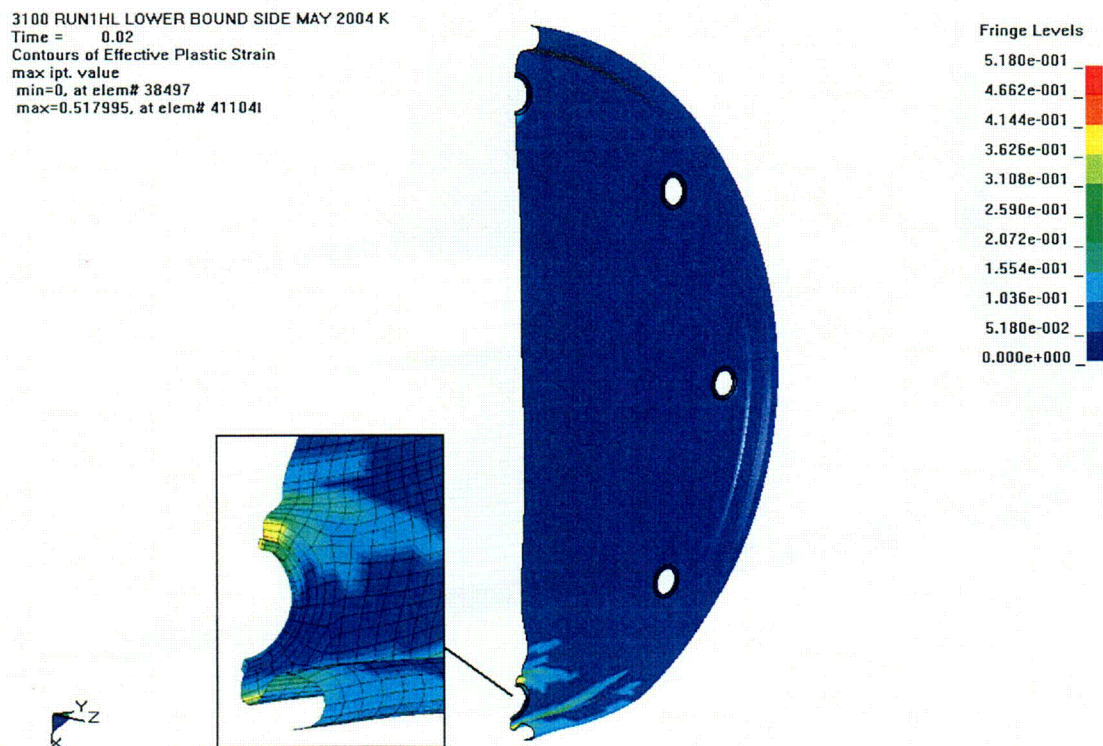
Figure 3.3.9 - Run1hl, 30-Foot Impact, Effective Plastic Strain in the Lid

is shown to be 0.5180 in/in in Figure 3.3.9. The maximum lid strain is a surface strain at the stud hole nearest the rigid surface ( $0^\circ$ ). The membrane effective plastic strain component is 0.4026 in/in in the localized region near the stud hole. Effective plastic strain levels in other components for the 30-foot impact are given in Table 3.3.2.

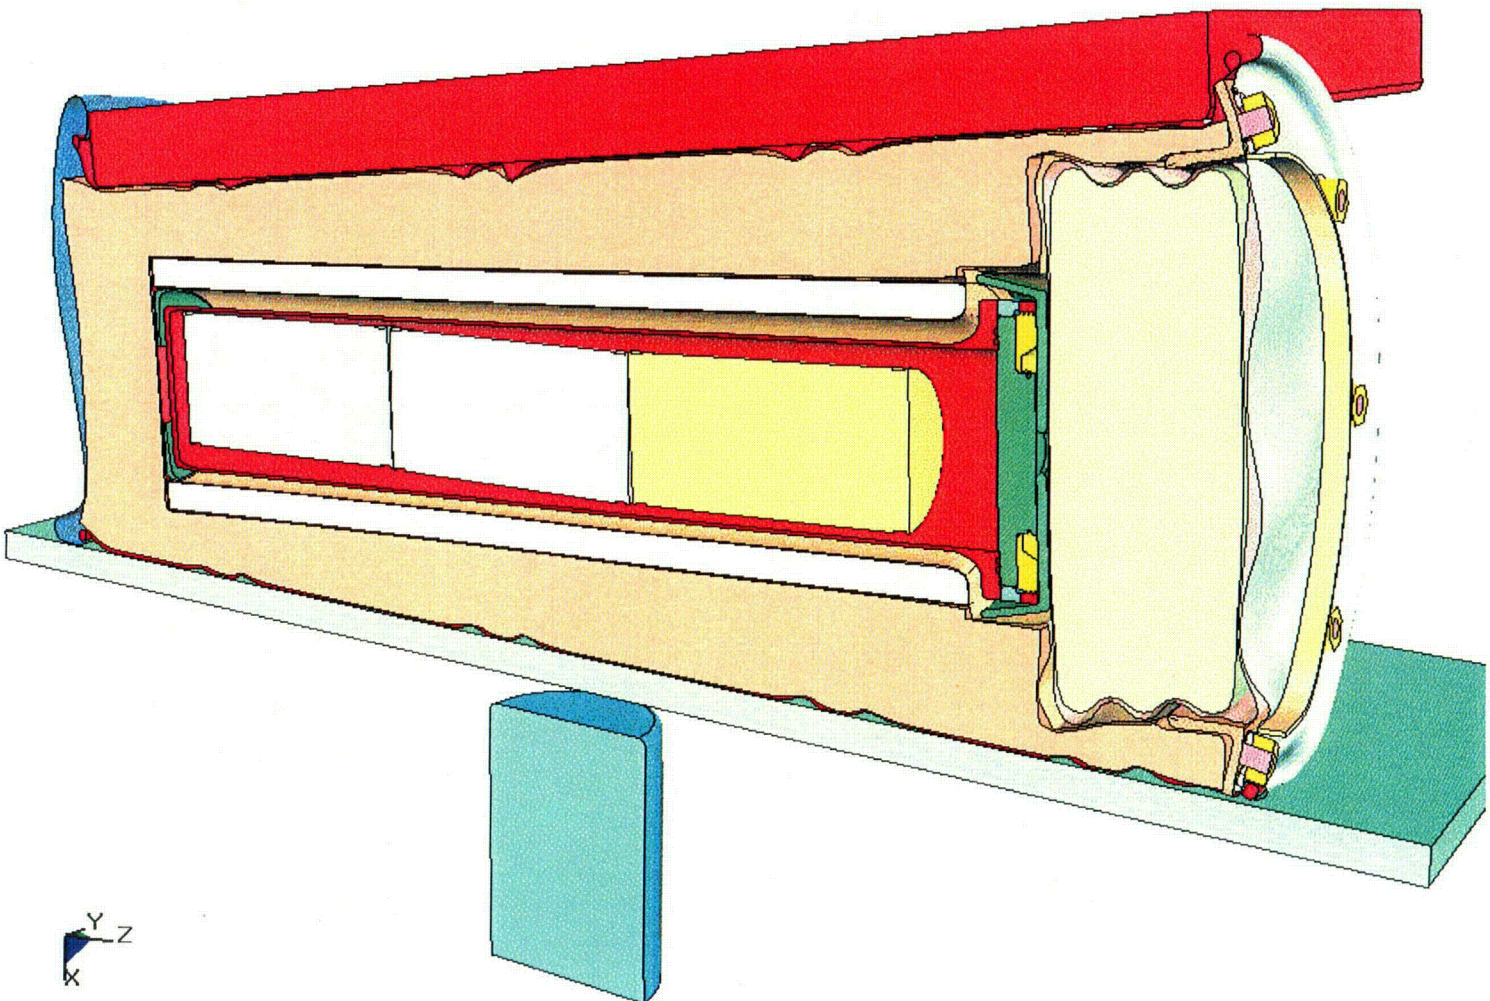
Figure 3.3.10 - Run1hl, Crush Impact, Final Configuration

The final configuration for the crush impact is shown in Figure 3.3.10. The configuration at the package extremes are shown in Figure 3.3.11. The maximum effective plastic strain in the CV body is 0.0287 in/in as shown in Figure 3.3.12. The maximum effective plastic strain in the drum for the crush impact is 0.5309 in/in (surface strain). The maximum in the drum occurs near the angle on the crush plate side of the drum as shown in Figure 3.3.13. The maximum membrane effective plastic strain at this location is 0.3616 in/in.

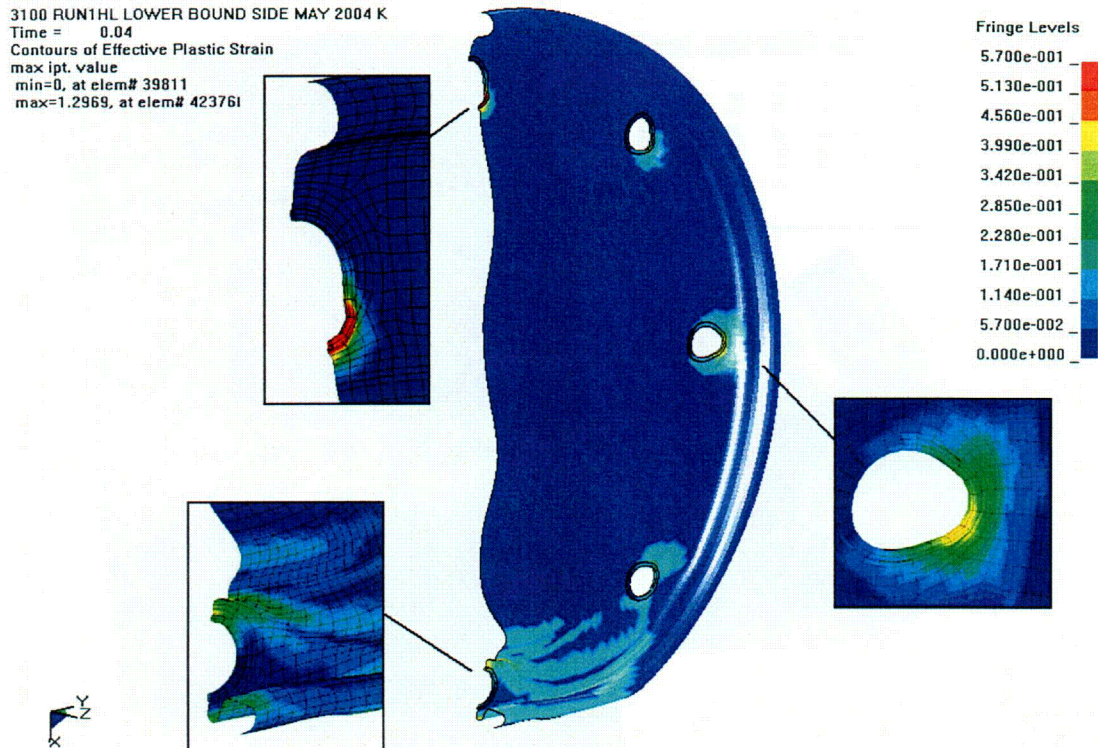
Figure 3.3.14 - Run1hl, Crush Impact, Effective Plastic Strain in the Lid

The maximum effective plastic strain in the lid is 1.2969 in/in (surface strain) and occurs just below the upper stud hole (hole nearest the crush plate,  $180^\circ$ ) as shown in Figure 3.3.14. The maximum membrane effective plastic strain in this region of the lid is 0.8995 in/in. A time line investigation during the crush impact shows that the lid exceeds 0.57 in/in strain in bending at about 0.0228 seconds at the  $180^\circ$  stud hole. The crush impact started at about 0.0200 seconds, so the lid reaches failure level near the start of the crush impact. The membrane levels in the lid reach 0.57 in/in at about 0.0236 seconds.

The elevated effective plastic strain levels in the lid are localized in the region just inboard of the upper stud.

Considering the strain levels in the lid and the studs, some tearing in the lid at the 180° stud hole would be expected. But the tearing would be localized to the stud hole due to the extent of the strain patterns. Failure of the stud to restrain the lid due to this tearing is not expected. The lid stiffener would limit any tearing from the stud at 180° and the large washer would be expected to restrain the lid.

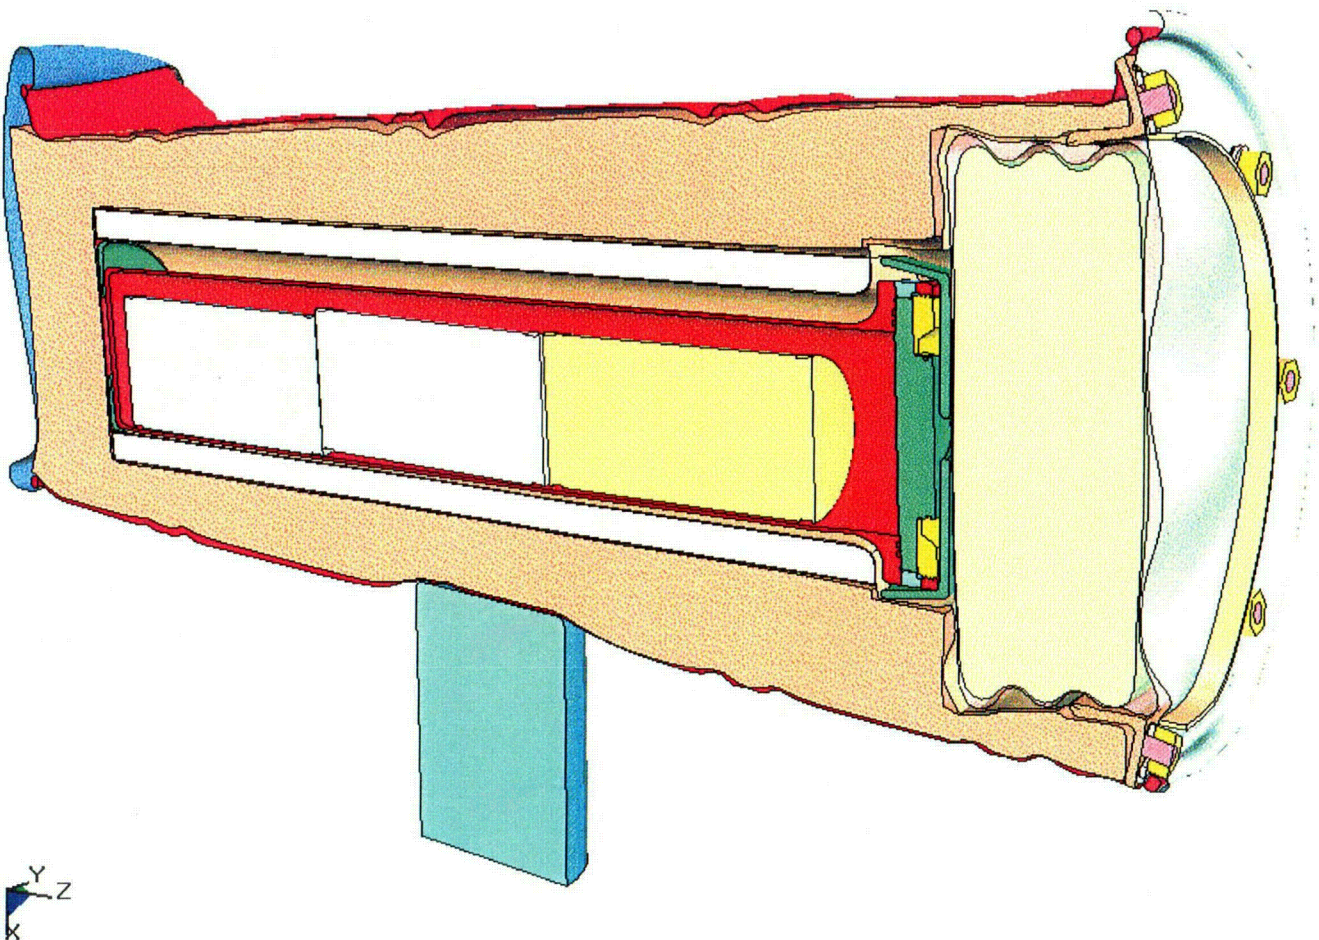
Figure 3.3.16 - Run1hl, Punch Impact, Final Configuration

The final configuration after the punch impact is shown in Figure 3.3.16. The effective plastic strain level in the CV body is shown in Figure 3.3.6. The maximum strain is 0.0299 in/in and is located near the bottom head. The effective plastic strain level in the drum after the punch impact remains at 0.5309 in/in as shown in Figure 3.3.18. The maximum effective plastic strain in the other package components for the punch impact are listed in Table 3.3.4.

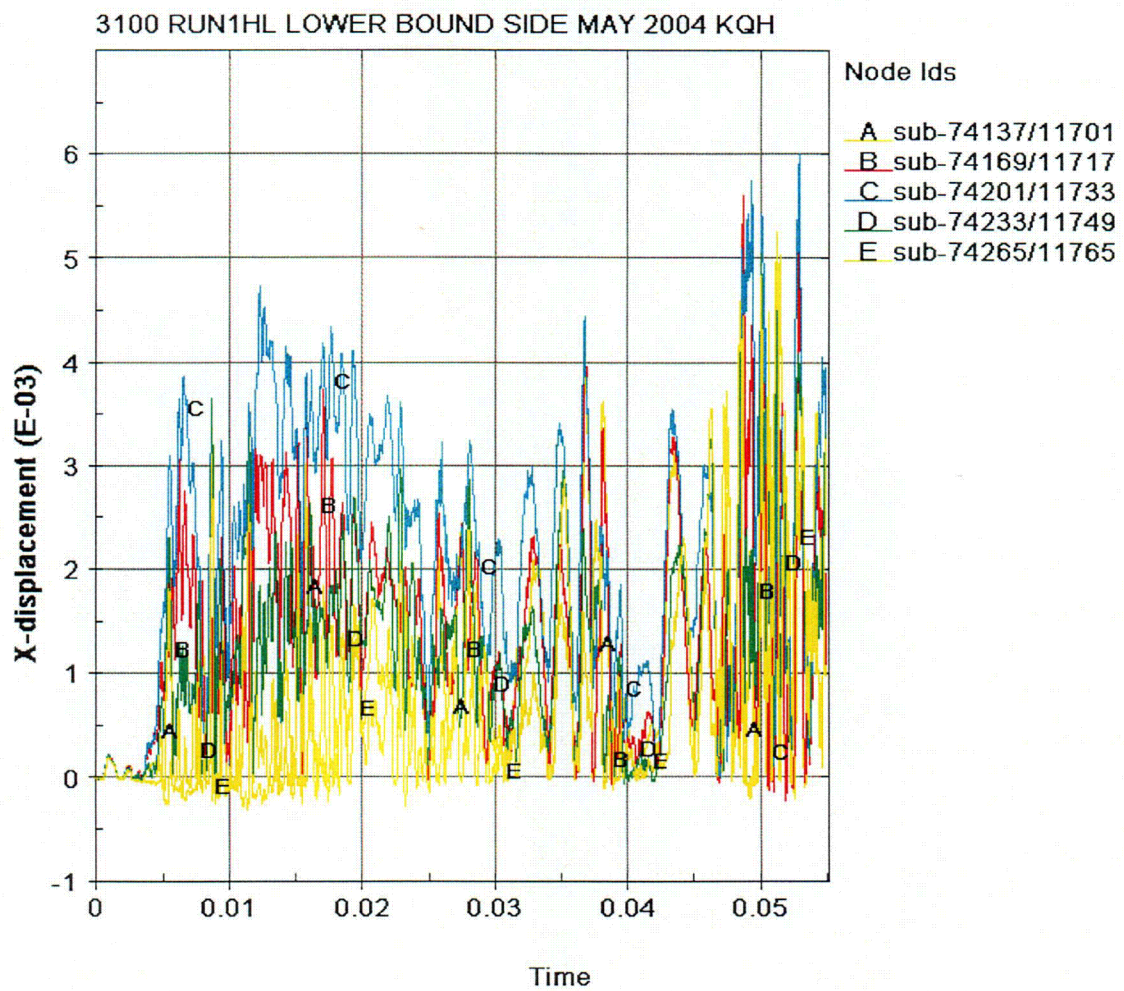
Figure 3.3.19 - Run1hl, CV Lid Separation Time History

Figure 3.3.19 shows the lid separation time history for all the impacts. The CV lid separation shows a maximum spike separation of about 0.006 inches occurs during the punch. The spike is a response to the rebounding impact of the CV/weights. An average value of .003 in or less is demonstrated in the response when the solution is stopped.
