### 3.2 Run1ga - Side

The run1ga is a 30-foot impact followed by a crush impact, with the crush plate centered above the CV flange. The run1g 30-foot impact restart file was used and the crush plate was moved during the restart phase so that its centerline was approximately above the CV flange. The 30-foot impact was from time 0.0 to 0.0085 sec. The crush plate translation to center it above the CV flange was from time 0.0085 sec to 0.0086 sec. The run1ga crush occurred from 0.0086 sec to 0.027 sec. Therefore, the 30-foot impact results for this run would be the Section 3.1, 30-foot results for run1g, and the crush results for run 1ga (offset crush) are presented in this section.

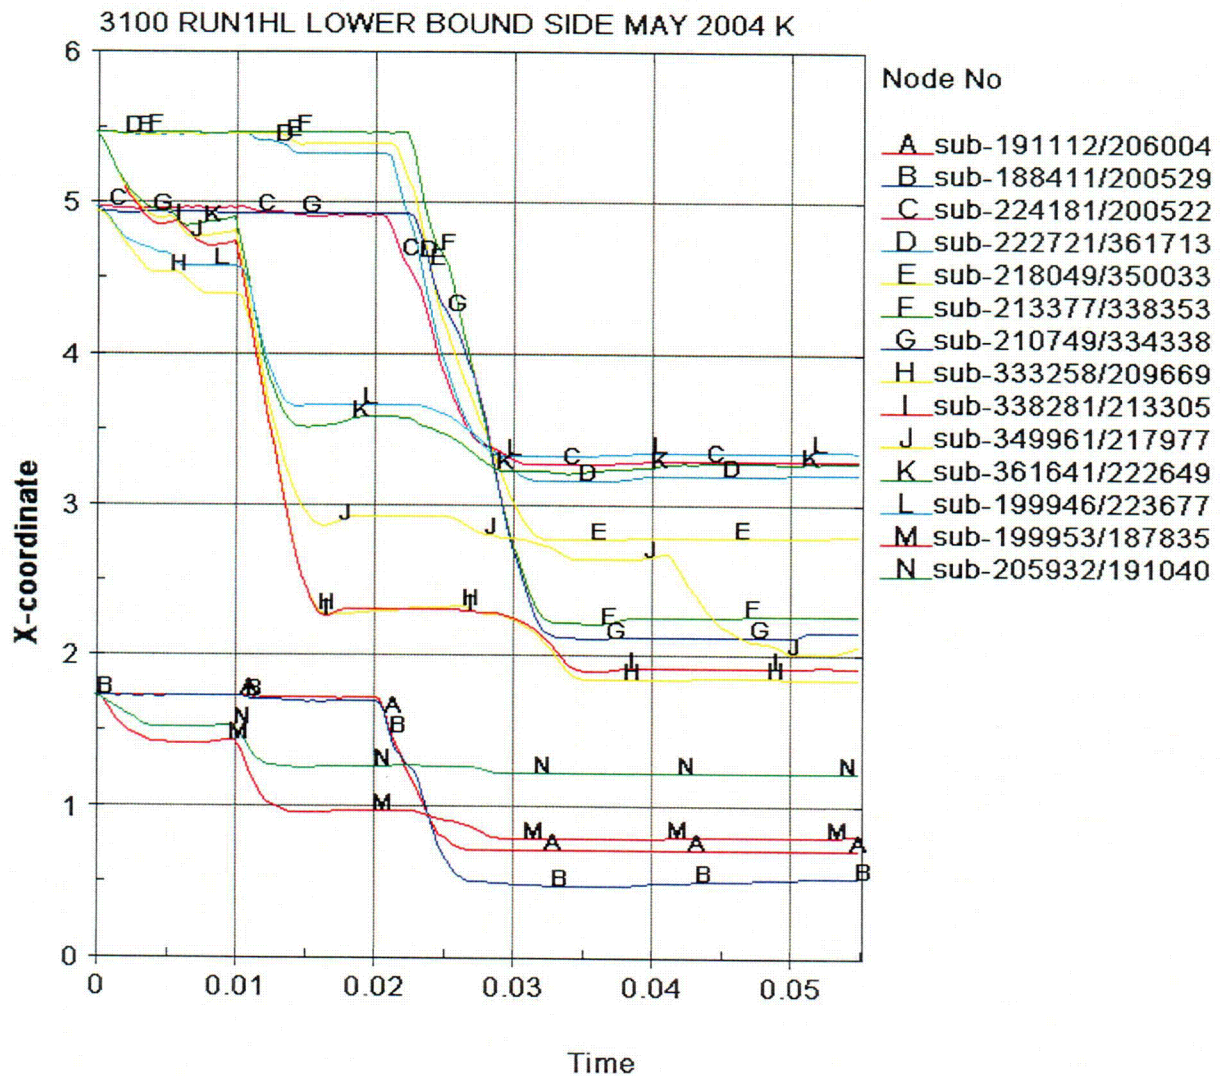
Figure 3.3.20- Run1hl, Kaolite Thickness Time History

Figure 3.3.20 shows the time history for the kaolite thicknesses. The nodal locations for nodes shown in Figure 3.3.20 are shown in Figure 3.1.32.

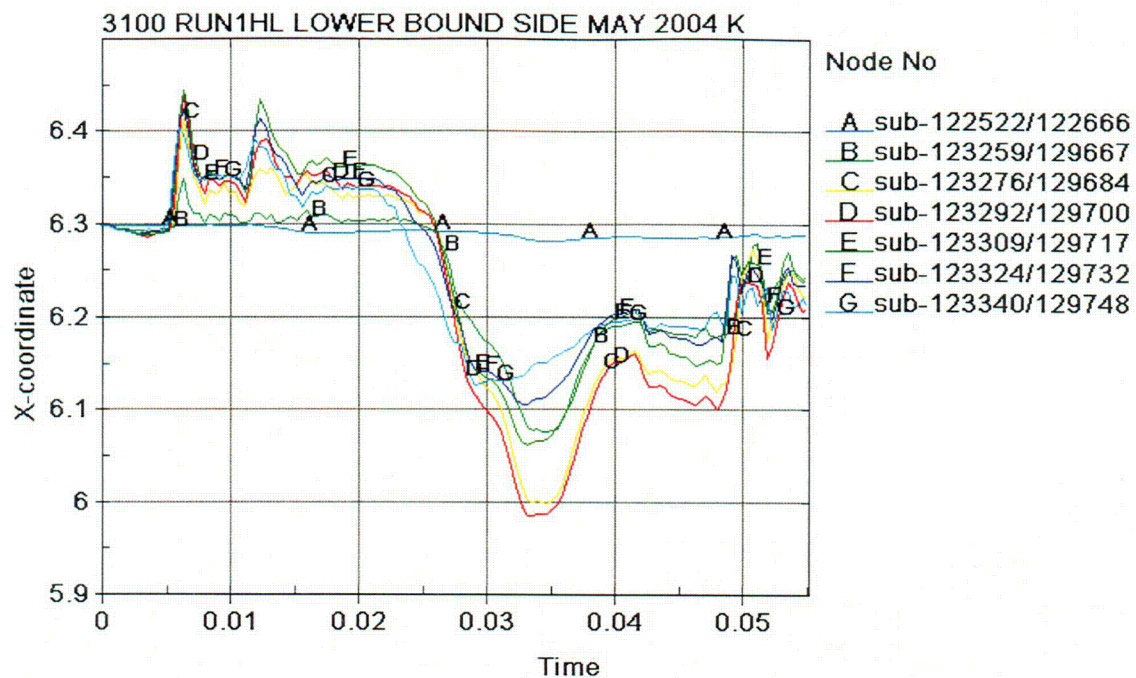
Figure 3.3.23 - Run1hl, Liner Diameter Time History

Figure 3.3.23 shows the liner diameter time history. The node pair locations are shown in Figure 3.1.37 and Table 3.1.3.

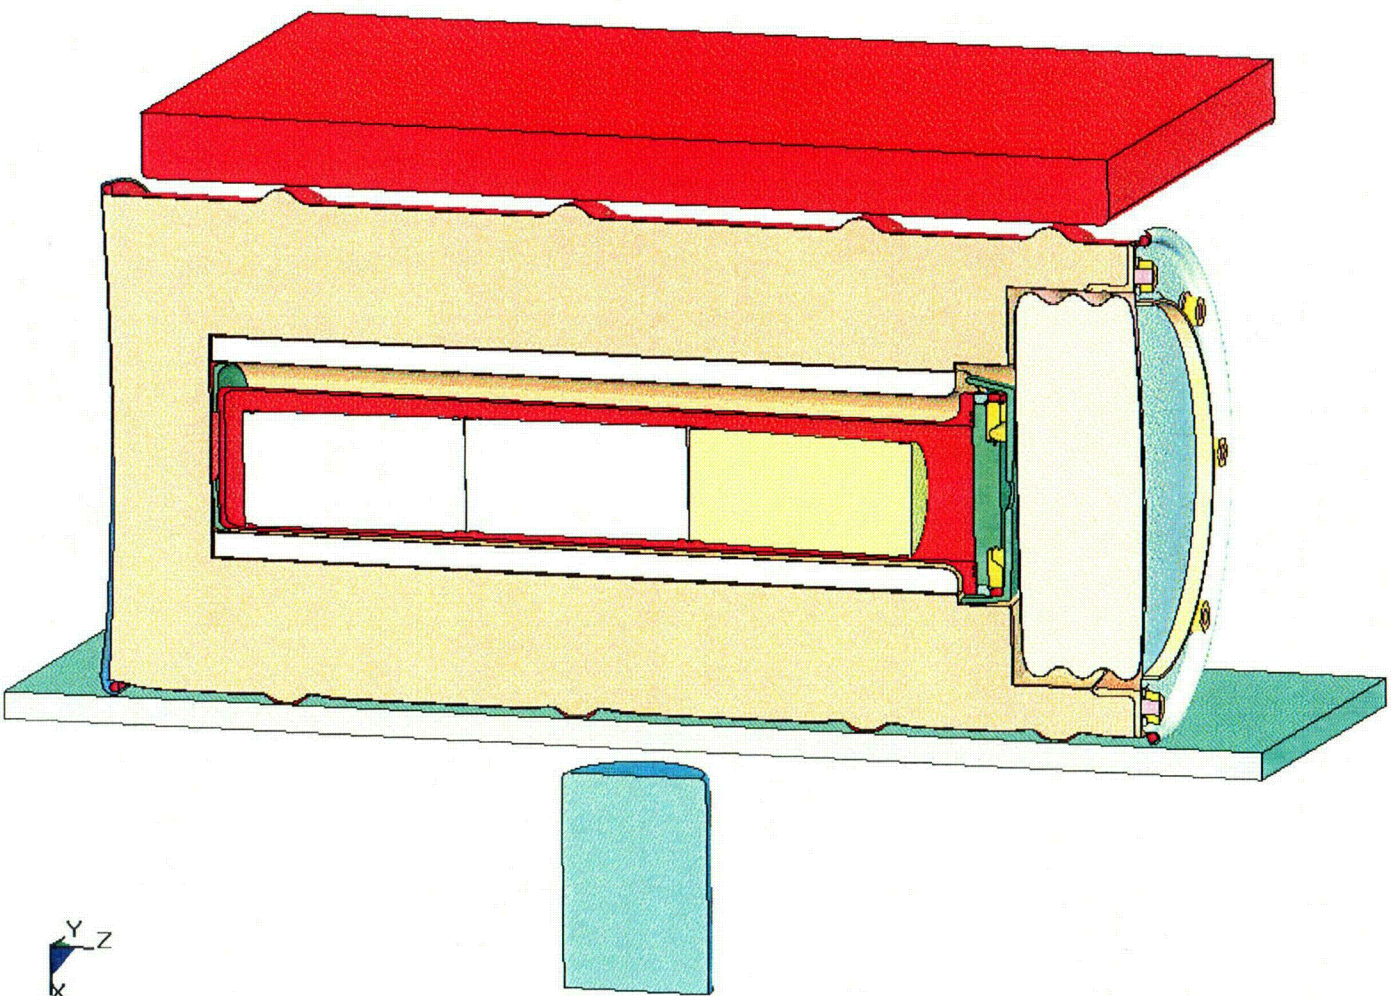
Figure 3.4.1 - Run1hh, 4-Foot Impact, Final Configuration

The final configuration for the 4-foot impact is shown in Figure 3.4.1. Figures 3.4.2 and 3.4.3 show the configuration at the corners of the shipping package. The effective plastic strain in the CV body for the 4-foot impact is shown in Figure 3.4.4. The maximum effective plastic strain is shown to be 0.0298 in/in near the bottom head. The effective plastic strain in other package components for the 4-foot impact are listed in Table 3.4.1.

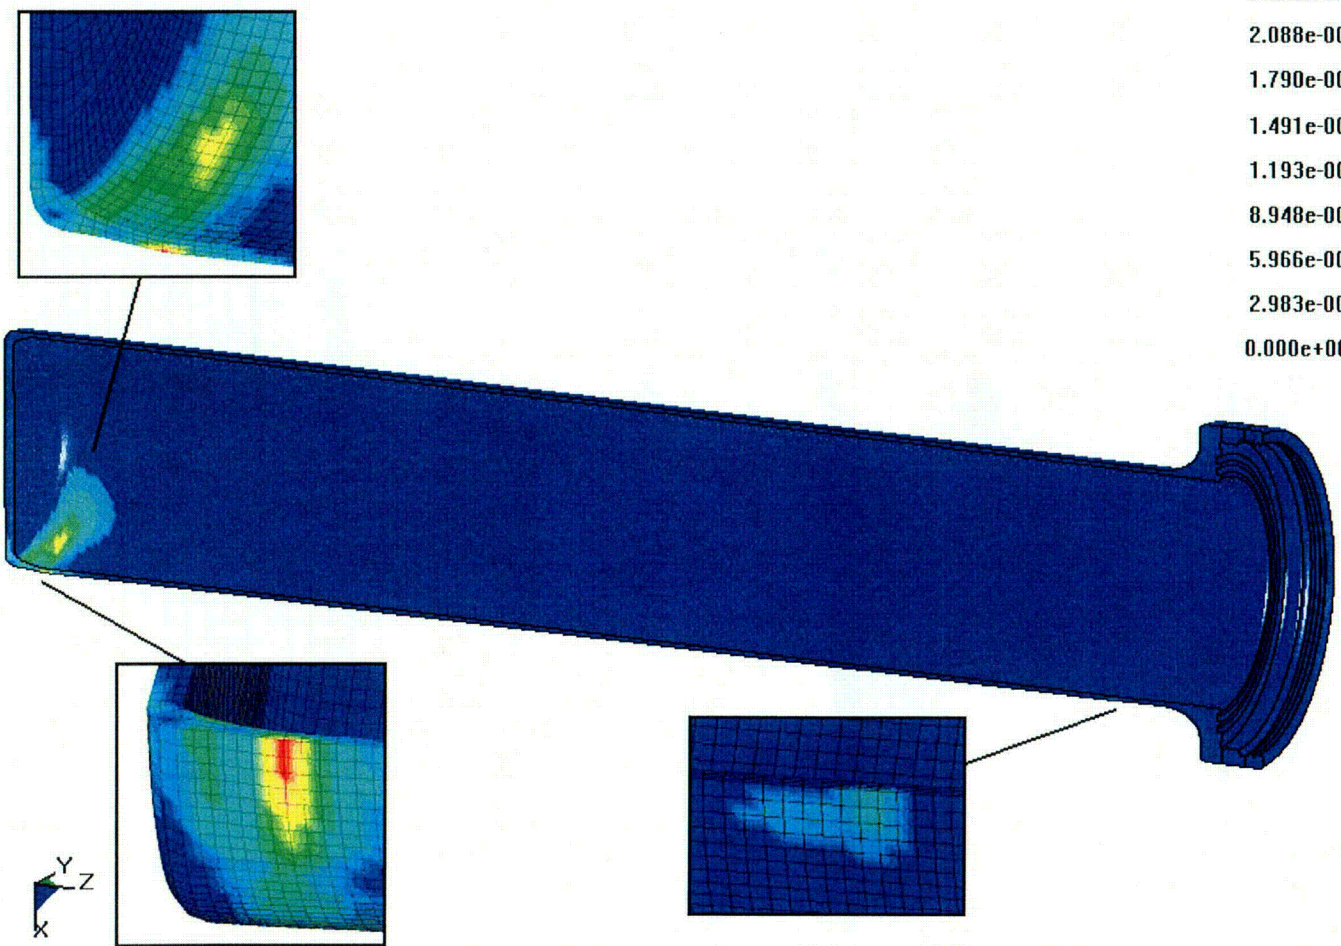
Figure 3.4.4 - Run1hh, 4-Foot Impact, Effective Plastic Strain in the CV Body

3100 RUN1HH UPPER BOUND SIDE MAY 2004 K  
 Time = 0.01  
 Contours of Effective Plastic Strain  
 max ipt. value  
 min=0, at elem# 1  
 max=0.0298283, at elem# 285471

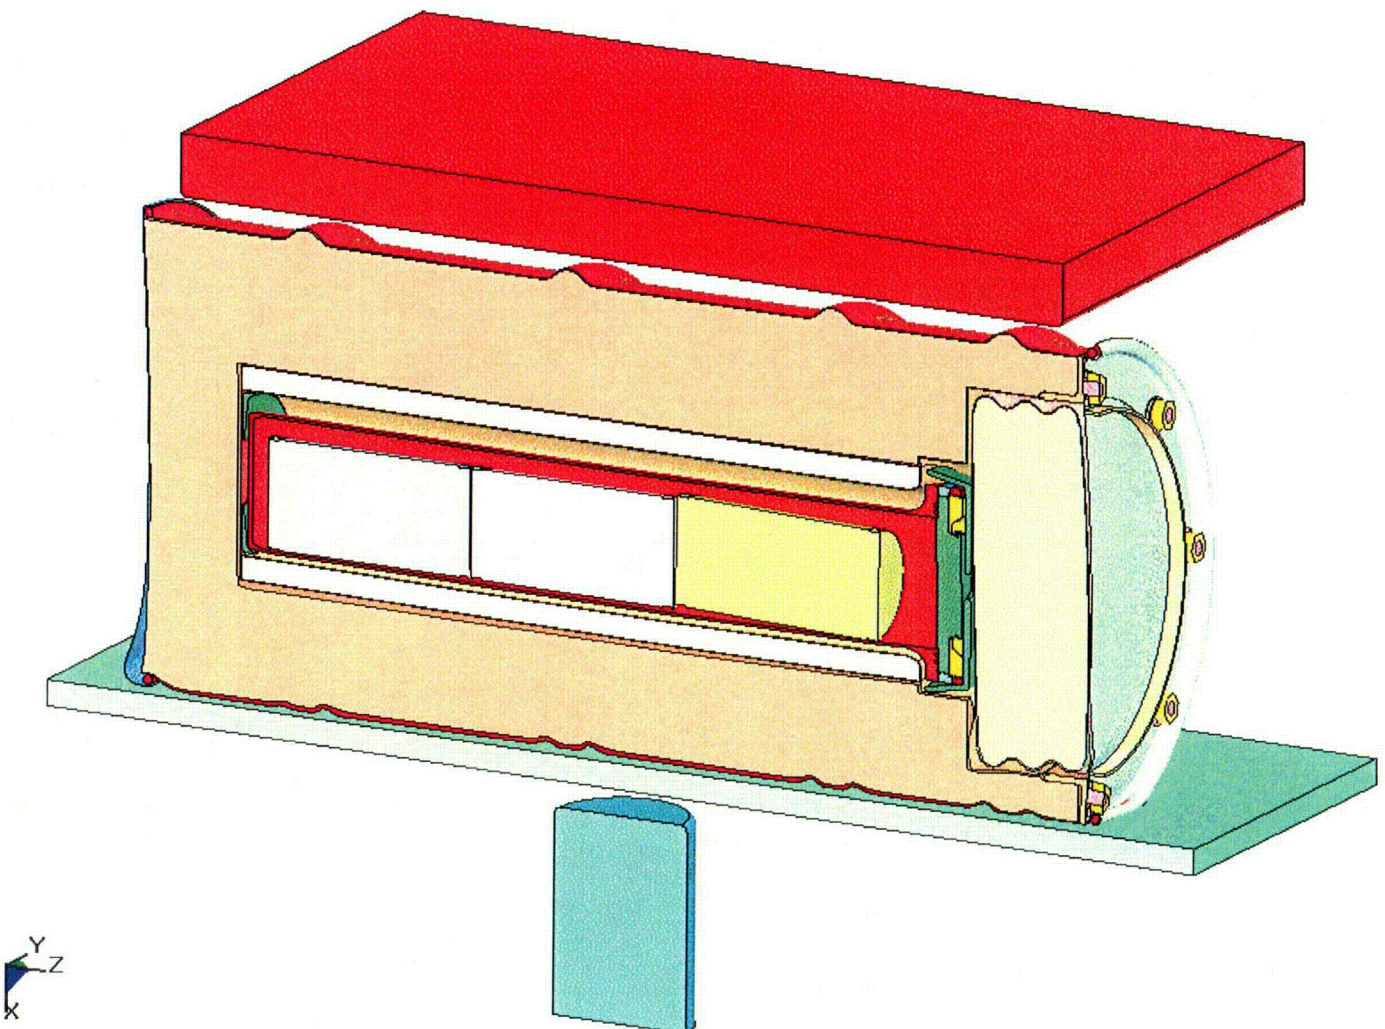
Figure 3.4.5 - Run1hh, 30-Foot Impact, Final Configuration

The final configuration for the 30-foot impact is shown in Figure 3.4.5. Figures 3.4.6 and 3.4.7 show the configuration at the corners of the package. The maximum effective plastic strain for the 30-foot impact in the CV Body is 0.0386 in/in near the bottom head. The maximum effective plastic strain in the drum lid is 0.4073 in/in near the rigid plane.

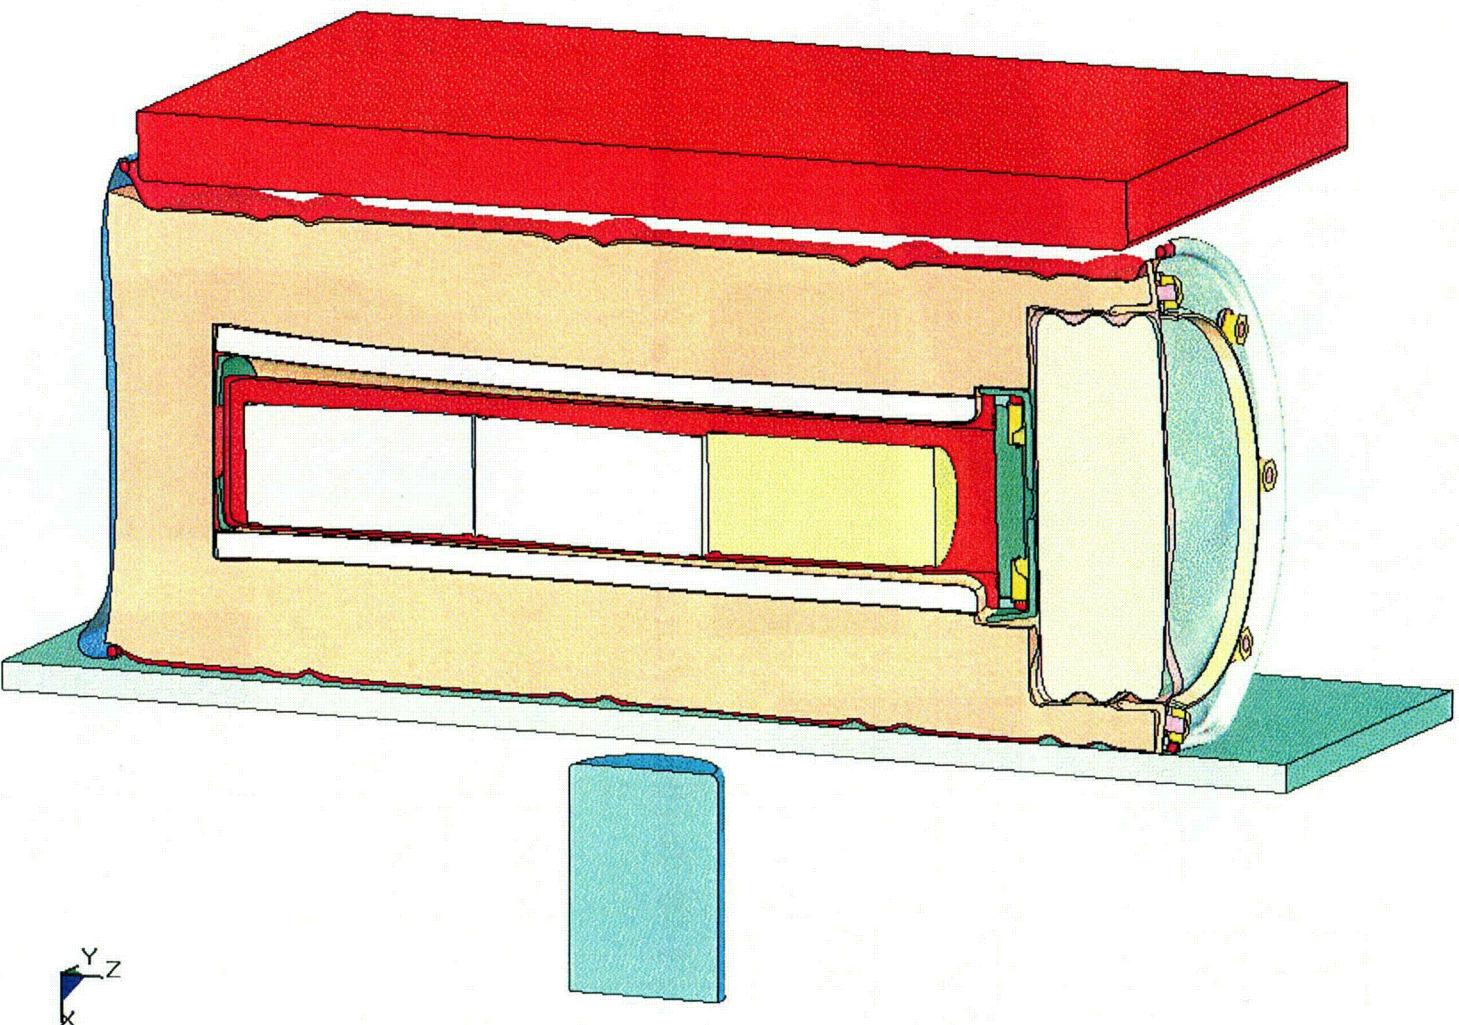
Figure 3.4.10 - Run1hh, Crush Impact, Final Configuration

The final configuration for the crush impact is shown in Figure 3.4.10. The configuration at the extremes of the package are shown in Figure 3.4.11. The maximum effective plastic strain for the crush impact in the CV body is 0.0462 in/in, on the crush plate side near the lid end of the top inner weight as shown in Figure 3.4.12. The maximum effective plastic strain in the drum is 0.2623 in/in near the angle and the rigid plane (Figure 3.4.13). The maximum effective plastic strain in the drum lid is 0.6411 in/in (surface strain), Figure 3.4.14. The maximum occurs at the lid hole for the stud closest to the crush plate (180°). The membrane effective plastic strain is 0.4922 in/in at this location. The effective plastic strain in the studs is 0.1753 in/in as shown in Figure 3.4.15. The effective plastic strain in other components are listed in Table 3.4.3 for the crush impact.

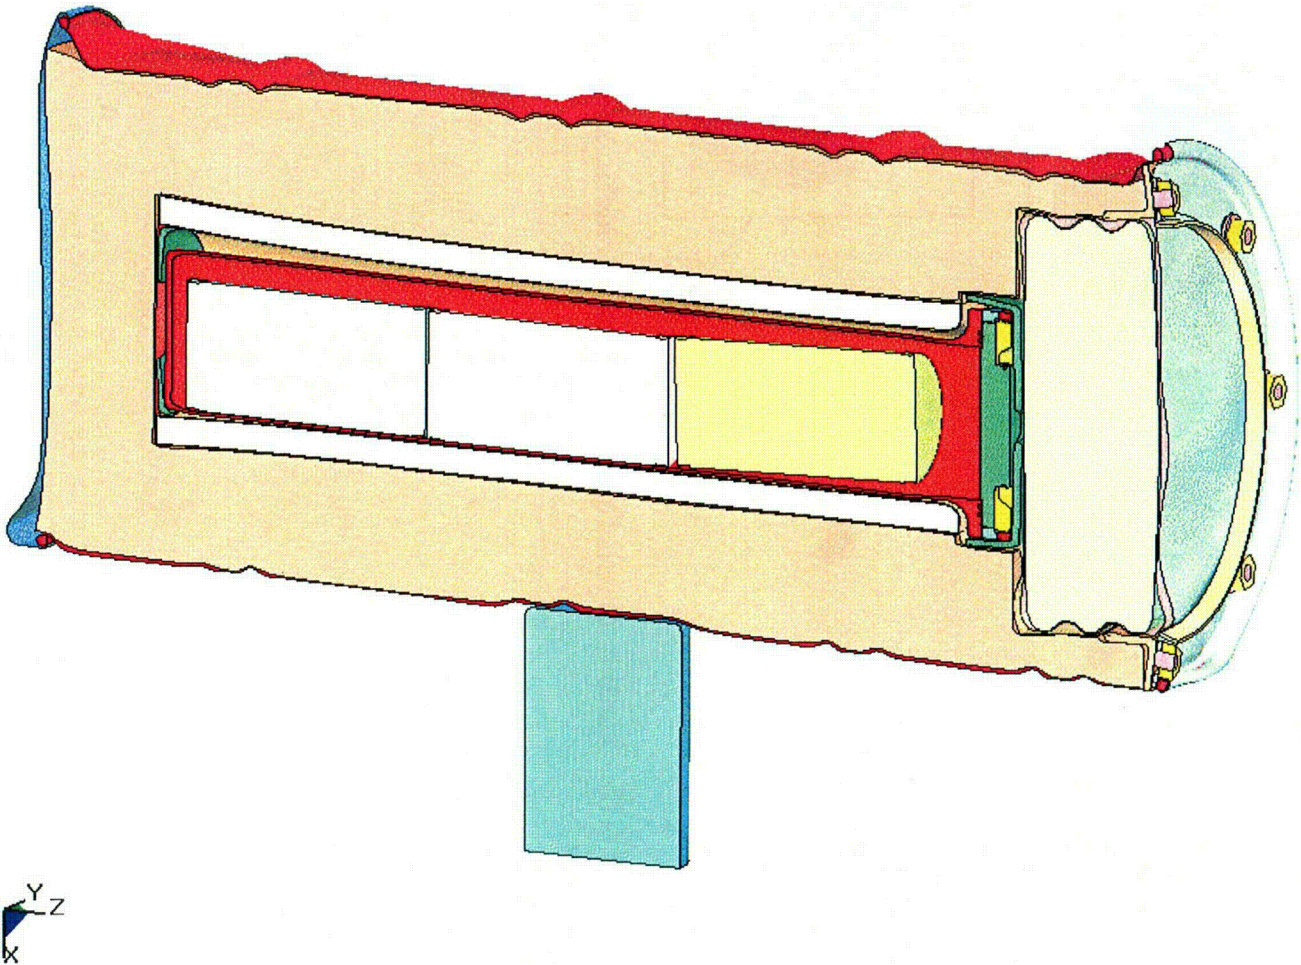
Figure 3.4.16 - Run1hh, Punch Impact, Final Configuration

The final configuration for the punch impact is shown in Figure 3.4.16. The maximum effective plastic strain in the CV body after the punch impact is shown to be 0.0599 in/in in Figure 3.4.17. The maximum effective plastic strain in the drum is 0.2623 in/in (surface strain) and is located near the angle at the rigid surface. The maximum effective plastic strain in elements local to the punch impact is 0.1382 in/in (surface strain) as shown in the insert in Figure 3.4.18. The maximum effective plastic strain for the lid and other package components at the end of the punch impact are listed in Table 3.4.4.

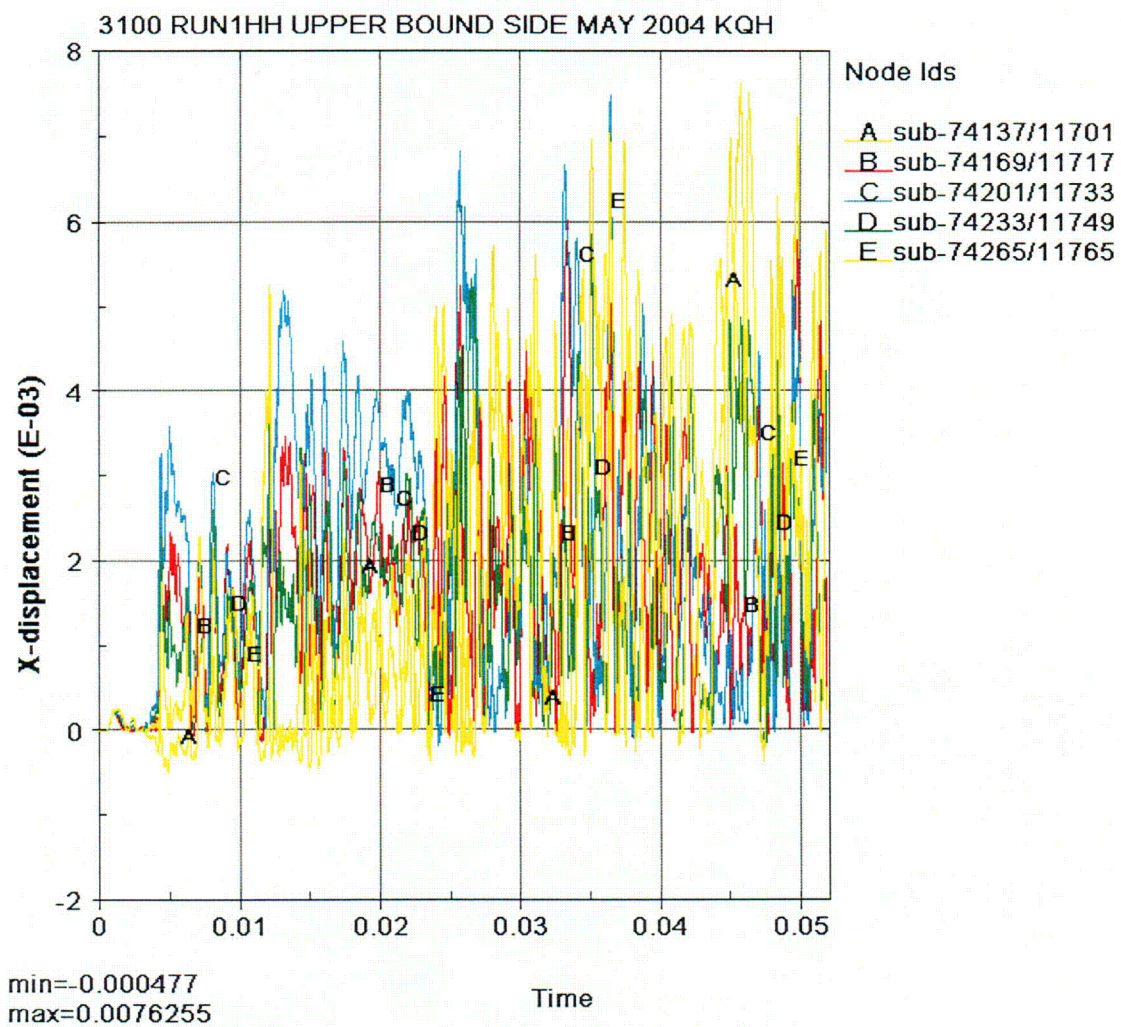
Figure 3.4.19 - Run1hh, CV Lid Separation Time History

Figure 3.4.19 shows the CV lid separation for all the impacts. A maximum spike for the lid separation of less than 0.008 inches is found. At the end of the impacts, the maximum separation is on the order of 0.006 in, with the response being oscillatory in nature. Average separation of 0.003 inches or less is shown to be expected after the successive impacts.

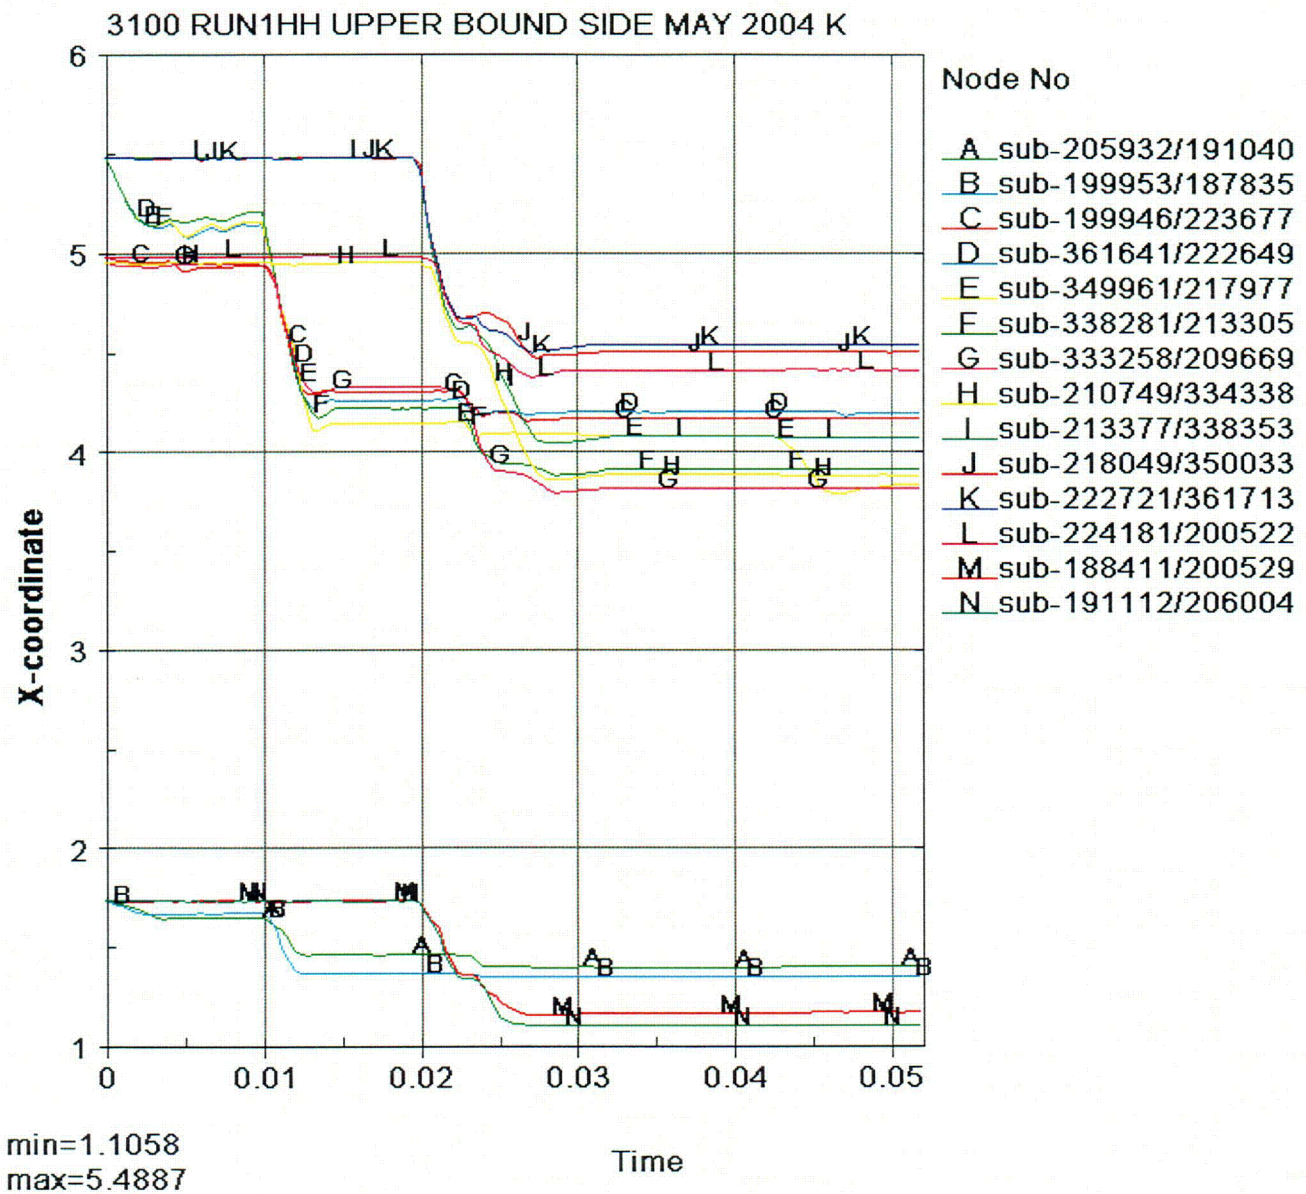
Figure 3.4.22 - Run1hh, Thickness Time History of the Drum Kaolite

The Figure 3.4.22 shows the kaolite thickness time history for the four impacts. Figure 3.1.32 shows the nodal locations.

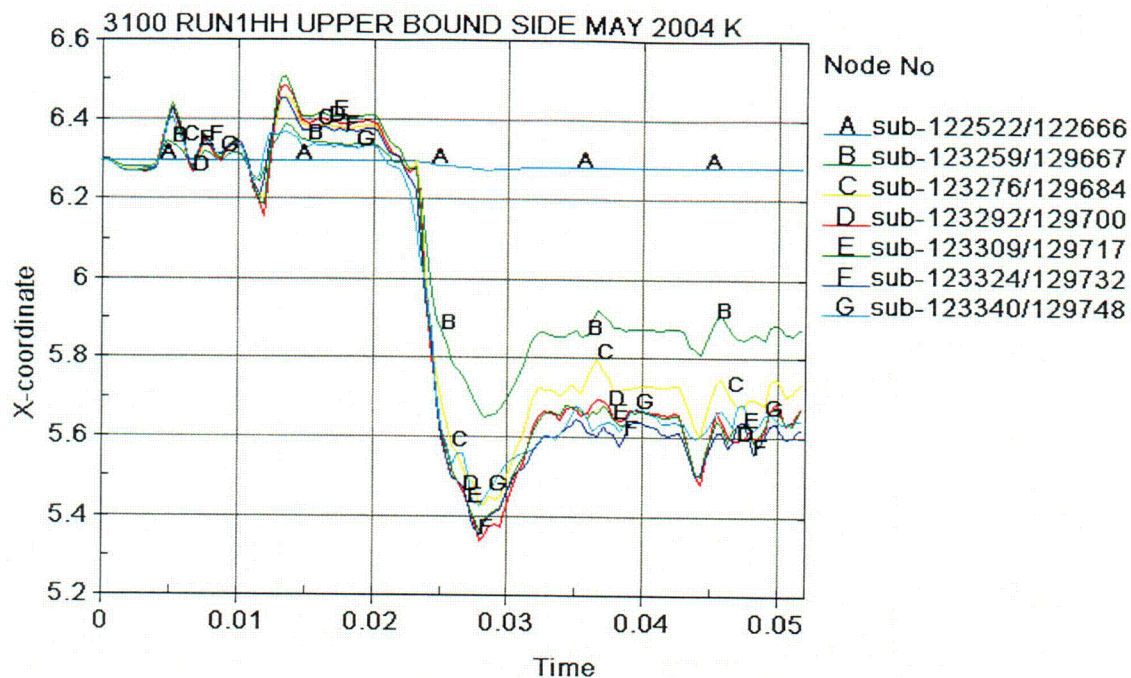
Figure 3.4.23 - Run1hh, Liner Diameter Time Histories

Figure 3.4.23 shows the liner diameter time history along its length. The nodal pairs are defined in Figure 3.1.37 and Table 3.1.3.

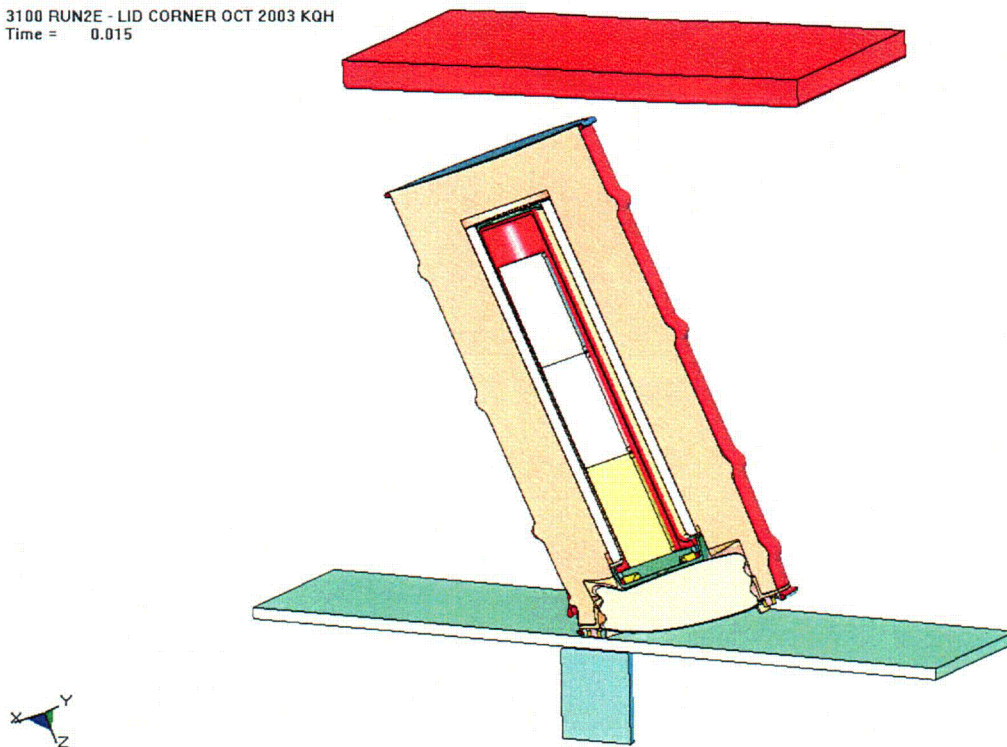
Figure 3.5.1 - Run2e, 30-Foot Impact, Final Configuration

The configuration after the 30-foot impact is shown in Figure 3.5.1. The maximum effective plastic strain in the lid studs is in the stud at the impact with the rigid plane ( $0^\circ$ ) and is 0.5197 in/in as shown in Figure 3.5.2. It can be seen from the insert in Figure 3.5.2, that strains near the maximum exist across the thickness of the stud. Therefore, it should be noted that slight differences between the modeled length and actual length of the stud could be significant relative to possible failure of the stud. Other differences such as friction and local flexibility in the test pad armored plate (stud "digging in") could also significantly effect this stud and cause failure. The maximum effective plastic strain of other components for this impact are listed in Table 3.5.1.

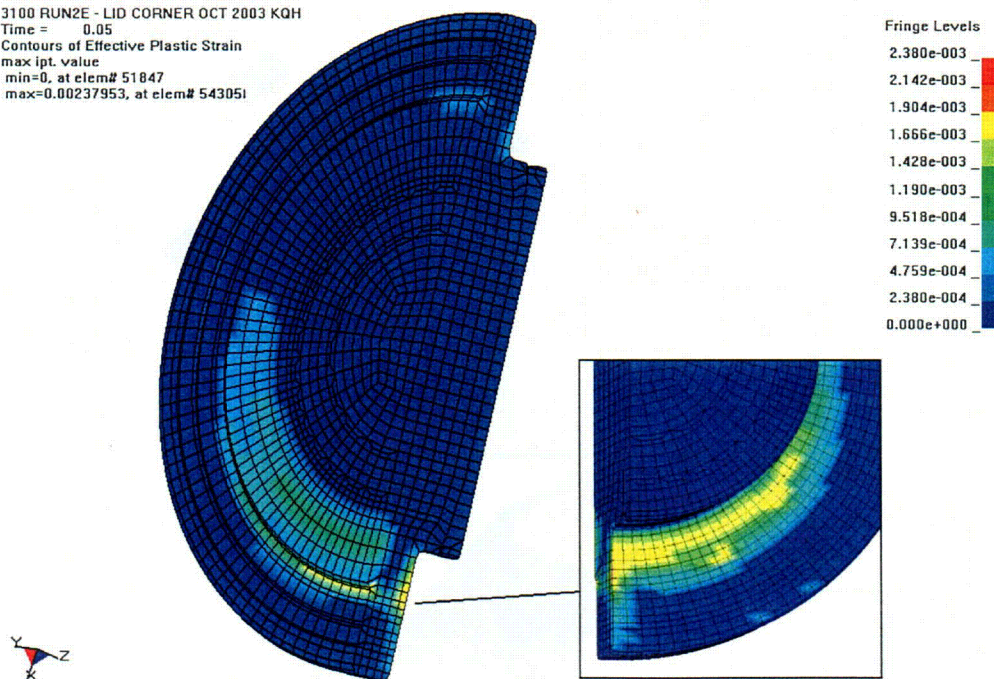
Figure 3.5.4 - Run2e, Crush Impact, Effective Plastic Strain in the CV Lid

3100 RUN2E - LID CORNER OCT 2003 KQH  
Time = 0.05  
Contours of Effective Plastic Strain  
max ipt. value  
min=0, at elem# 51847  
max=0.00237953, at elem# 543051

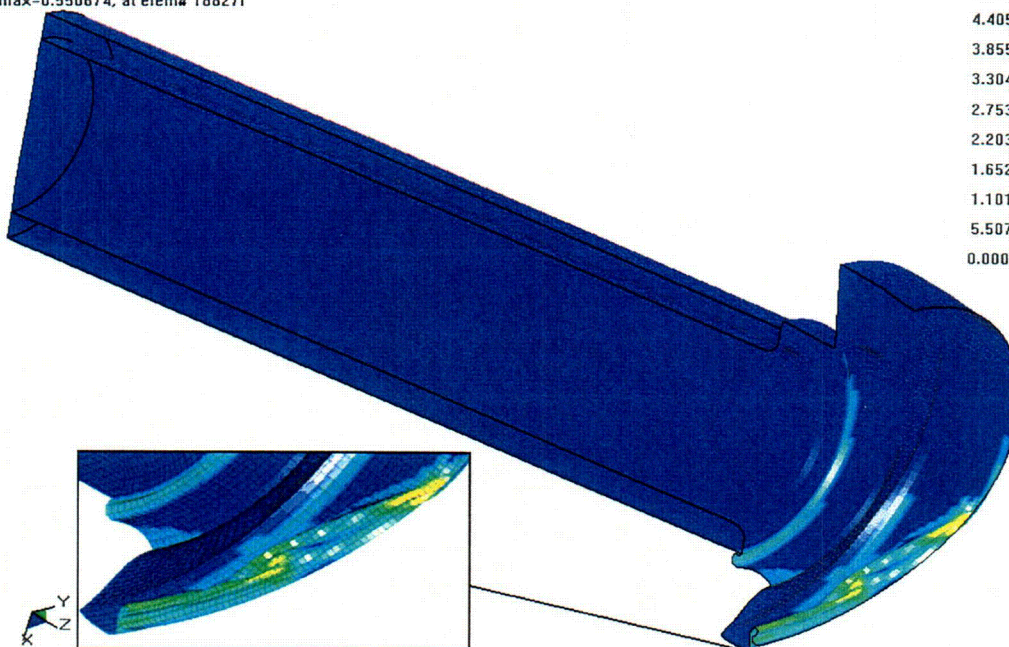
Figure 3.5.5 - Run2e, Crush Impact, Effective Plastic Strain in the Liner

3100 RUN2E - LID CORNER OCT 2003 KQH  
 Time = 0.05  
 Contours of Effective Plastic Strain  
 max ipt. value  
 min=0, at elem# 19053  
 max=0.550674, at elem# 188271

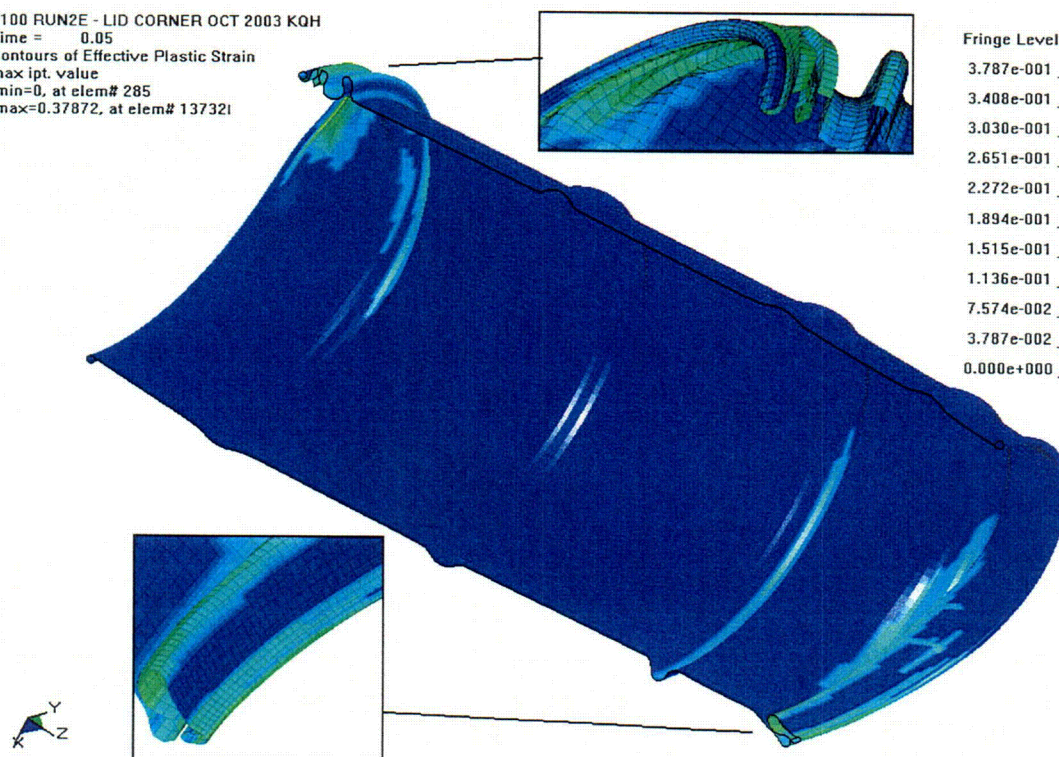
Figure 3.5.6 - Run2e, Crush Impact, Effective Plastic Strain in the Drum

3100 RUN2E - LID CORNER OCT 2003 KQH  
 Time = 0.05  
 Contours of Effective Plastic Strain  
 max ipt. value  
 min=0, at elem# 285  
 max=0.37872, at elem# 137321

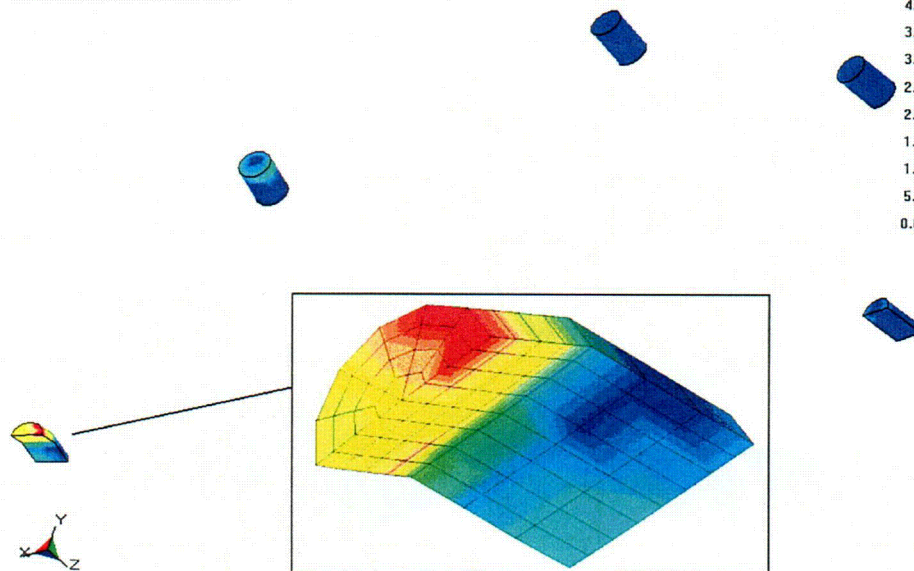
Figure 3.5.7 - Run2e, Crush Impact, Effective Plastic Strain in the Drum Studs

3100 RUN2E - LID CORNER OCT 2003 KQH  
Time = 0.05  
Contours of Effective Plastic Strain  
max ipr. value  
min=0, at elem# 72169  
max=0.557824, at elem# 719921

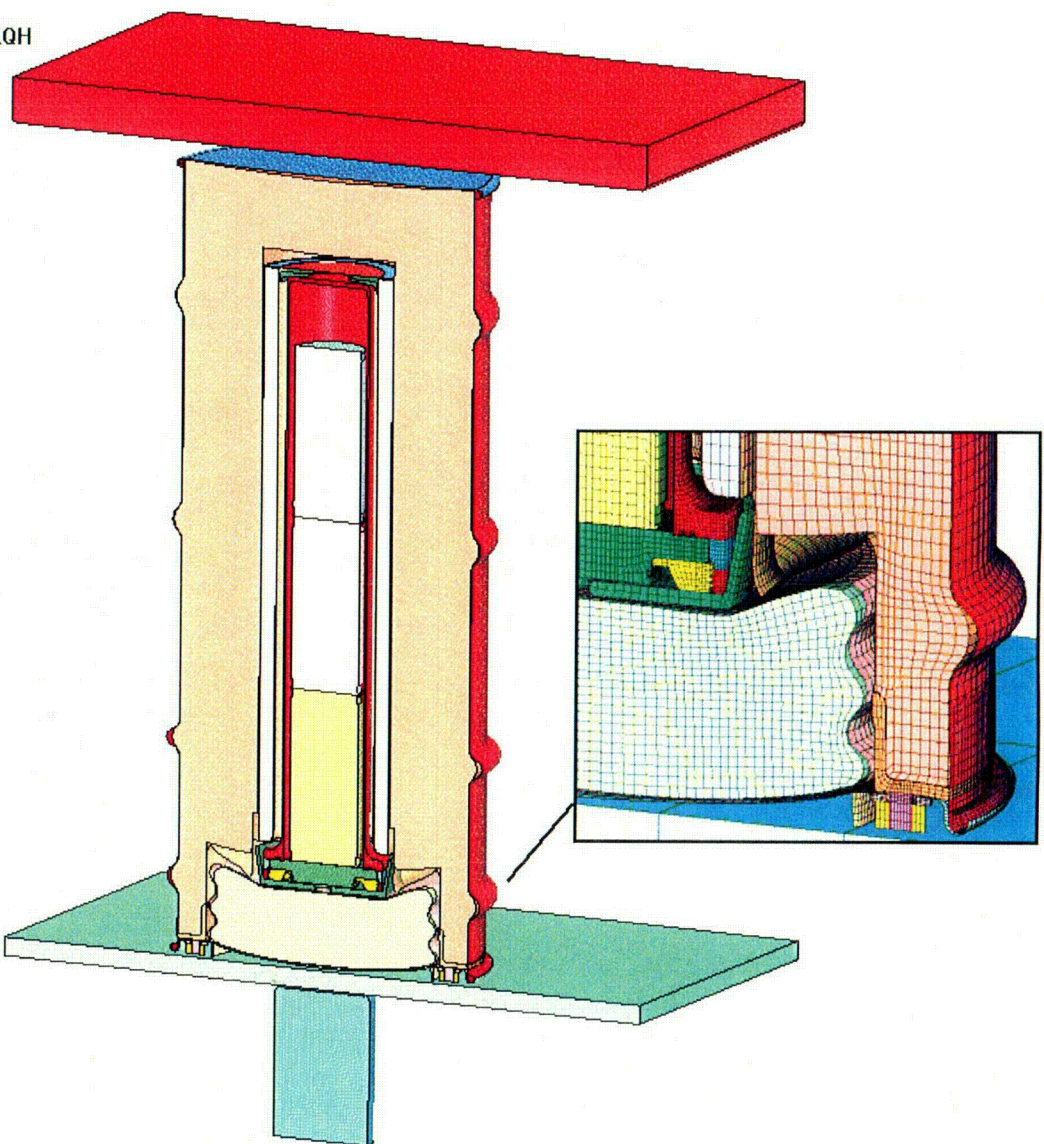
Figure 3.6.1 - Run3b, Configuration After the 30-Foot Impact

3100 RUN3B - Lid End - NOV 2003 KQH  
Time = 0.010001

Run3b is a 30-foot lid end impact (time = 0 to 0.010 seconds) followed by a crush impact onto the package bottom (0.010 to 0.028 seconds). Figure 3.6.1 shows the final configuration for the 30-foot impact. Because of the relatively low demand placed on the components, no strain plots are presented for the 30-foot impact. Table 3.6.1 summarizes the maximum effective plastic strains in the package components.

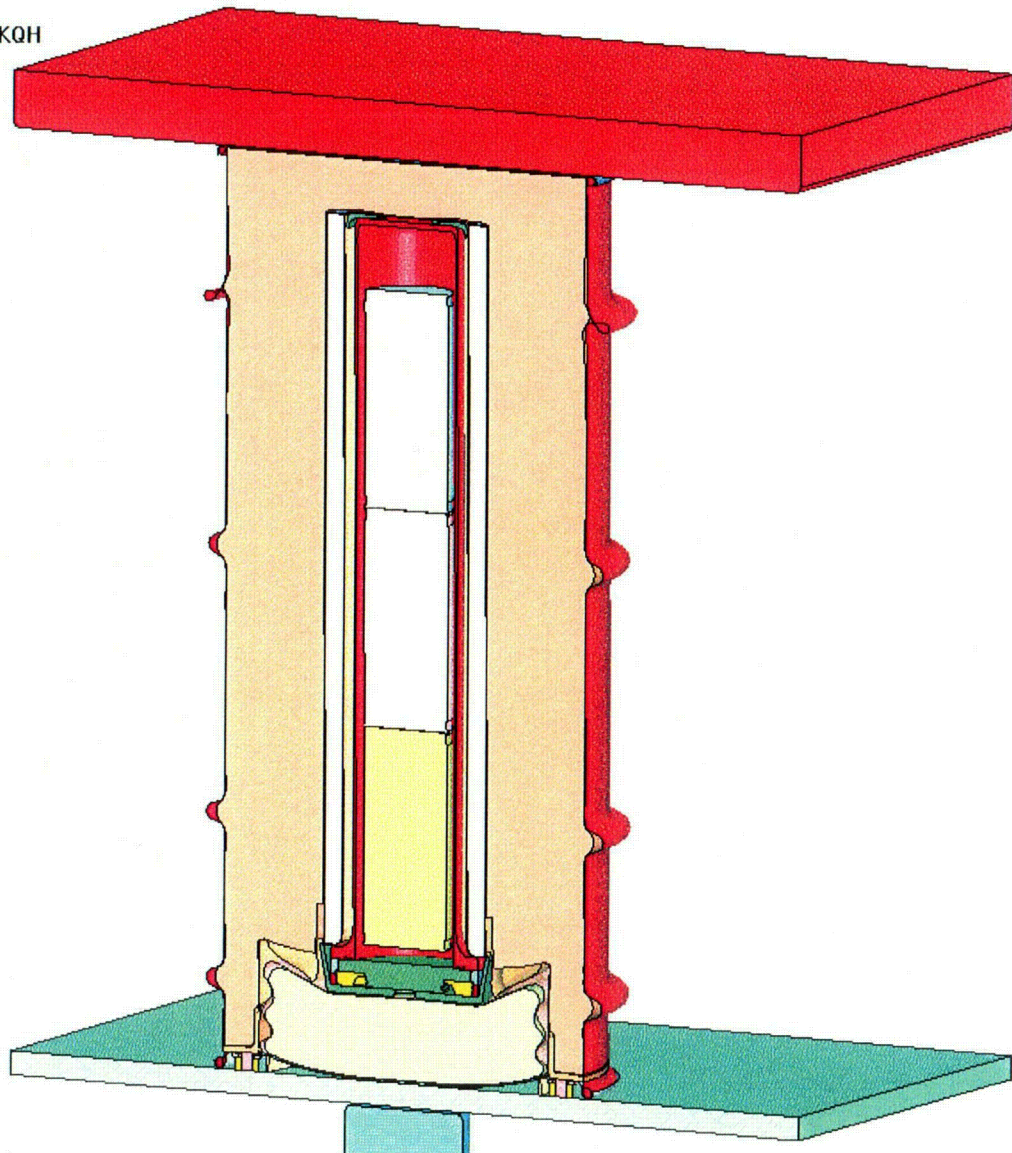
Figure 3.6.2 - Run3b, Crush Impact, Final Configuration

Figure 3.6.2 shows the final configuration for the 30-foot impact and the successive crush impact. Figure 3.6.3 shows that the maximum effective plastic strain in the CV body is 0.0053 in/in. The maximum occurs in the bearing of the body flange onto the lid (at the O-ring seals). The magnitude of effective plastic strain is questioned due to the fact that the elevated strains occur at single nodes and are not symmetric (see the insert in Figure 3.6.3). The maximum effective plastic strain in the bottom region of the CV body is found to be 0.0035 in/in and does exhibit a symmetric characteristic as is shown in Figure 3.6.3.

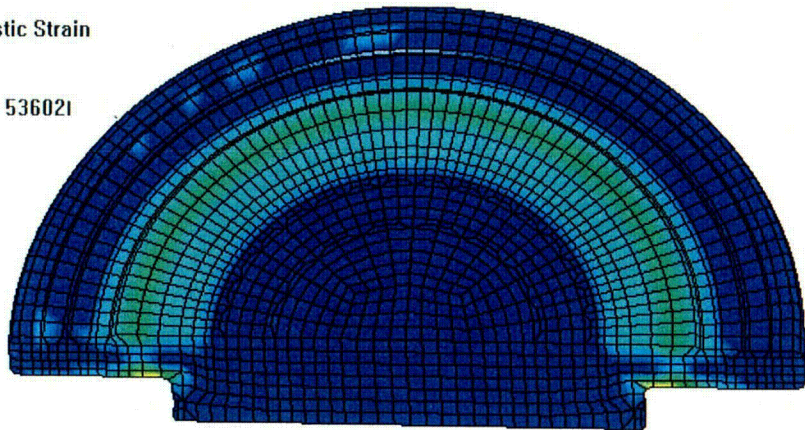
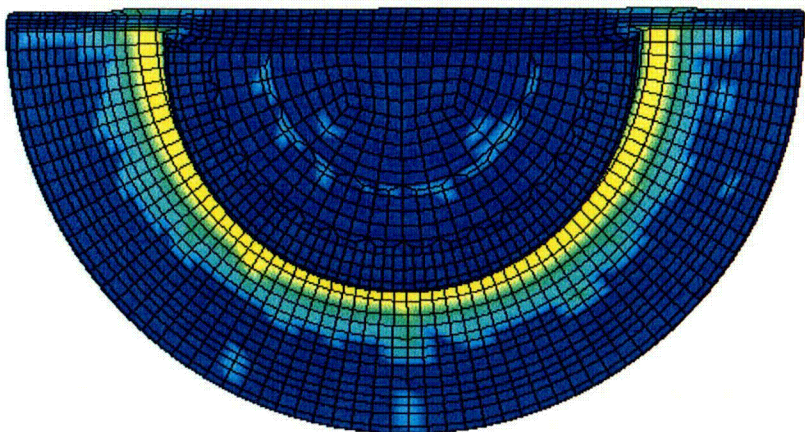
Figure 3.6.4 - Run3b, Crush Impact, Effective Plastic Strain in the CV Lid

3100 RUN3B-12-SLAP NOV 2003 KQH  
 Time = 0.028  
 Contours of Effective Plastic Strain  
 max ipt. value  
 min=0, at elem# 51947  
 max=0.003402, at elem# 536021

The CV lid effective plastic strain fringes are shown from both sides in a split image in Figure 3.6.4. The maximum effective plastic strain in the lid is shown to be 0.0034 in/in in the figure. The other components are summarized in Table 3.6.2.

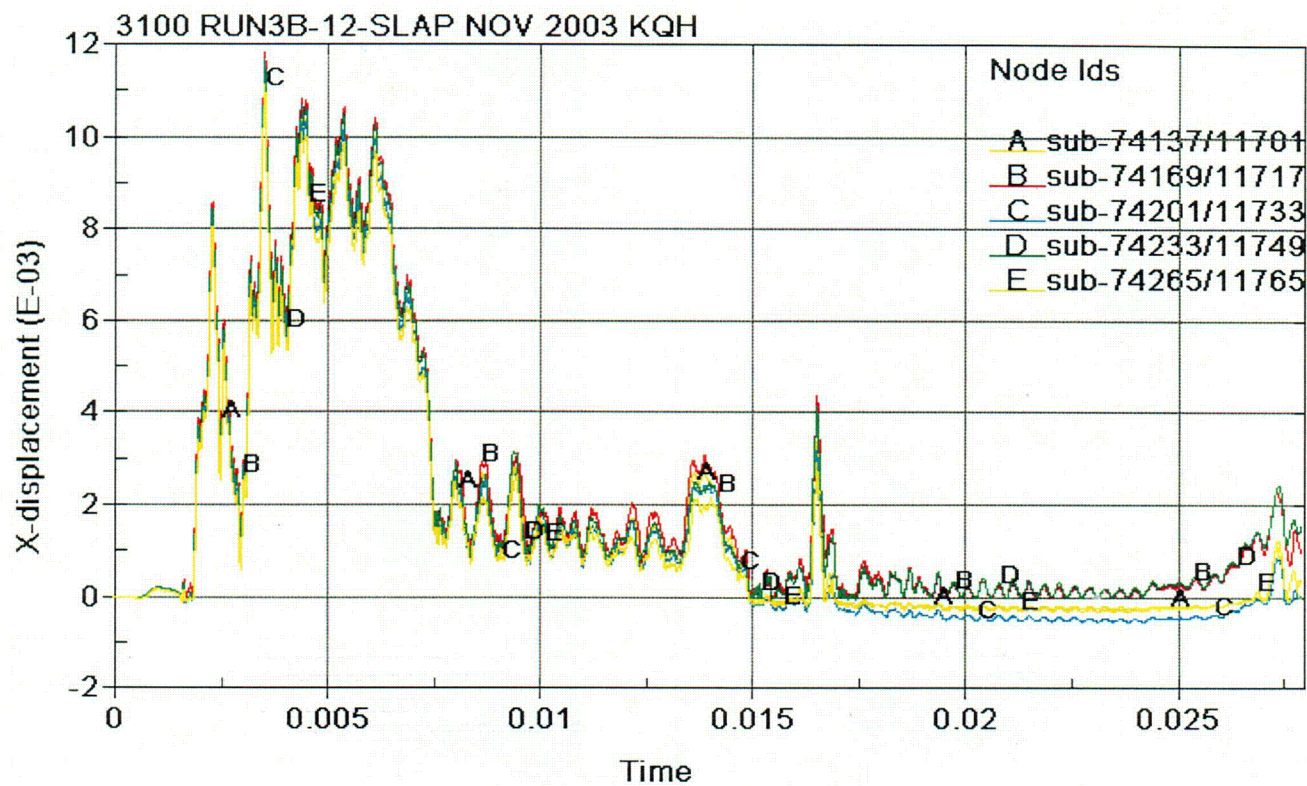
Figure 3.6.5 - Run3b, CV Lid Separation Time History

The CV lid separation time history is shown in Figure 3.6.5. The response during the 30-foot impact is a spike separation of about 0.012 inches, which relaxes to a maximum value of 0.003 inches for the remainder of the 30-foot impact. During the crush impact it is seen that separation spikes to a maximum of about 0.004 inches, but the average remains at about 0.002 inches or less at the end of the impact.
