### 3.2 Run1ga - Side

The run1ga is a 30-foot impact followed by a crush impact, with the crush plate centered above the CV flange. The run1g 30-foot impact restart file was used and the crush plate was moved during the restart phase so that its centerline was approximately above the CV flange. The 30-foot impact was from time 0.0 to 0.0085 sec. The crush plate translation to center it above the CV flange was from time 0.0085 sec to 0.0086 sec. The run1ga crush occurred from 0.0086 sec to 0.027 sec. Therefore, the 30-foot impact results for this run would be the Section 3.1, 30-foot results for run1g, and the crush results for run 1ga (offset crush) are presented in this section.

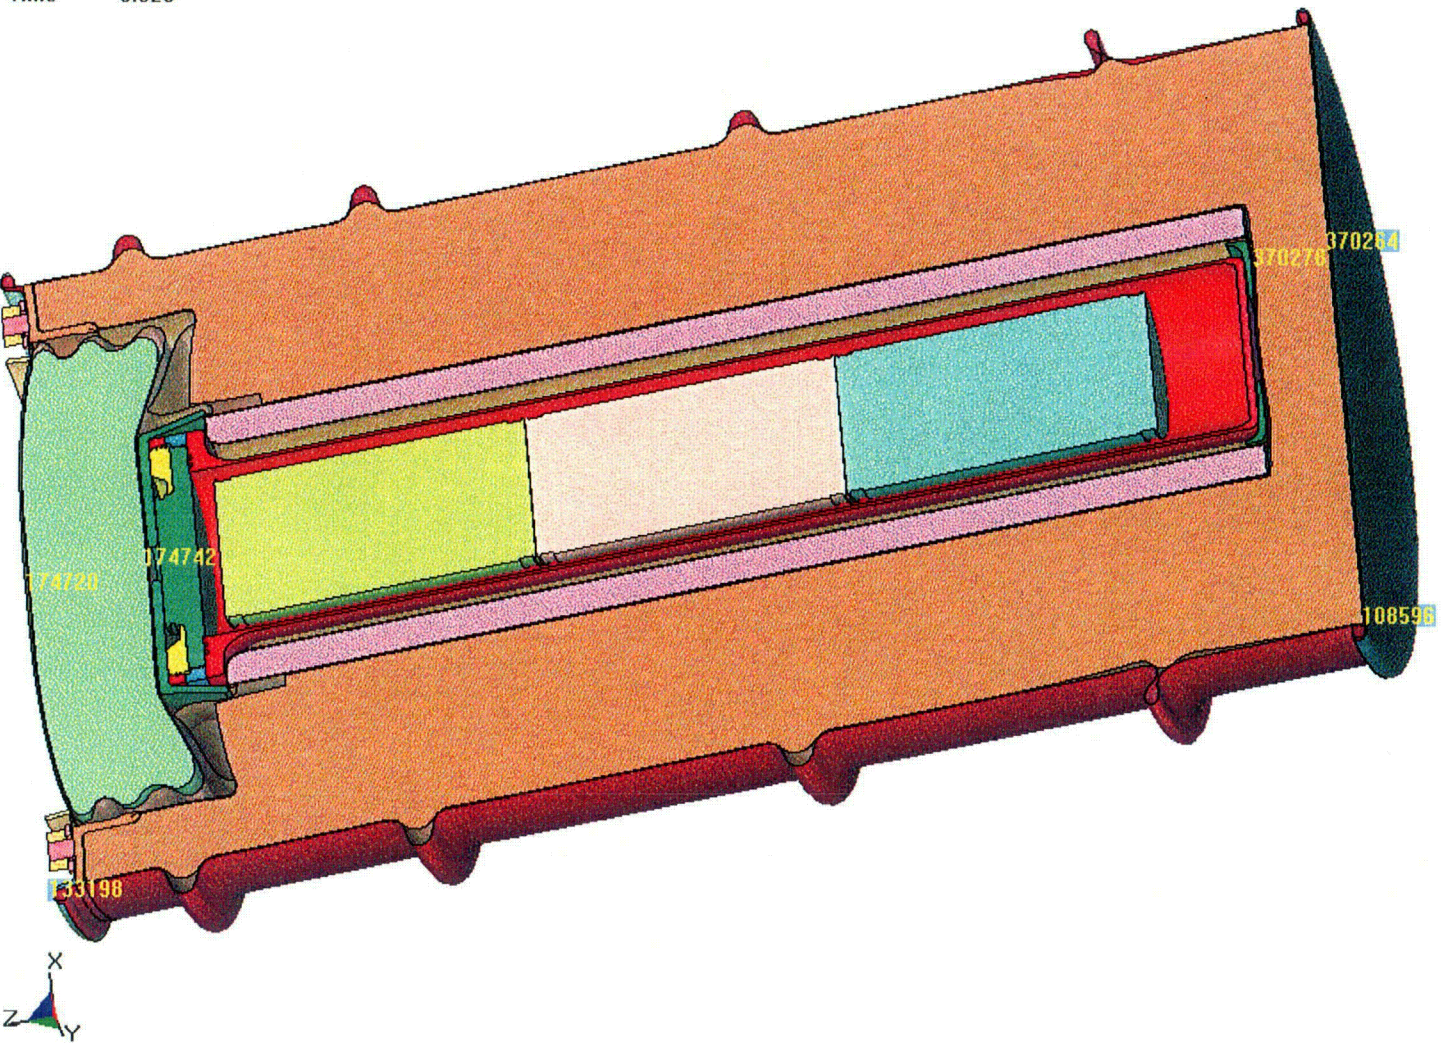
Figure 3.6.6 - Run3b, Nodes Chosen for Displacement Time Histories

Figure 3.6.6 shows the nodes chosen to obtain the drum height and kaolite thickness time history data. Figure 3.6.7 shows the drum height time history. From the figure it is seen that the overall height would be approximately 39 inches. Figure 3.6.8 shows the thickness time histories in the kaolite for the plug and the bottom. The curve A in the figure is for the bottom kaolite thickness, and it reaches about 2.2 inches as a final value. Curve B, is for the plug and it reaches about 3.4 inches for the final kaolite thickness.
