FINAL REPORT

BUILDING 150/UNDERGROUND STORAGE TANK DECOMMISSIONING PROJECT

BETHESDA NATIONAL NAVAL MEDICAL CENTER

**Revision 3
January 6, 2004**

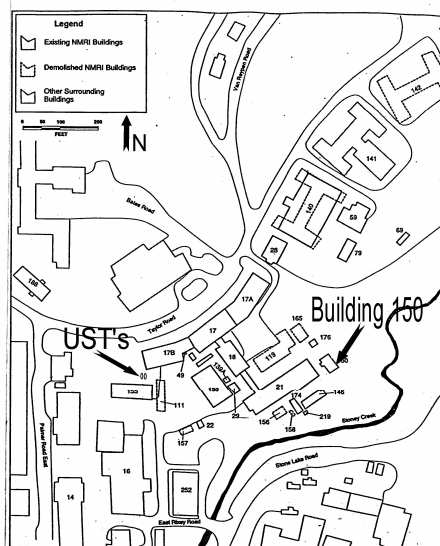
Figure 1. Building 150 and UST Location Map

Building 150 and the two underground storage tanks (UST's) were located at the Bethesda National Naval Medical Center (NNMC) facility located in Bethesda, Maryland. See Figure 1 for the location of Building 150 and the two UST's.

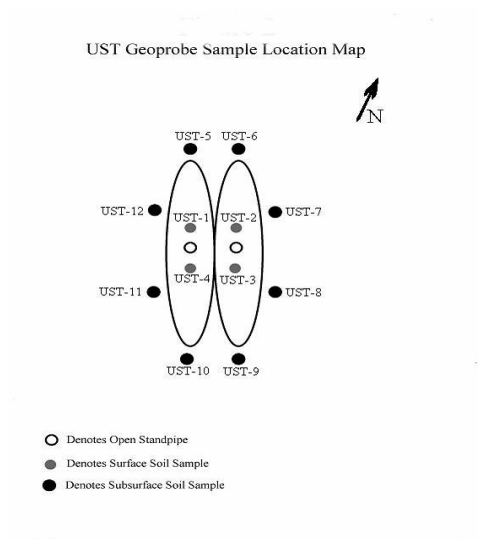
Figure 2. UST Geoprobe Sample Location Diagram

Pre excavation geoprobe soil sampling of the soils around and above the two UST's was performed during NWT's previous site visit in March of 2002. The purpose of the soil sampling prior to removal of the two UST's was to provide data as to the physical condition of the two UST's and whether or not material inside of the UST's had leaked into the surrounding soils. Based upon the results of the soil sampling, the two UST's were intact and the contents of the

Figure 2 present a diagram of the pre excavation geoprobe sampling locations.

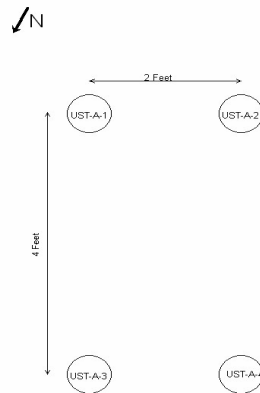
Figure 3. UST-A

- f. Table 5 presents a summary of the UST footprint soil sample analysis.
- g. Sample USTA-1 results (15.9 pCi/g) were above natural background levels but well below the DCGL. This sample was taken from an area where a small amount (~ 1 pint) of water leaked from the tank during removal.

UST Tank Sampling Pattern Diagram

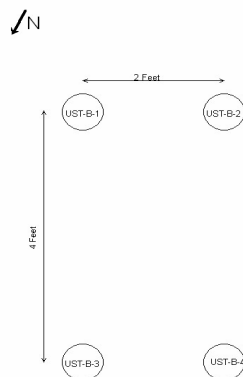
Figure 4. UST-B Footprint Sample Location Diagram

UST Tank Sampling Pattern Diagram

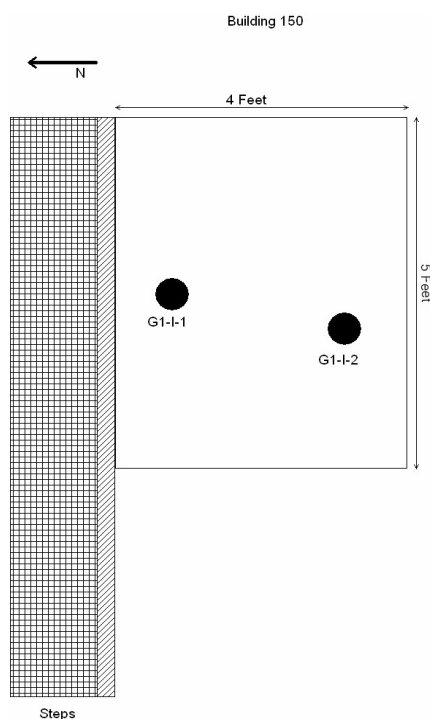
Figure 5. Post Remediation Soil Sample Location Diagram

- a. Two soil samples were collected from the area following the gamma scan survey. The samples were sent to NWT's laboratory in Livermore, CA for gamma spectroscopy analysis to quantify Co-60 concentrations. The results of the samples were below the DCGL.

- b. The laboratory data for the soil samples is presented in this report in Appendix K.
- c. Figure 5 presents a diagram showing the soil sample locations for the remediated area.
- d. Table 6 presents a summary of the post remediation soil samples.

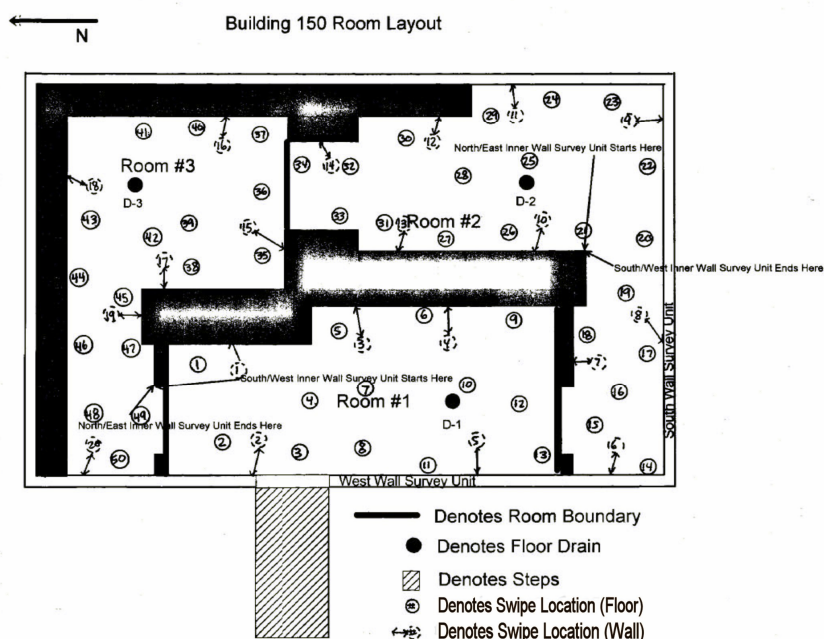
Figure 6. Building 150 Swipe Location Map

- A detailed loose surface contamination survey was performed on the surfaces and debris located inside of the building prior to work starting inside of the building.
- Swipe samples were collected for analysis of removable alpha and beta contamination activity. The swipes were collected over an area of 100 cm². Dry cloth swipes were used for the swipe samples. Samples were analyzed using a Ludlum Model 2929 Dual Channel Scaler. The Ludlum Model 2929 Dual Channel Scaler is ZnS(Ag) phoswich scintillation alpha/beta radiation counter. This unit provides a full range of simultaneous alpha and beta counting at the levels required for environmental release surveys. Data is reported in units of dpm per 100 cm².
- The locations of the swipe samples are presented in Figure 6 below.

- Appendix L provides the swipe results. None of the swipe samples exceeded the MDA of 12 dpm/100cm² α and 228 dpm/100cm² βγ. None of the swipe measurements exceeded 10% of the DCGL.

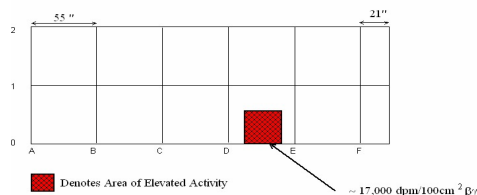
Figure 7. Building 150 Wall Areas Requiring Remediation

North Outer Wall Grid Layout Map

- a. Any areas identified during the scan survey performed as outlined in Section 9.3 of this report that were above the DCGL, required remediation.
- b. It was anticipated that the contamination was in the uppermost 1/2 inch (approximate) of the concrete. The areas identified during the scan survey as requiring remediation were remediated using a concrete scabbler. Removal of 1/2 inch of the concrete surface in the identified areas was sufficient.

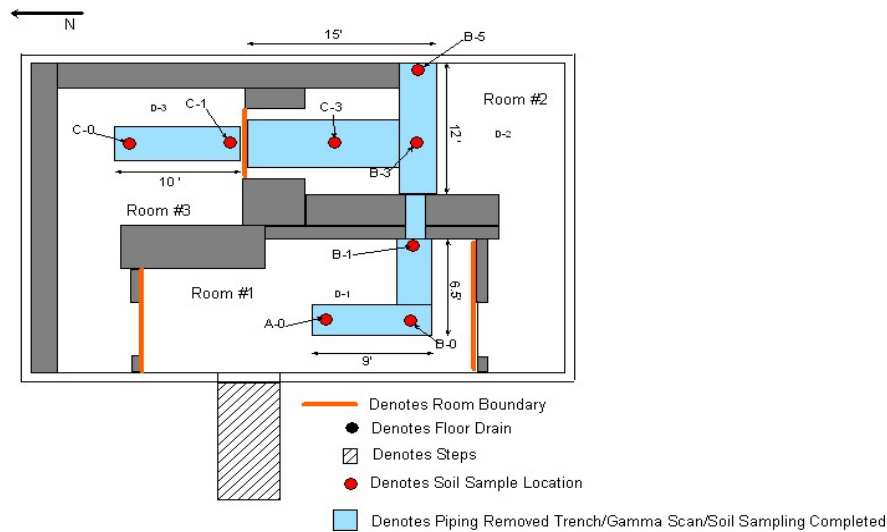
Figure 9. Building 150 Interior Trench/Sample Location Map

- a. The drain lines were removed from the trenches using hand tools and chain-falls.
- b. A 100 % gamma scan survey was performed inside of the trenches. The survey was conducted with 2" by 2" NaI detectors coupled to data loggers operating in the single channel analyzer mode.
- c. No detectable activity above background radiation levels was detected during these surveys.
- d. Soil samples were collected at a maximum of every 10 linear feet of the trenches. The samples were sent to an offsite laboratory for gamma spectroscopy analysis to quantify Co-60 concentrations. None of the soil sample results exceeded the DCGL. The laboratory data for the soil samples is presented in Appendix Q.
- e. Table 8 presents a summary of the soil sample results.
- f. Figure 9 presents a map of the interior trenches and soil sample locations inside of Building 150.

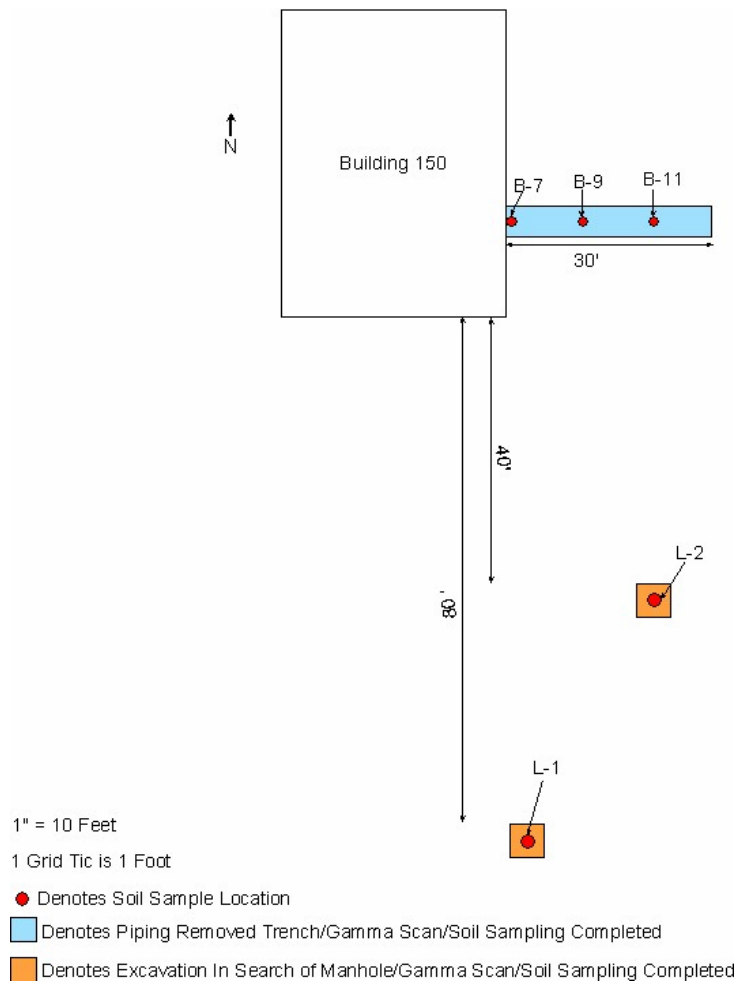
Figure 10. Building 150 Exterior Trench/Sample Location Map

- a. A 100 % gamma scan survey was performed inside of the trenches. The survey was conducted with 2" by 2" Nal detectors coupled to data loggers operating in the single channel analyzer mode.
- b. No detectable activity above background radiation levels was detected during these surveys.
- c. Soil samples were collected at a maximum of every 10 linear feet of the trenches. The samples were sent to an offsite laboratory for gamma spectroscopy analysis to quantify Co-60 concentrations. None of the soil sample results exceeded the DCGL. The laboratory data for the soil samples is presented in Appendix R.
- d. Table 8 presents a summary of the soil sample results.
- e. Figure 10 presents a map of the exterior trenches and soil sample locations outside of Building 150.

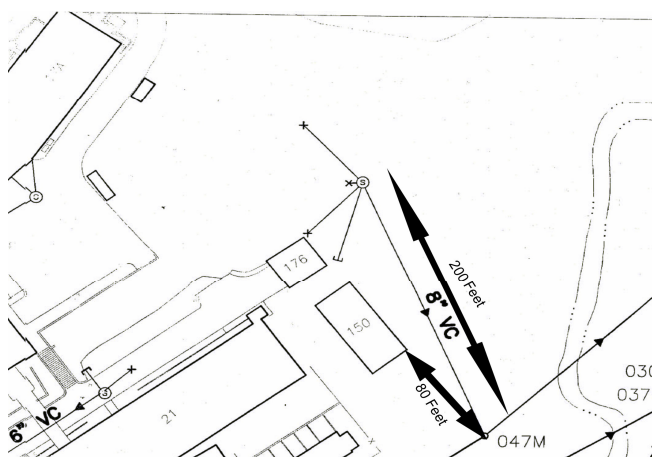
Figure 11. Manhole 047M Location Map

- An attempt to locate manhole 047M was made by excavating test holes in the locations where site engineering drawings indicated the manhole was located.
- Figure 11 presents a map of the possible location of manhole 047M.
- The test holes were approximately 5 feet in diameter and 8 foot in depth. No indication of the manhole was identified inside of the test holes.

- d. A 100 % gamma scan survey was performed inside of the test holes. The survey was conducted with 2" by 2" NaI detectors coupled to data loggers operating in the single channel analyzer mode.
- e. No detectable activity above background radiation levels was detected during these surveys.
- f. Soil samples were collected in the bottom of each of the test holes. The samples were sent to an offsite laboratory for gamma spectroscopy analysis to quantify Co-60 concentrations. None of the soil sample results exceeded the DCGL. The laboratory data for the soil samples is presented in Appendix S.
- g. Table 8 presents a summary of the soil sample results.
- h. Figure 10 presents a map of the manhole investigation trenches and soil sample locations outside of Building 150.

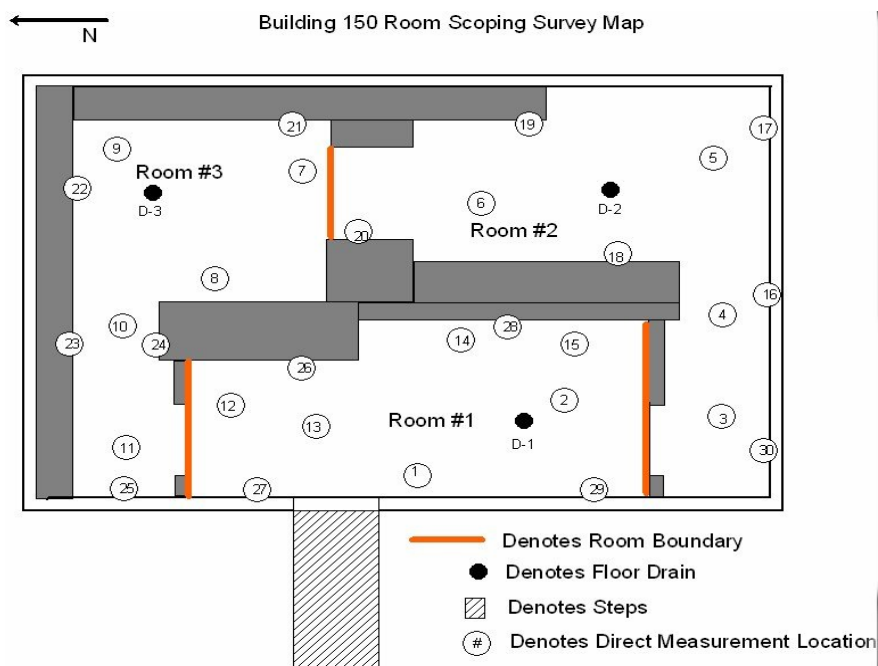
Figure 12. Scoping Survey Map

Table 9 presents a summary of the results of the scoping survey.

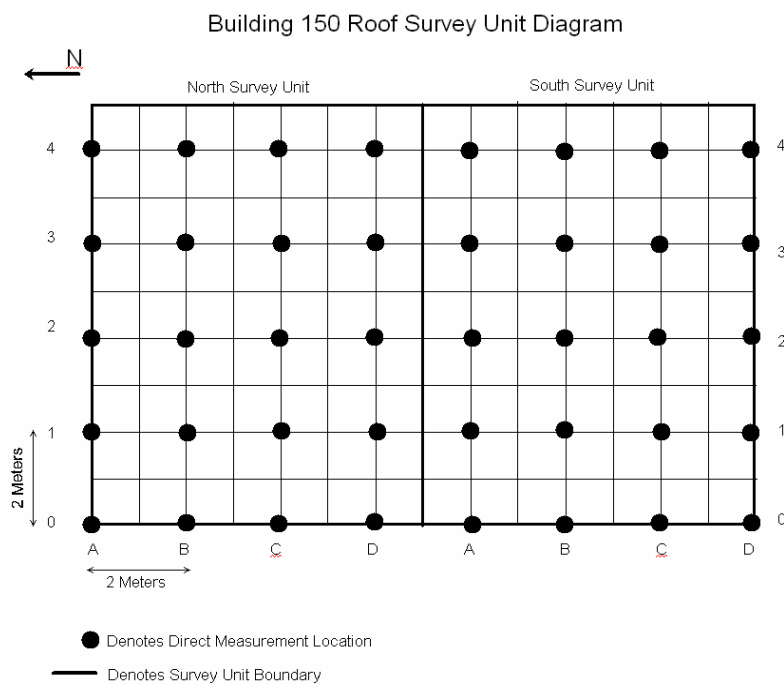
Figure 15. Building 150 Roof Survey Unit Diagram

Figure 15 is a diagram of the Building 150 roof area, presenting a layout of the different survey units.

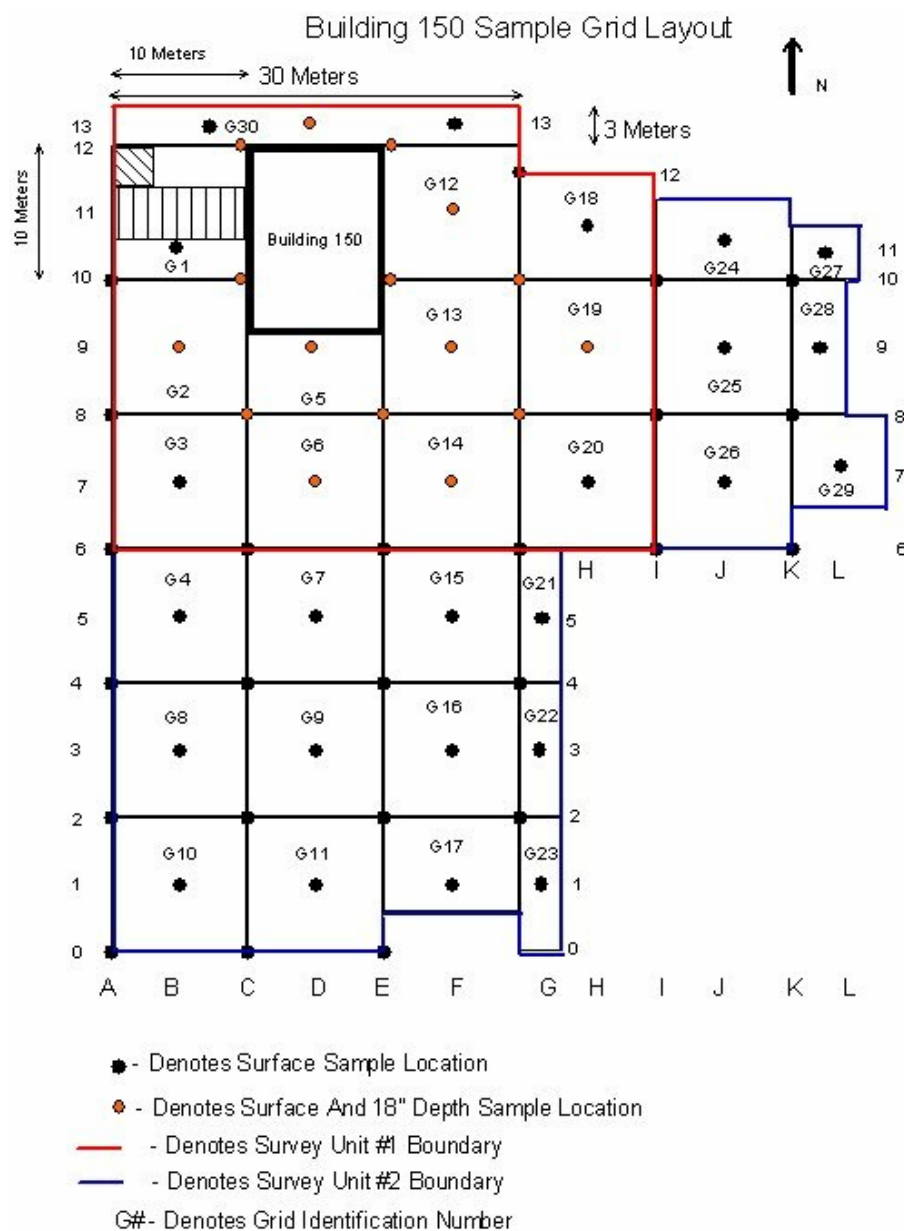
Figure 16. Building 150 Outside Open Land Area Survey Unit Layout Diagram

The open land area outside of Building 150 was divided into two survey units based upon contamination potential. Whenever possible, ten meter by ten meter grids were setup in each of the survey units.

Figure 16 presents a diagram showing the survey units outside of Building 150.

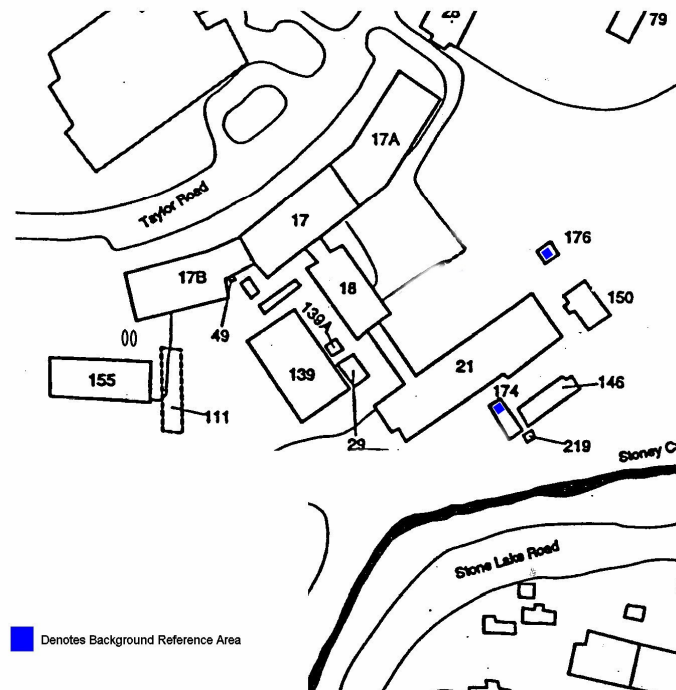
Figure 17. Background Reference Areas-Building Surfaces

The results of the building surface background reference area surveys are presented in Appendix V.

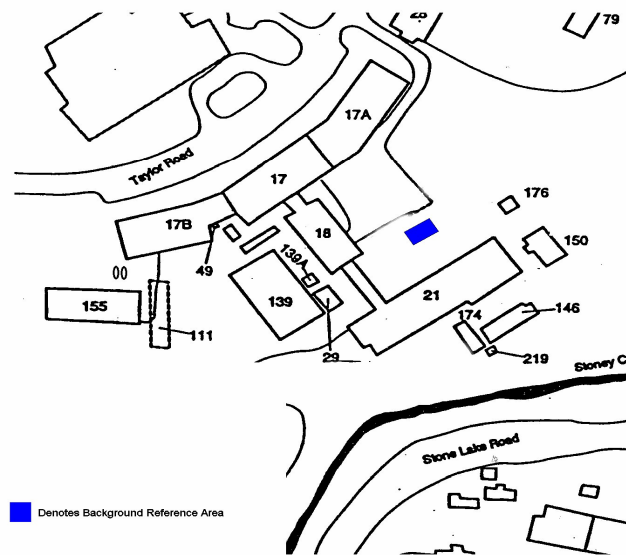
Figure 18. Background Reference Area-Outside Land Areas

An open land area north east of Building 21 was selected as the reference (background) areas for the open land areas outside of Building 150. This area was selected because it was non-impacted from Building 150 operations and has the same chemical, physical, biological, and geological characteristics as the exterior open land areas outside of Building 150. Figure 18 provides a diagram of the reference area showing the location where radiation measurements were taken.

The results of the outside land area background reference area surveys are presented in Appendix W.

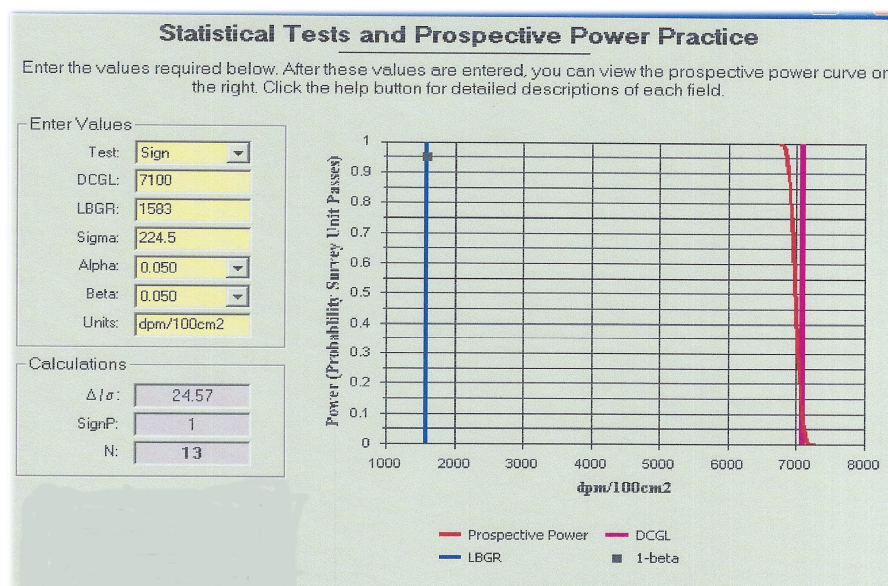
Figure 19. Statistical Test and Power Curve

As a conservative measure, 16 data points were selected as the required number of data points. Figure 19 presents a graphical illustration of the prospective power curve, calculated relative shift and Sign p values that were generated when calculating the required number of data points.

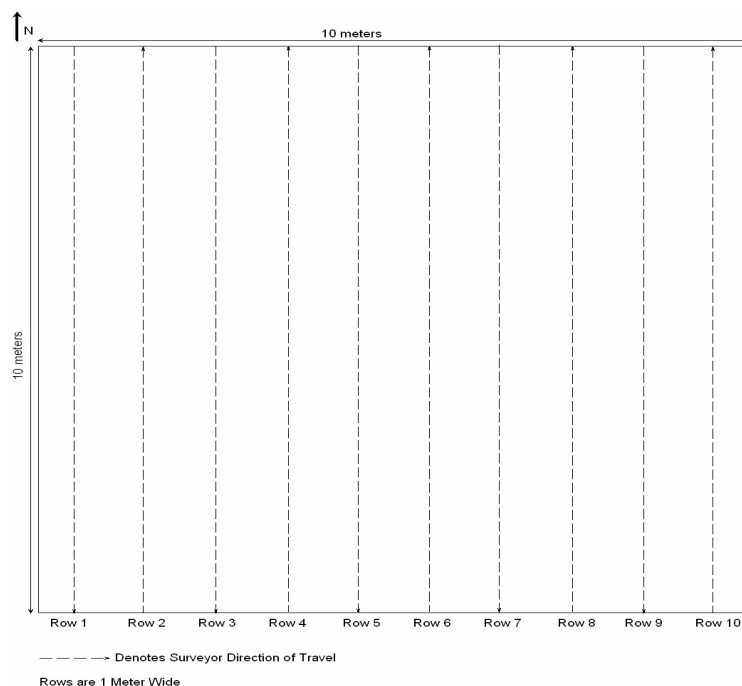
Figure 20. Surveyor Direction of Travel Diagram

NOTE: All the grids were surveyed with the same starting point and direction of travel with the exception of Grid #30.

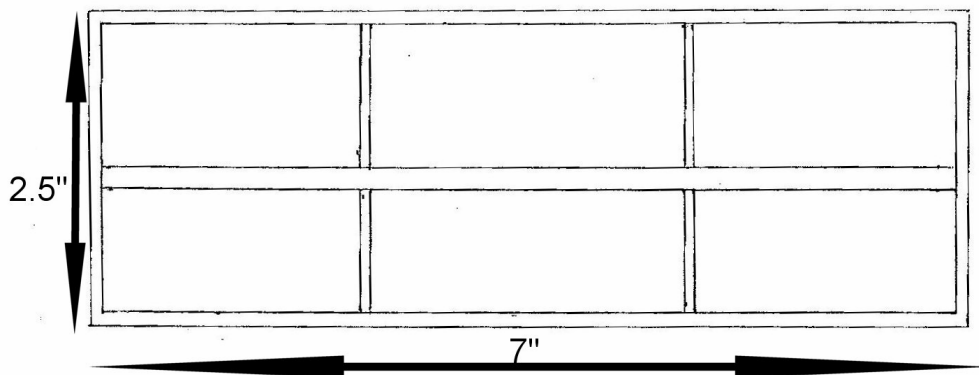
Diagram 1. Model 43-37 Detector Dimension Diagram

Drawing is 50% of Full Scale With Exception of Center Bar Which is Full Scale
