## **Bottom Mounted Nozzle Strategic Plan: Industry Update**

NRC Meeting  
September 29, 2005

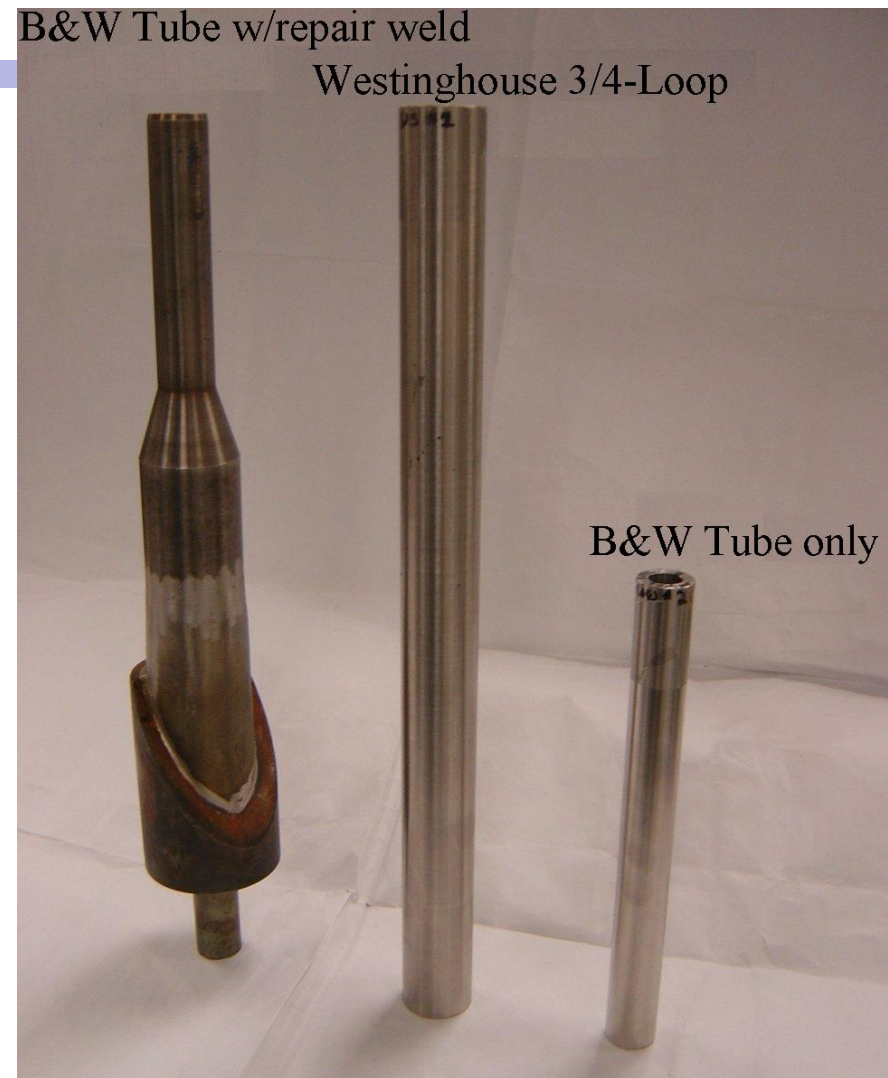
# BMN Practice Mockups (Non-Blind)

- 4 Practice Mockups
  - 2 Westinghouse 3/4-Loop
  - 2 B&W Designs
    - Tube Only
    - Tube w/repair weld
- Made available in 2003

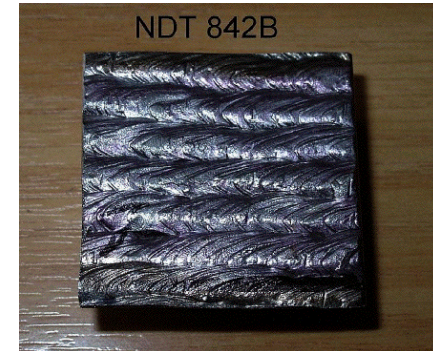
# BMN Blind Demonstration Mockups

- 7 Mockups for Volumetric and Surface Inspection
  - 6 Full-Scale Mockups
    - 2 Westinghouse 2-Loop Design
    - 2 B&W Design
    - 2 Westinghouse 3/4-Loop Design
  - 1 Mockup with coupons containing Lab-grown SCC
