Integrated Chemical Effects Test Project: Test #2 Data Report

Los Alamos National Laboratory

**U.S. Nuclear Regulatory Commission
Office of Nuclear Regulatory Research
Washington, DC 20555-0001**

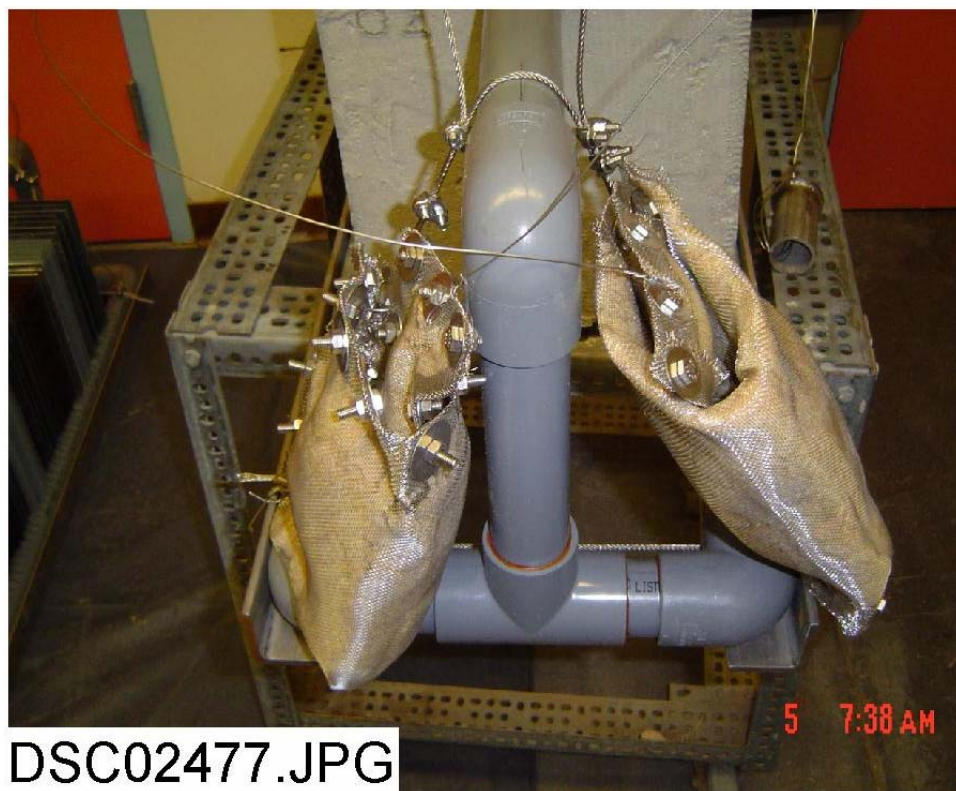
Figure 3-4. Fiberglass samples attached to the submerged coupon rack.

Several fiberglass samples were placed in the ICET tank. Samples were either submerged below the water level or held above the water level. The unsubmerged fiberglass samples were positioned so they would be exposed to sprays. The fiberglass samples were contained in stainless steel wire mesh that allowed water flow, while confining the fiberglass material. Both loosely-packed and more tightly-packed samples were used. In addition, some submerged fiberglass samples were located where they would be exposed to relatively high-flow conditions and others were located in regions of the tank with quiescent conditions. Figure 3-4 illustrates the so-called sacrificial fiberglass samples in wire mesh pouches attached to the submerged coupon rack (rack #1 in Figure 3-2). Each pouch contains approximately 5 g of fiberglass. Those samples were attached with SS wire and removed from the tank midway through the test and examined. Bigger insulation bags, those that resemble the two saddle bags in the figure, were wrapped around the sacrificial specimens during the test. See Section 3.3.1 for descriptions of other fiberglass samples.

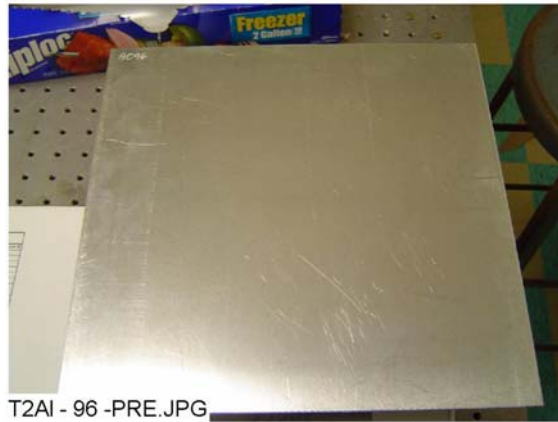
Figure 4-2. Al-96 submerged, pre-test.

According to SEM/EDS results, the dominant corrosion products on the submerged Al coupons are likely aluminum hydroxide with other substances containing Si, Ca, Na, Mg, P, C, and O. In addition, evidence was found that some Cu deposited on the submerged aluminum coupon surfaces. Comparing the redox potential (E^0) of Al^{3+} and Cu^{2+} , which is -1.662 and 0.3419 V (Ref. 6), respectively, Cu^{2+} in the solution may oxidize Al metal. As a result, Al metal may be oxidized into Al^{3+} and released to the solution. Correspondingly Cu^{2+} is reduced into metallic Cu and subsequently deposits at the aluminum coupon surface.

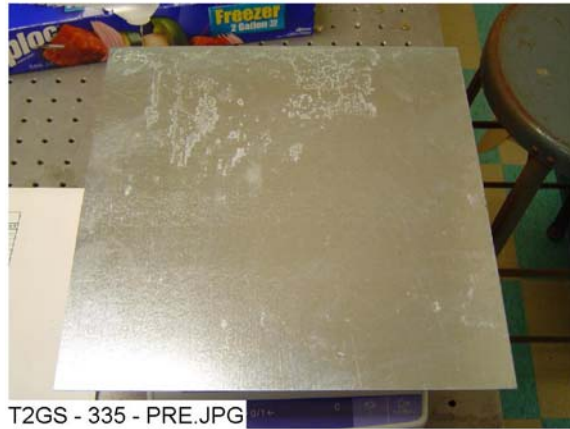
Figure 4-8. GS-335 submerged, pre-test.

Figure 4-8 through Figure 4-13 present the pre-test and post-test pictures of three submerged galvanized steel coupons. Each post-test galvanized steel coupon exhibits nearly identical patterns of dense gray particle deposits. The relative spatial location of these coupons, given in order from the west side of the tank to the east side of the tank, is as follows: GS-337, GS-338, and GS-335. There is no discernable relationship between the spatial location of the coupons and particle deposition patterns or density. For the submerged galvanized steel coupons, the possible corrosion products are phosphoric and carbonate compounds of Zn and Ca.

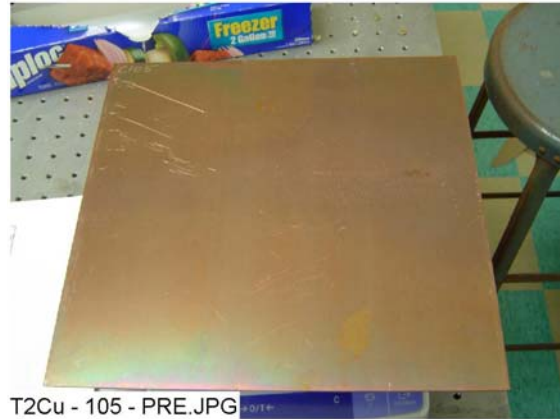
Figure 4-18. Cu-105 submerged, pre-test.

Figure 4-18 through Figure 4-21 present the pre-test and post-test pictures of two submerged copper coupons. Each post-test copper coupon exhibits similar patterns of white, streak-like deposits. The deposition streaks are almost perfectly horizontal and are more highly concentrated for coupon Cu-123. Different corrosion effects are visible at the contact points. The Cu-123 coupon is located on the west side of the tank in relation to the Cu-105 coupon. The Cu-105 coupon appears to have a greater distribution of these white, streak deposits. For submerged Cu coupons, the possible corrosion products include CuO , $\text{Cu}_2(\text{CO}_3)(\text{OH})_2$, $\text{Mg}_3(\text{PO}_4)_2$, and substances containing Mg, Cu, Na, Al, Ca, C, and O.

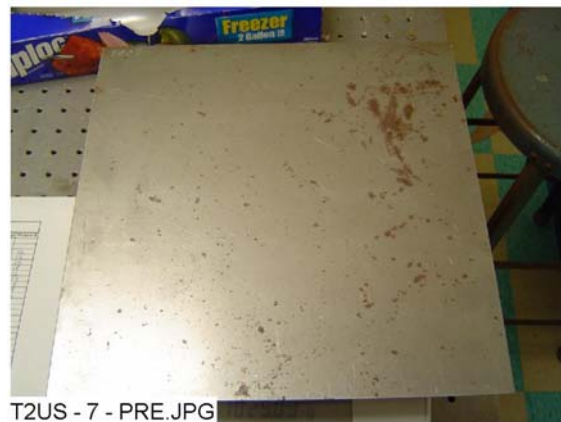
Figure 4-22. US-7 submerged, pre-test.

Figure 4-22 and Figure 4-23 present the pre-test and post-test pictures of the submerged carbon steel coupon. The post-test carbon steel coupon exhibits a reddish-brown color and significant corrosion around the edges. Different corrosion effects are visible at the contact points. This carbon steel coupon was adjacent to a copper coupon. For the submerged steel coupon, the possible corrosion products include phosphoric and carbonate compounds of Fe and Ca and compounds composed by Fe, Al, Si, Na, Ca, Mg, P, and O.

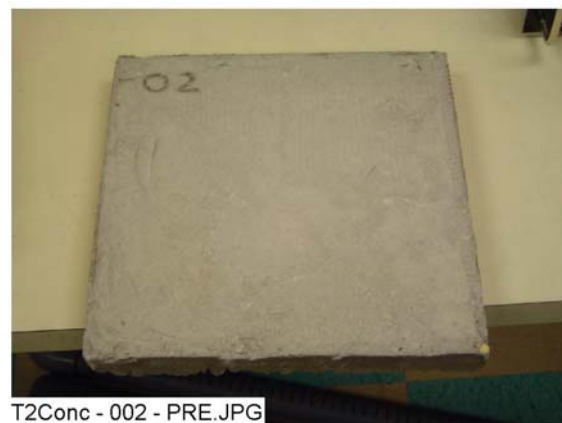
Figure 4-24. Conc-002 submerged, pre-test.

Figure 4-24 and Figure 4-25 present the pre-test and post-test pictures of the submerged concrete coupon. The post-test concrete coupon exhibits an enhanced gray color as compared with the pre-test coupon.

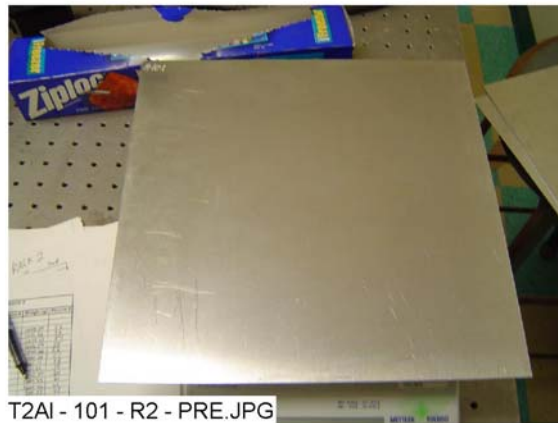
**Figure 4-26. Al-101 unsubmerged, pre-test.**

The physical and chemical changes that the unsubmerged coupons experienced during Test #2 are less significant than the submerged coupons. Figure 4-26 through Figure 4-29 demonstrate the pre-test and post-test pictures of two unsubmerged aluminum coupons. Each post-test aluminum coupon exhibits similar deposits. Also, the texture of each coupon is coarser and the surface is less lustrous than its pre-test appearance. The reddish-brown color that was observed on the submerged coupons is absent on the unsubmerged coupons. The Al-101 coupon was loaded into rack 2, which was located in the southern position on the tank's middle tier (see Figure 3-2). The Al-132 coupon was loaded into rack 5, which was located in the southern position of the tank's top tier. The Al-101 specimen exhibits a greater concentration of these deposits.
