## Appendix A

### SEM and ESEM/EDS Data for Test #3 Day-4 Fiberglass in Low-Flow Zone

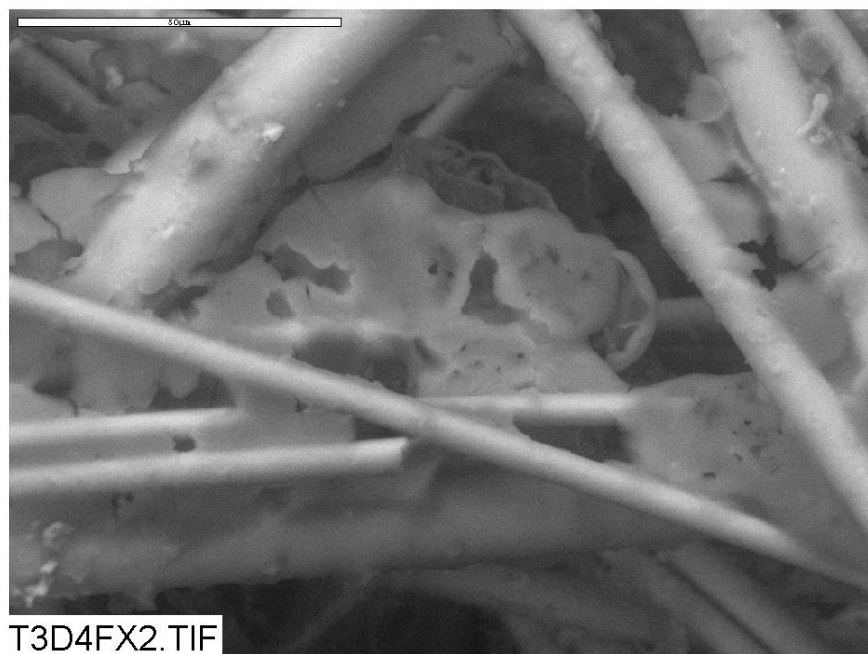
**Figure A-2: Environmental SEM image magnified 1000 times for a Test #3 Day-4 low-flow exterior fiberglass sample. (T3D4FX2)**

Image:	T3D4FX1	150 ×	ESEM image	Figure A-1
	T3D4FX2	1000 ×	ESEM at higher magnification	Figure A-2
EDS:	T3D4FX3		Particles on Image FX2	Figure A-3
	T3D4FX4		FX2 particles after calibration with primed elemental analysis	Figure A-4
Image:	T3D4FX5	500 ×	ESEM image	Figure A-5

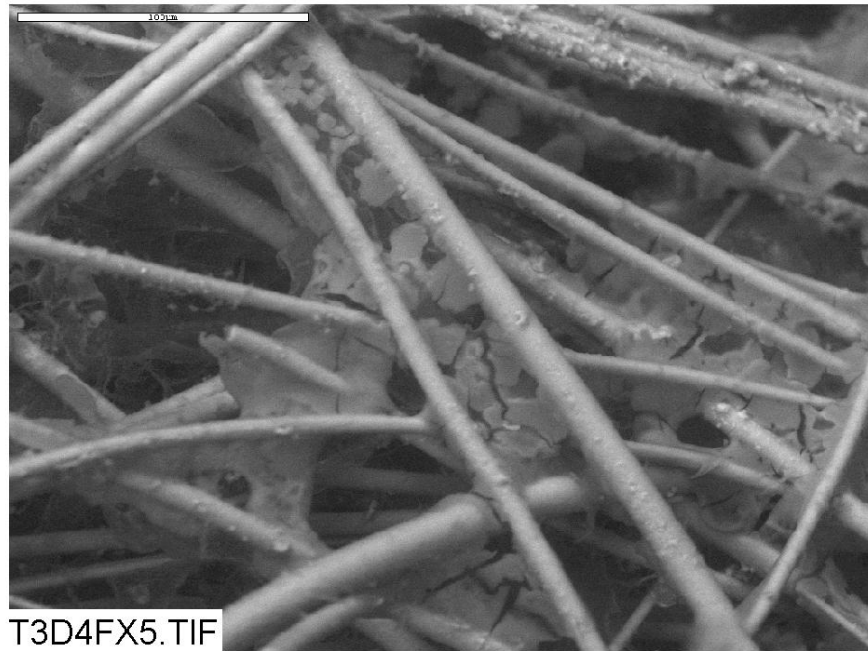
**Figure A-5: Environmental SEM image magnified 500 times for a Test #3 Day-4 low-flow exterior fiberglass sample. (T3D4FX5)**

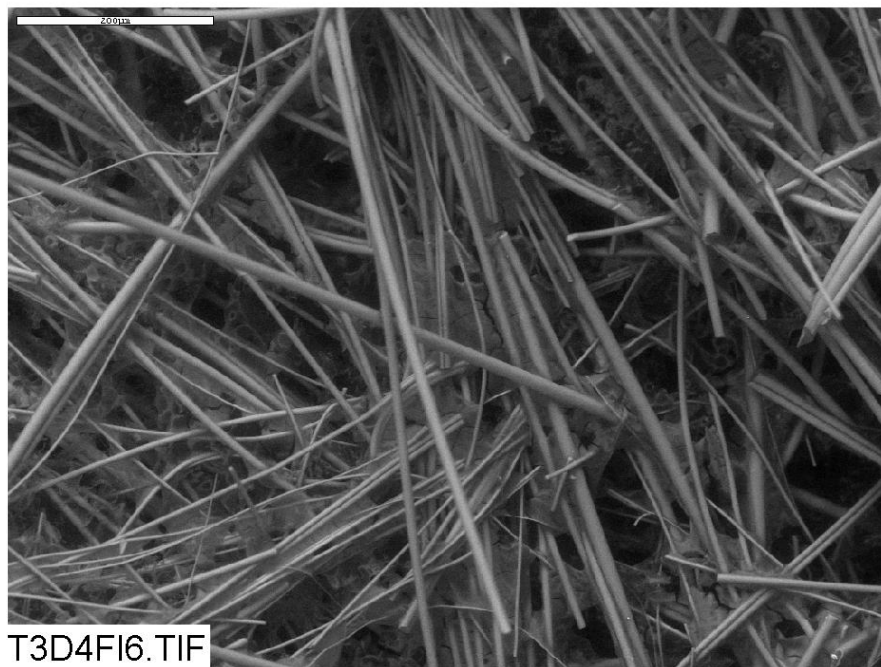
**Figure A-6: Environmental SEM image magnified 150 times for a Test #3 Day-4 low-flow interior fiberglass sample. (T3D4FI6)**

Image:	T3D4FI6	150 ×	ESEM image	Figure A-6
	T3D4FI7	1000 ×	ESEM at higher magnification	Figure A-7
EDS:	T3D4FI8		EDS of particles on FI7	Figure A-8

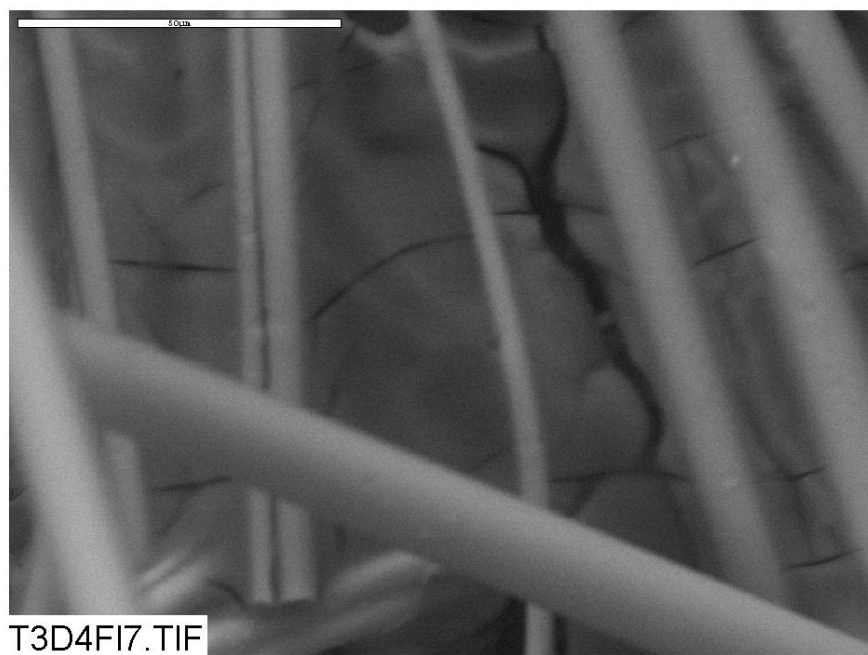
**Figure A-7: Environmental SEM image magnified 1000 times for a Test #3 Day-4 low-flow interior fiberglass sample. (T3D4FI7)**

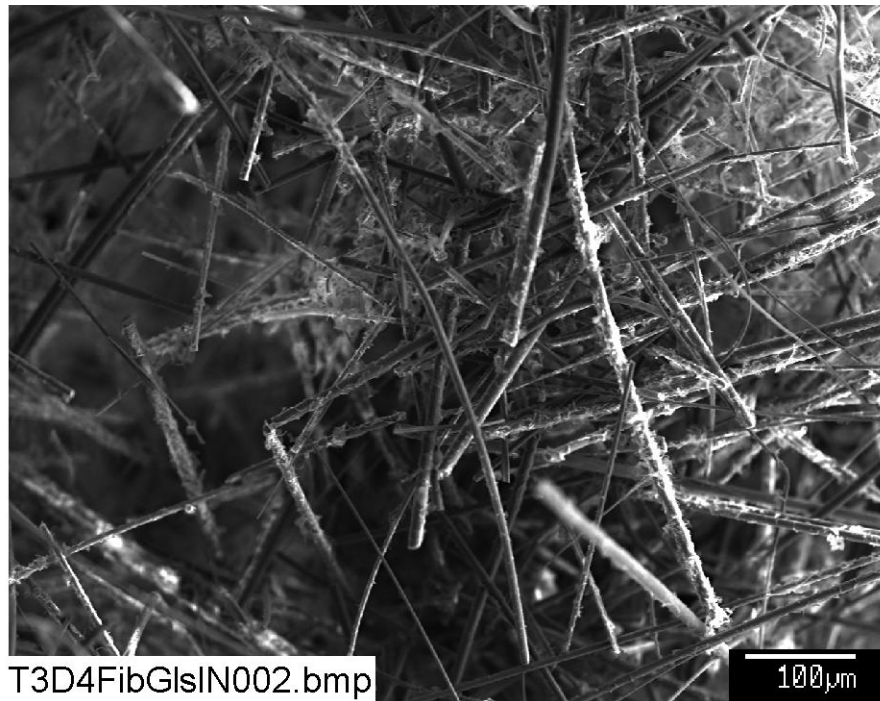
**Figure A-13: SEM image magnified 150 times for a Test #3 Day-4 low-flow interior fiberglass sample. (T3D4FibGlsIN002)**

Image:	T3D4FibGlsIn001	50 ×	SEM image	Figure A-12
	T3D4FibGlsIn002	150 ×	SEM image	Figure A-13
	T3D4FibGlsIn003	400 ×	SEM image	Figure A-14
	T3D4FibGlsIn004	1000 ×	SEM at higher magnification	Figure A-15

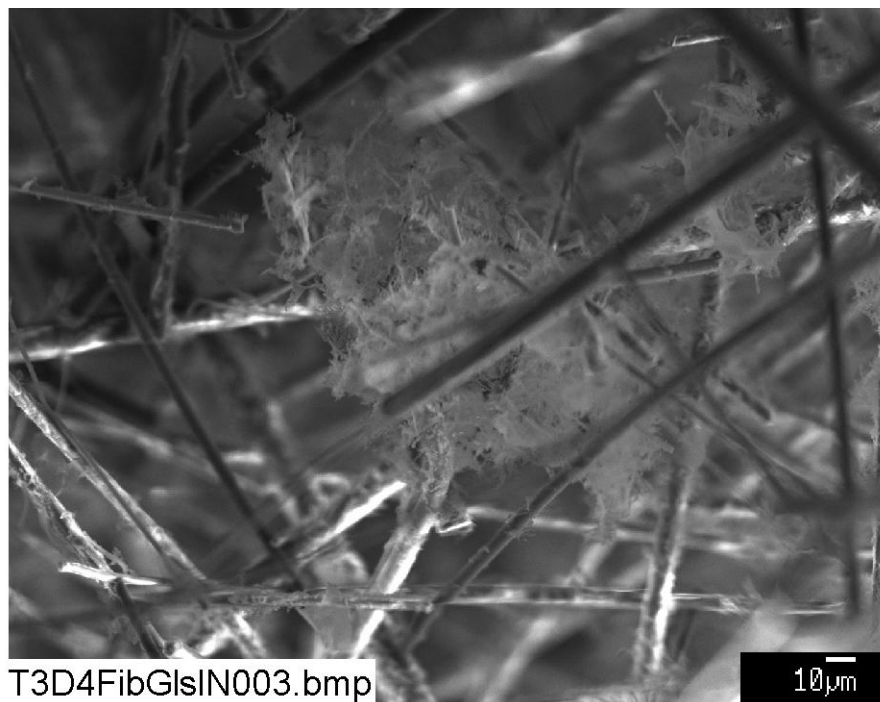
**Figure A-14: SEM image magnified 400 times for a Test #3 Day-4 low-flow interior fiberglass sample. (T3D4FibGlsIN003)**

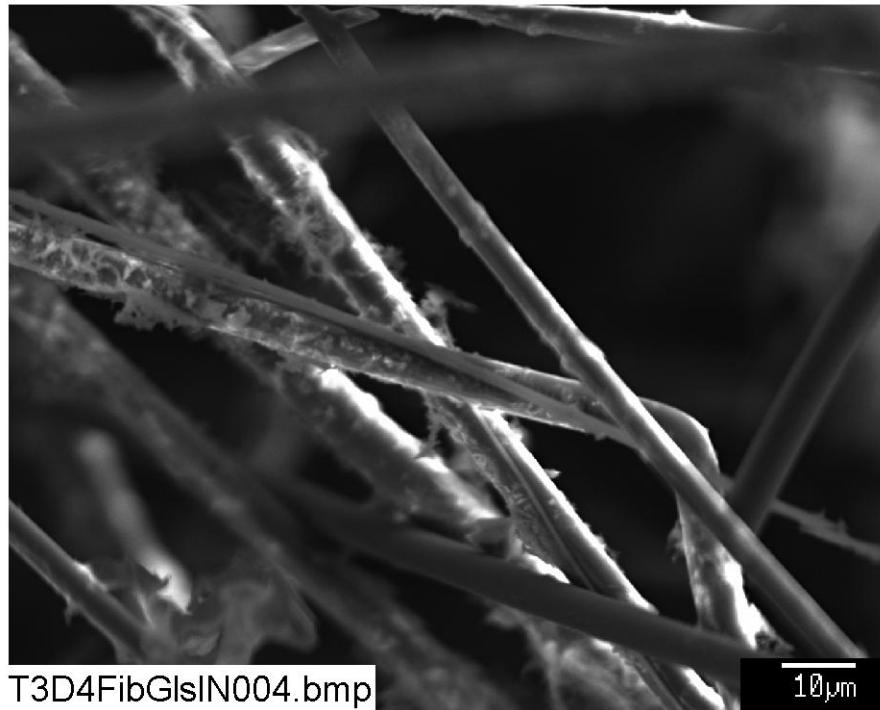
**Figure A-15: SEM image magnified 1000 times for a Test #3 Day-4 low-flow interior fiberglass sample. (T3D4FibGlsIN004)**
