Section 3:
Session 2: Continued Plant Operation

Background and Technical Basis: Evaluation of Upper Head Penetration Flaws in the ASME Code

MAINTENANCE STRATEGY OF INCONEL COMPONENTS IN PWR PRIMARY SYSTEM IN FRANCE : Bugey Leak

The Embedded Flaw Process for Repair of Reactor Vessel Head Penetrations

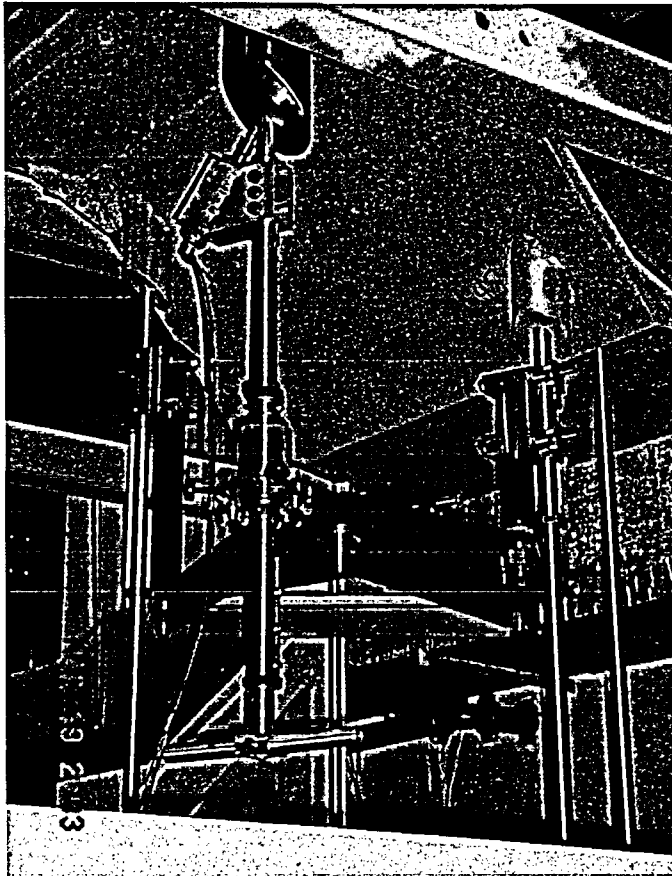
J-Prep Tool

- > ***Proven reliable design used previously on pressurizer nozzles***
- > ***Lightweight, one-man installation***
- > ***Custom cam for each nozzle location to grind appropriate angle of J-prep***
- > ***Features a debris collection device with vacuum attachment to collect grinding flakes***
- > ***J-Prep tool can be used as-is for using an specific set of burrs and cams***

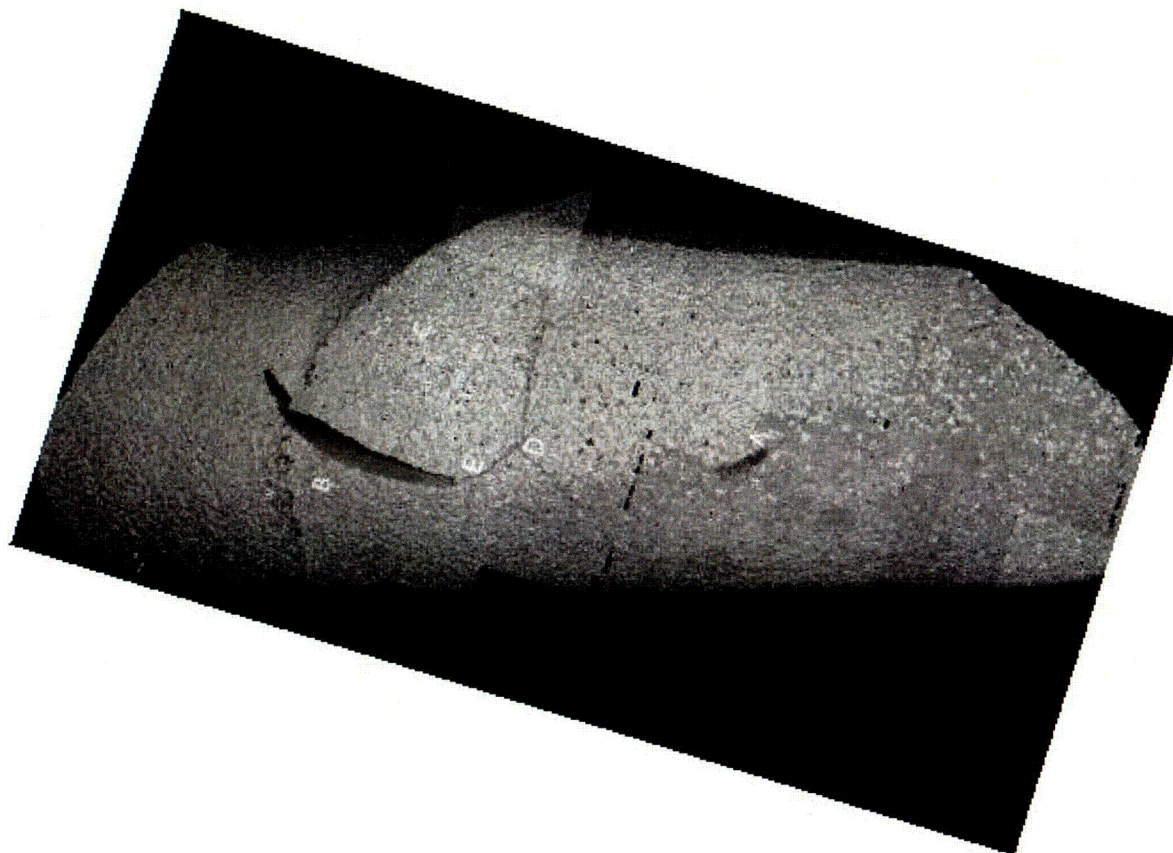
Boat Sample SEM/EDS As-Received
