## Fact Sheets and Maps

### Off-Site Tritium Map

### Blowdown Line Map

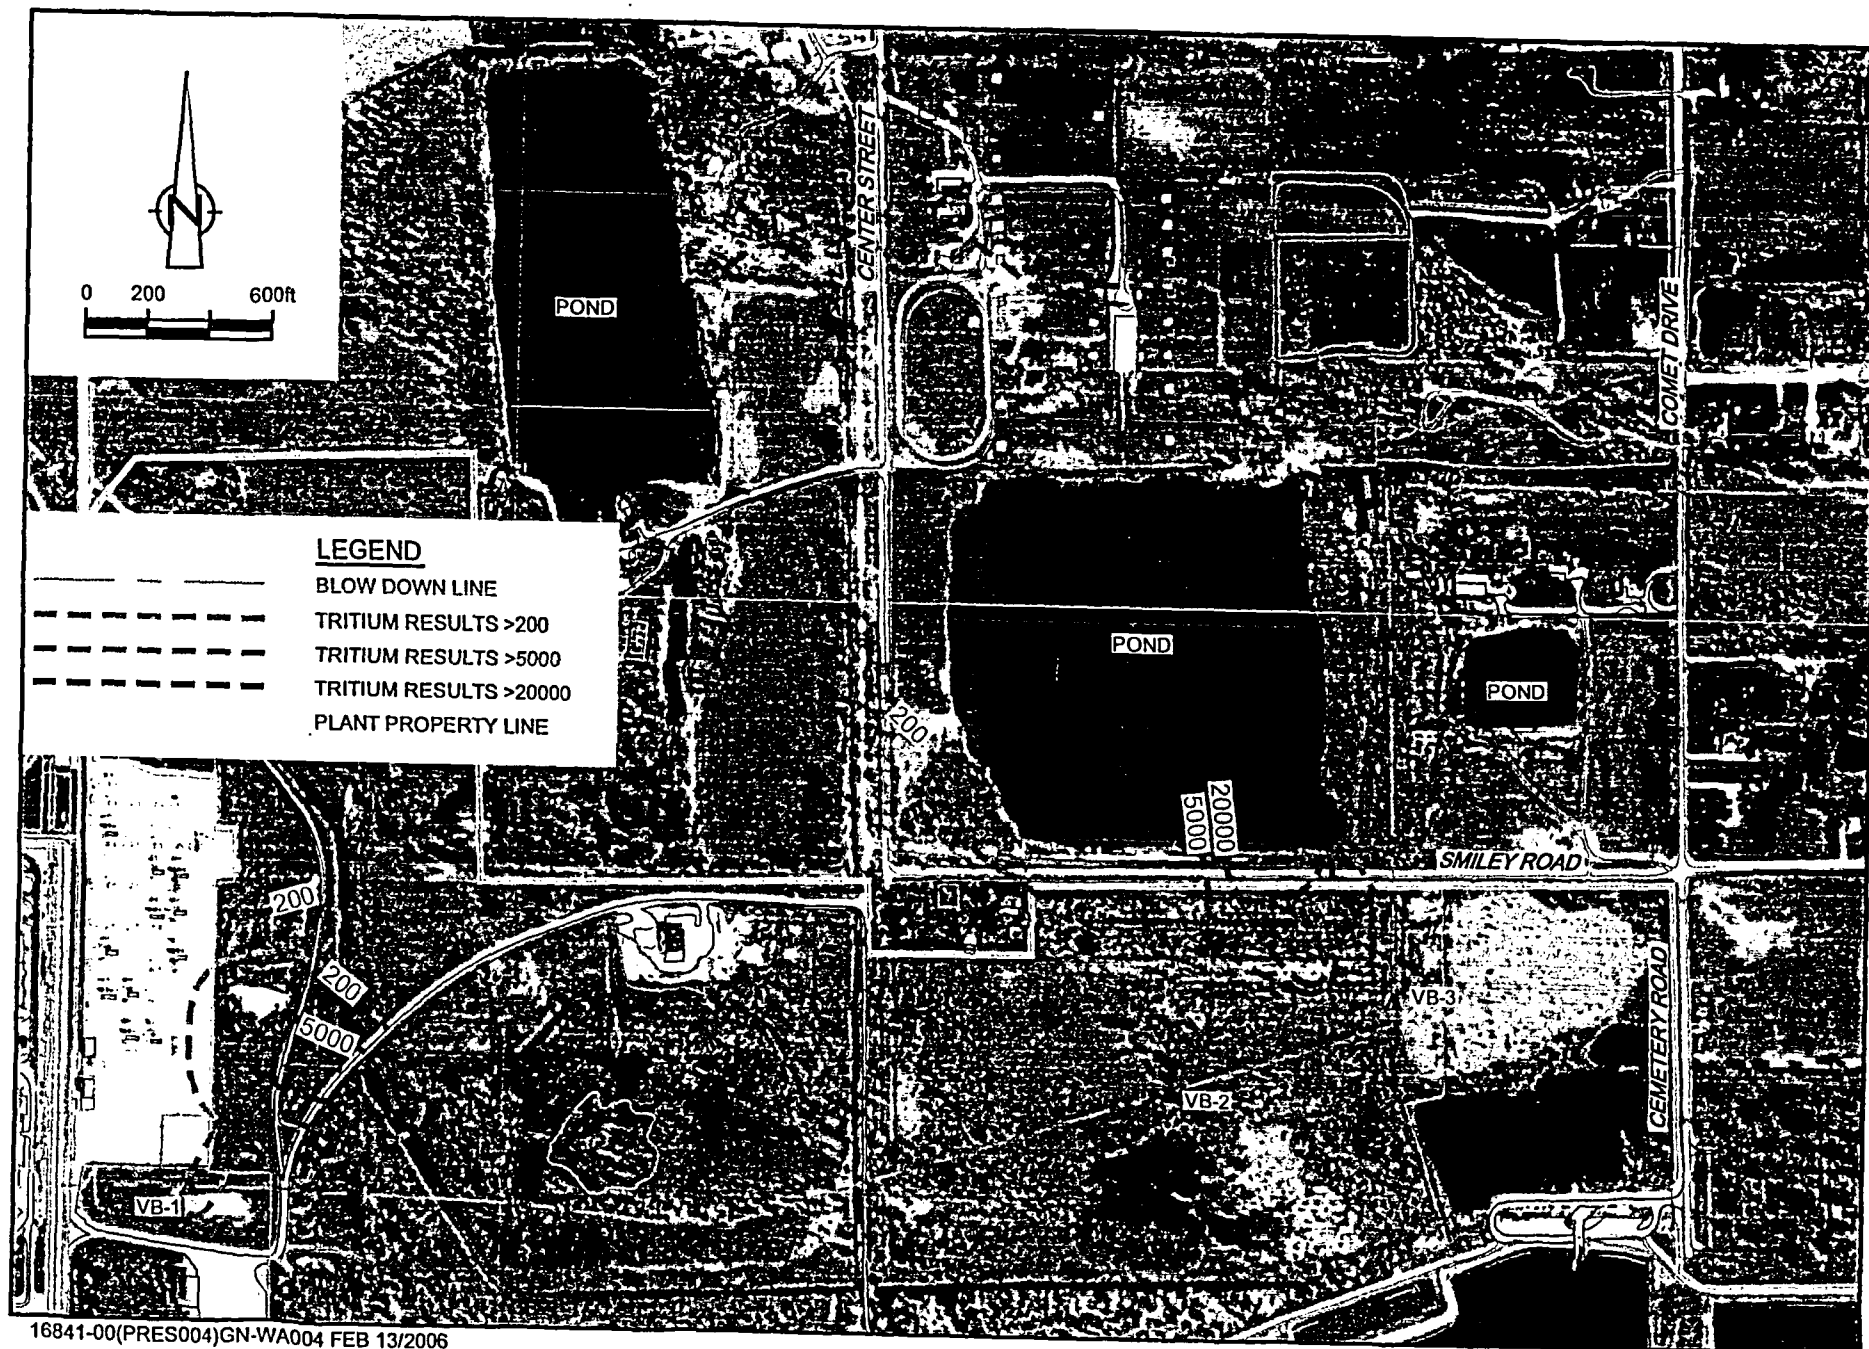
B-1

The small area marked with a red line on this aerial photo outlines the area of groundwater tritium that is above the U.S. EPA upper limit for safe drinking water (the limit is 20,000 picocuries of tritium per liter of water). There are no drinking water wells in this area, which is mostly on Braidwood plant property. Water drawn from outside the red area poses no health or safety hazard.

The slightly bigger area marked with a blue line indicates the area in which groundwater test wells have shown above one fourth of the limit. There are no drinking water wells in this area. The larger area marked by the green line outlines the area where lower concentrations of tritium were found. There is one private drinking water well in this area, measuring 1,550 picocuries per liter of tritium.
