SG-SGDA-05-48-NP  
Revision 1

**WOG PA-MSC-0190, Revision 1:  
Test Results Related to TIG and  
Alloy 800 Sleeve Installation in 3/4  
Inch and 7/8 Inch OD SG Tubing In-  
Service Inspection Requirements**

**William K. Cullen  
Chemistry Diagnostics and Materials Engineering**

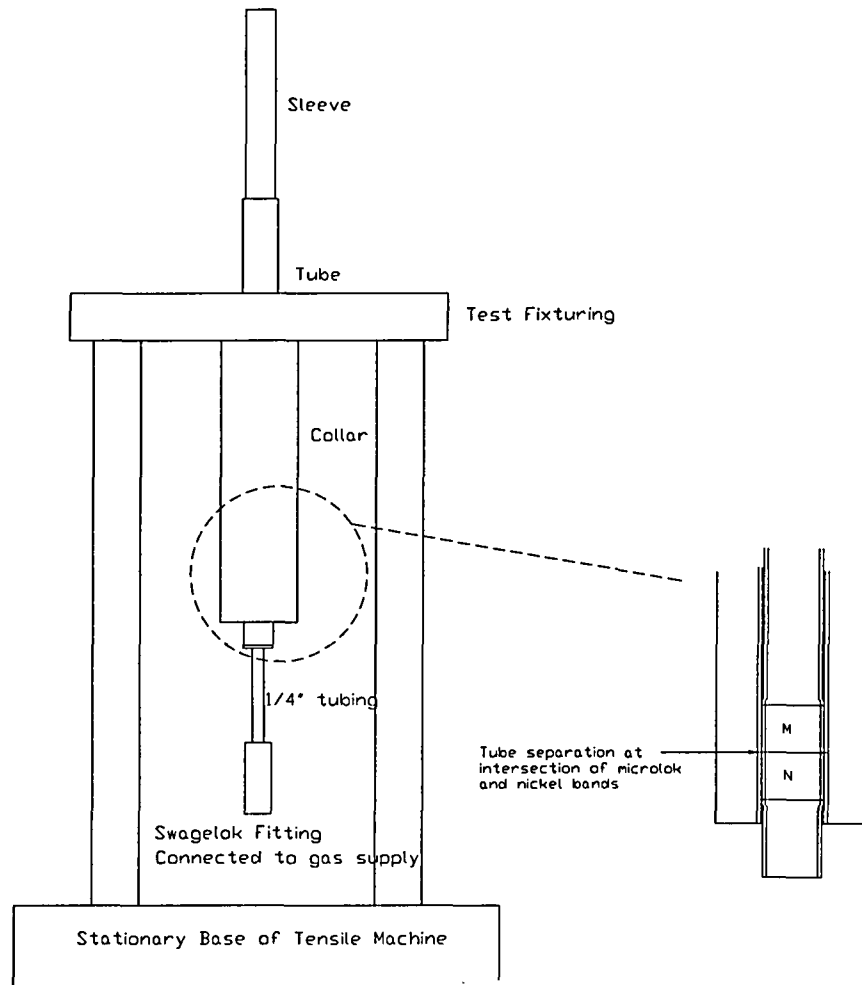
**Figure 2-1 Schematic of Tensile Test Setup**

The first of these programs involved tensile testing of Alloy 800 sleeves installed in full depth mechanical roll expanded joints using 3/4" OD x 0.043" wall thickness tubing. These specimens simulate the condition at Comanche Peak Unit 1 and Watts Bar Unit 1. These specimens were configured to simulate a complete separation of the tube adjacent to the intersection of the microlok and nickel band regions. Figure 2-1 presents a schematic of the test configuration.

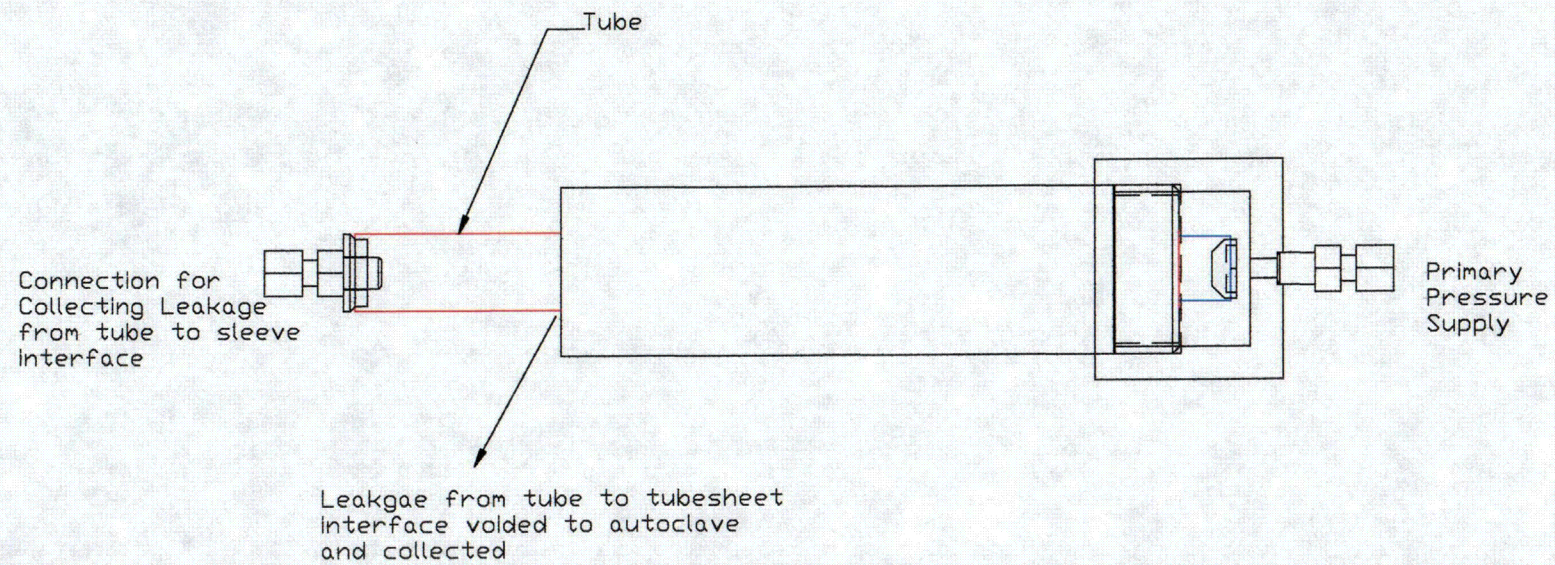
**Figure 3-1 Leak Specimen Configuration**

The leak specimen configuration is shown in Figures 3-1, 3-2, and 3-3. The specimens were configured such that the primary fluid communicated with both the tube to collar and tube to sleeve joint regions. Two 1/16 inch diameter holes were milled through the collar to the point where the full mill diameter affected the sleeve OD surface. A 1/8 inch diameter hole was milled to a depth where the full mill diameter affected the tube OD surface. The sleeve was then deformed by staking to introduce a 0.001 to 0.003 inch separation from the tube ensuring that the primary fluid had a direct path to the sleeve to tube joint interface. The hole locations were such that the edge of the hole was consistent with the microlok to nickel band interface. Leak test primary to secondary pressure differentials used were 1500 psi and 2560 psi. Figure 3-3 presents a schematic of the leak test sample modification to permit primary fluid communication with both the tube to tubesheet and tube to sleeve interfaces. In addition, the end of the sleeve inside of the end cap was plugged, thus there was no pressure inside of the sleeve. Any pressure expansion benefit upon the sleeve to tube interface was not included. Also, due to the manner in which the primary fluid was delivered to the sleeve to tube interface, the direction of the pressure developed forces act to keep the sleeve to tube interface open to the primary fluid.

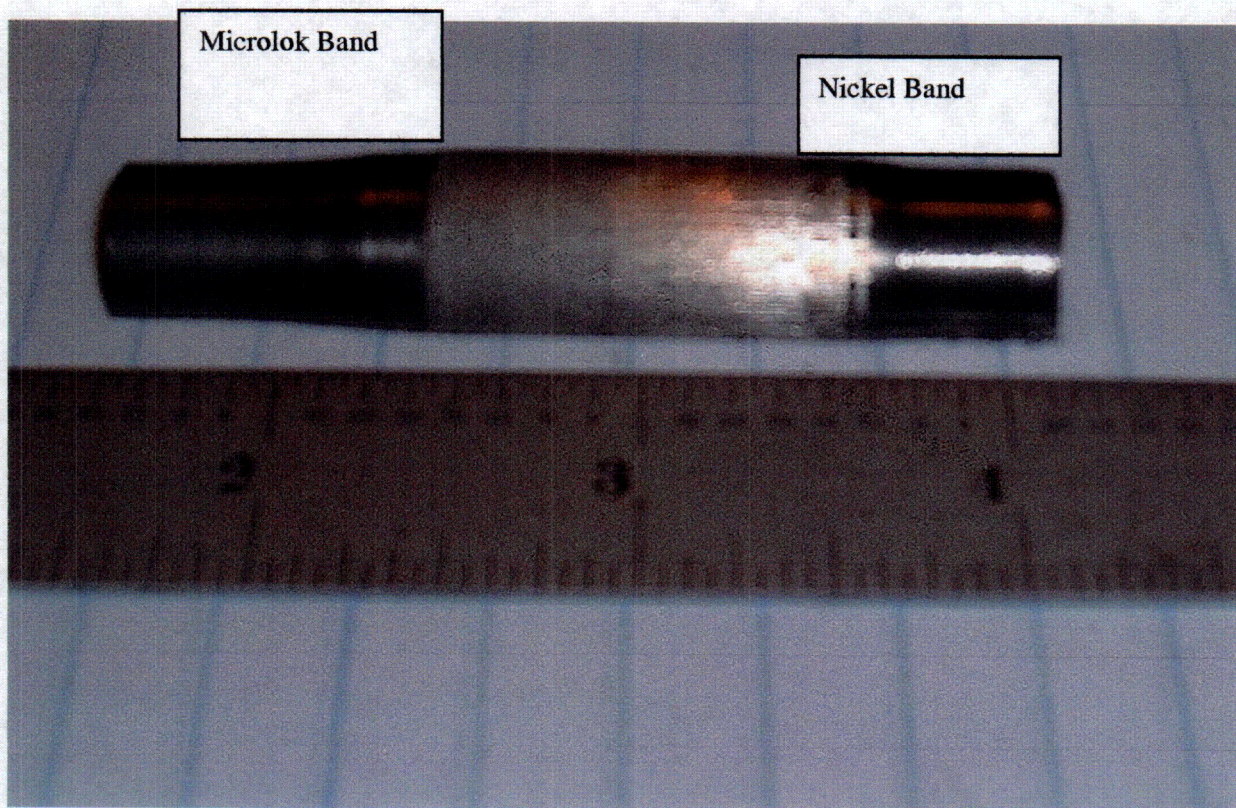
**Figure 5-2 Specimen CE Tensile-03 Post Pull Sectioning**

Following tensile testing several specimens were sectioned to examine the condition of the microlok and nickel bands after displacement within the tube. A photograph of the sleeve from C-E Tensile-03 is included as Figure 5-2. The microlok band appears to be relatively unaffected by the displacement. This helps to establish the integrity characteristics of the microlok region. A 7/8 inch OD tube specimen was also sectioned; the appearance of the microlok region is similar as shown in Figure 5-2.

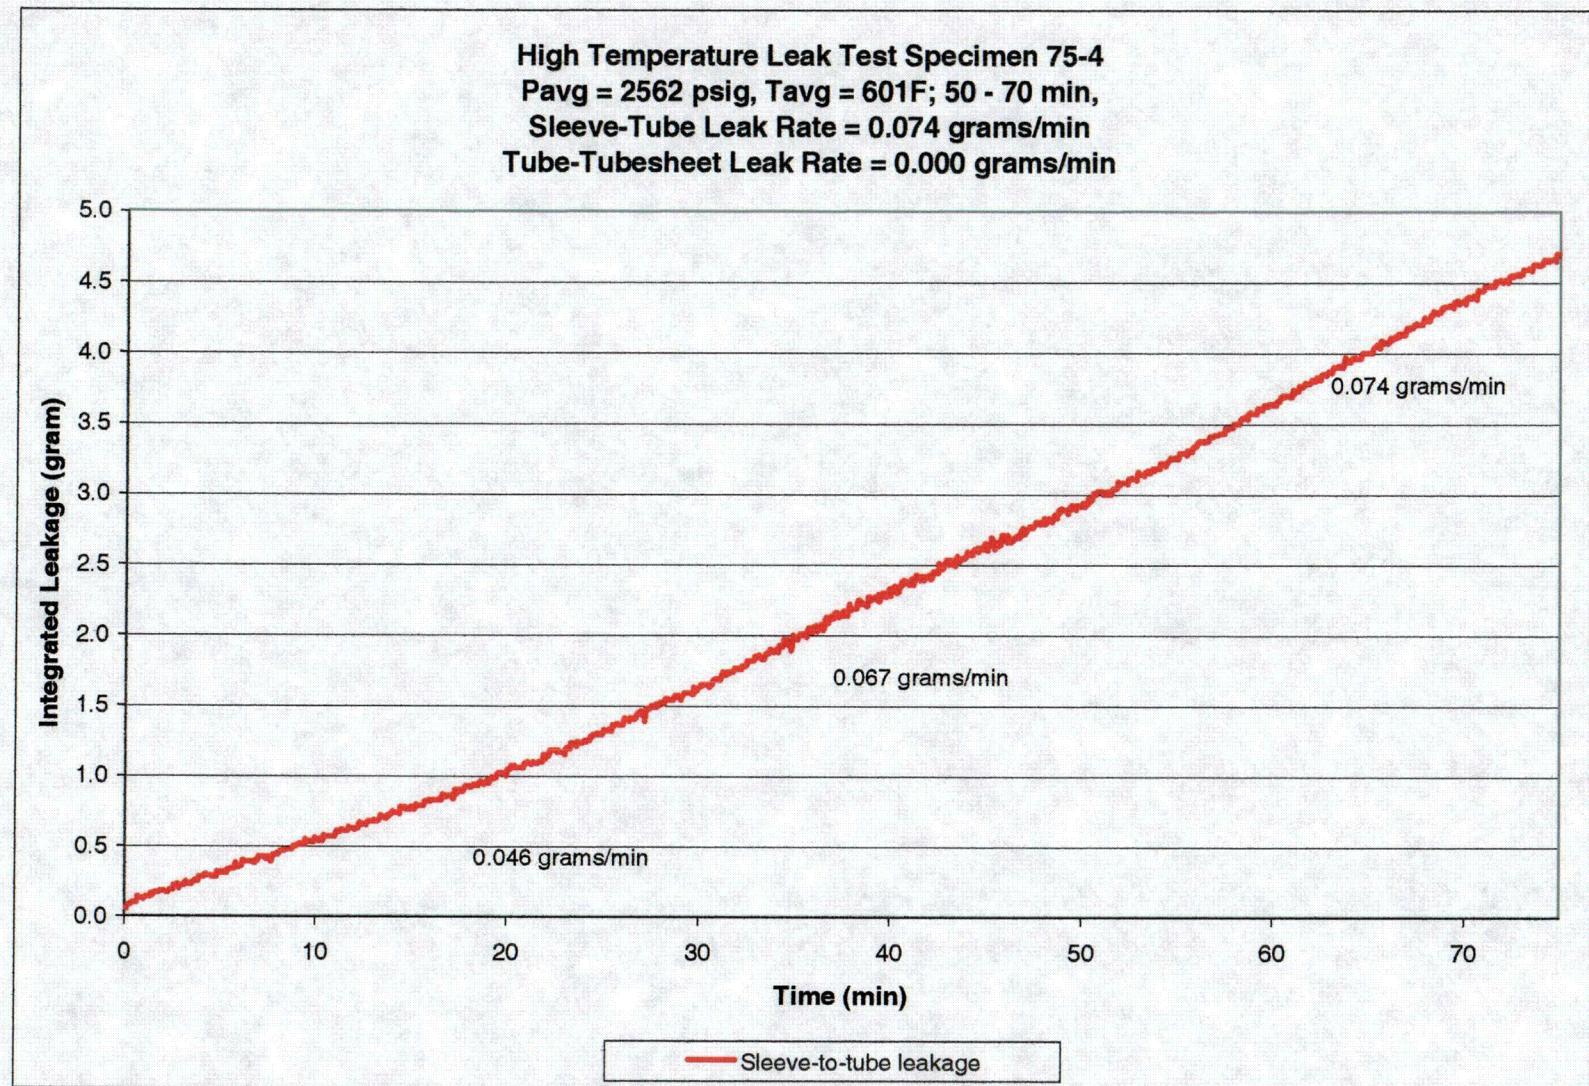
**Figure 6-1 Integrated Leak Rate History of Specimen 75 Leak-4: 2560 psi Differential Pressure**

For all room temperature leak rate tests at a pressure differential of 2560 psi, the maximum observed value of  $9 \times 10^{-5}$  gpm is so small that any postulated leakage from sleeved tubes will have no meaningful impact upon allowable leakage comparison of the operational assessment. The high temperature leak rate for this sample was reduced to  $2 \times 10^{-5}$  gpm. Note also that this specimen utilized EDM notched tubing.

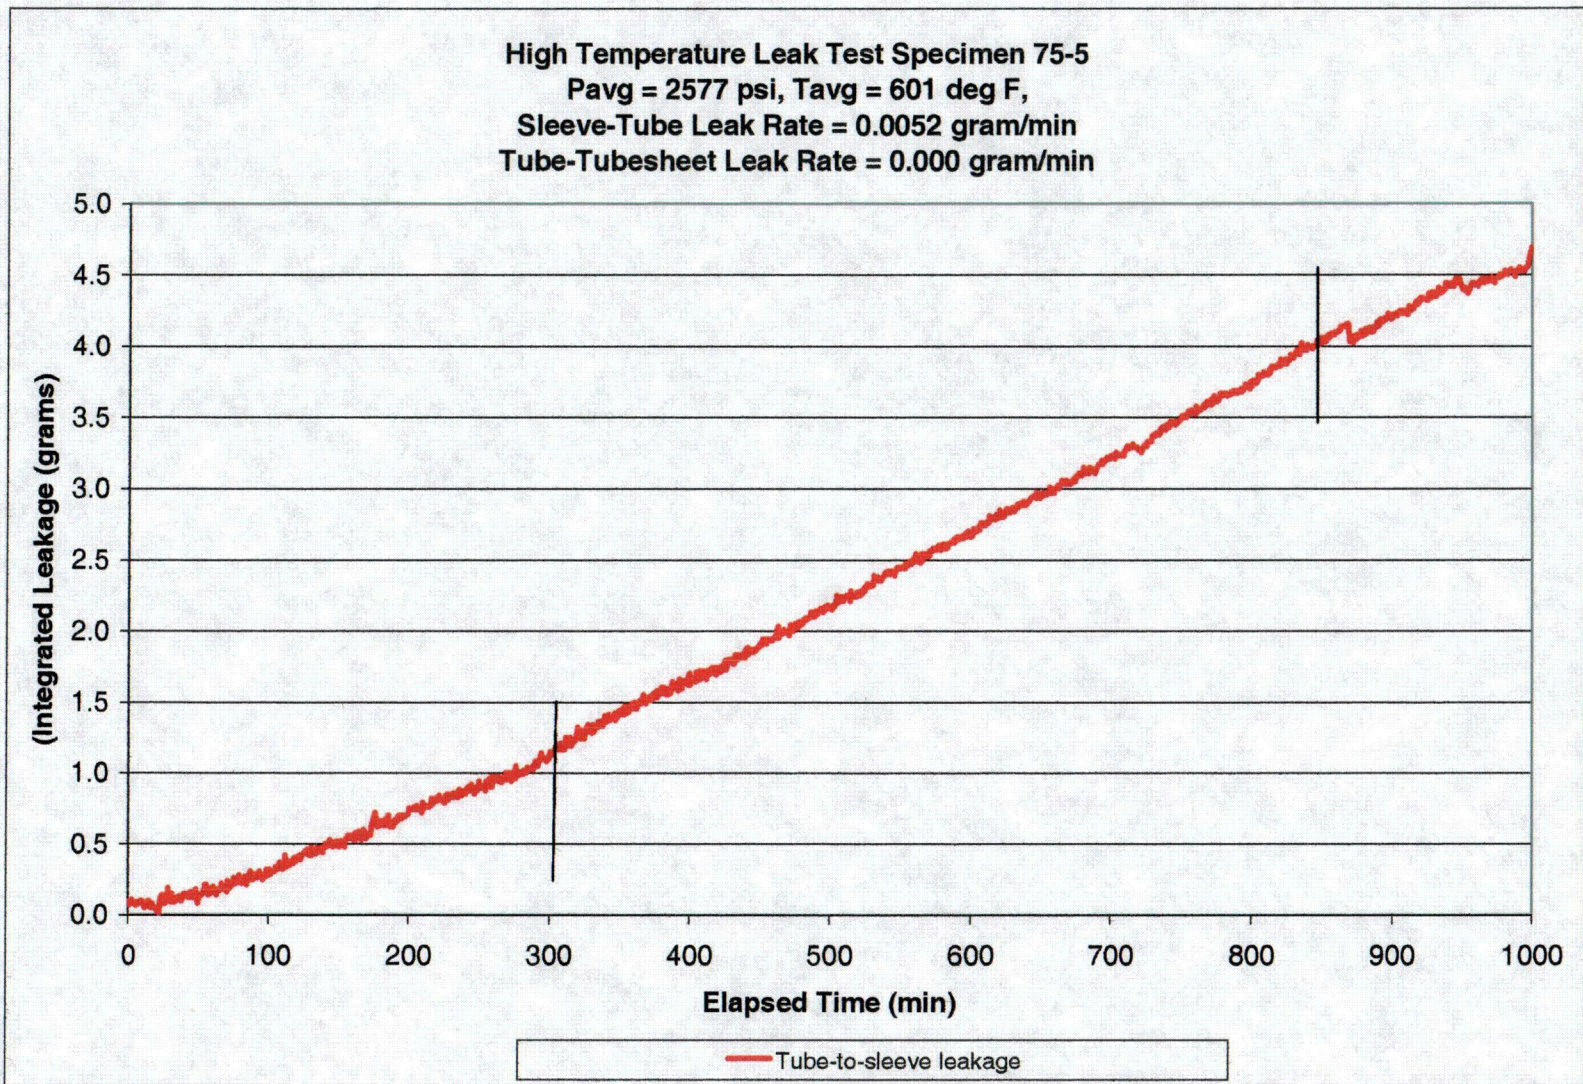
Figure 6-2 Integrated Leak Rate History of Specimen 75 Leak-5: 2560 psi Differential Pressure

The results of the room temperature leak test show that the postulated condition of a degraded parent tube has essentially no impact to leakage performance of the sleeve to tube joint. Results of the high temperature autoclave testing show that for three of the four tests performed, the high temperature leak rate was 4 to 10 times less than the room temperature leak rate. One of the high temperature tests had a larger leak rate than the room temperature (3/4 OD, sample #5). However, when the rates are examined, the high temperature rate of  $8.2 \times 10^{-6}$  gpm is so small that judgments between leak and no leak condition are difficult. The high temperature tests were held at pressure for 70 minutes for sample #4, and overnight (about 15 hours) for sample #5. Figures 6-1 and 6-2 present a plot of the integrated leak rate over the test period for these samples. The integrated leak rate was essentially constant over these periods. Note that the leak rate is measured in grams per minute due to the low level of leakage observed. After completion of the leak test, 3/4 inch OD specimen number 4 was sectioned to determine the exact placement of the leak path holes with reference to the microlok to nickel band interface. The lower edge of the 1/16 inch diameter holes that intersected the sleeve were located at the microlok to nickel band interface, thus the placement of the holes was within the microlok band.
