NDE Assessment of PWSCC in Control Rod Drive Mechanism Housings

Pacific Northwest National Laboratory

Outline

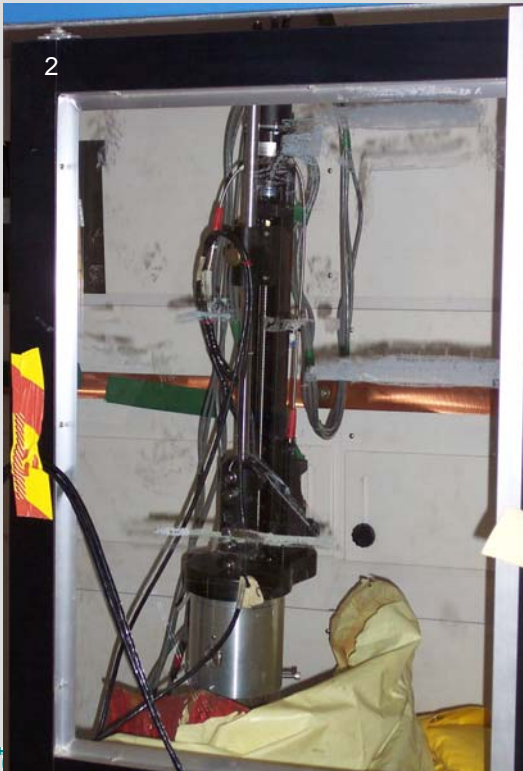
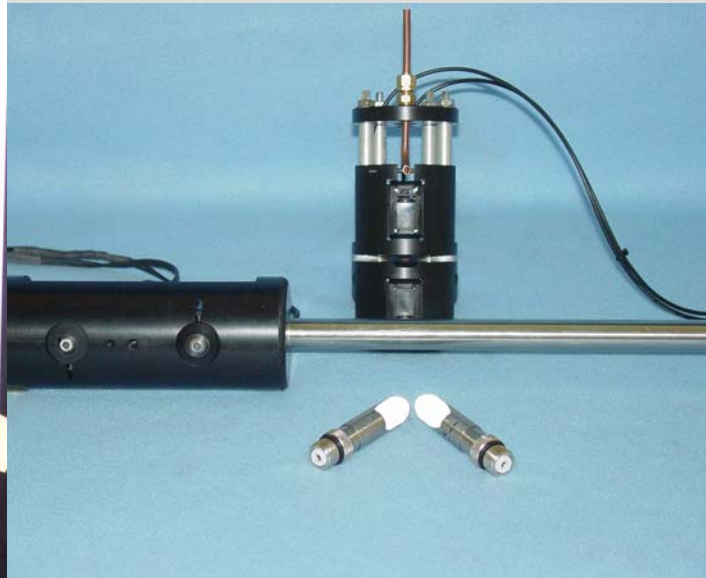
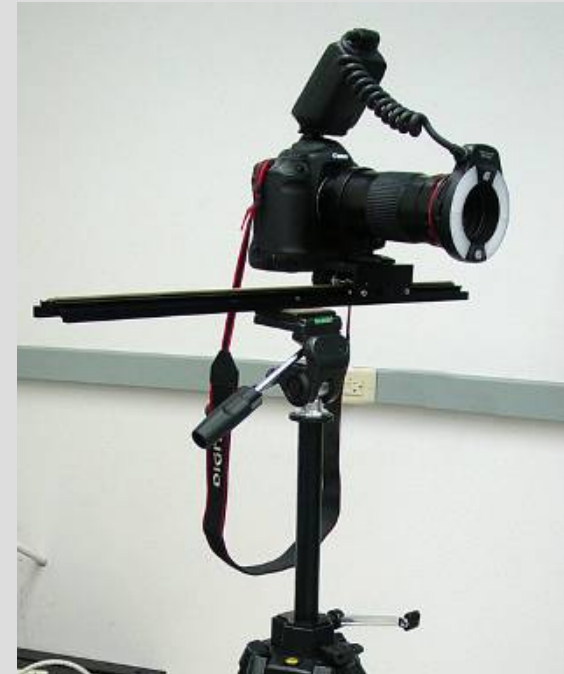
Laboratory NDE Performed on CRDM Nozzles

- ▶ The interior of two penetration tubes was inspected using eddy current, TOFD, and the penetration tube of Nozzle #59 was also inspected using visual testing via Microset.
- ▶ The J-groove weld metal of both Nozzles was volumetrically inspected using zero-degree ultrasound.
- ▶ The J-groove weld area of both nozzles was examined using visual testing via Microset.

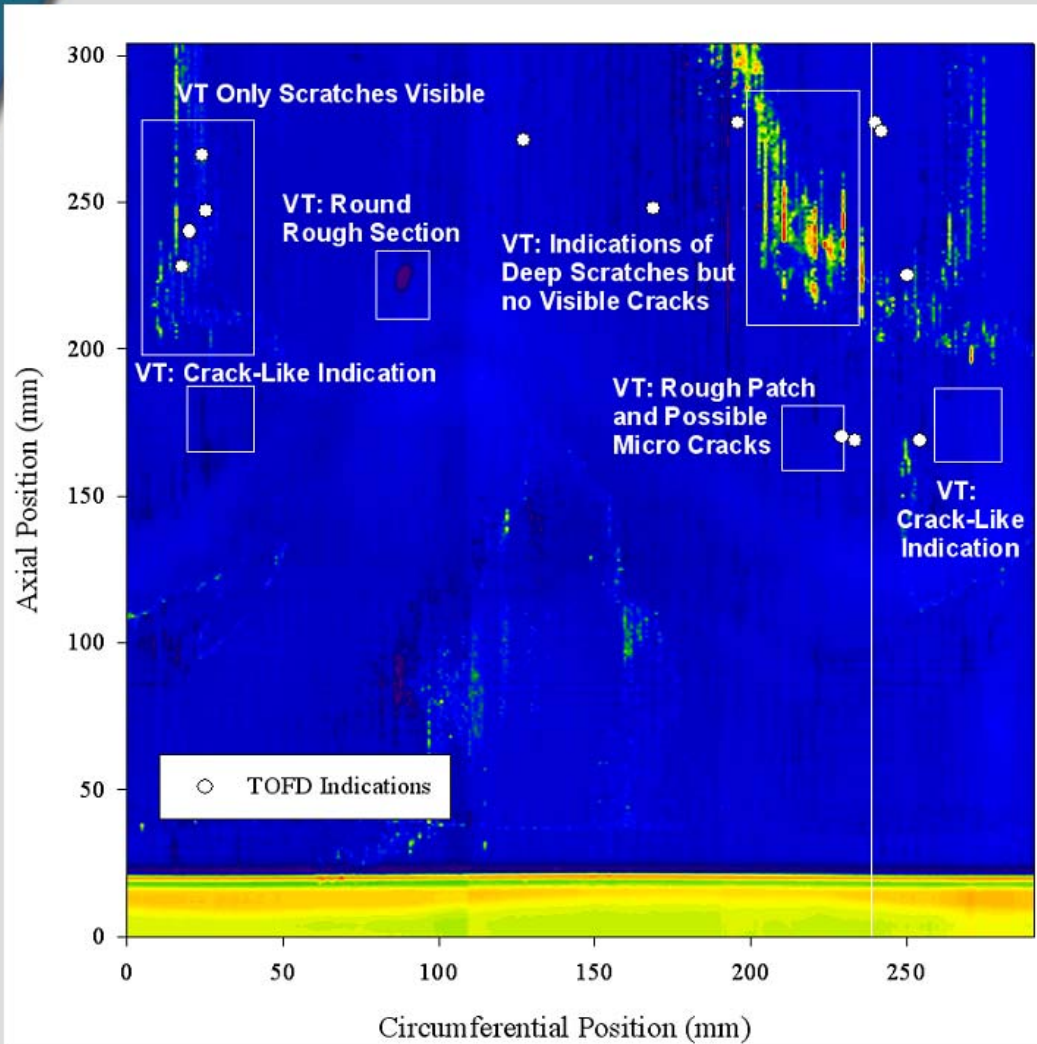
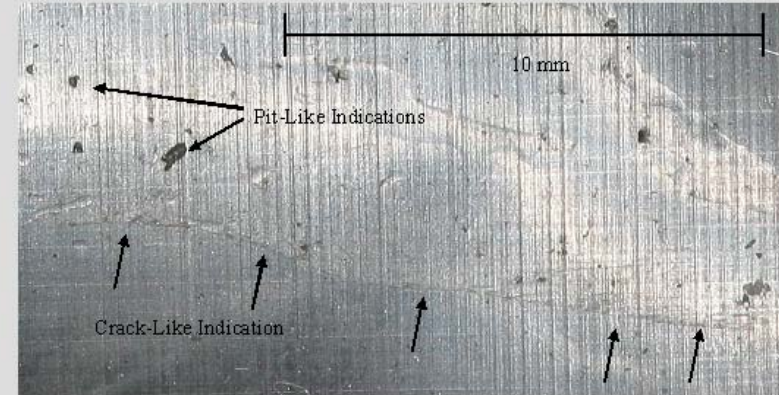
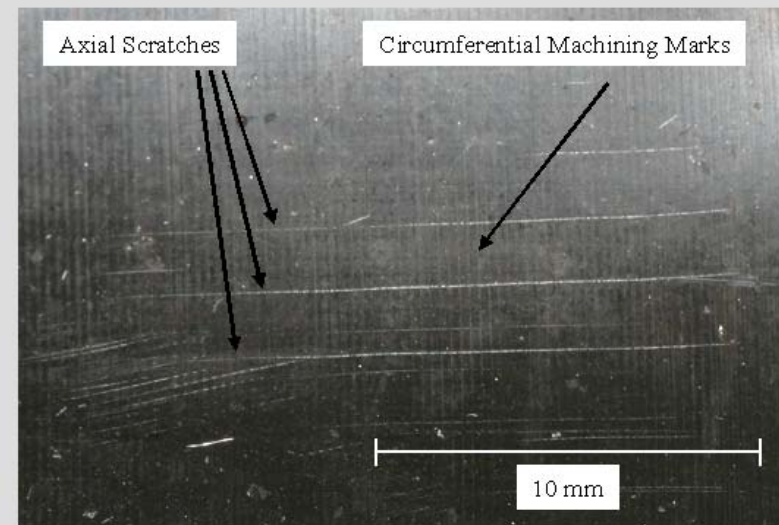
Nozzle #59- Penetration Tube ID

- ▶ Many indications were found in the penetration tube using TOFD and ET, but the TOFD and ET results are inconsistent as to where the flaws are located.
- ▶ VT found many axial scratches and pit-like indications that may have accounted for much of the ET results. One crack-like indication was discovered, although this was not solidly corroborated by the ET results.
- ▶ The examination of the J-groove weld using VT and UT showed defects in the weld.
- ▶ UT found strong reflection from the interference fit. One region of ultrasonic transmission was seen but is likely the result of the construction technique used to make the interference fit.

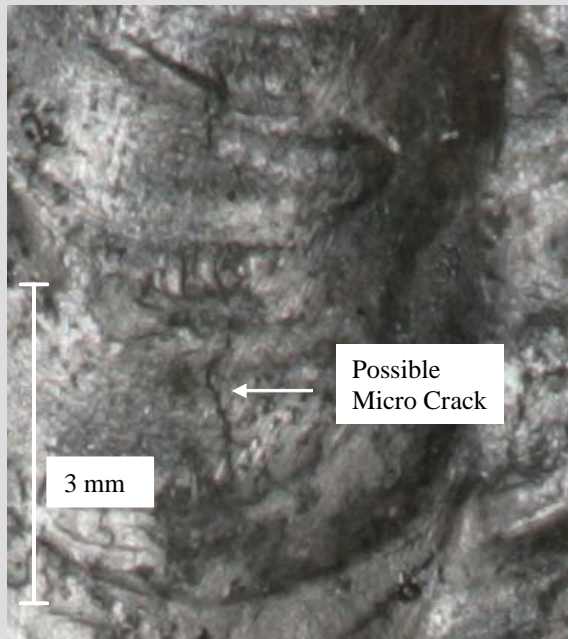
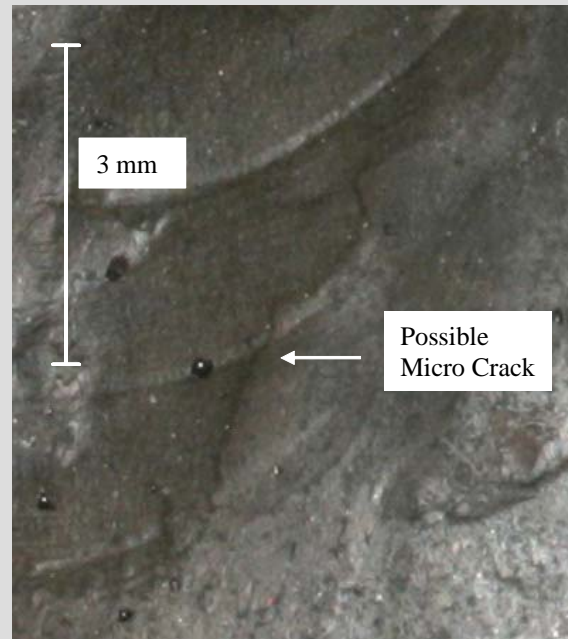
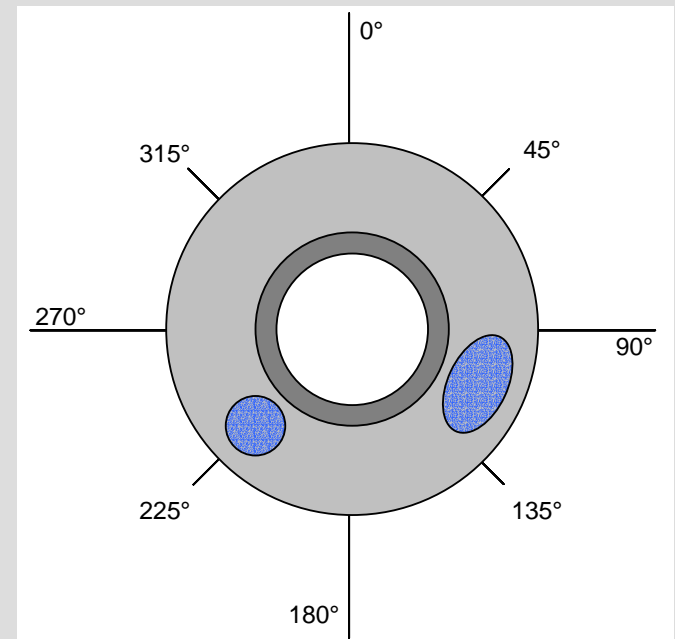
Nozzle #59- J-Groove Weld

Only indications for small cracks, no long crack-like indications discovered.

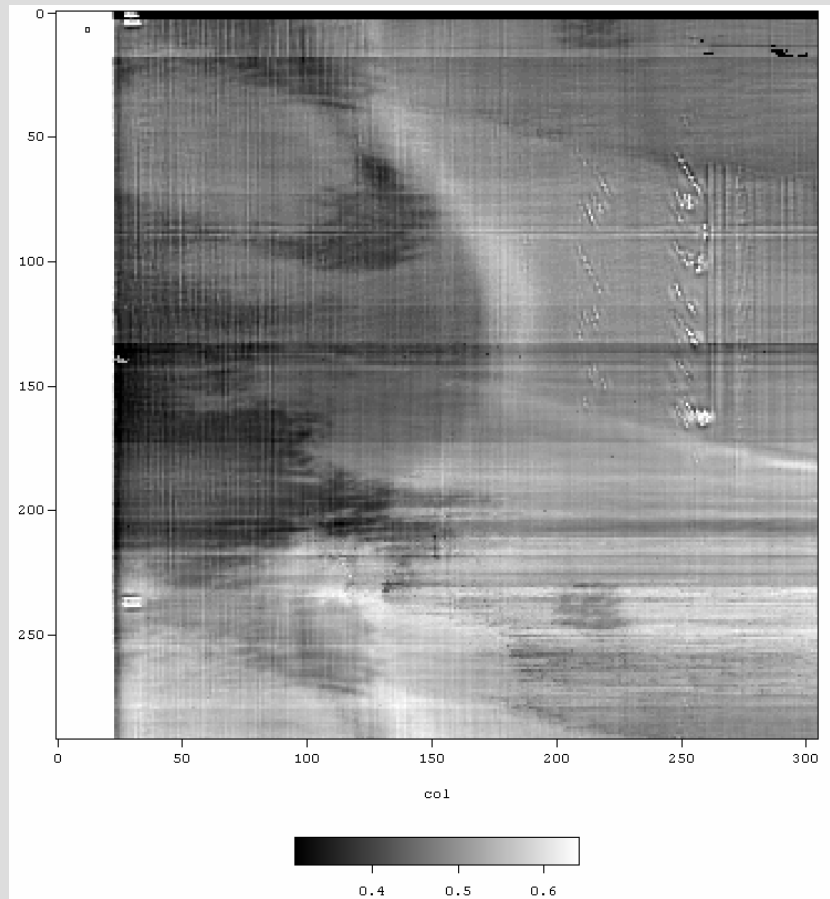
Nozzle #31- Penetration Tube

- ▶ No crack-like indications found.
- ▶ Indications consistent with shallow scratches discovered.
- ▶ J-groove weld clearly visible in data.

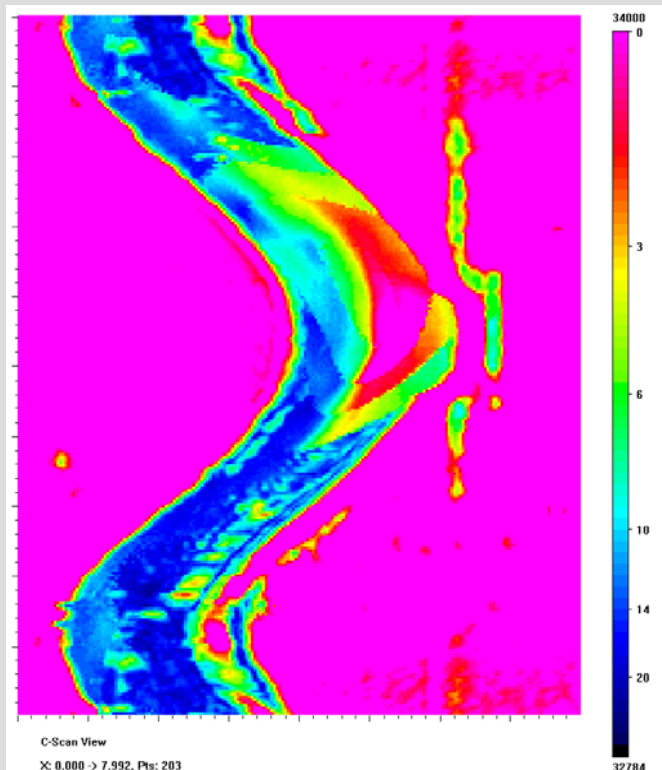
Nozzle #59 2.25 MHz

- ▶ In many places in the interference fit, the UT was well-coupled and produced a mottled pattern in the UT results. This is in strong contrast to the results seen in Nozzle #59 and the calibration Midland CRDM, where the interference fit allowed no coupling between the penetration tube and the carbon steel.
