# Shipment of Spent Fuel by Rail: Safety by Design

**Midwestern Radioactive Materials Transportation Committee  
Traverse City, Michigan  
May 24, 2005**

**Earl Easton  
Spent Fuel Project Office  
U.S. Nuclear Regulatory Commission**

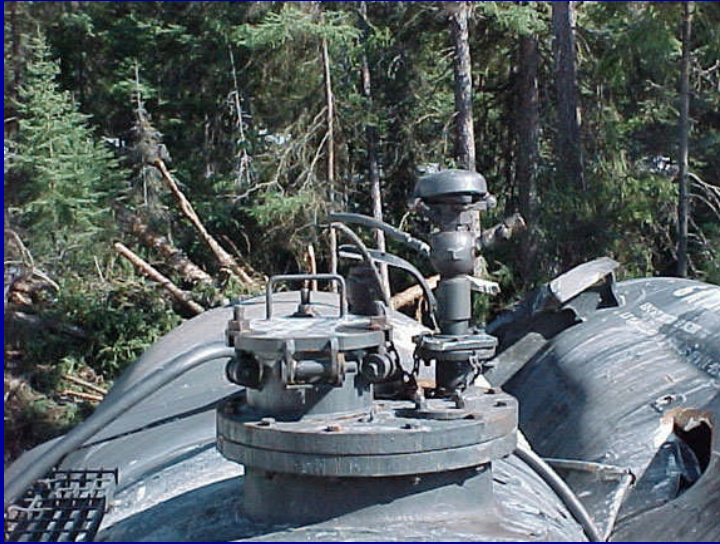
Above: Examples of top fittings on rail tank cars

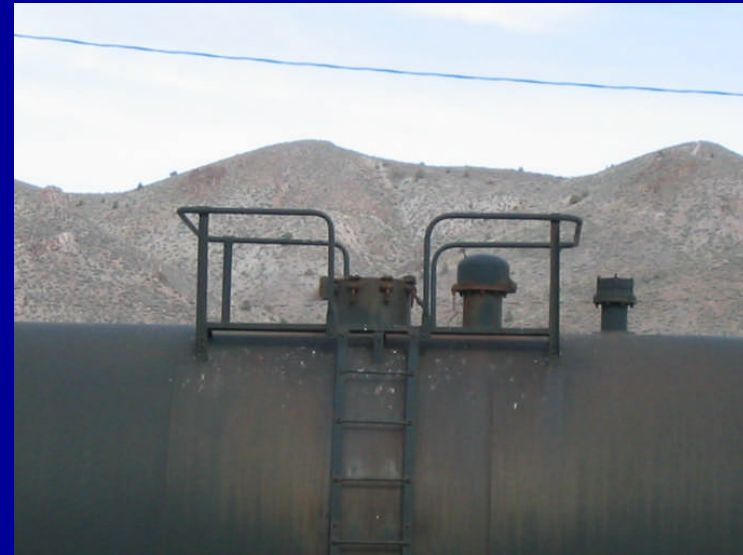
Right: Top fitting sheared off in an accident

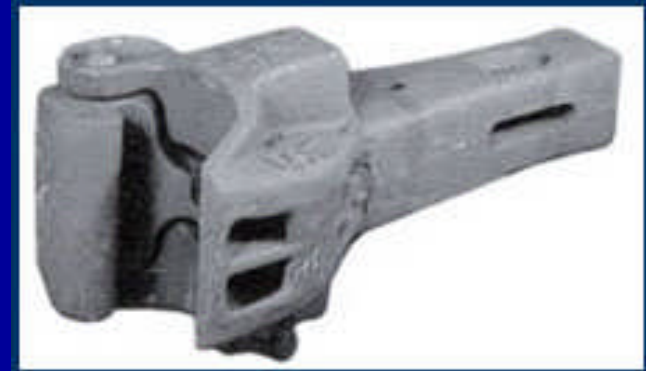
Rail Coupler

- Account for 17% of accidents releasing hazardous materials.
- Often caused by rail coupler.
- Characterized by low puncture velocities.

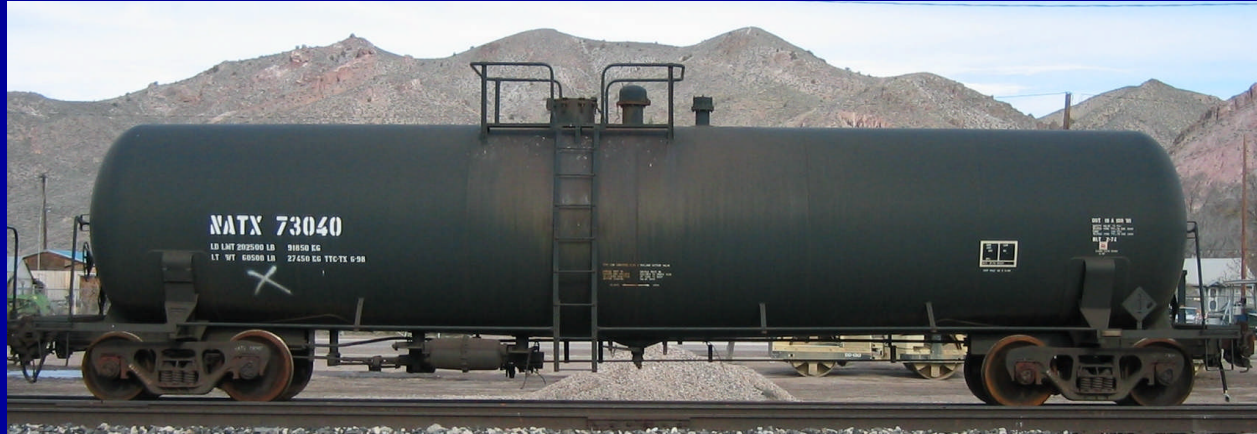
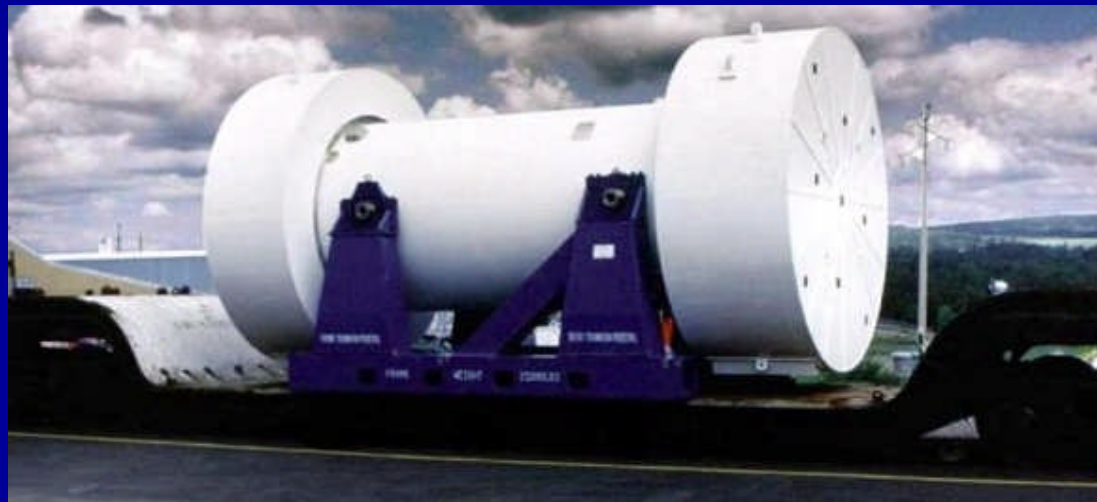
Note location of tank car/cask from nearest coupler

SIDE VIEW

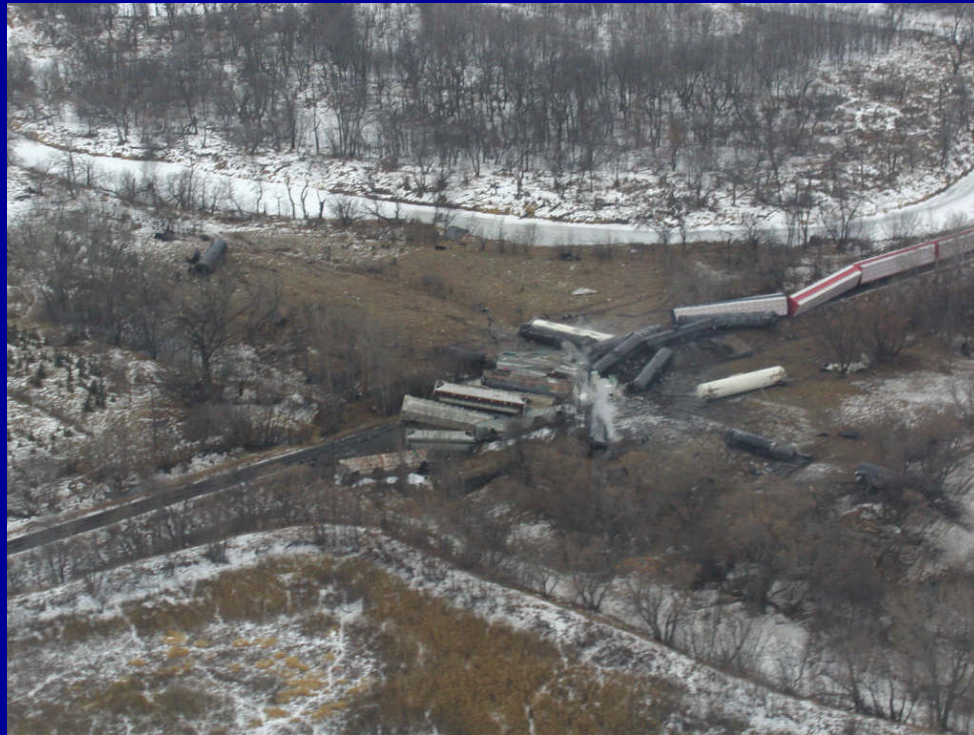
Rail Accident near Minot, ND,  
in January 2002.

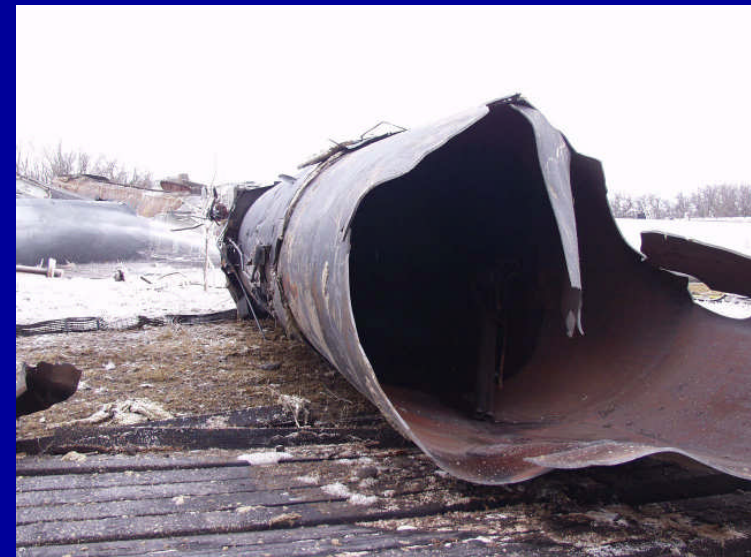
Right: Failure of anhydrous ammonia  
(liquefied compressed gas) tank car.  
Note wall thickness.

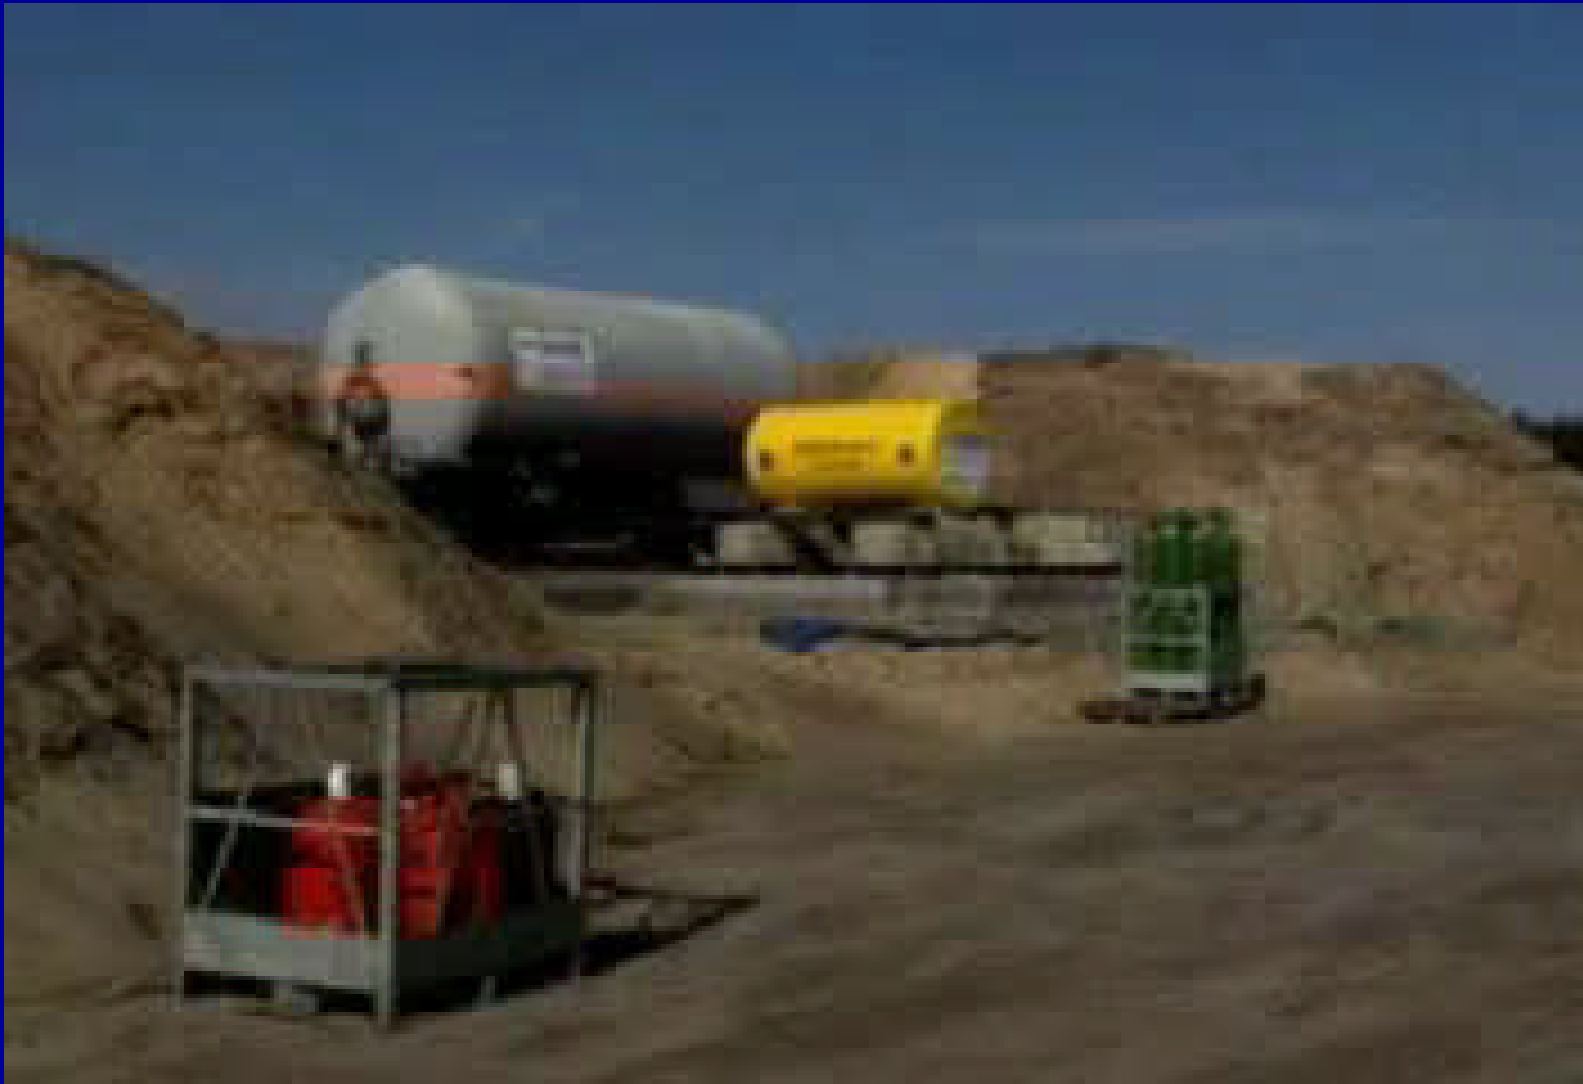
**BAM Test Simulating the effects of a Propane Tank Car  
on a CASTOR Transport/Storage Cask**
