**Edwin I. Hatch Nuclear Plant  
Request to Implement an Alternative Source Term**

# Seismic Evaluation Guidelines for HVAC Duct and Damper Systems

**1007896**

**Final Report, April 2003**

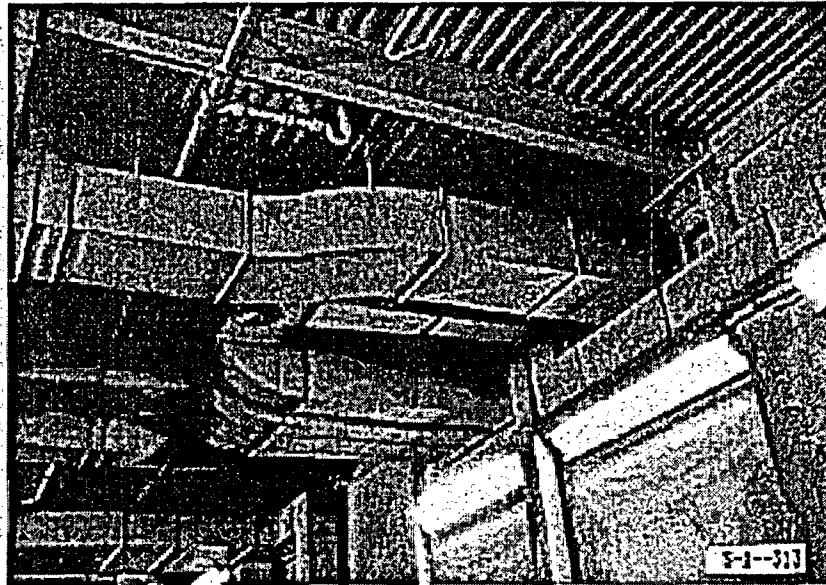
**Figure A-1**  
**Sylmar Converter Station, 1971 San Fernando Earthquake. Strap-Hung and Wall-Mounted Duct with Wall Penetrations**

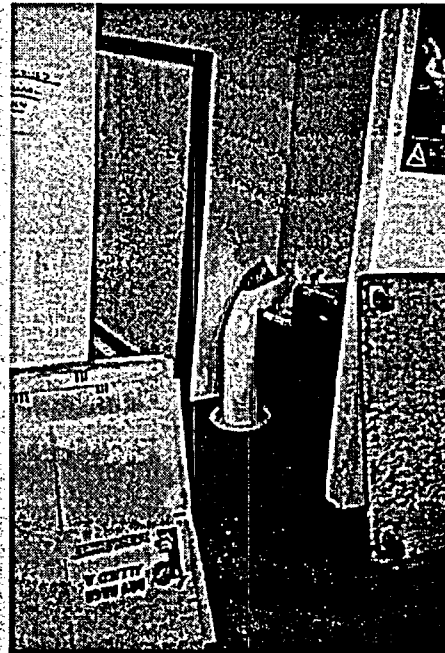
At the Wiltron Facility, a four foot long vertical cantilevered section of HVAC ductwork broke from its supporting header and fell to the floor (see Figure A-9). The round duct was constructed of riveted lap joints which failed under the cantilever's inertial loads.

**Figure A-9**  
Wiltron Facility, 1984 Morgan Hill Earthquake. A 4-Foot Long Vertical Cantilever Broke from Its Supporting Header and Fell
