LONG-TERM SURVEILLANCE PLAN FOR THE TUBA CITY, ARIZONA DISPOSAL SITE

October 1996

Uranium Mill Tailings Remedial Action Project

**Prepared by
Jacobs Engineering Group Inc.
Albuquerque, New Mexico**

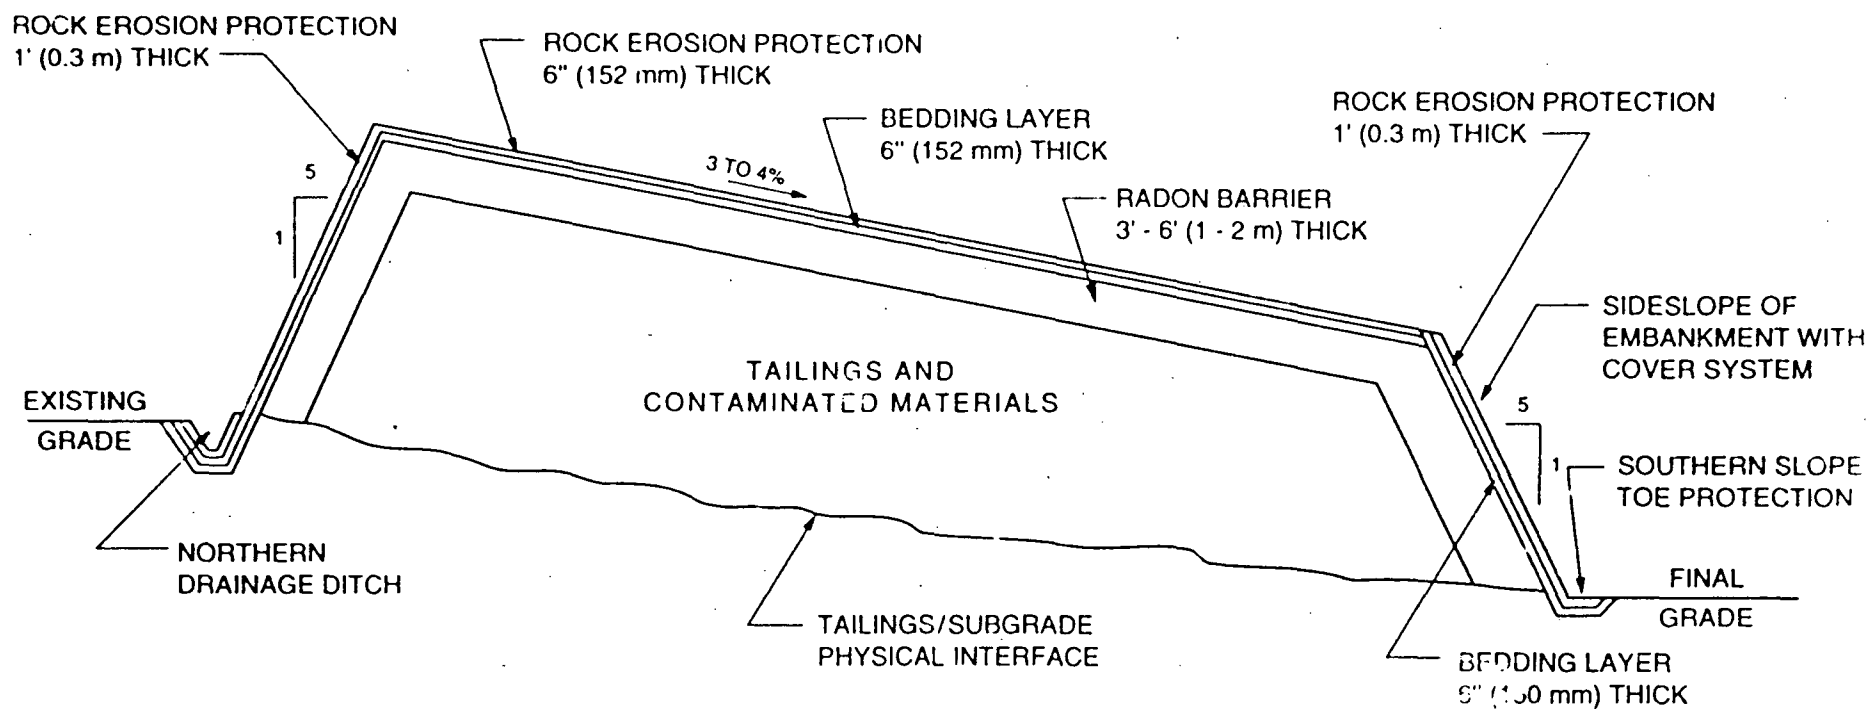
FIGURE 2.1
DISPOSAL CELL CROSS SECTION
TUBA CITY, ARIZONA, SITE

A 3.5-ft (1-m) thick infiltration/radon barrier (Figure 2.1) constructed of compacted clay is designed to protect the ground water by minimizing infiltration into the disposal cell and reducing the radon emanations from the

NOTE: COVER THICKNESSES IN EMBANKMENT COVER SYSTEM
ARE NOT TO SCALE (CONCEPTUAL ONLY).

disposal cell to less than 20 picocuries per square meter per second ($\text{pCi}/\text{m}^2\text{s}$). A field test of the cover indicates the borrow material would ensure the compacted infiltration/radon barrier would have a saturated hydraulic conductivity of $1.0\text{E-}8$ centimeters (cm) per second (DOE, 1988).

Relocated tailings from the adjacent subpiles and windblown and other contaminated materials were placed in the original tailings pile and compacted for stability. The above-grade disposal cell is roughly triangular, with a maximum side length of 1940 ft (590 m) and a minimum side length of 1580 ft (480 m). The average height of the disposal cell is about 30 ft (10 m) above ground level (DOE, 1989). A drainage ditch on the north and west sides of the disposal cell directs runoff water away from the site. Figure 2.1 and Plate 1 show plan and cross-sectional views.

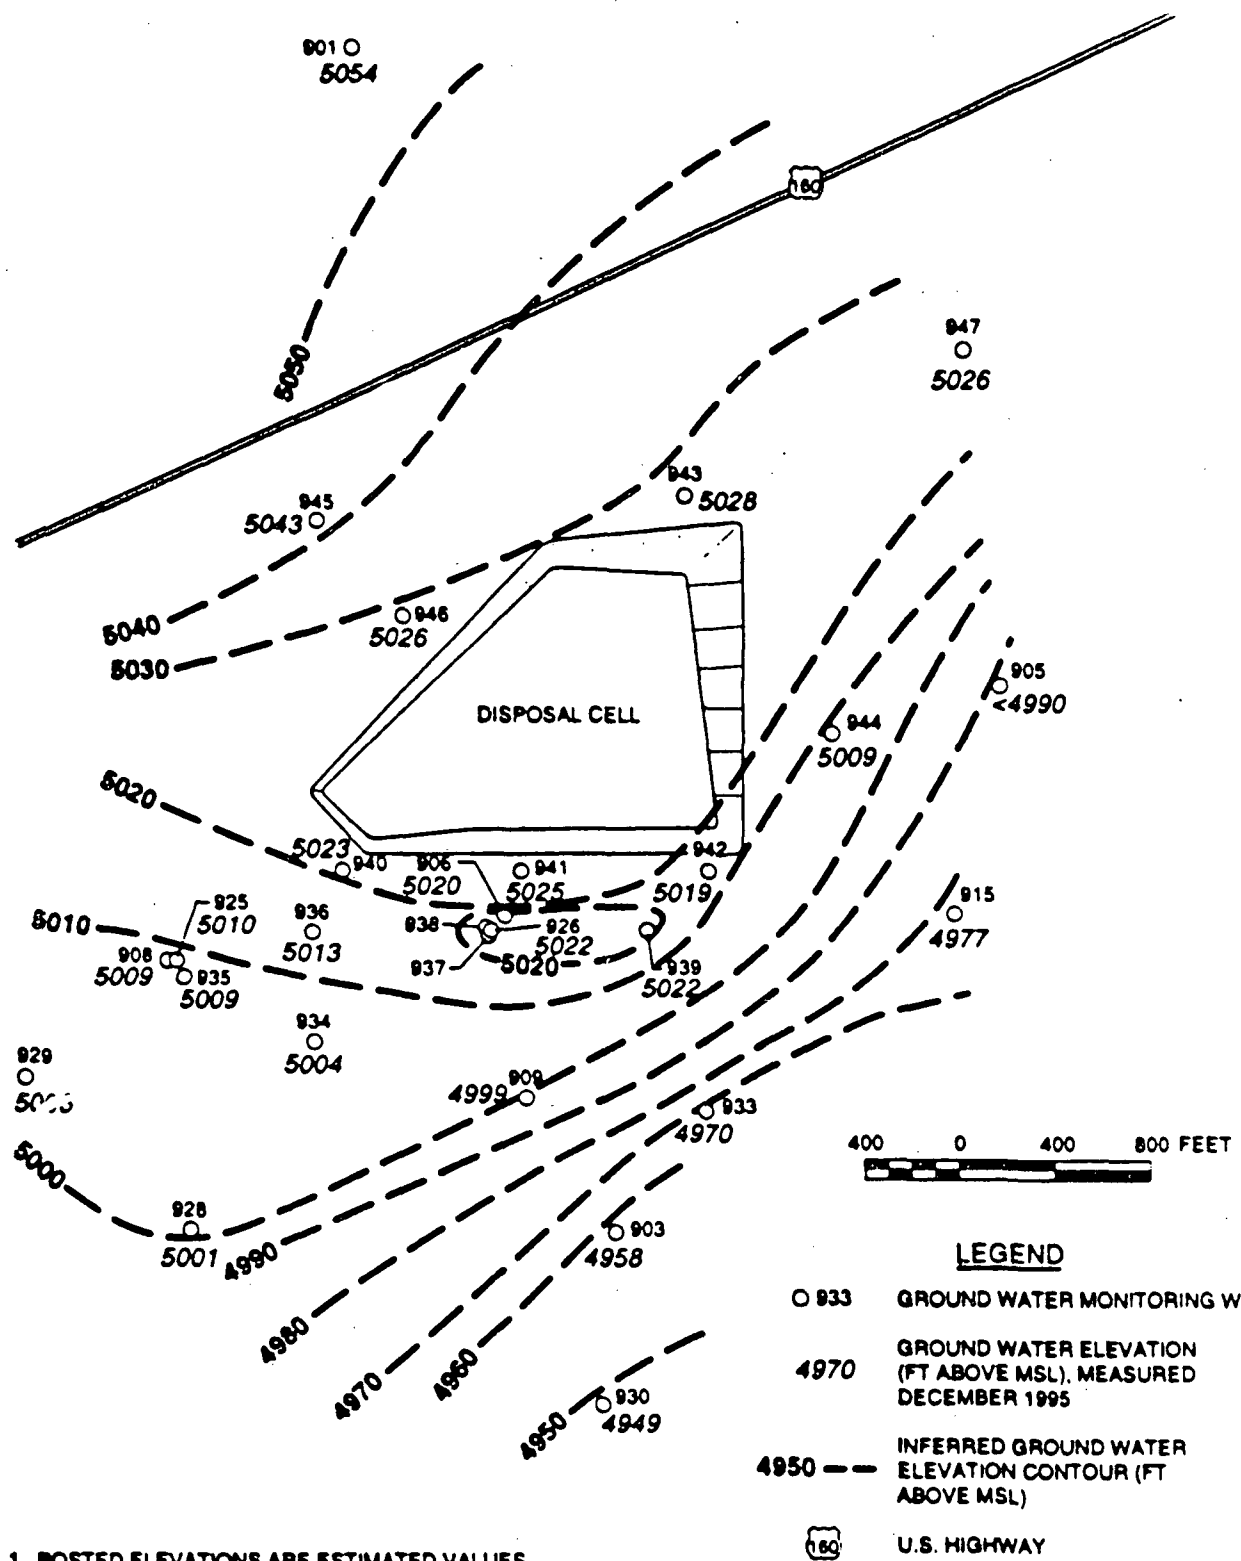
FIGURE 5.1
ESTIMATED WATER TABLE ELEVATION CONTOUR MAP
OF SHALLOW NAVAJO SANDSTONE AQUIFER
TUBA CITY PROCESSING SITE/DISPOSAL SITE

NOTES: 1. POSTED ELEVATIONS ARE ESTIMATED VALUES.
FINAL VERTICAL GEODETIC SURVEYS HAVE
NOT BEEN DETERMINED FOR SOME LOCATIONS.

2. CONTOUR INTERVAL = 10 FT.

The depth to the water table in the Navajo Sandstone ranges from about 20 to 150 ft (6 to 45 m) below land surface in the site vicinity. Figures 5.1 and 5.2 show the shallow ground water table surface and deeper potentiometric surface determined for wells completed in the Navajo Sandstone at the site. The ground water table gradient is to the southeast toward Moenkopi Wash. Springs occurring on both sides of Moenkopi Wash indicate the N-aquifer discharges to the wash (USGS, 1969). Hydraulic conductivity in the Navajo Sandstone (based on slug tests performed in eight monitor wells) ranged from 50 to 900 ft (15 to 270 m) per year, with a geometric mean of 160 ft (50 m) per year. The average linear ground water velocity ranged from 10 to 200 ft (3 to 60 m) per year with a geometric mean of 30 ft (10 m) per year, assuming a hydraulic gradient of 0.04, and an effective porosity of 0.2 (Freeze and Cherry, 1979; DOE, 1989).

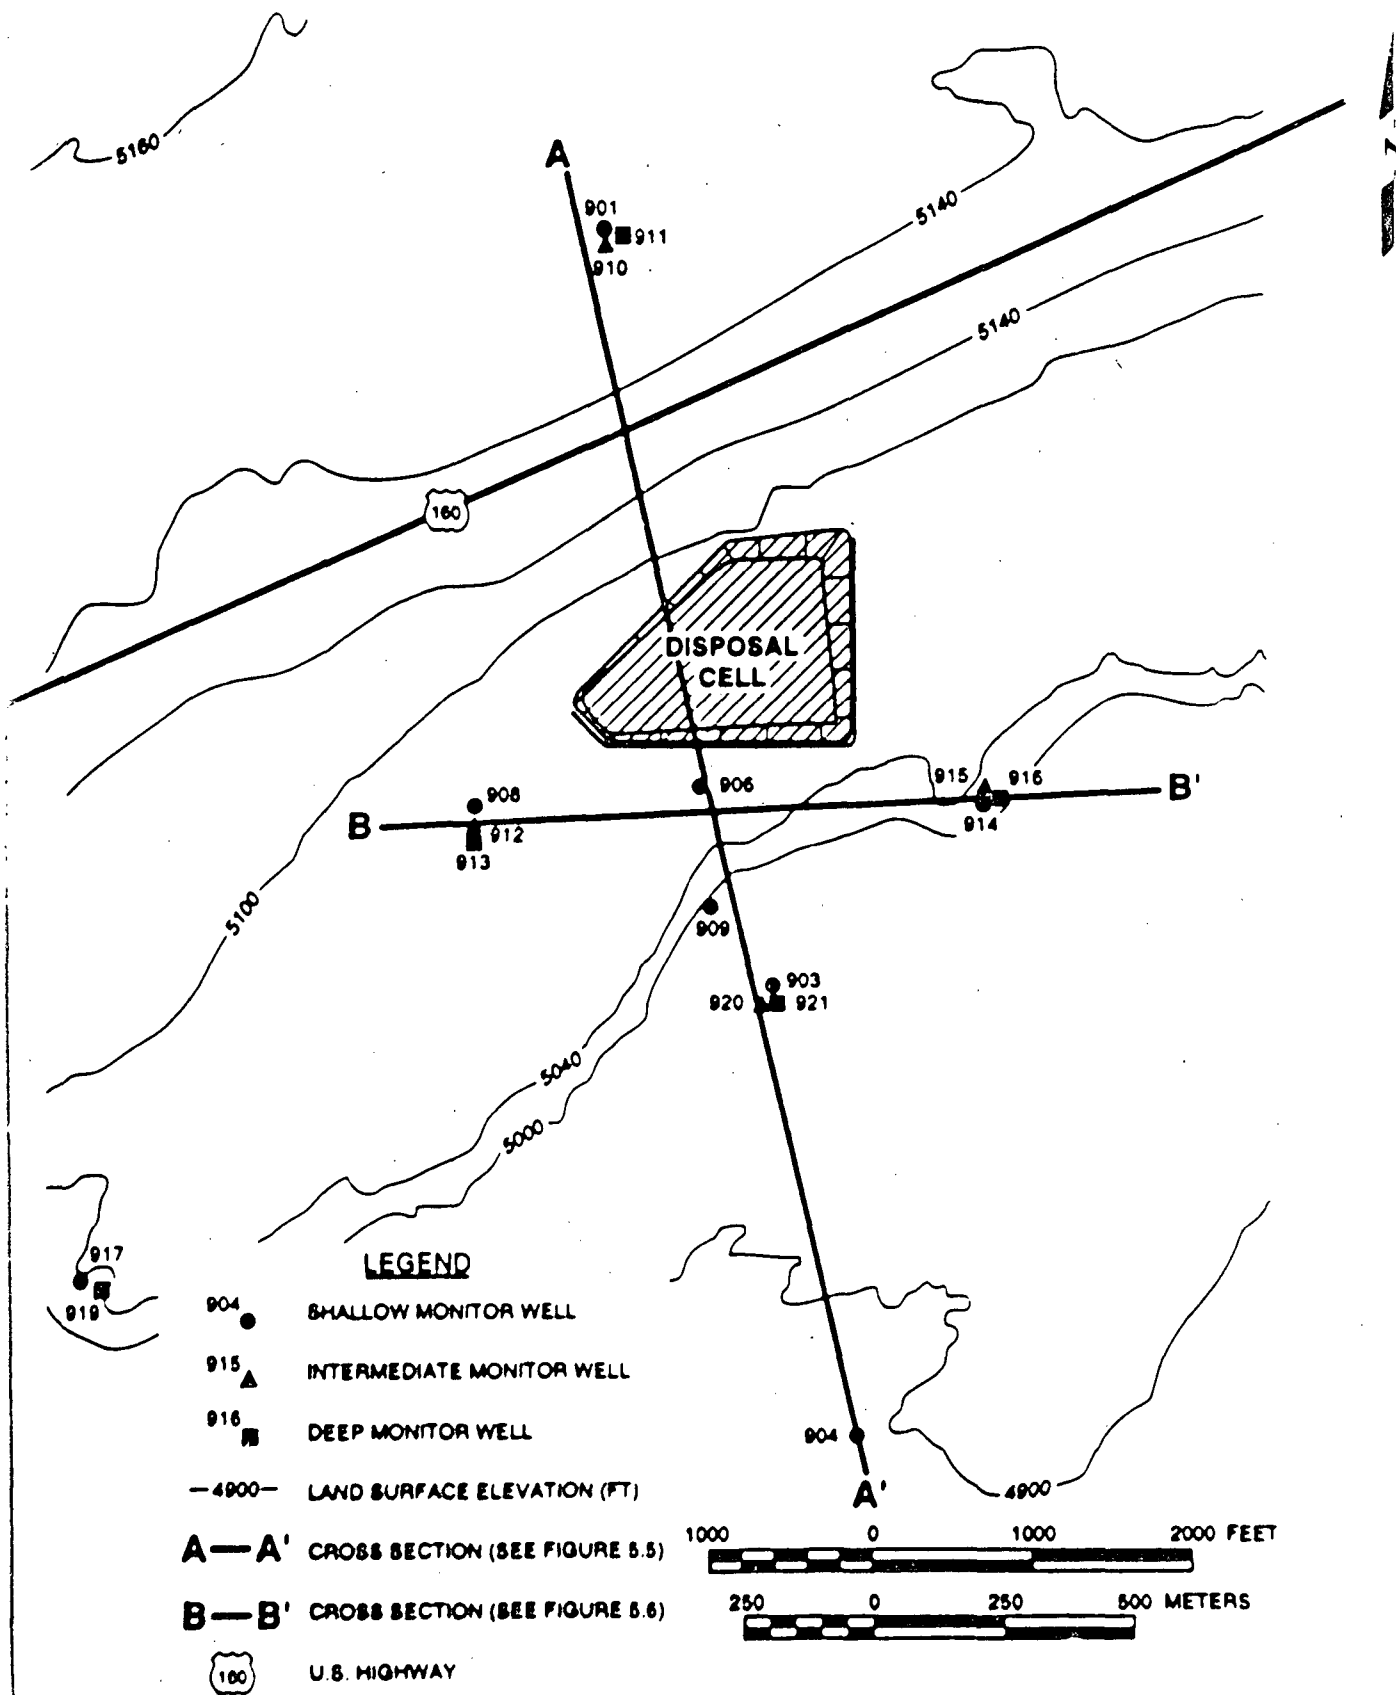
FIGURE 5.5
HYDROGEOLOGIC CROSS SECTION A-A'
TUBA CITY, ARIZONA, SITE

Figure 5.4 gives the locations of cross sections showing the vertical distribution of nitrate, sulfate, TDS, and uranium (Figures 5.5 and 5.6). Contaminant migration appears to be contained vertically, with constituents concentrated in the upper 50 ft (15 m) of the aquifer. The monitor well cluster 908, 912, and 913 appears to provide evidence of contaminant stratification, with nitrate concentrations ranging from

Contaminated ground water in the uppermost aquifer near the source area (represented by monitor well 906) is characterized by nitrate concentrations at 1310 mg/L, sulfate at 3840 mg/L, and TDS at 7100 mg/L. Ground water quality at the fringe of the contaminated area (represented by monitor well 903, approximately 1400 ft (427 m) south of well 906) is characterized by nitrate concentrations at 43 mg/L, sulfate at 37 mg/L, and TDS at 268 mg/L (DOE, 1996).

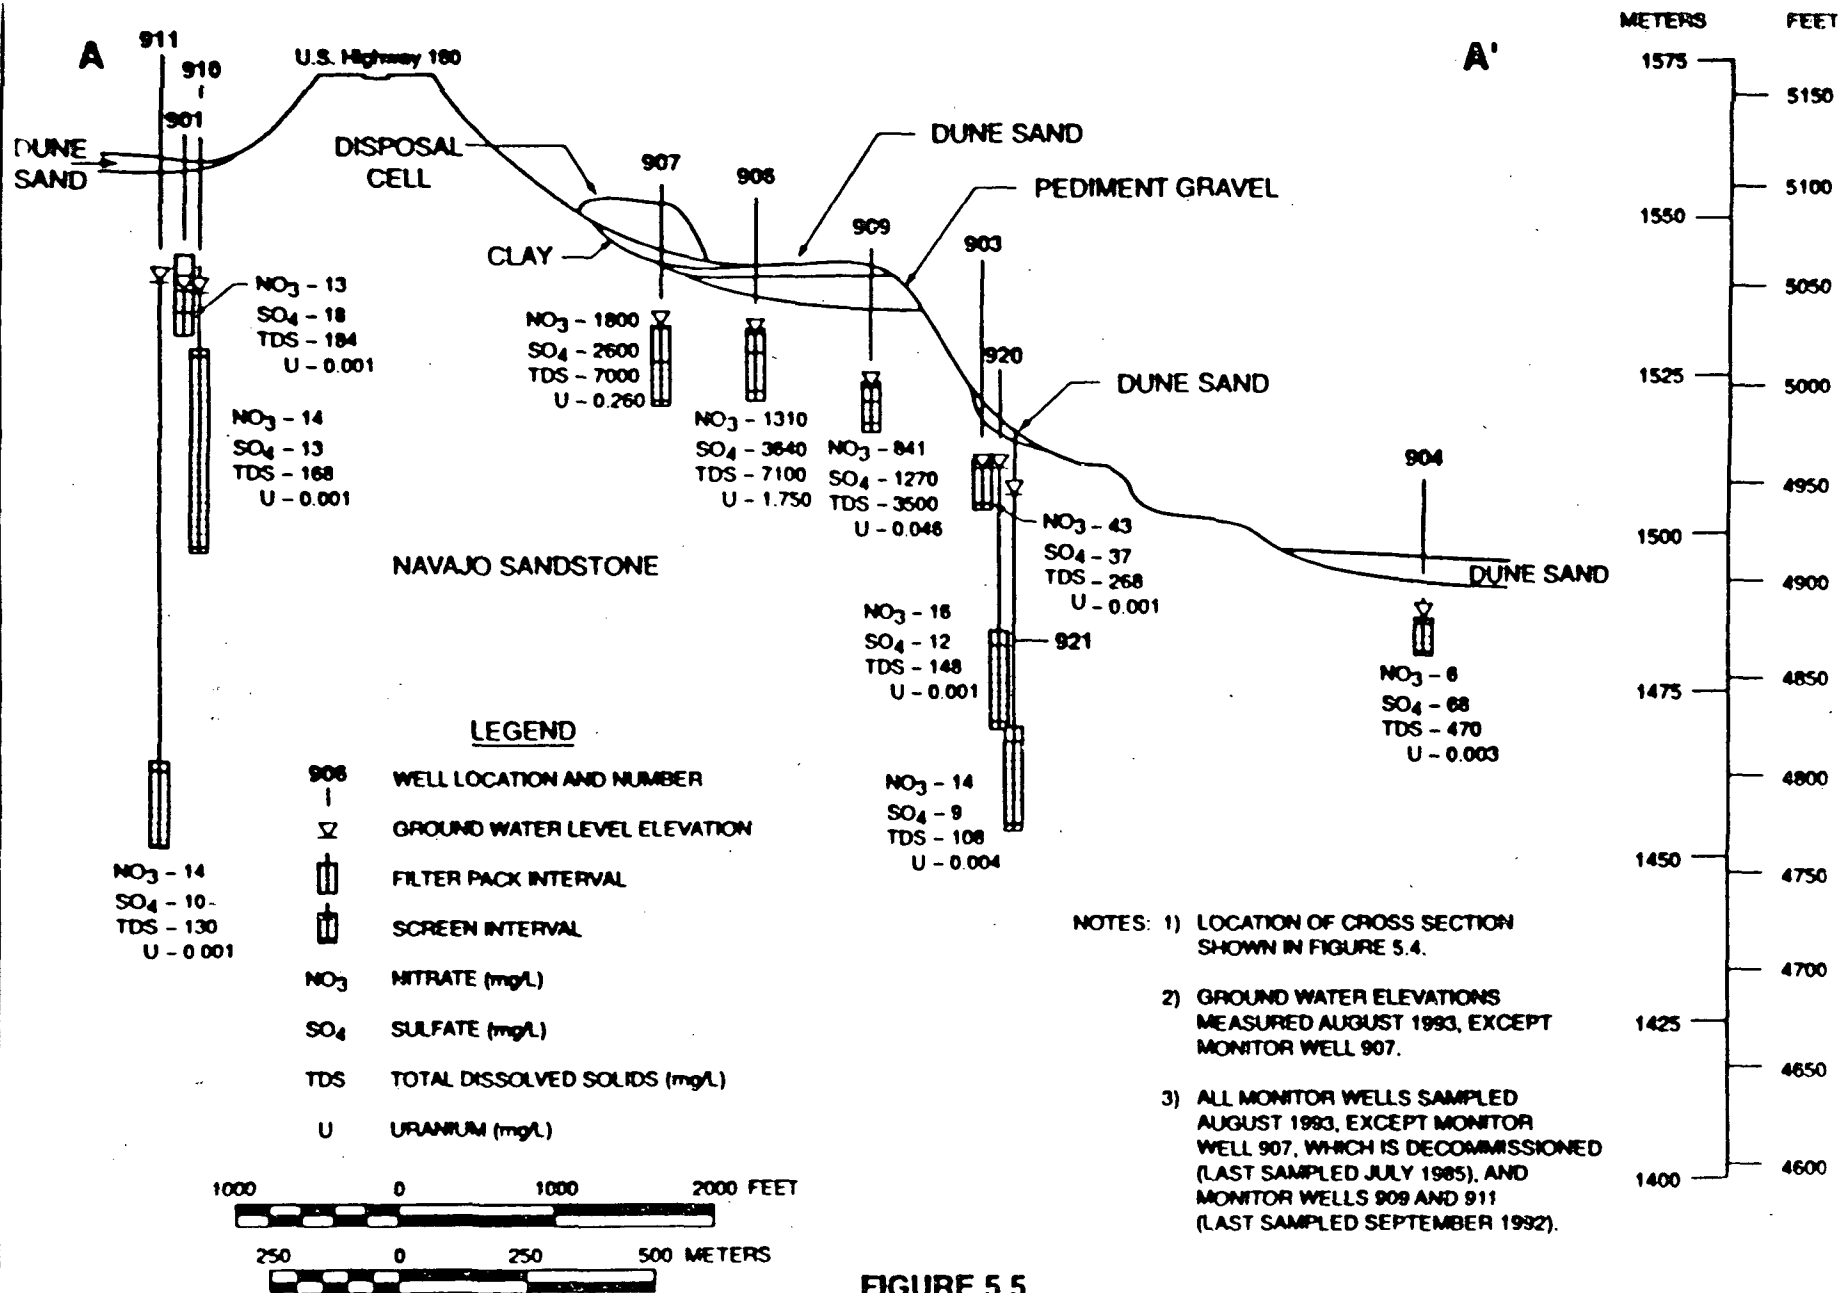
1200 mg/L in the shallowest well (908) to virtually background in the deepest well (913). The stratification of contaminants within
