SEABROOK STATION
UPDATED FINAL SAFETY
ANALYSIS REPORT

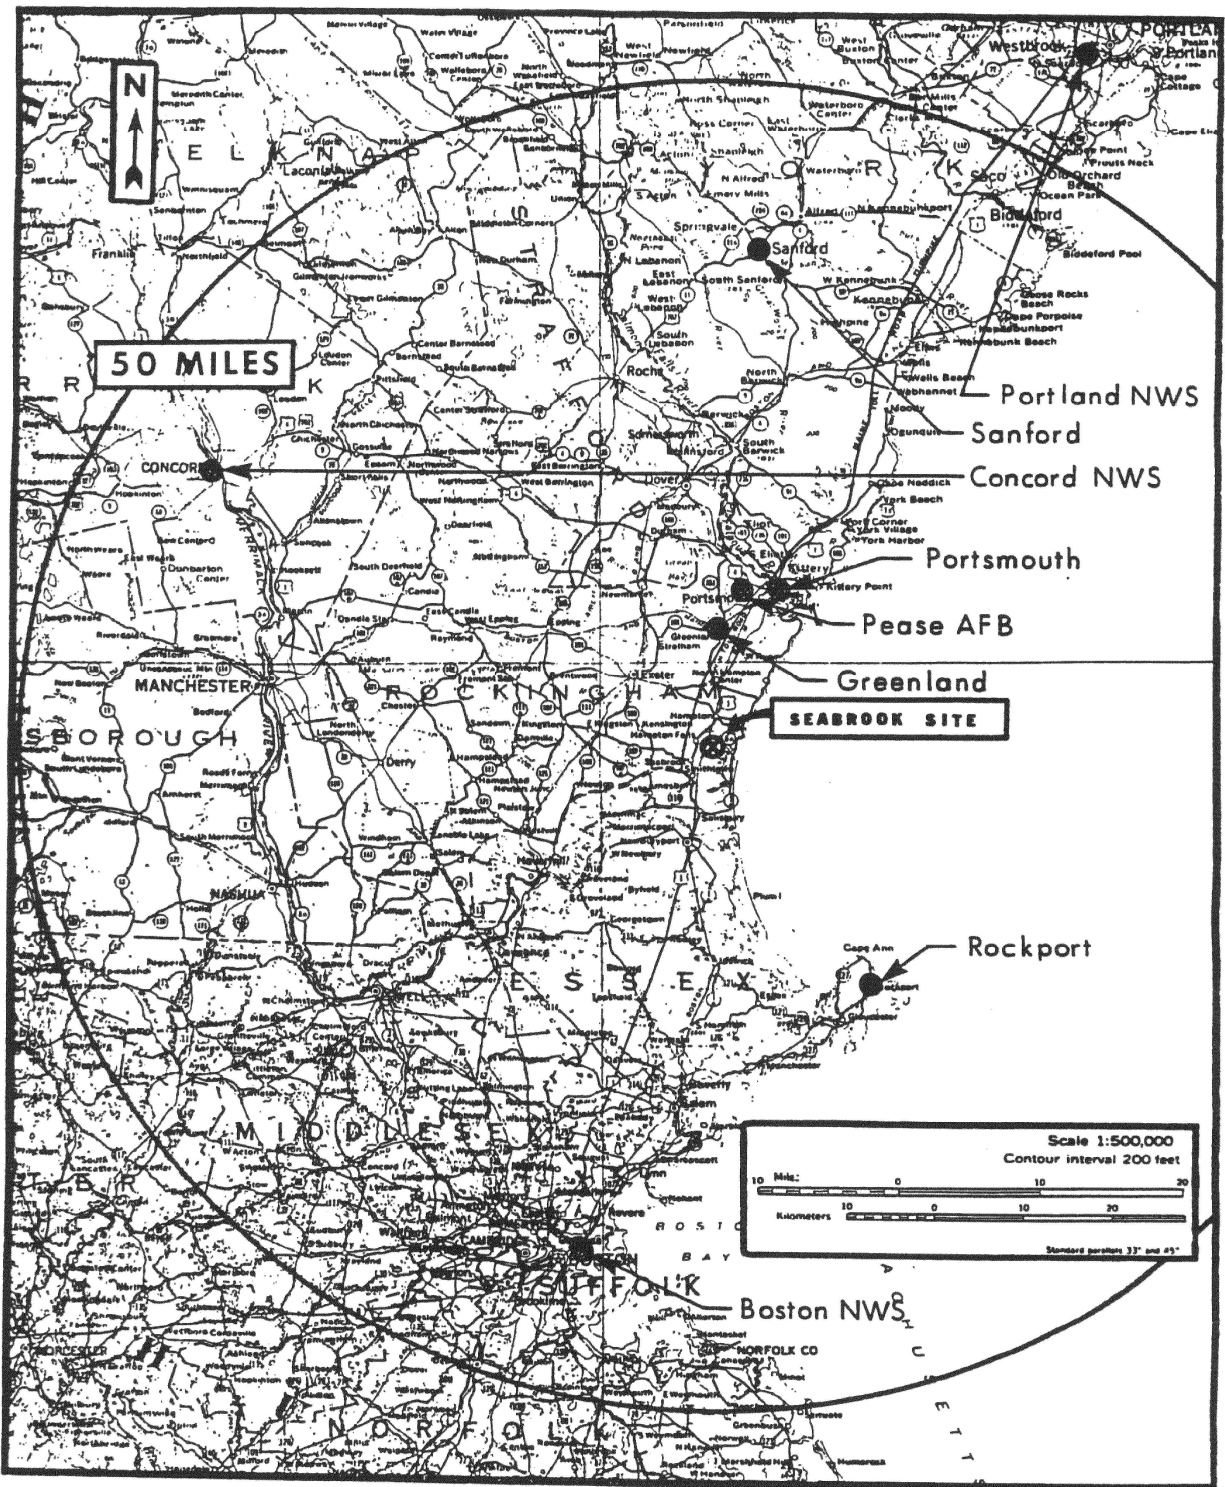
Figure 2.3-1

Seabrook Site – 50 Mile Radius Regional Climatological
Data Stations

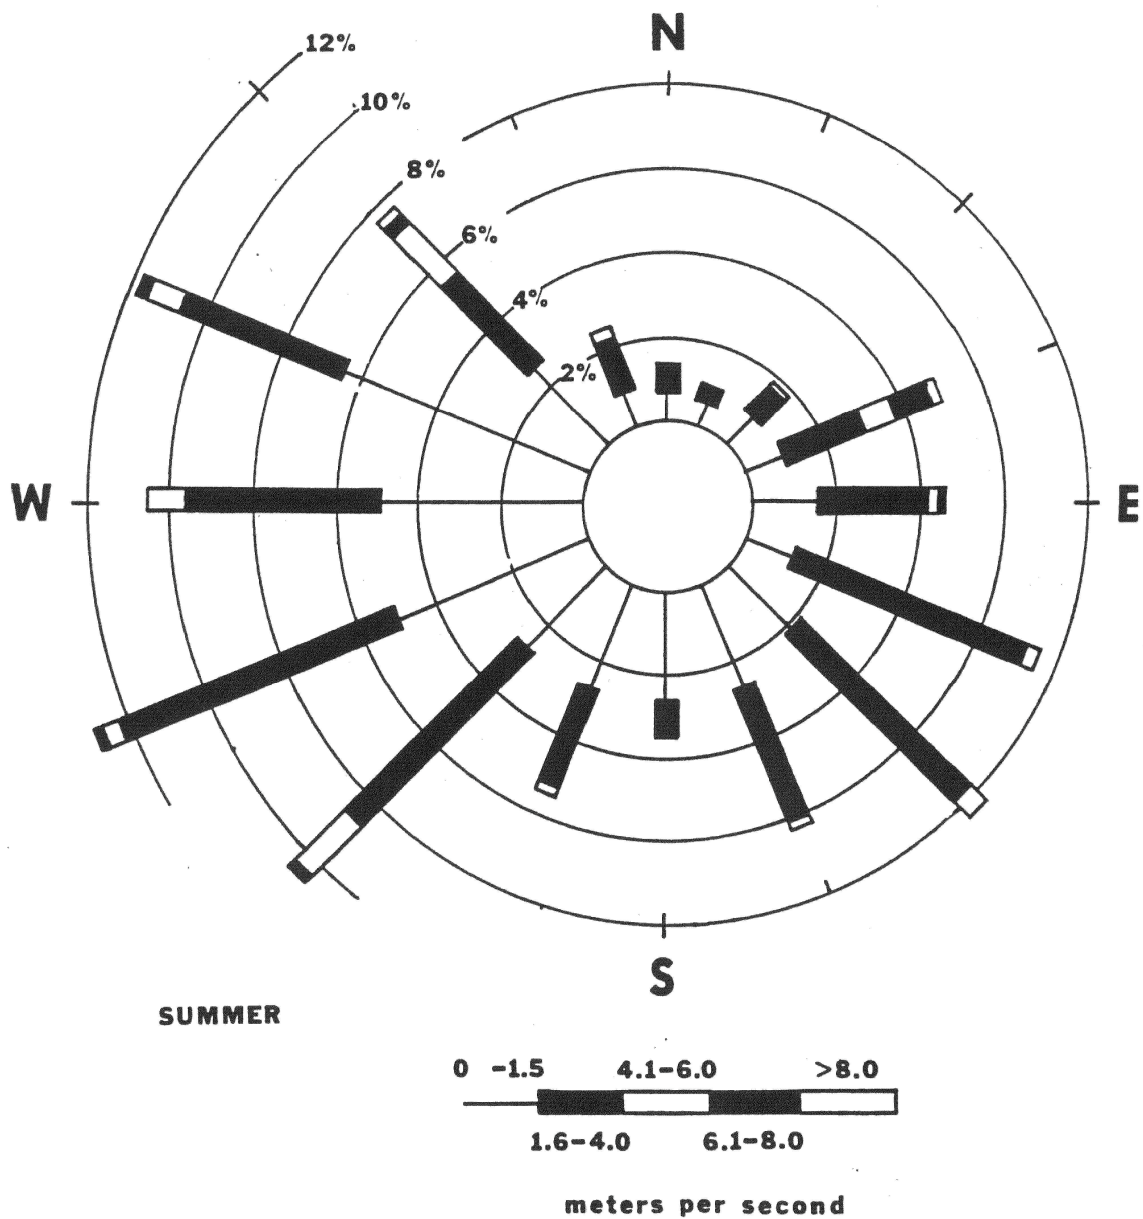
SEABROOK STATION UPDATED FINAL SAFETY ANALYSIS REPORT	Summer Wind Rose for the 30 ft. Level (June 1972 – August 1972)	
		Figure 2.3-3

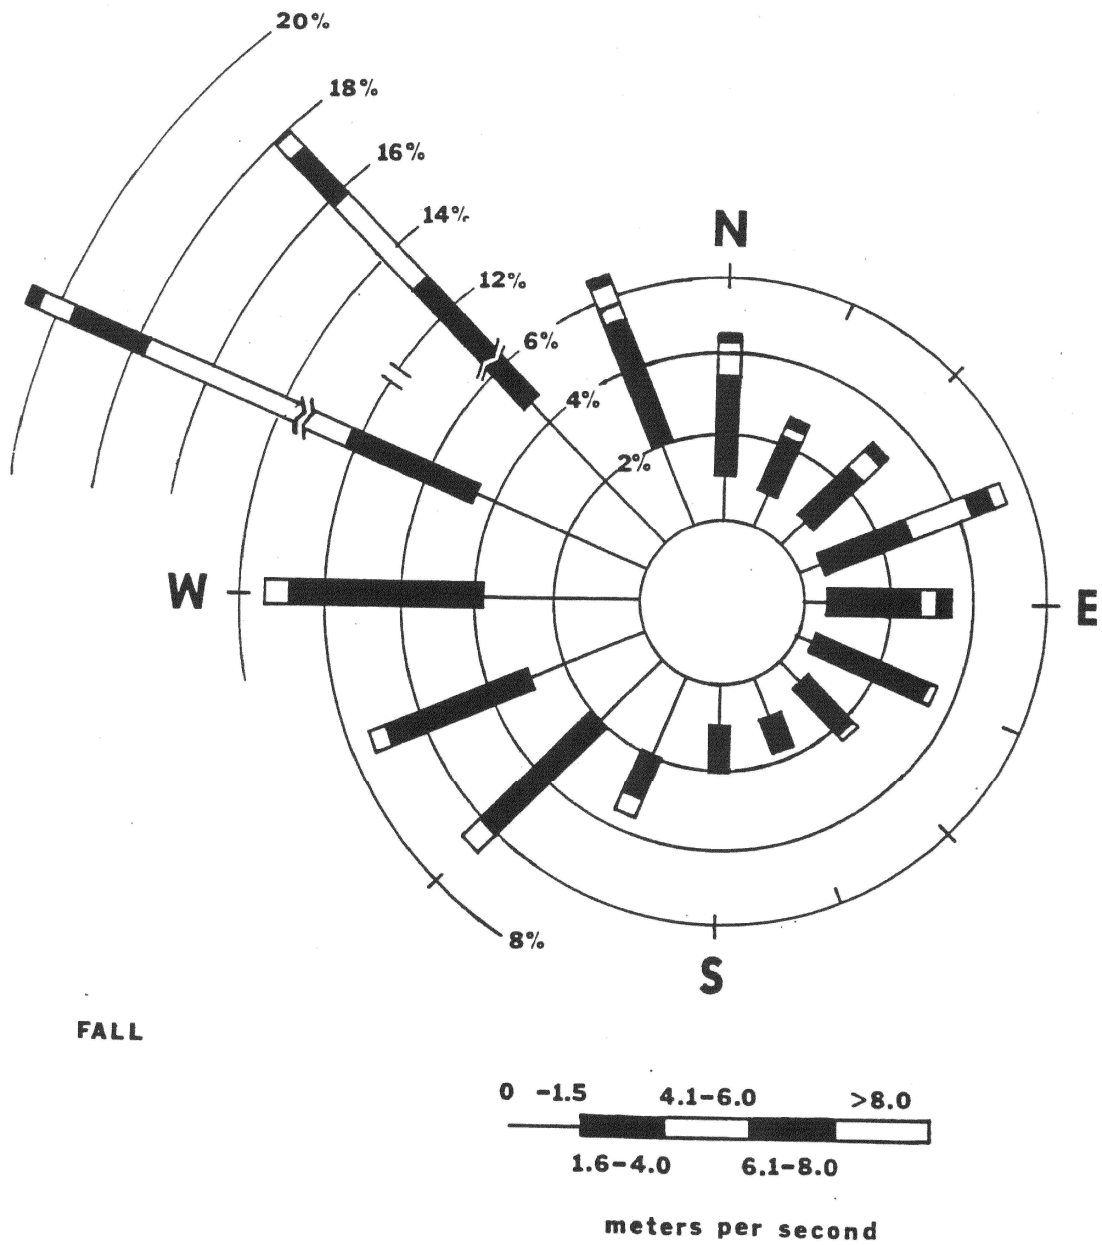
SEABROOK STATION UPDATED FINAL SAFETY ANALYSIS REPORT	Fall Wind Rose for the 30 ft. Level (November 1971 and September, October 1972)	
		Figure 2.3-4

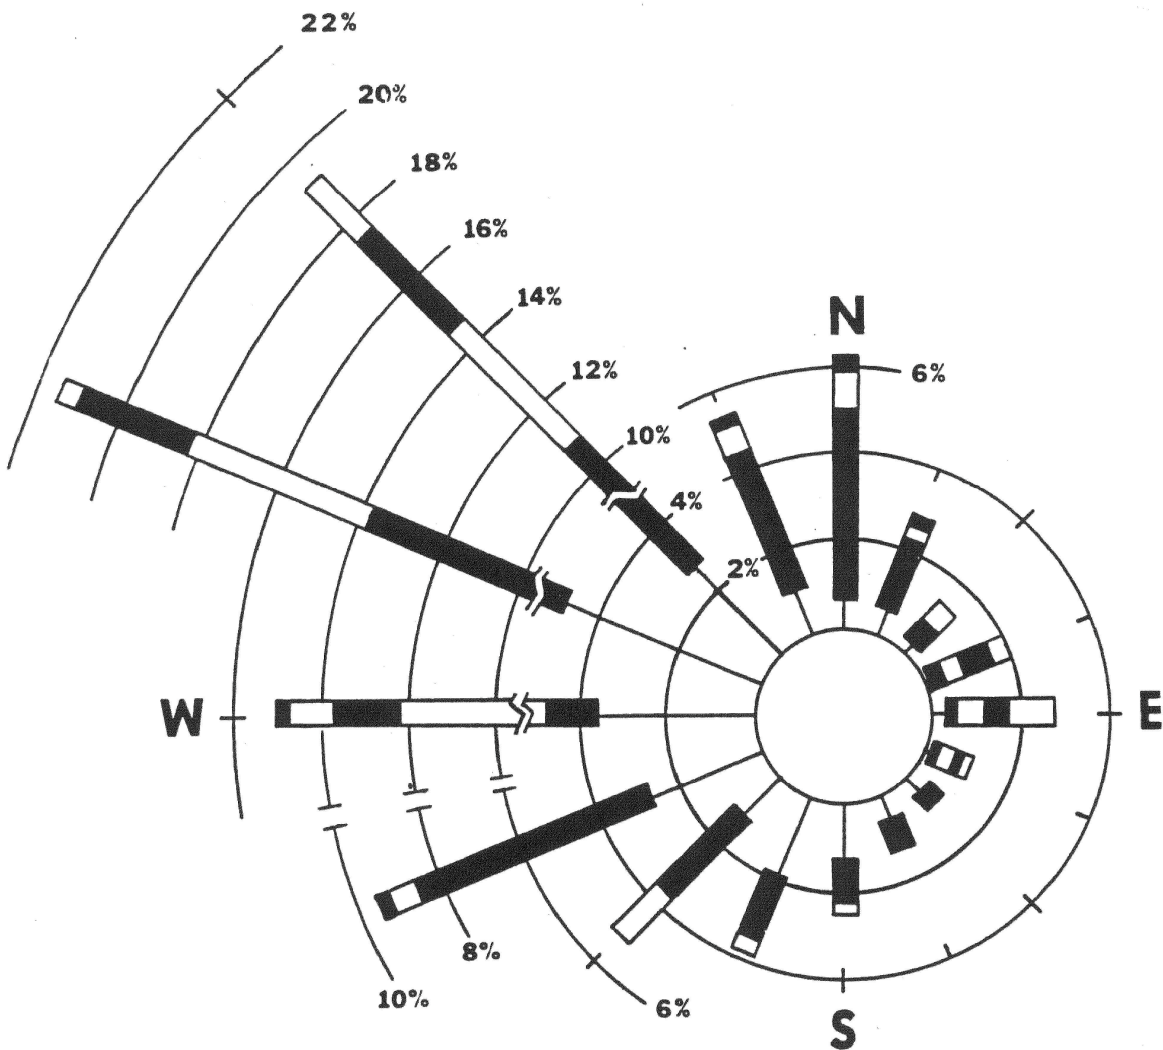
Figure 2.3-5

Winter Wind Rose for the 30 ft. Level (December 1971 – February 1972)

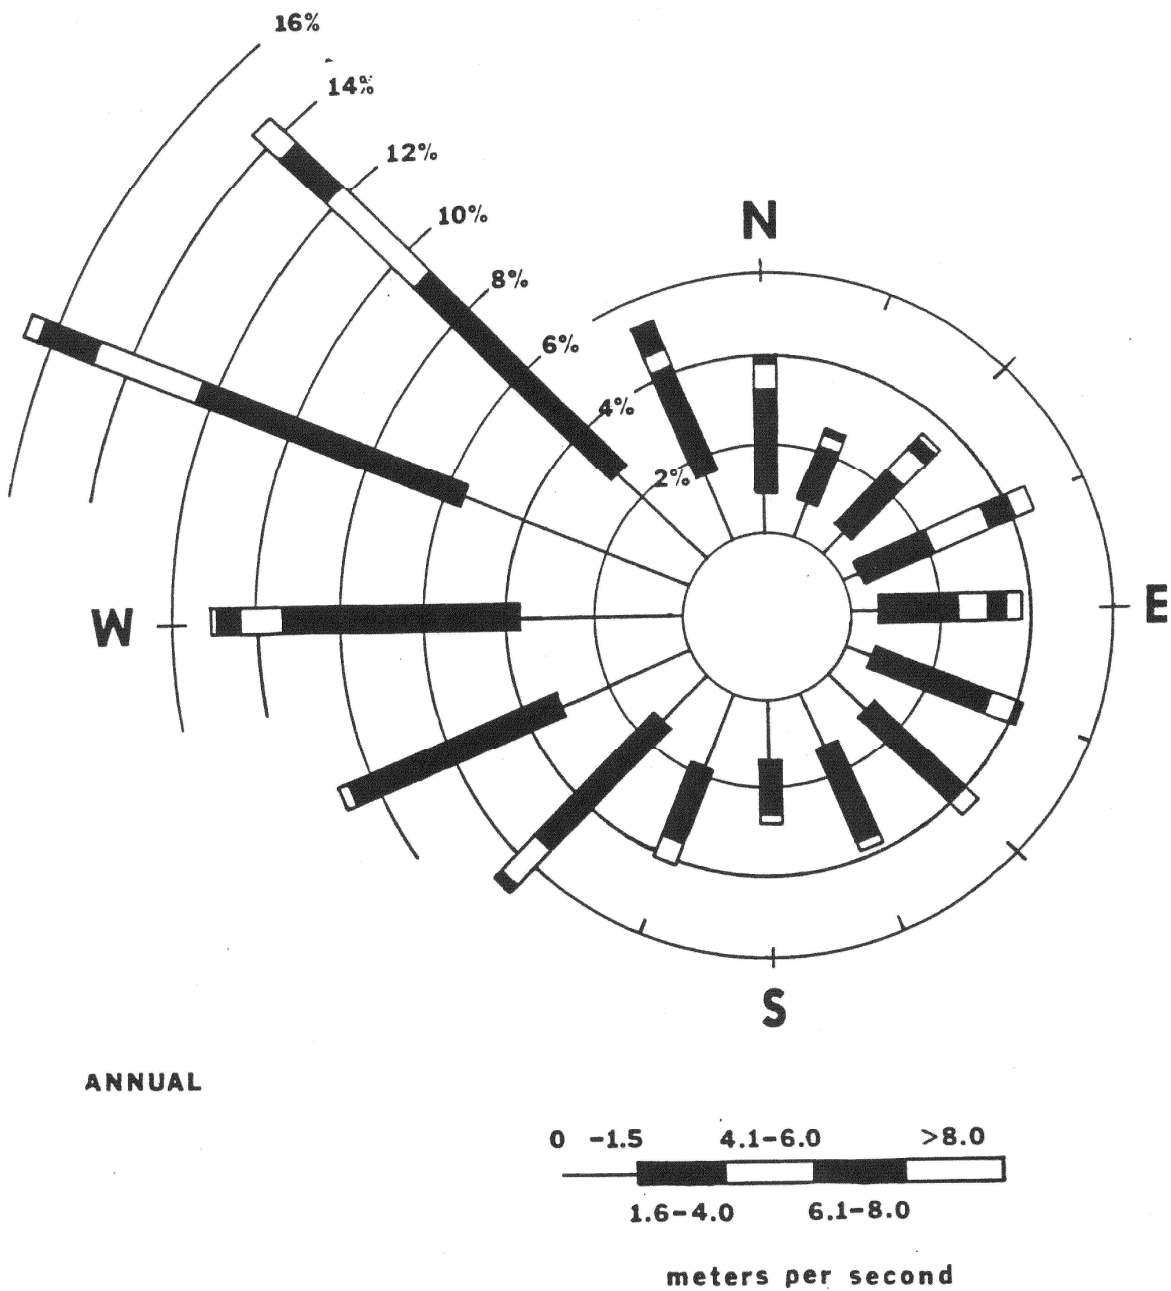
Figure 2.3-6

Annual Wind Rose for the 30 ft. Level (November 1971 – October 1972)

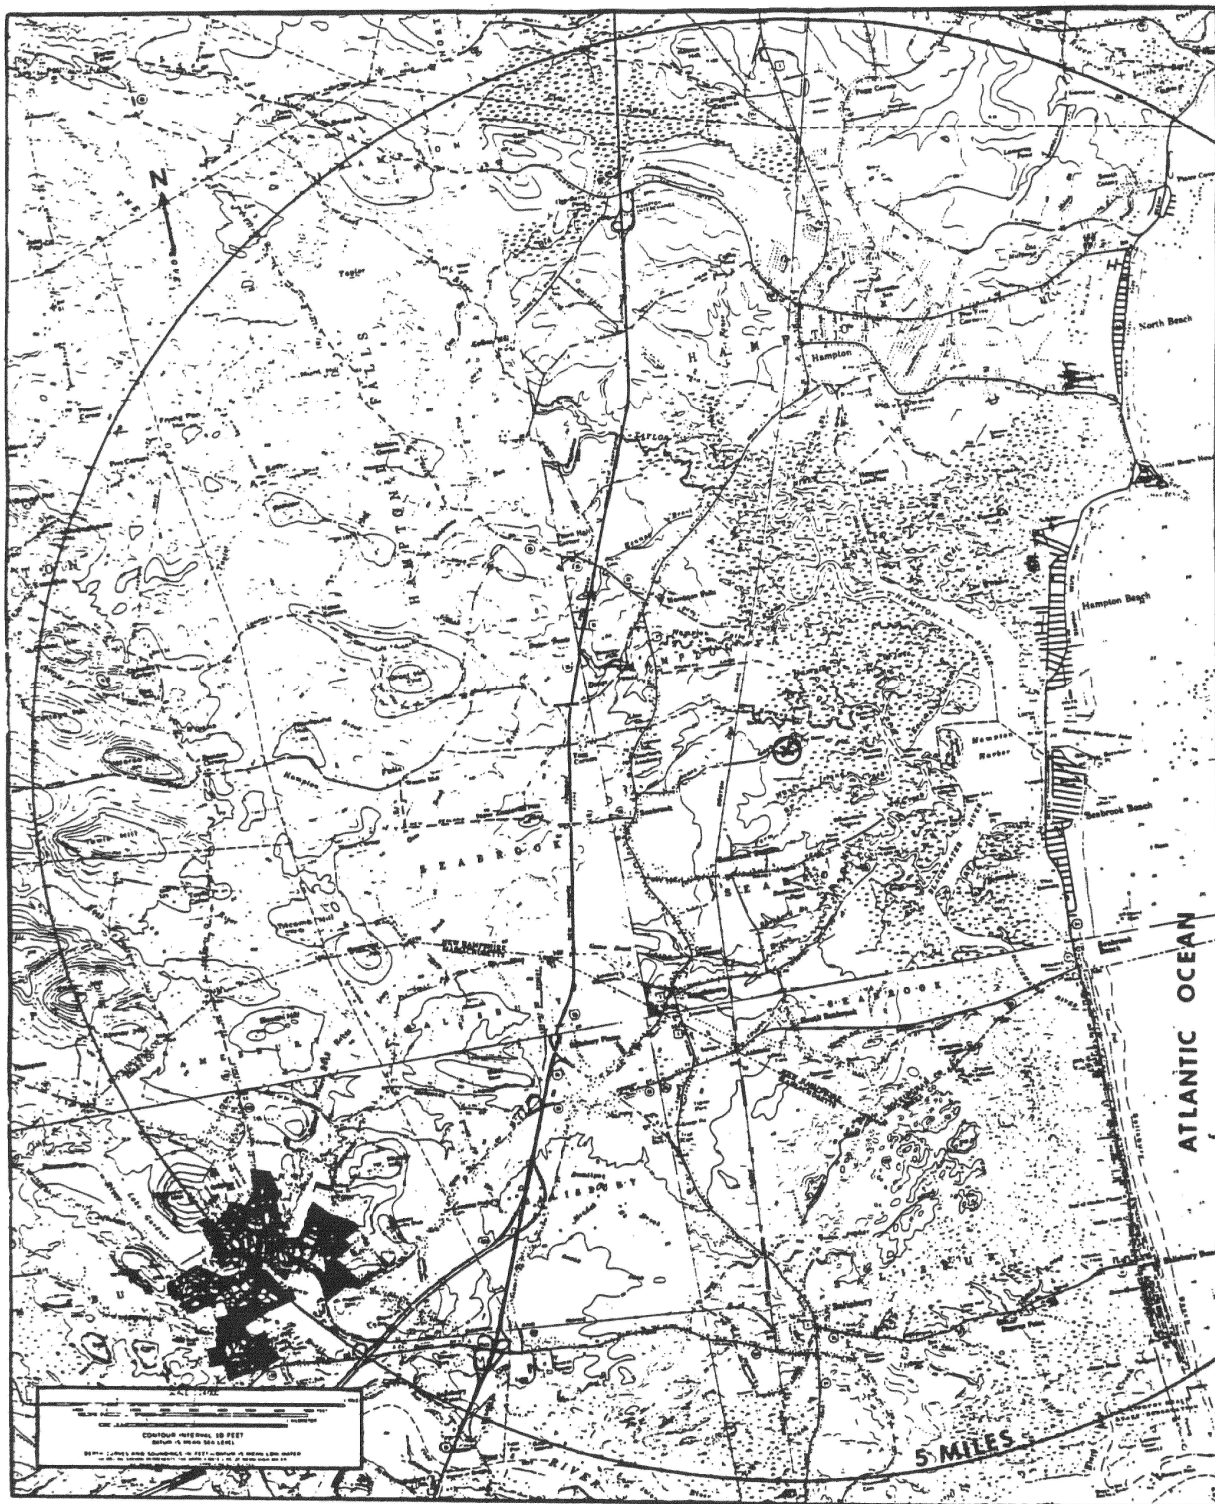
Figure 2.3-7

Topographic Map within a Five Mile Radius of the Seabrook
Site

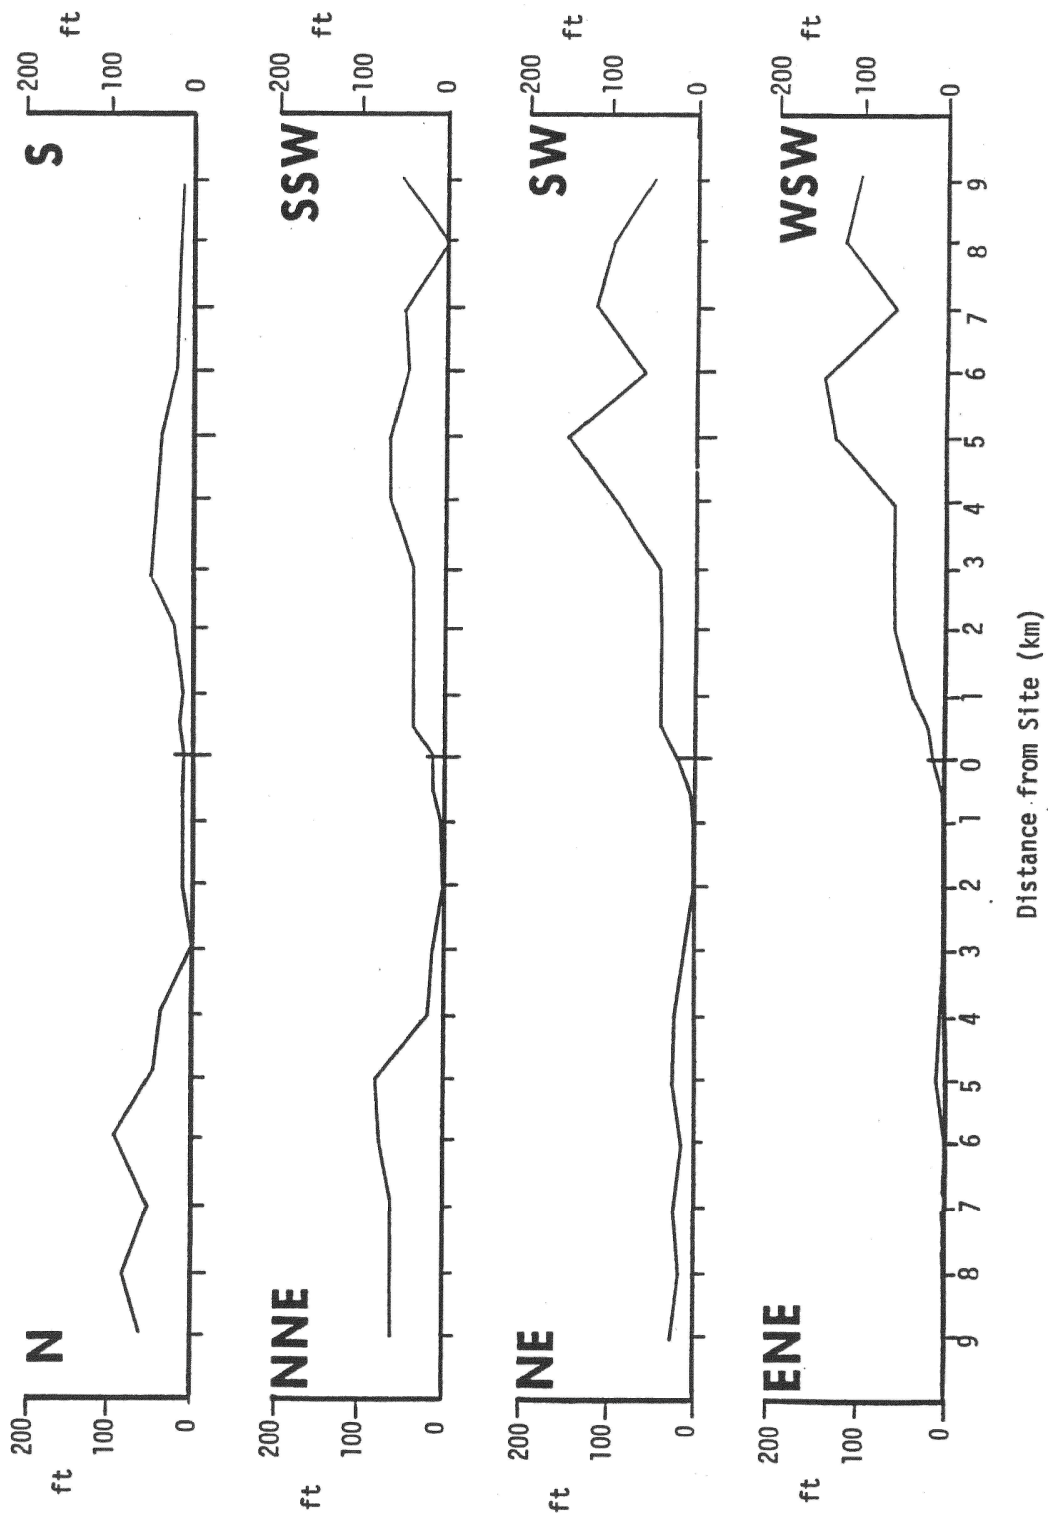
SEABROOK STATION UPDATED FINAL SAFETY ANALYSIS REPORT	Terrain Cross Section [2 Sheets]	
		Figure 2.3-8, Sh. 1 of 2

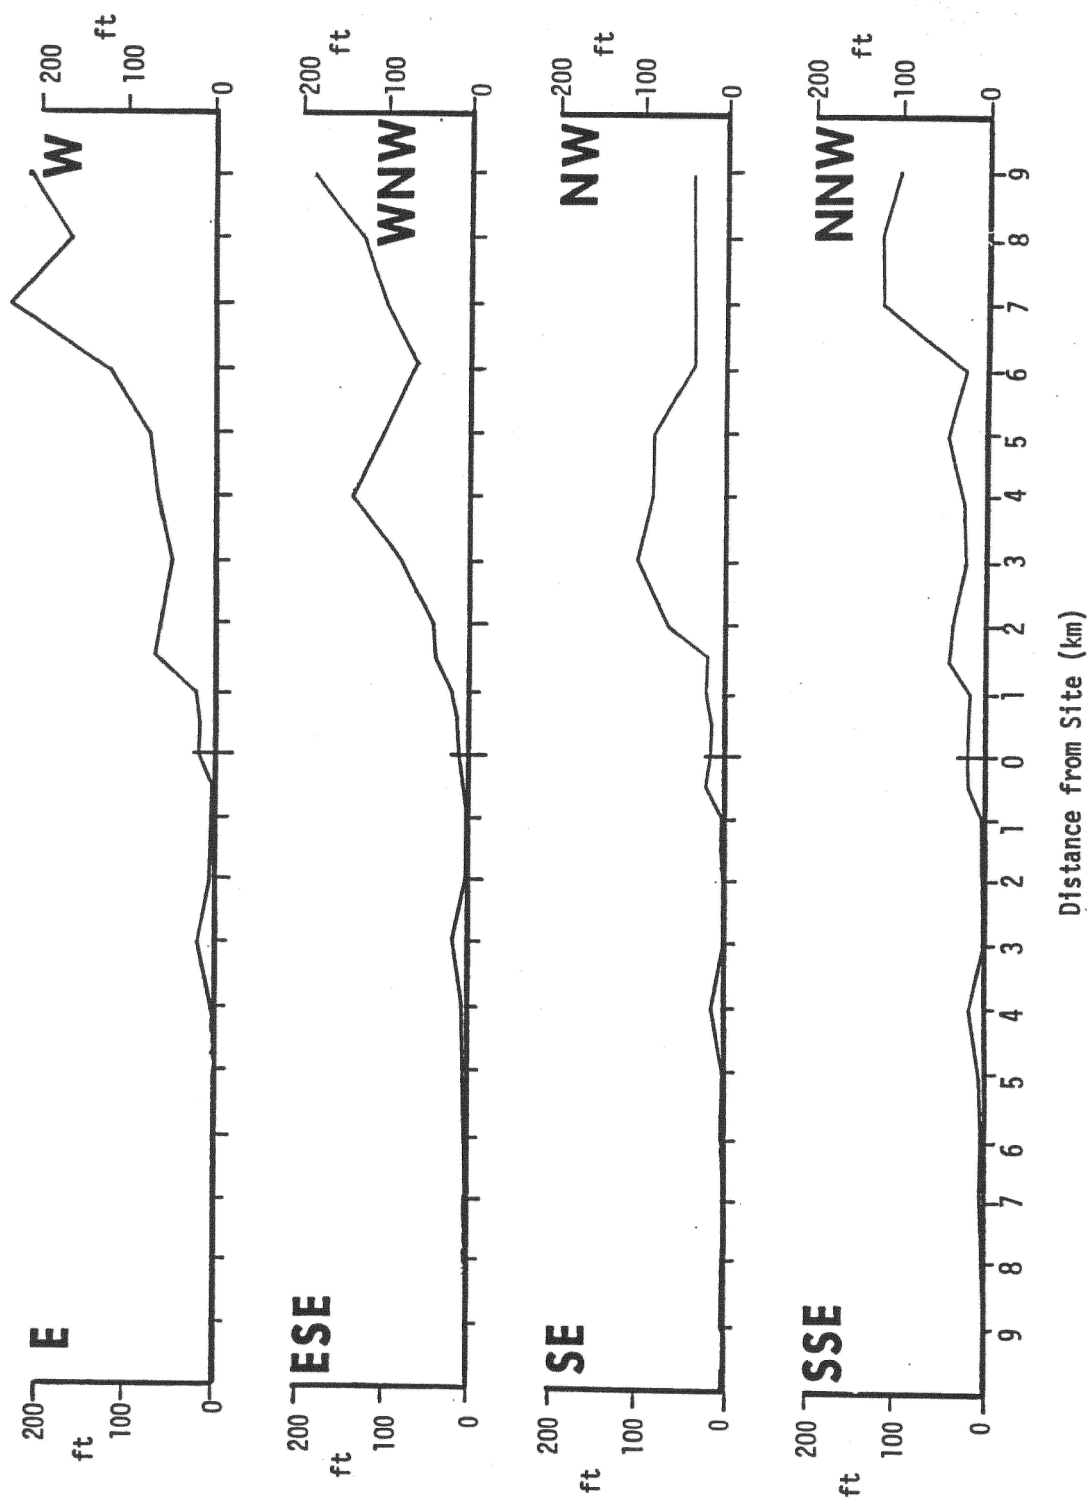
SEABROOK STATION UPDATED FINAL SAFETY ANALYSIS REPORT	Terrain Cross Section [2 Sheets]	
		Figure 2.3-8, Sh. 2 of 2

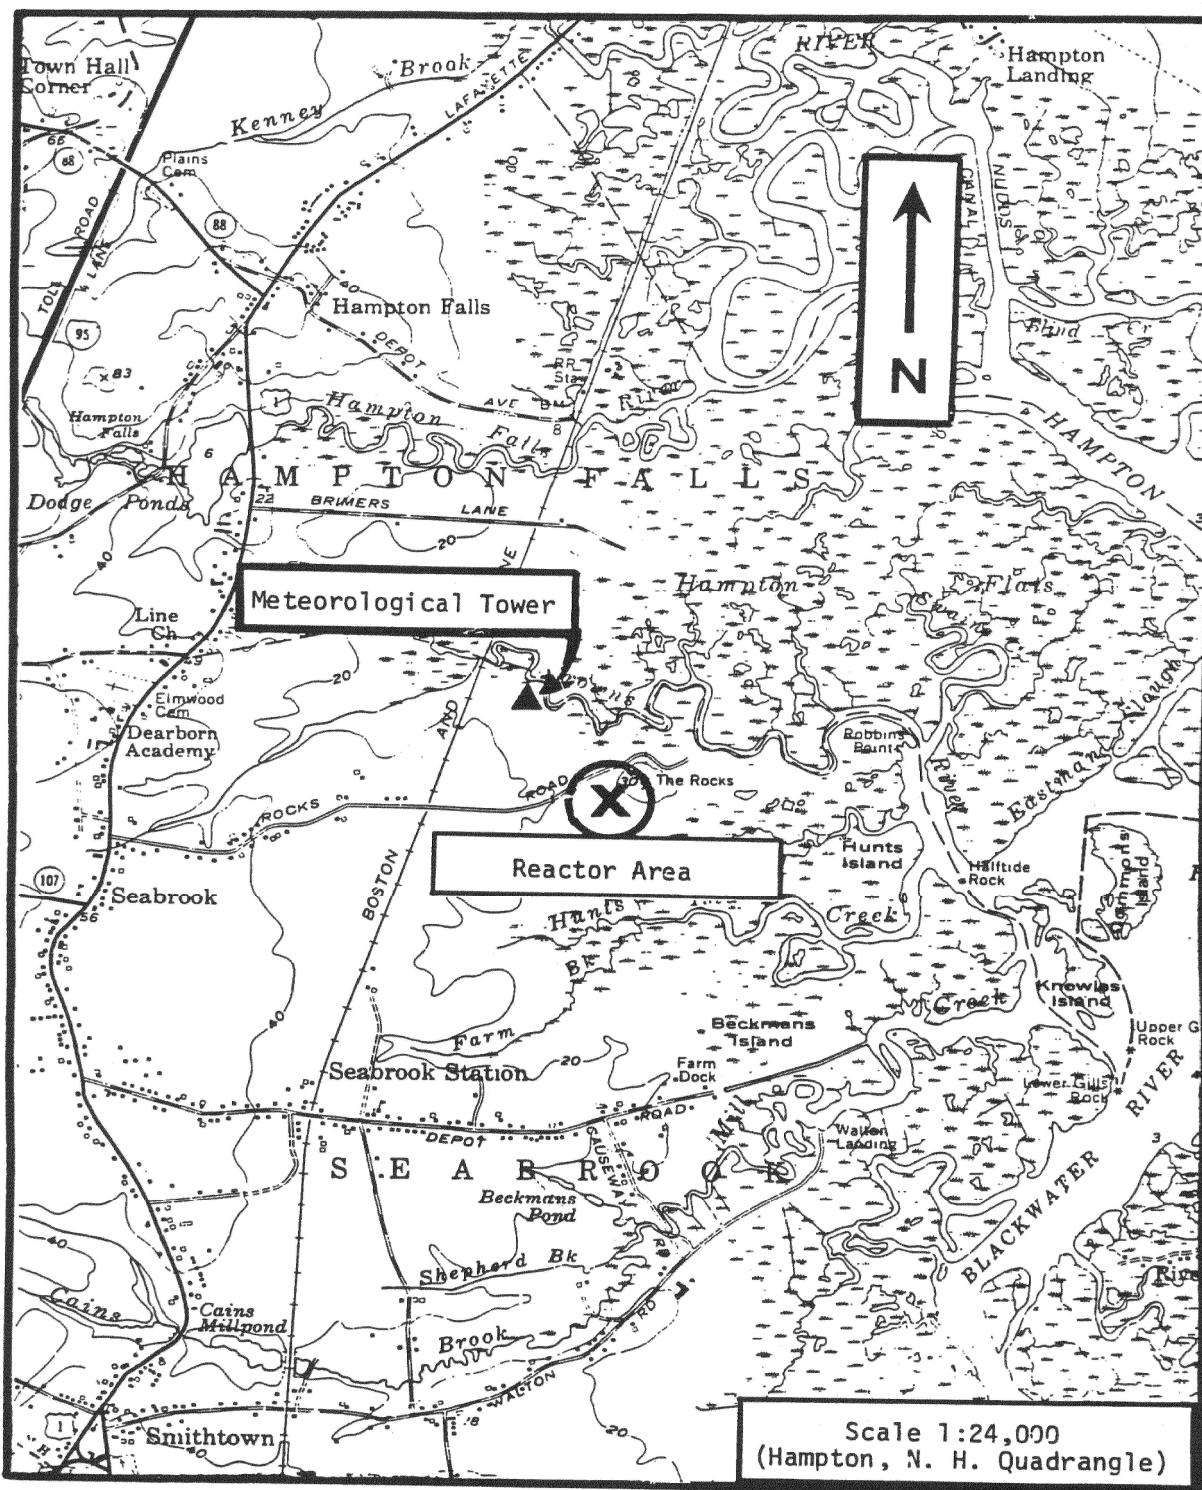
Figure 2.3-9

Topographic Map Showing the Location of the
Meteorological Tower with Respect to the Reactor Area

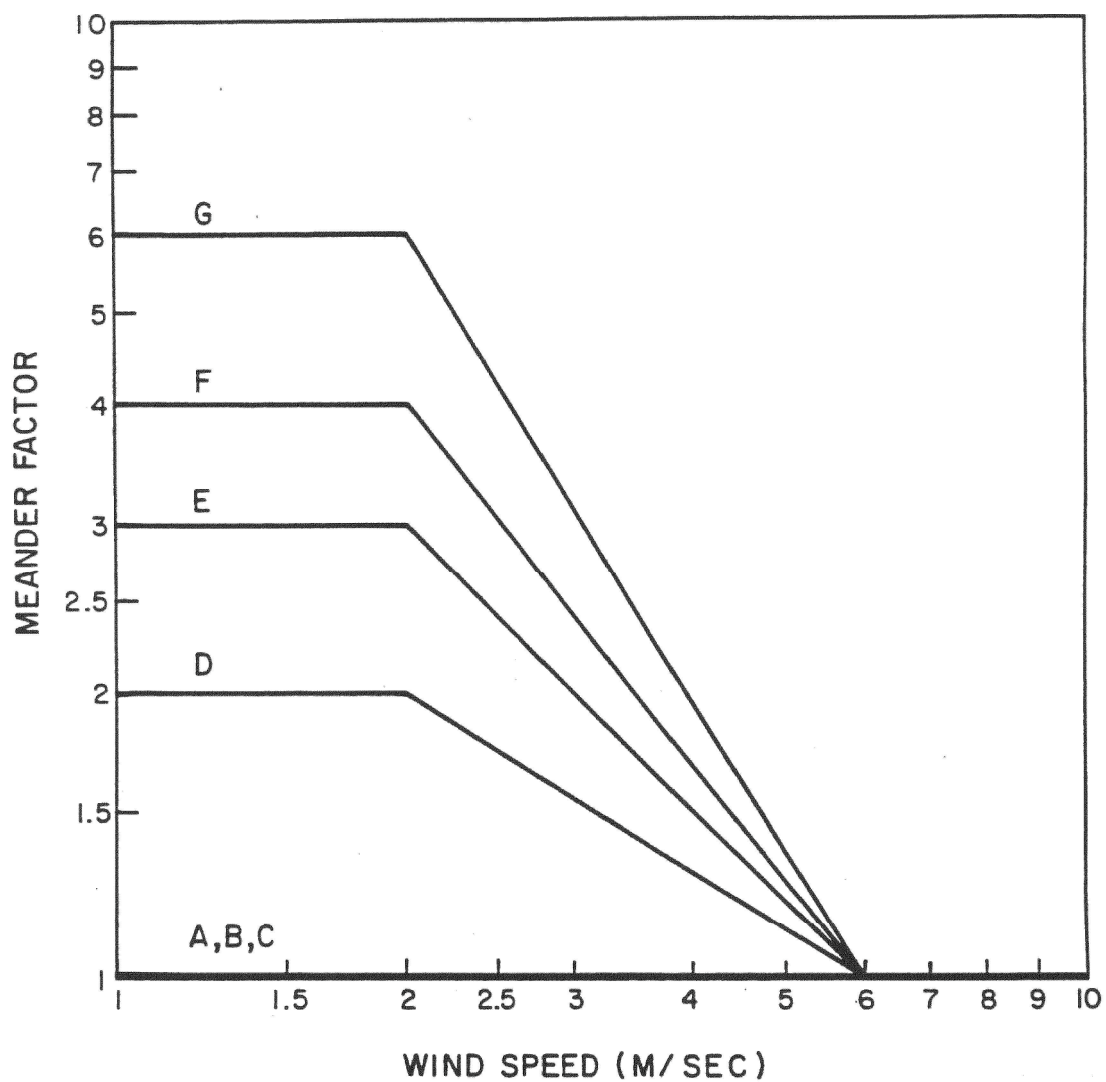
MEANDER FACTOR IS VALID UP TO 800 METERS FROM SOURCE.

SEABROOK STATION UPDATED FINAL SAFETY ANALYSIS REPORT	Meander as a Function of Wind Speed and Stability	
		Figure 2.3-10

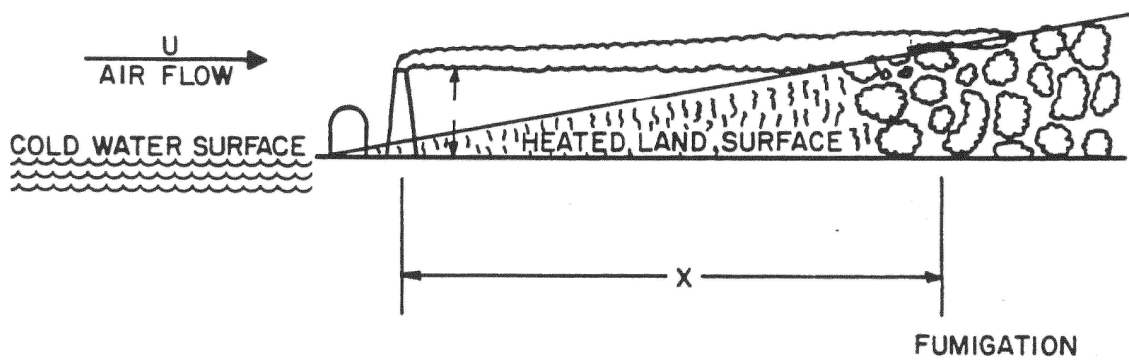
SEABROOK STATION UPDATED FINAL SAFETY ANALYSIS REPORT	Plume and TIBL Interaction	
		Figure 2.3-11
