SEABROOK UPDATED FSAR

APPENDIX 2K

SEISMIC SURVEY

APPENDIX 2E
SEISMIC SURVEYS

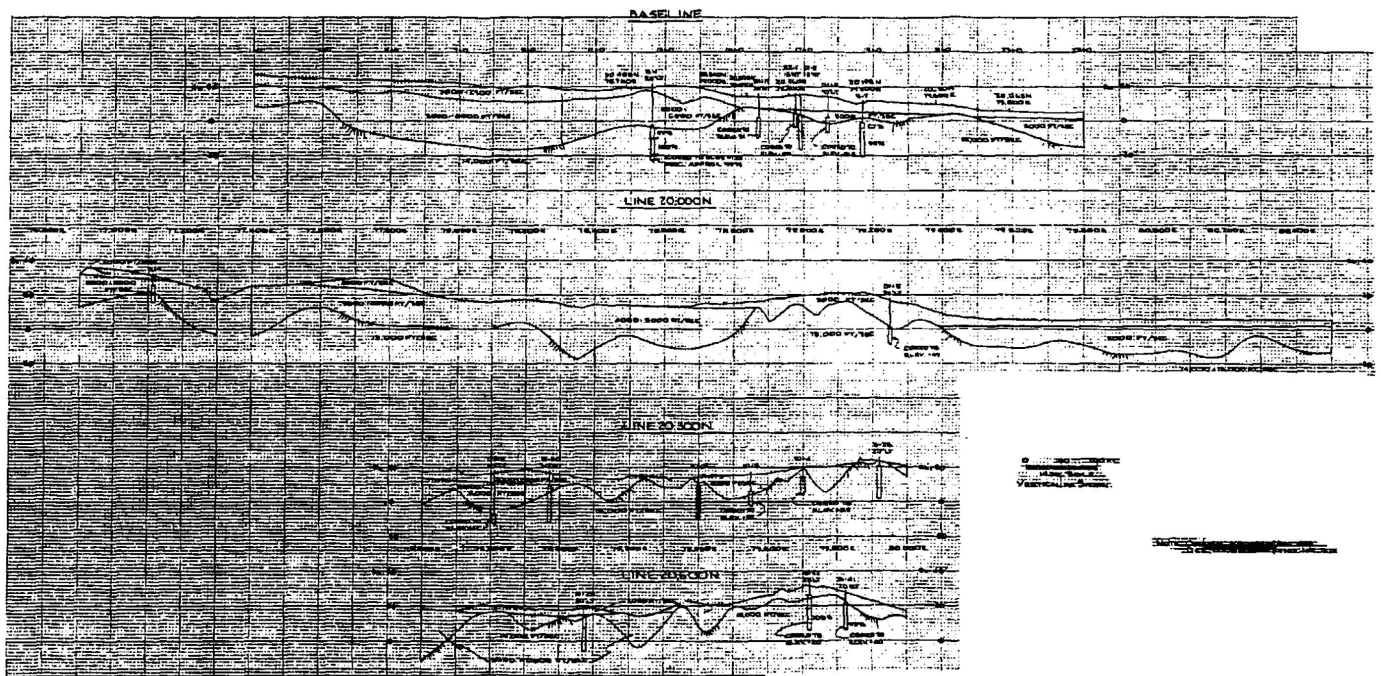
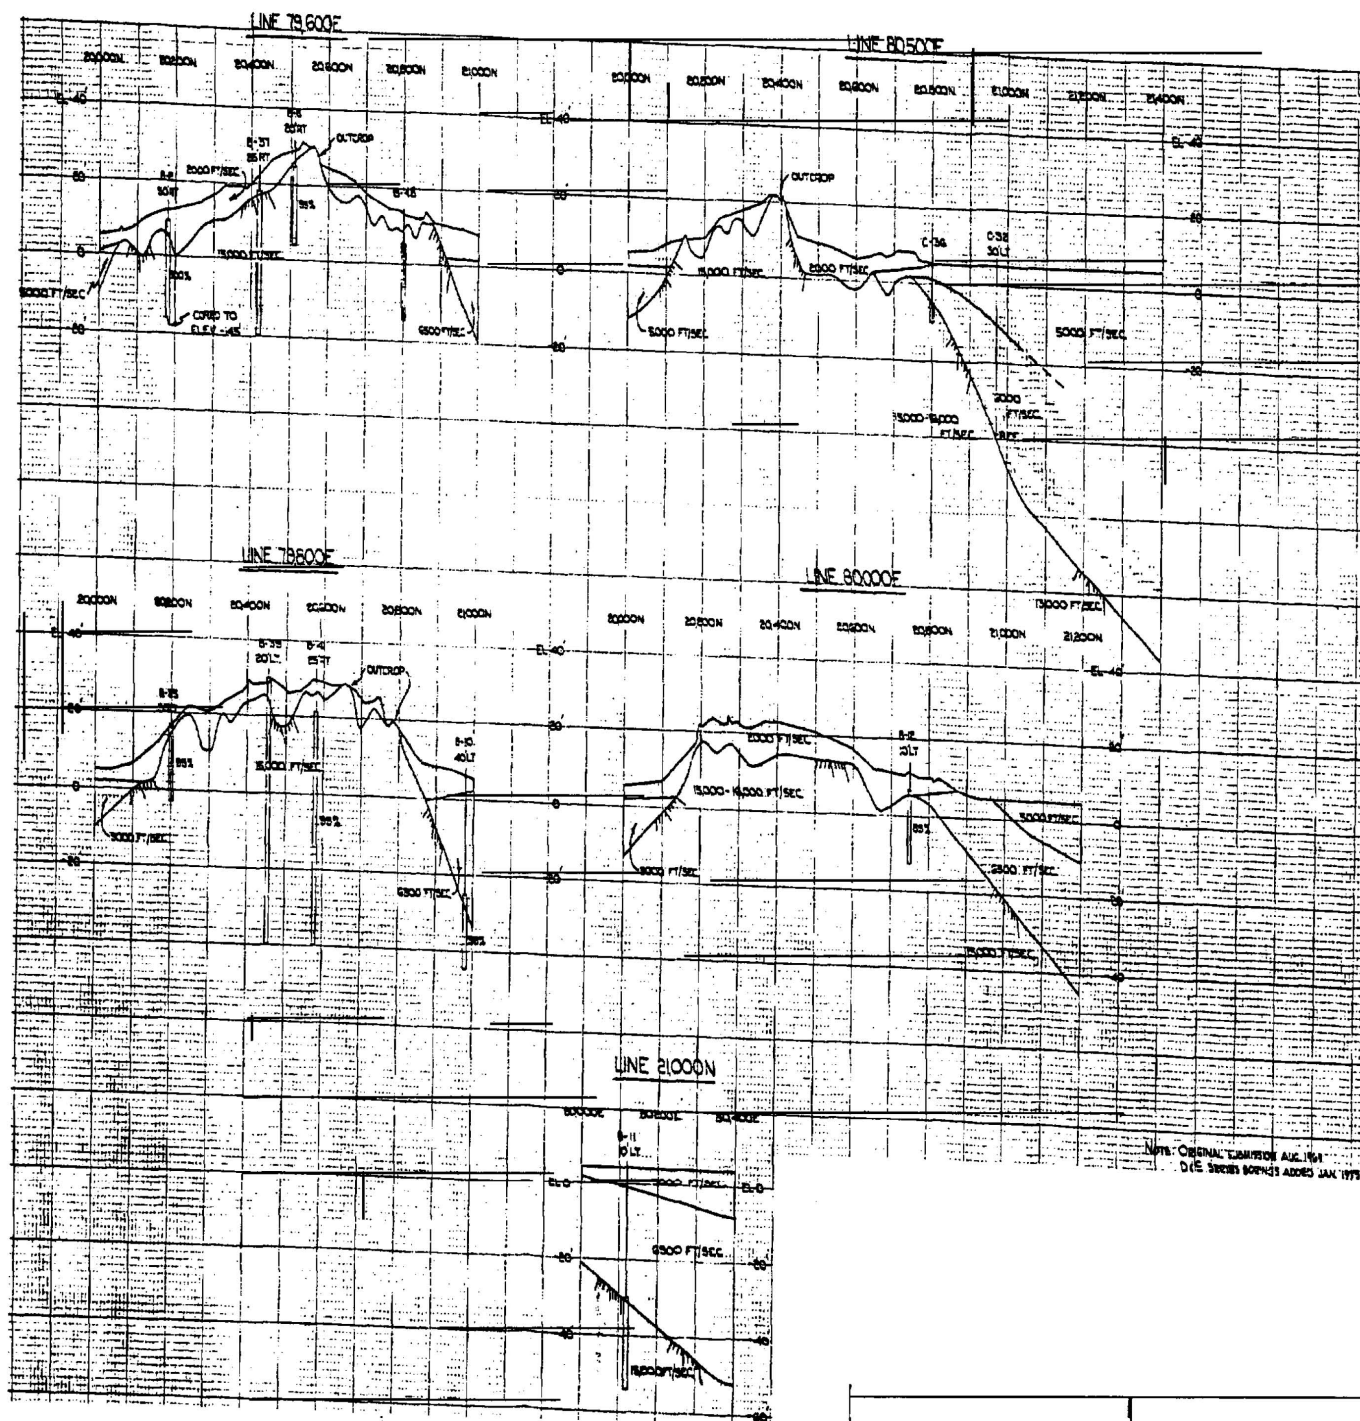
PUBLIC SERVICE COMPANY OF NEW HAMPSHIRE SEABROOK STATION FINAL SAFETY ANALYSIS REPORT	PLANT SITE AREA PROFILE SEISMIC SURVEY
FIG. 2E-2	S4.1 SS.1 & 2

The results of refraction surveys in the plant site area are shown on Figure **2E-2** (Sheets 1, 2, and 3). In general, the **seismic** survey showed that hard rock was shallow in the vicinity of the selected plant location, with dense till along the north side of the site and less dense till and possible other overburden materials west of the plant location. There is good correlation between seismic and boring data.

The bedrock velocities measured by surface refraction techniques ranged between 13,000 **and** 16,000 ft/sec; this is indicative of sound bedrock conditions.

Overburden materials can be tentatively identified by their respective seismic velocities. Velocities **for** the overburden materials ranged from 2,000 ft/sec for loose, unconsolidated overburden materials to 6,500 to 6,800 ft/sec for dense glacial till. In general, overburden materials with velocities in excess of 5,500 ft/sec and in excess of 3,000 ft/sec for unsaturated materials are indicative of glacial till.

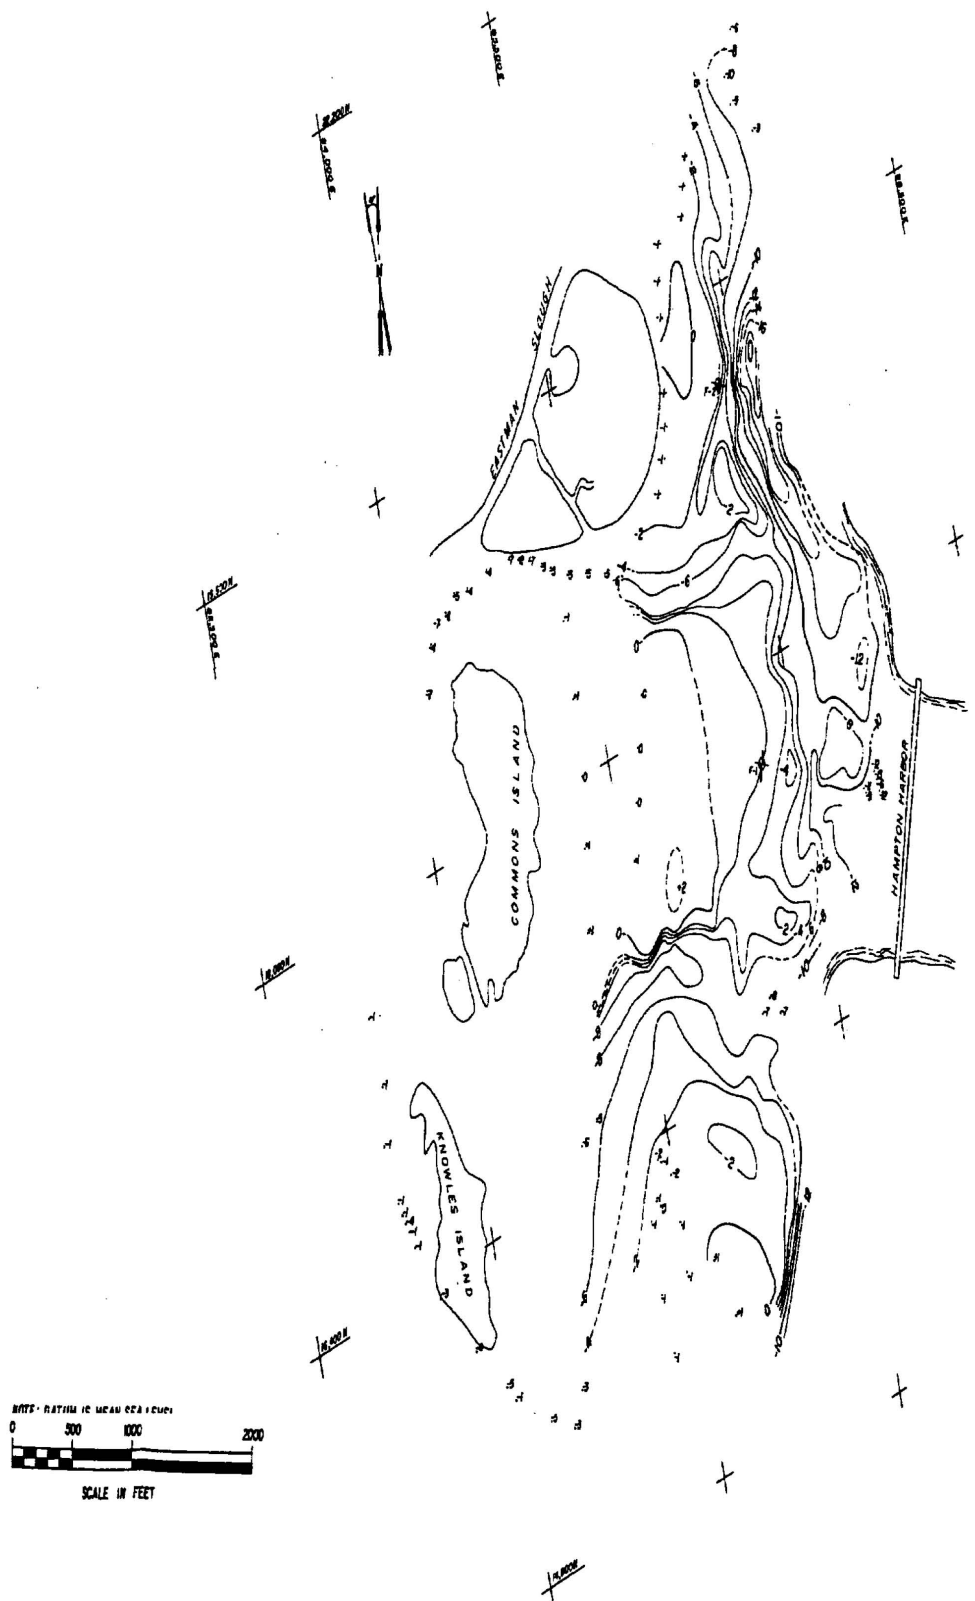
FIG. 2E-5

The results of the fathometer **survey** which took place during **March** and April 1973 are shown in the **form** of a bottom contour

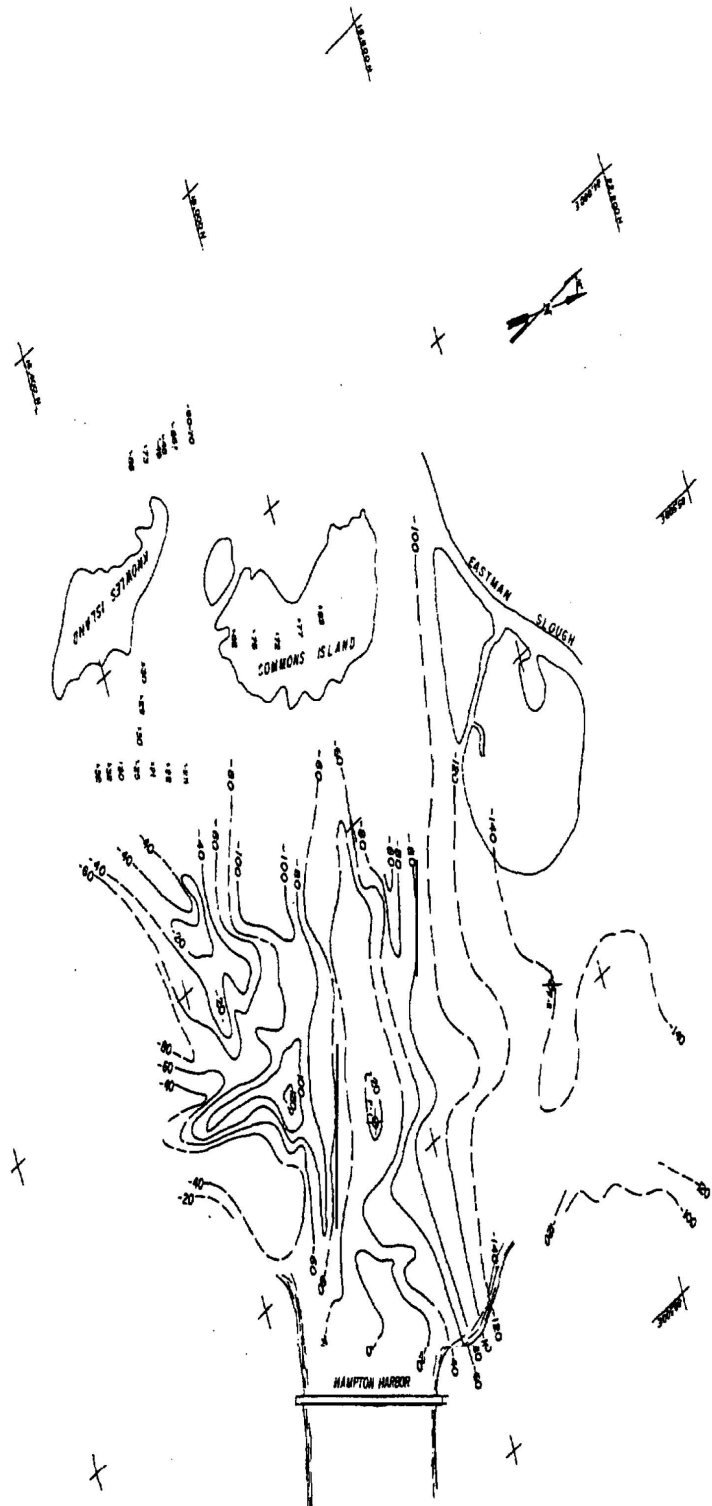
FIG. 2E-6

map (Figure 2E-5). The results of the seismic investigations are shown in the **form of** a bedrock contour map (Figure 2E-6). The contours are based on seismic reflection and seismic refraction surveys conducted during March and April 1973 and augmented by the data obtained from **a** seismic refraction survey conducted in the fall of 1968. The 1968 data were obtained in the northern half of the area shown on Figure 2E-6 and mainly consisted of information on the minimum depths to a bedrock with only a few computed bedrock **depths**. The track maps for the 1973 reflection and refraction surveys are shown on Figures 2E-7 and 2E-8, respectively.

In the southern half of the area the bedrock was found to be generally shallow and somewhat irregular. The bedrock contour map in **this** area was based principally on seismic reflection data, the interpretation of which was confirmed by Boring **FLA**. Organic materials which prevented the generation of a good seismic signal were noted in a few small areas and at the southern edge of the area of investigation.

The bedrock contour map in the northern half of the area of investigation is based on a combination of seismic reflection and refraction data. Glacial till was detected against the north side of the shallow rock area by the seismic reflection.

The till appeared to thin towards the north so that the till and bedrock could not be distinguished on the seismic reflection records. Based on Boring F-2 which encountered 14 feet of till above bedrock, the seismic reflection data were reevaluated and the contours, as shown on Figure **2E-6**, were constructed from the reevaluated reflection data and the seismic refraction data.

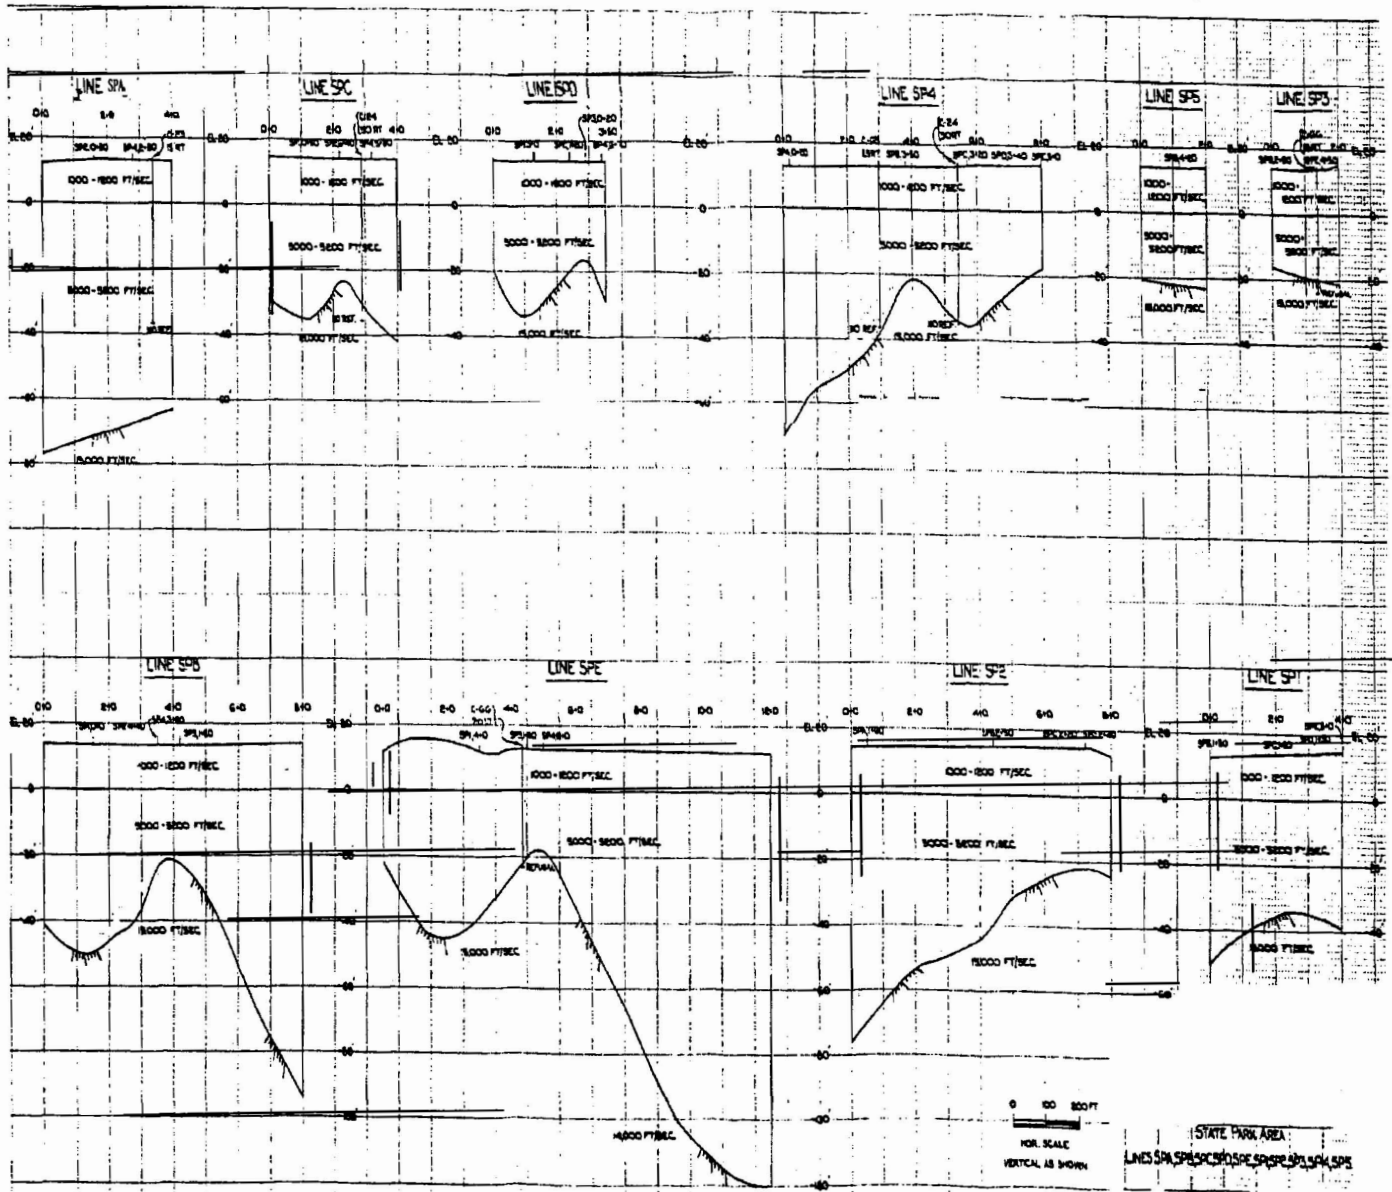
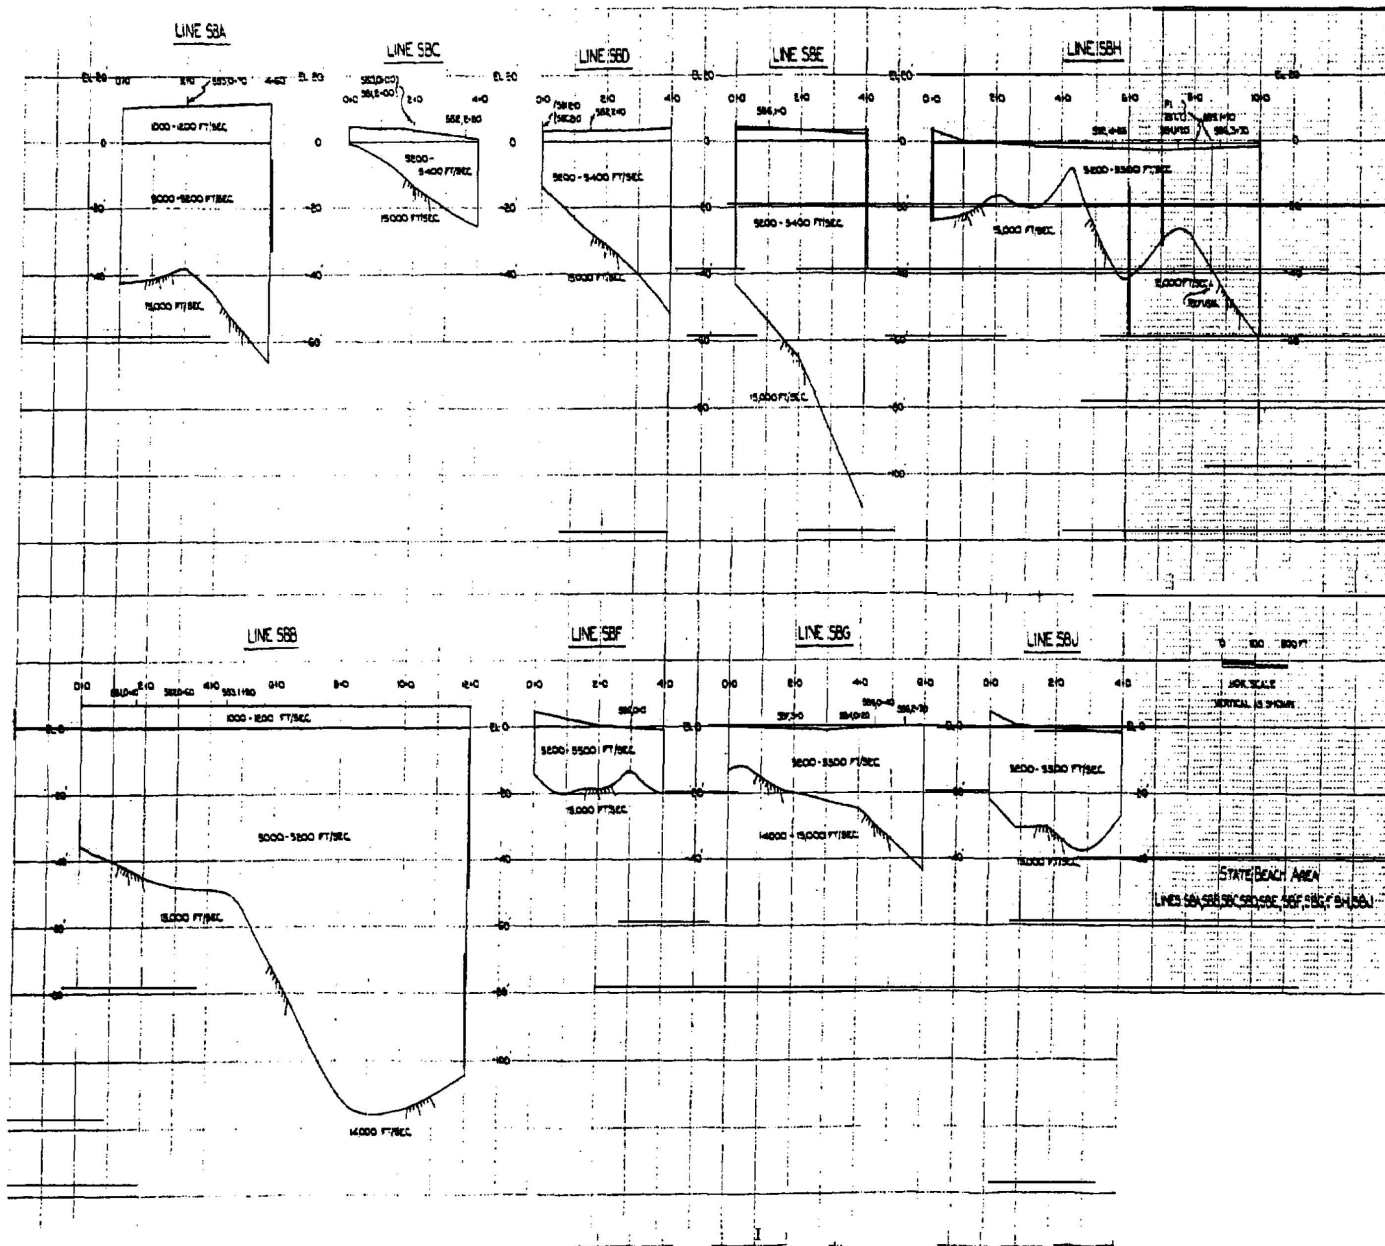
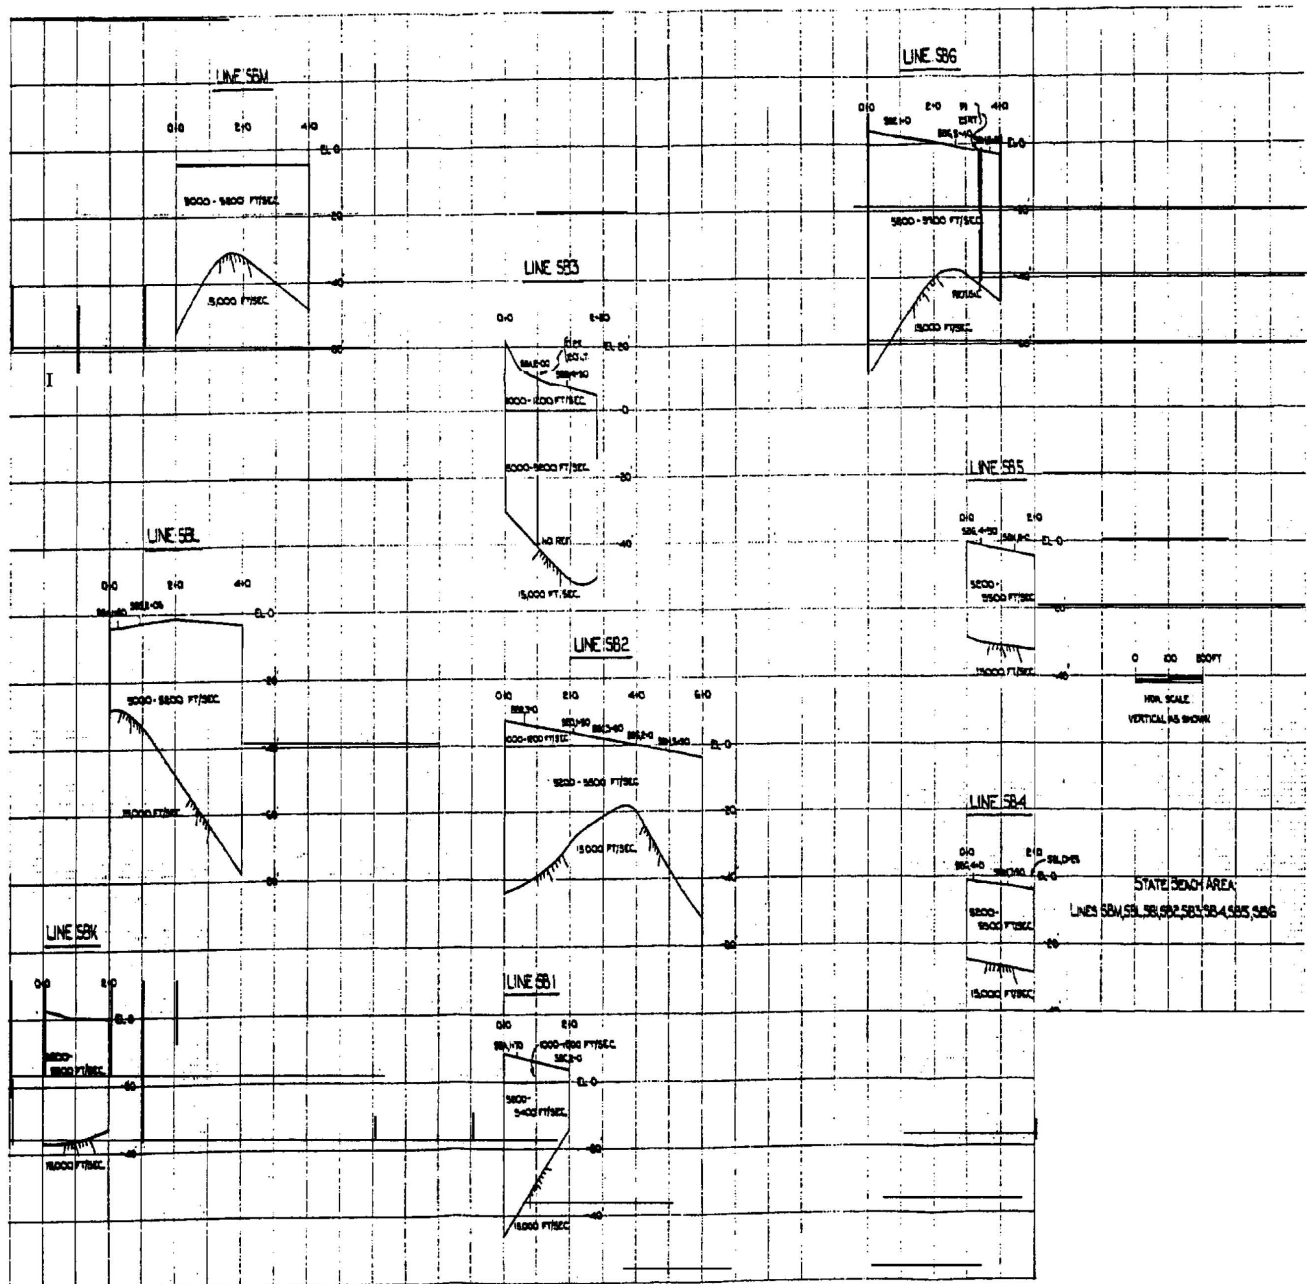
The location plan of the seismic lines in this area is shown on Figure **2E-9** and the seismic results are shown on Figure **2E-10** (Sheets 1, 2, and 3). Two relatively shallow areas in the bedrock surface were detected in the State Park: one in the vicinity of Lines SPS and SPB, just north of Boring C-56; the second, in the vicinity of Lines SP3, SP4, and SPE, just north of Boring C-66. Boring C-24 confirmed the fact that a depression in the bedrock surface exists between the two high areas of rock.

In the State' Beach area, a thin layer of glacial till was encountered by Boring P-1, but was not detected seismically. The seismic overburden velocity of 5,500 **ft/sec**, as detected on the more **easterly lines** of the State Beach area, may be indicative of a dense sand.

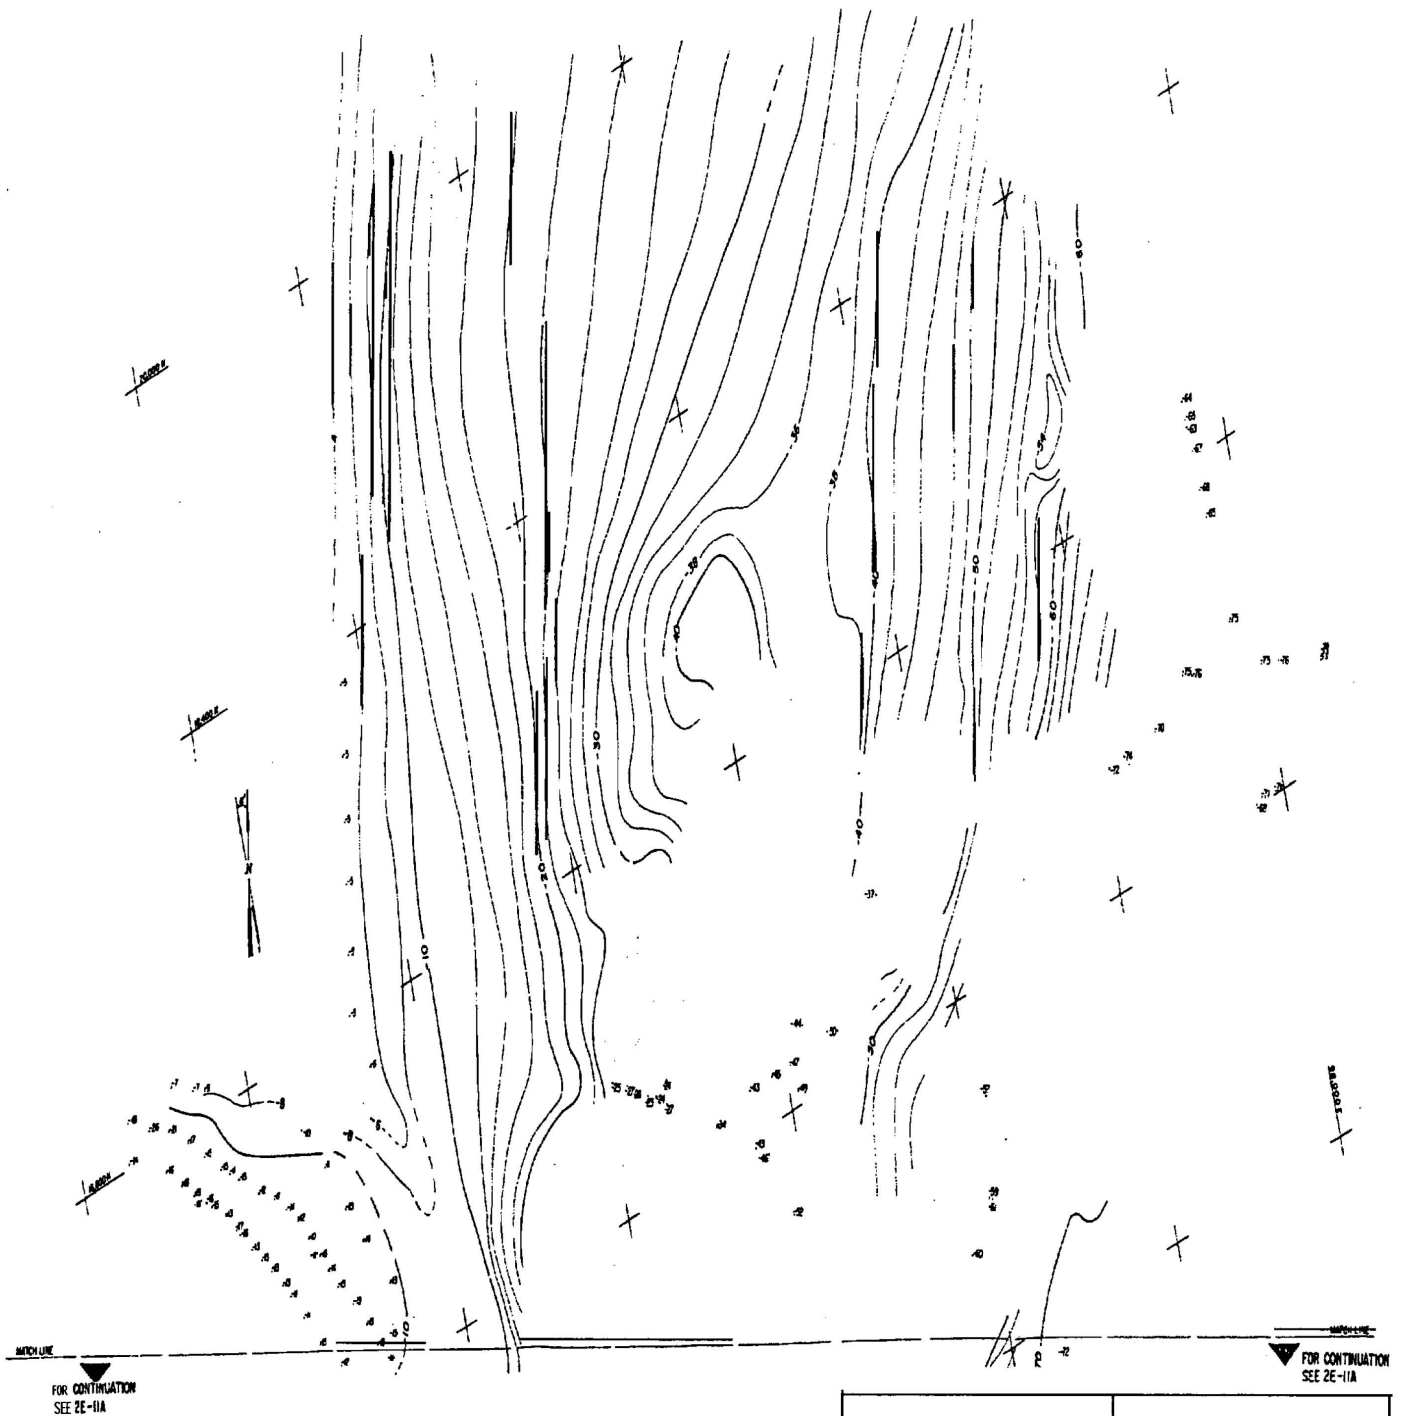
FIG 2E-11B

The results of the fathometer survey which took place in **March** and April 1973 are shown on Figure **2E-11**. The bedrock contour map, **Figure 2E-12**, was constructed from seismic reflection and refraction data obtained in March and April 1973, and from a seismic refraction survey conducted during the fall of 1968. The track map for the 1973 reflection and refraction surveys is shown on Figure **2E-13**. The 1968 seismic refraction survey was conducted in an area extending in an east-northeasterly direction for a **distance** of about a mile from the Hampton State Beach.

The contour maps show that much of the ocean bottom **offshore** consists of highly irregular bedrock outcrops. A denser material, possibly glacial till as indicated by the seismic refraction velocities, was found along the northern and western sides of the ledge outcrops. Refraction velocities in the 5,500 to 5,700 **ft/sec** range were found in this area, while away from the area, velocities generally ranged between 5,100 and 5,400 **ft/sec**. The seismic reflection data showed both glacial till and bedrock, although in some areas, reflections were only obtained from the till. **In** these latter cases, the refraction data provided the basis for the bedrock contours. **Boring**~~P~~**P-2** through P-10 conformed to the general picture shown by the seismic data.
