**CHARACTERIZATION OF
NORM
WASTE MATERIAL**

**UNION CARBIDE CHEMICALS
AND PLASTICS COMPANY
SPECIALTY CHEMICALS DIVISION**

**SOUTH CHARLESTON
WEST VIRGINIA**

JULY 26, 1993

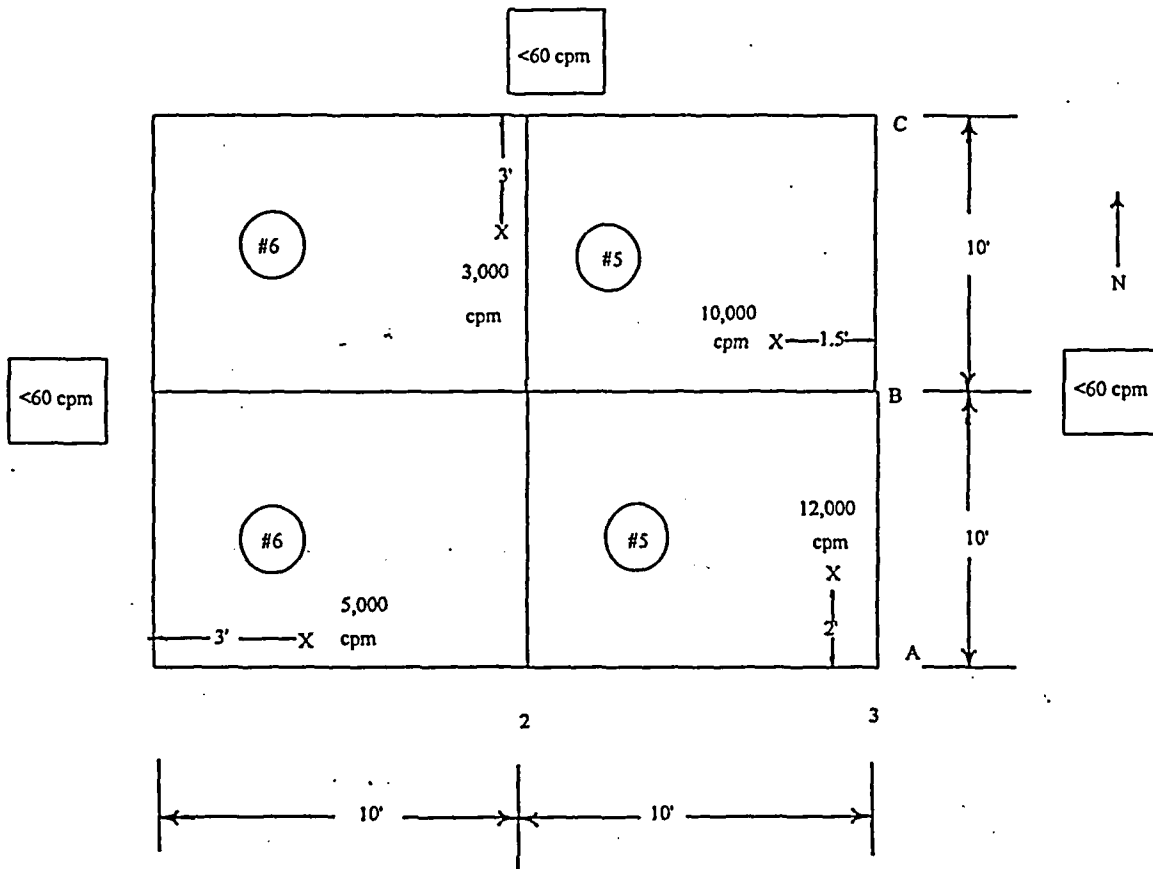
ATTACHMENT B

The results of the survey taken in Location #1, Grid #1 are indicated on Attachment B. The results of the survey taken in Location #1, Grid #2 are indicated on Attachment C. The location of the highest survey reading in each 10 foot by 10 foot grid is indicated on the grids contained in Attachments B and C. Also indicated on the grids contained in Attachments B and C are the survey readings taken outside of Grids #1 and #2, Location #1. These results showed no indication of contamination outside of Grids #1 and #2, Location #1.

When the surveys of Location #1, Grids #1 and #2 were completed, a sampling protocol was established. Samples #1 and #2 were background samples of soil/gravel and were obtained from the locations indicated on Attachment B. Samples #3 and #4 were taken from Grid #2 and were soil/gravel samples of areas where survey readings as well as visual observation (rust colored soil/gravel) indicated contamination. Samples #5 and #6 were taken from Grid #1 and were composite samples of soil/gravel/pipe scale. Samples #7 and #8 were taken from Grid #2 and were also composite samples of soil/gravel/pipe scale.

Sample Locations
Union Carbide Soil Characterization
Location 1 Grid 1
7/8/93

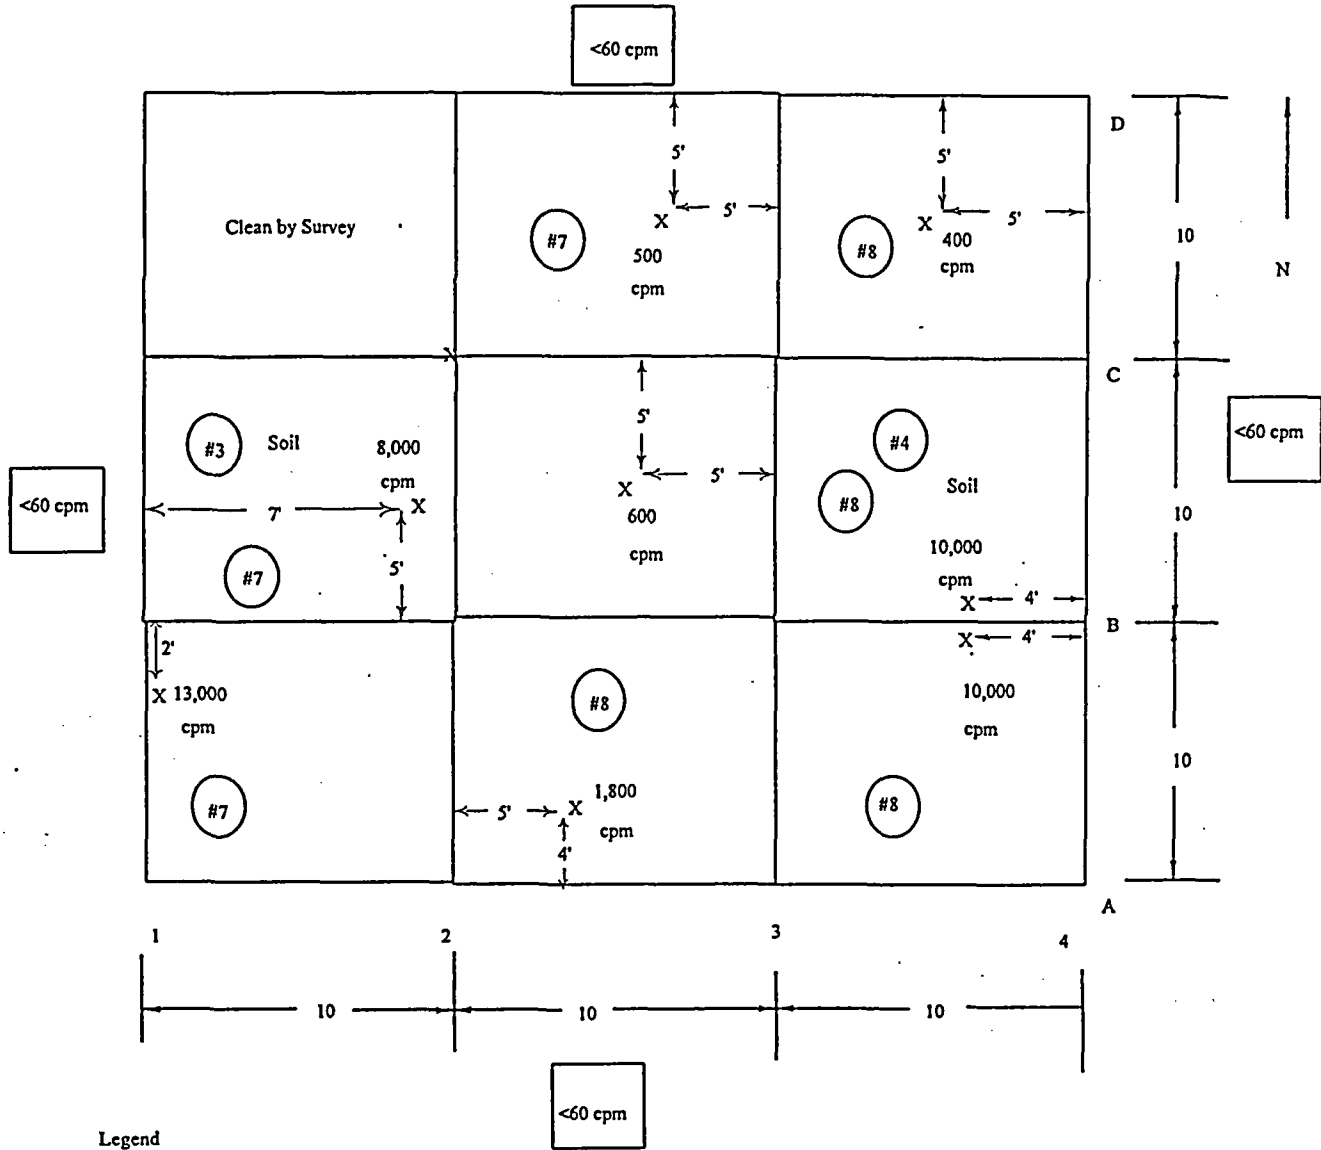
ATTACHMENT C

the general area. For example, Sample #3 has a Radium-226 (Ra-226) activity of 48.1 pCi/gram. The activity levels for these two samples, as well as the survey readings, indicate that some of the soil/gravel in Grid #2, Location #1 will need to be either processed to remove the radioactive contamination or disposed of at a radioactive waste disposal facility.

Sample Locations
Union Carbide Soil Characterization
Location 1 Grid 2
7/8/93

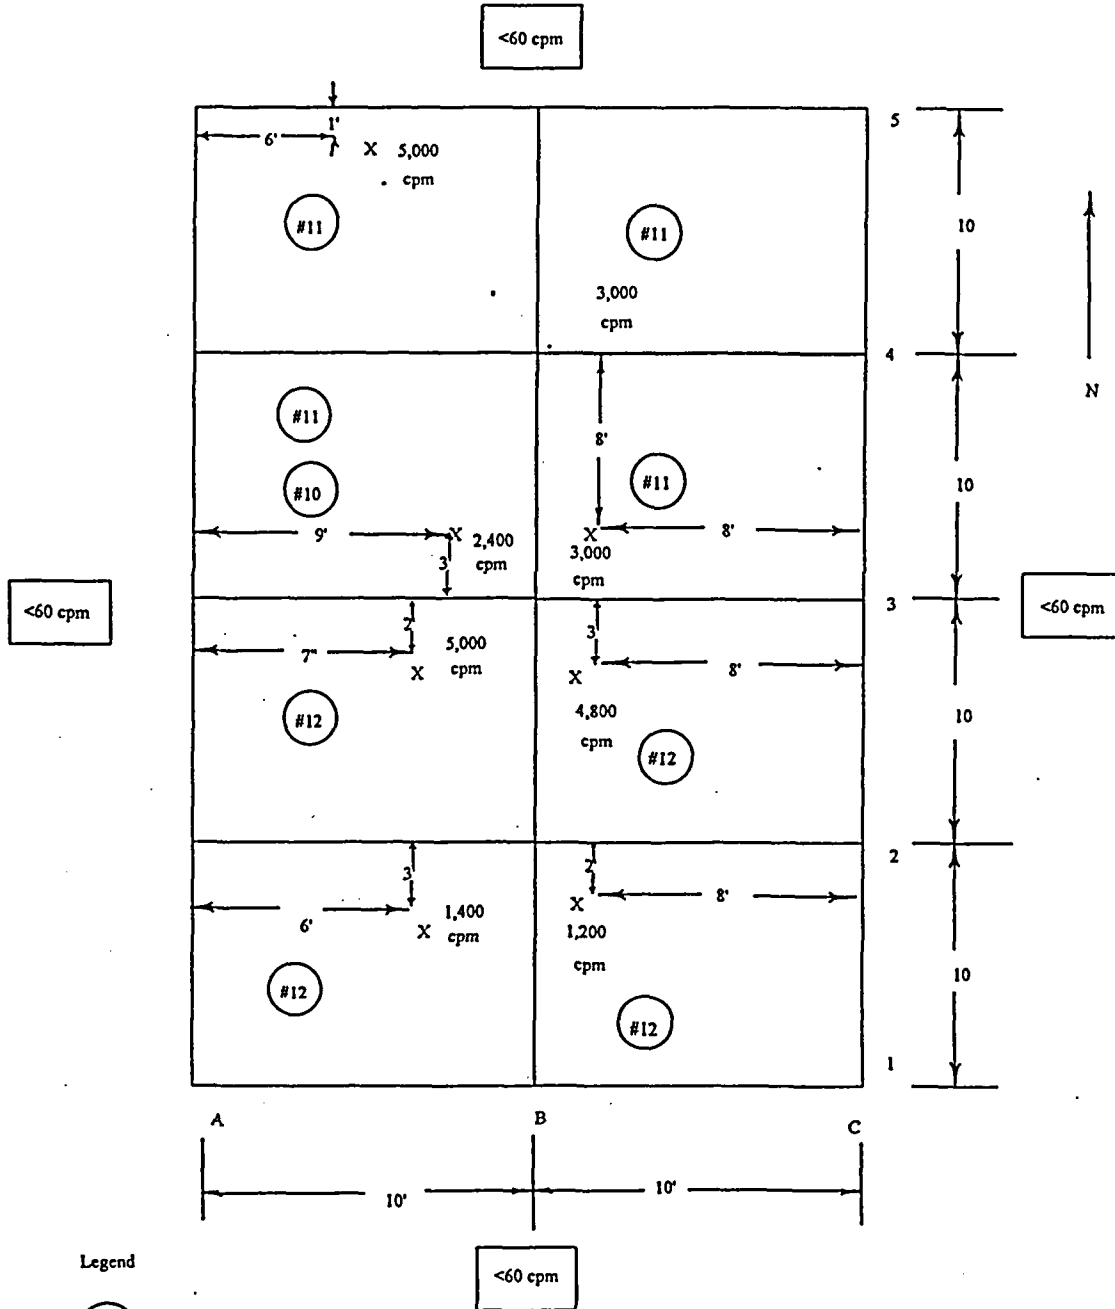
ATTACHMENT D

The survey results for Location #2, Grid #1 are indicated on Attachment D. The location of the highest survey reading for each 10 foot by 10 foot grid is indicated on the grids contained in Attachment D. Also indicated in the grid contained in Attachment D are the survey readings taken outside of the grid. These survey results indicated no contamination outside of Location #2, Grid #1..

When the surveys of Location #2, Grid #1 were completed, the sampling protocol was established. Sample #9 was a background sample of soil/gravel and was obtained in the location as indicated on Attachment D. Sample #10 was taken from Location #2, Grid #1 and was soil/gravel samples of areas where survey readings as well as visual observation (rust colored soil/gravel) indicated contamination. Samples #11 and #12 were taken from Grid #1, Location #2 and were composite samples of soil/gravel/pipe scale.

Sample #10, which is a Soil/Gravel sample from Grid #1, Location #2, shows significantly elevated activity levels as compared to the background sample (Sample #9) and the Soil/Gravel samples (Samples #3 and #4) taken in Location #1. For example, Sample #10 has a radium-226 (Ra-226) activity of 201 pCi/gram (Radium-226 is a daughter of Uranium-238). Sample #10 has an Actinium-228 (Ac-228) activity of 4.01 pCi/gram (Actinium-228 is a daughter of Thorium-232). The activity level for this sample, as well as survey readings, indicate that some of the soil/gravel in Grid #1,

Sample Locations
Union Carbide Soil Characterization
Location 2 Grid 1
7/8/93

Location #2 will need to be either processed to remove the radioactive contamination or disposed of at a radioactive waste disposal facility.

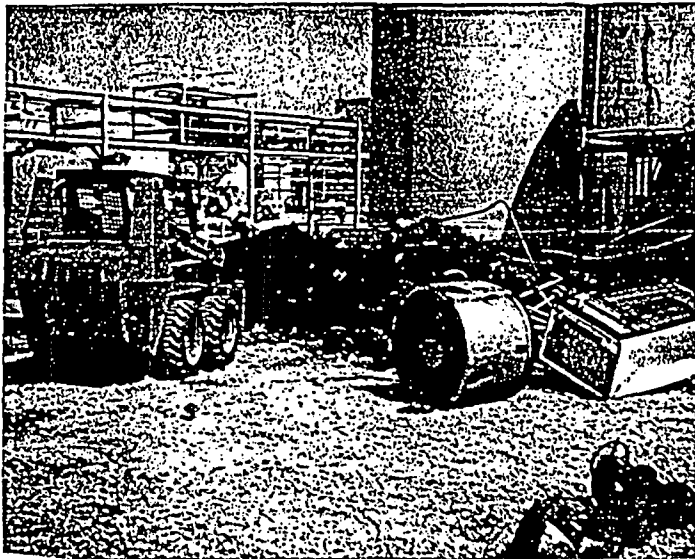
While performing the initial screening survey, CEG staff determined that numerous pieces of equipment, pipe, conduit, tanks, etc. located within the pile of debris were not radioactively contaminated. The non-contaminated material was intermingled with the radioactively contaminated material. CEG staff directed Union Carbide equipment operators during the separation of the non-contaminated material from the contaminated material.

Location #1
Waste debris intermingled with radioactively contaminated materials located within the Union Carbide facility. Photograph taken prior to commencing work. View toward the northwest.

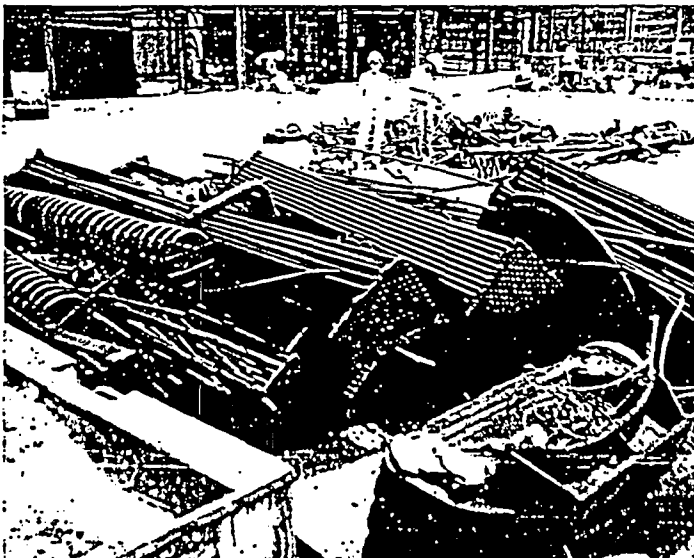
Location #1
View of grid #2 area following segregation of non-radioactive contaminated material. CEG staff shown in background surveying materials segregated from the original debris pile.

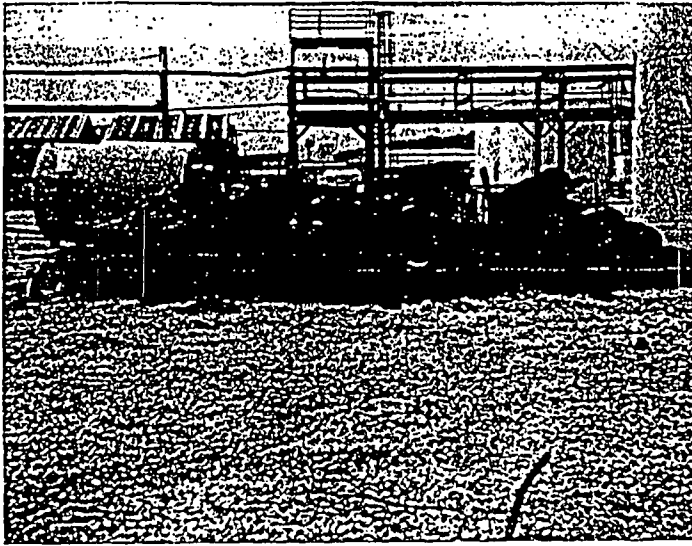
Location #1

Debris pile consisting primarily of tubing and pipe. View toward west.

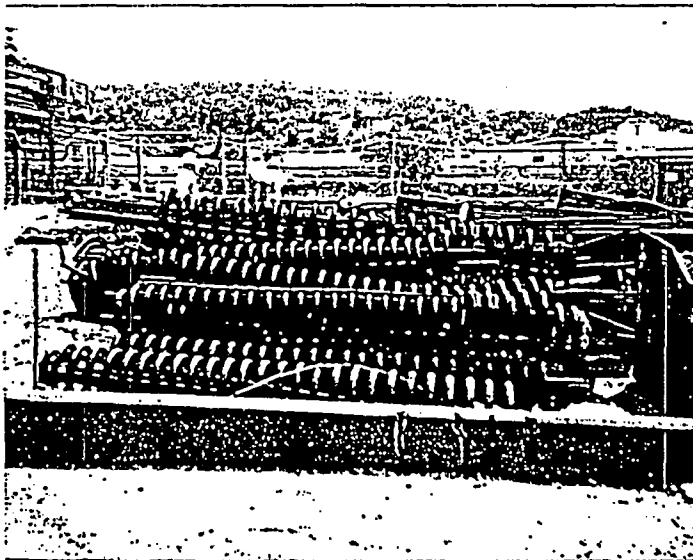
Location #1

Debris pile consisting of tubing and pipe. View toward the south.

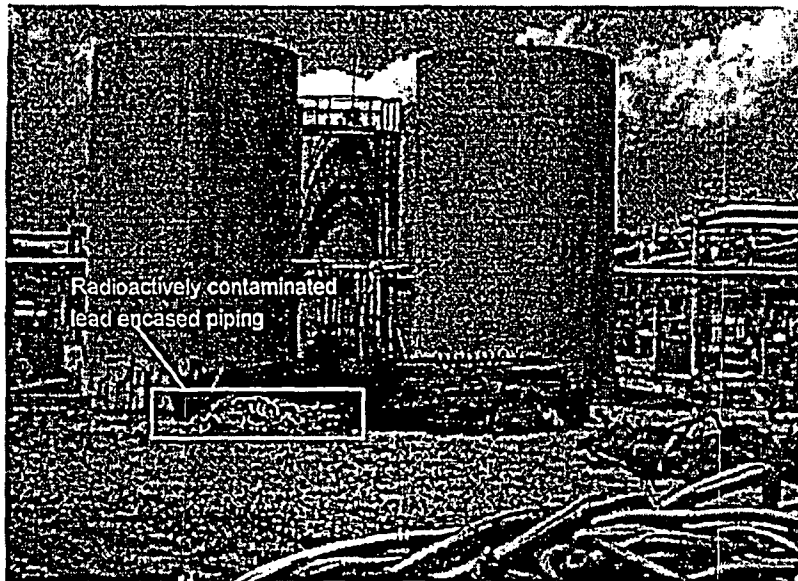
Location #1

View toward north showing radioactive contaminated debris following segregation of materials. The debris primarily consists of steel tubing and pipe. Surface area is approximately 30 feet by 30 feet.

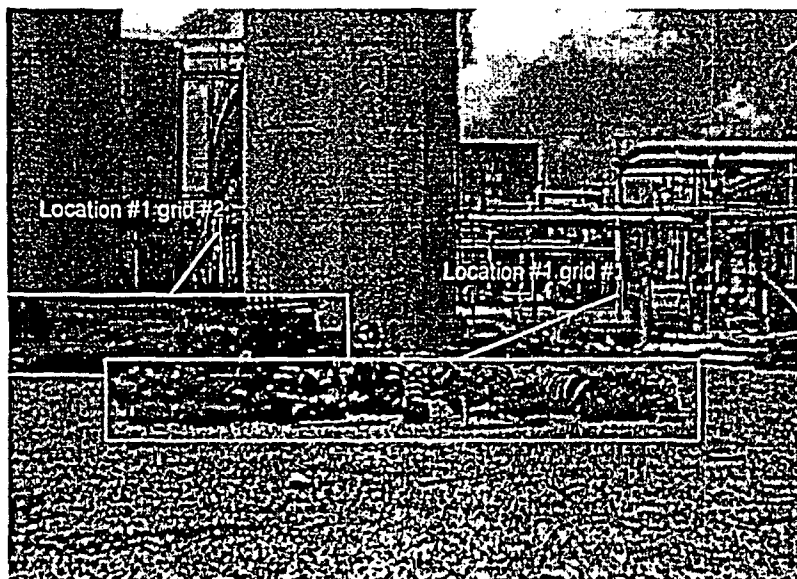
Location #1

After the two grid systems were established, a detailed survey was conducted for both Grids #1 and #2 of Location #1. This in-depth survey indicated that the remaining piping, valves, flanges, condenser tubing, and other pieces of metal were contaminated. (Few valves and flanges were removed from Grid #1. In addition, some of the soil/gravel in Grids #1 and #2 appeared to be contaminated. The soil/gravel contamination within Grid #2 appeared to be significant and widespread. The soil/gravel contamination appeared to have been caused by rainfall which transported the corrosion products from the piping, valves, etc., to the soil/gravel. Upon discovery of contamination in the soil/gravel, another screening survey was conducted in the areas surrounding both Grids #1 and #2 to determine whether contamination had been transported outside of these two

View toward north showing Grid #1 and Grid #2 containing radioactively contaminated materials. Grid #1 generally consists of steel valves and flanges which were segregated from the original debris pile to facilitate surveys.

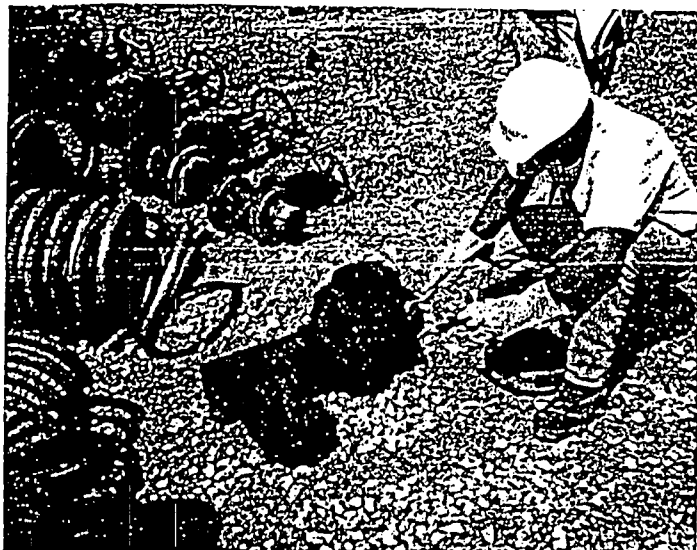
Composite sample being collected at Location #1 Grid #1
by CEG staff.

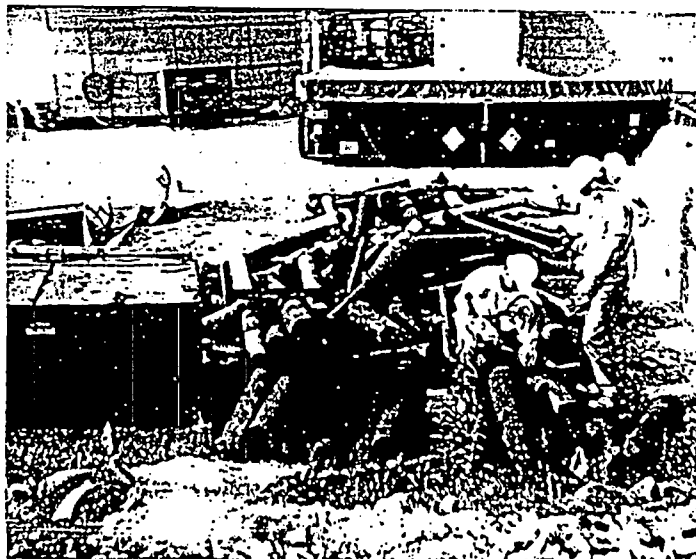
Soil/gravel sample being collected at Location #2 Grid #1
within the Union Carbide facility. View toward north.
