**SAFETY ANALYSIS REPORT  
FOR THE  
MODEL ESP-30X PROTECTIVE SHIPPING PACKAGE  
FOR 30-INCH UF<sub>6</sub> CYLINDERS**

Eco-Pak Specialty Packaging  
Elizabethton, Tennessee 37643

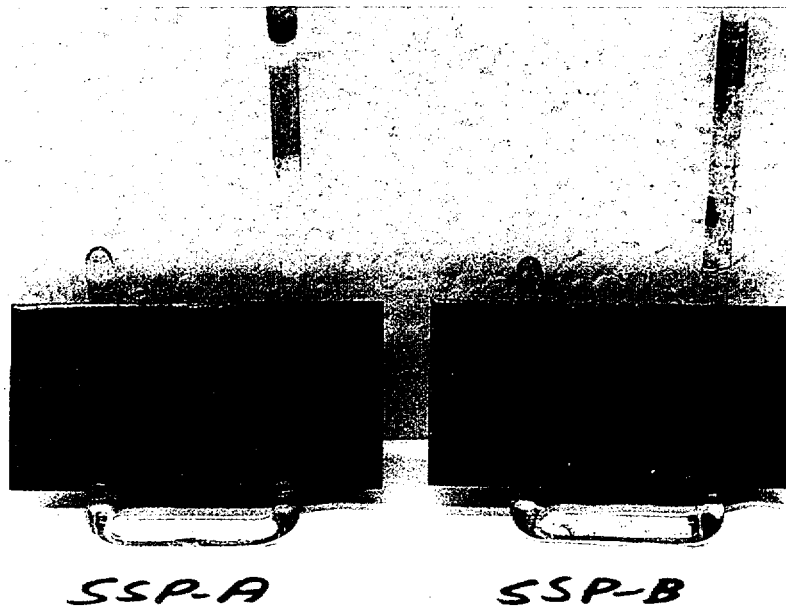
Figure 5b. Stainless steel specimens coated with primer (SSP-A, SSP-B) in post-test condition.

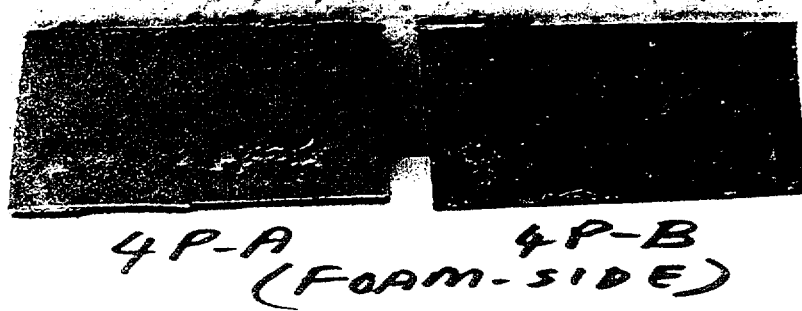
Figure 8c. Stainless steel/foam specimens (4P-A, 4P-B) in pretest condition. (Showing the side facing the foam)

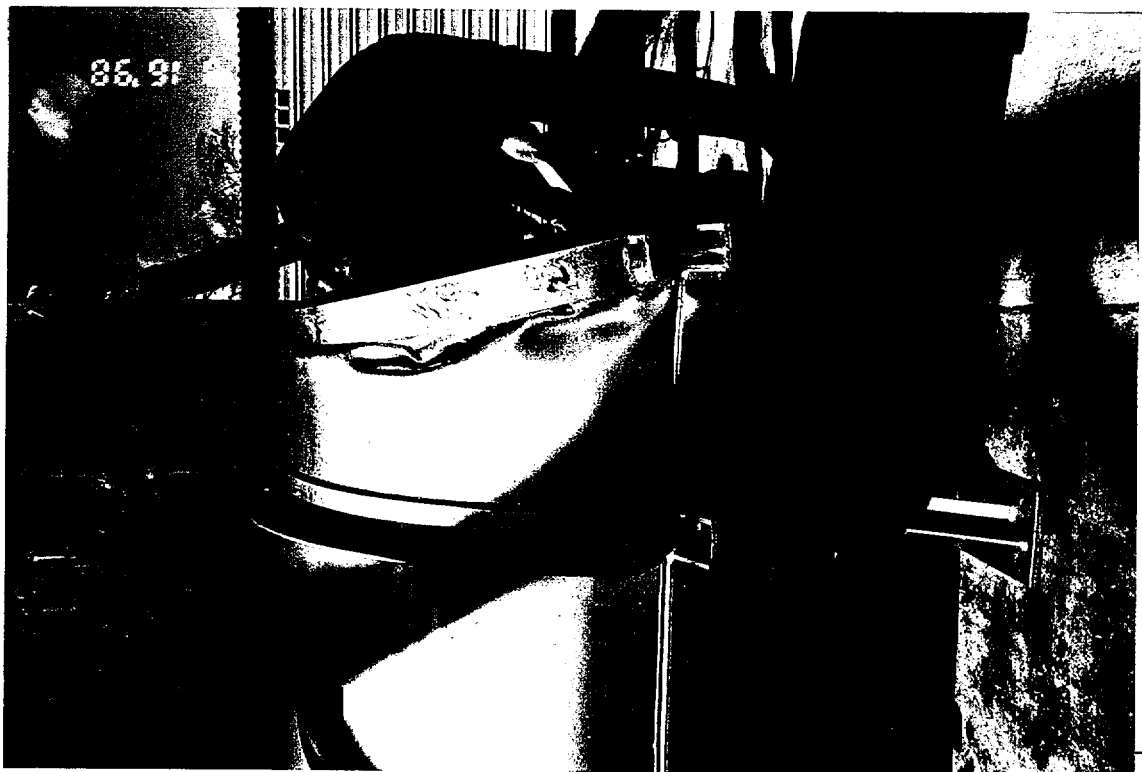
2.10.8p-8 ESP-30X Test Article #1 Damage Following 30 Foot Free Drop

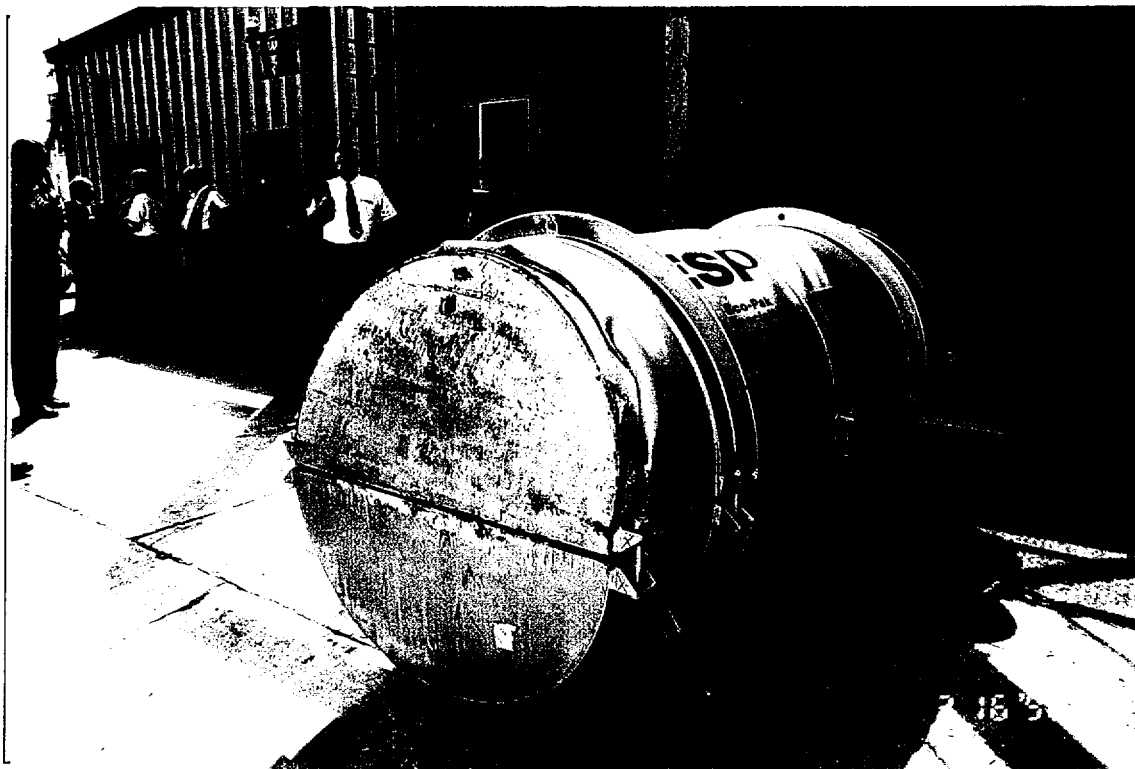
2.10.8p-9 ESP-30X Test Article #1 Damage Following 30 Foot Free Drop

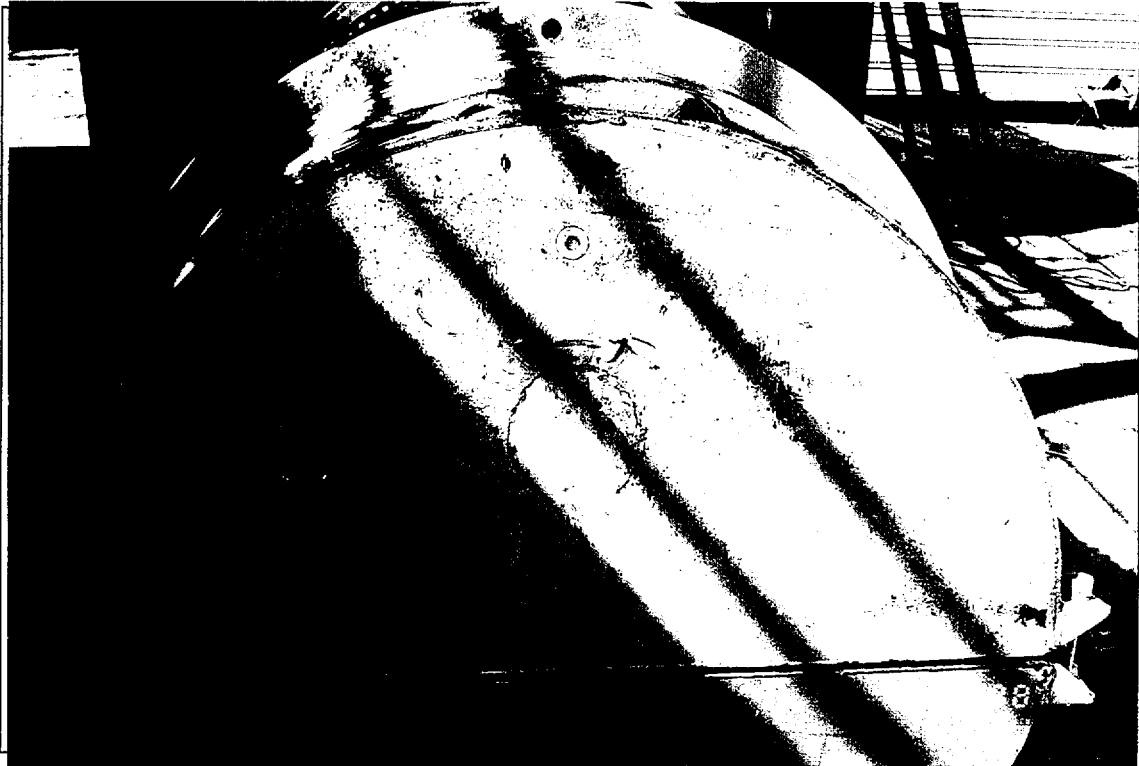
2.10.8p-11 ESP-30X Test Article #1 Damage After 40 Inch Puncture Drop

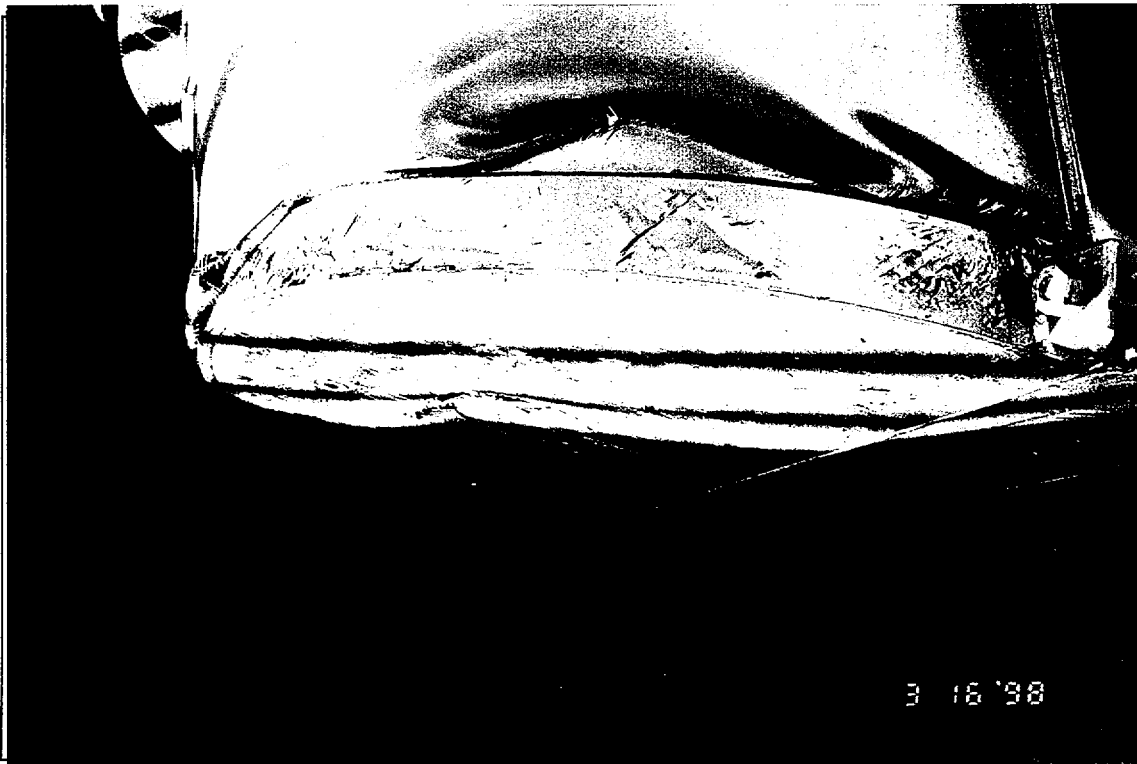
2.10.8p-12 ESP-30X Test Article #1 Damage After 40 Inch Puncture Drop

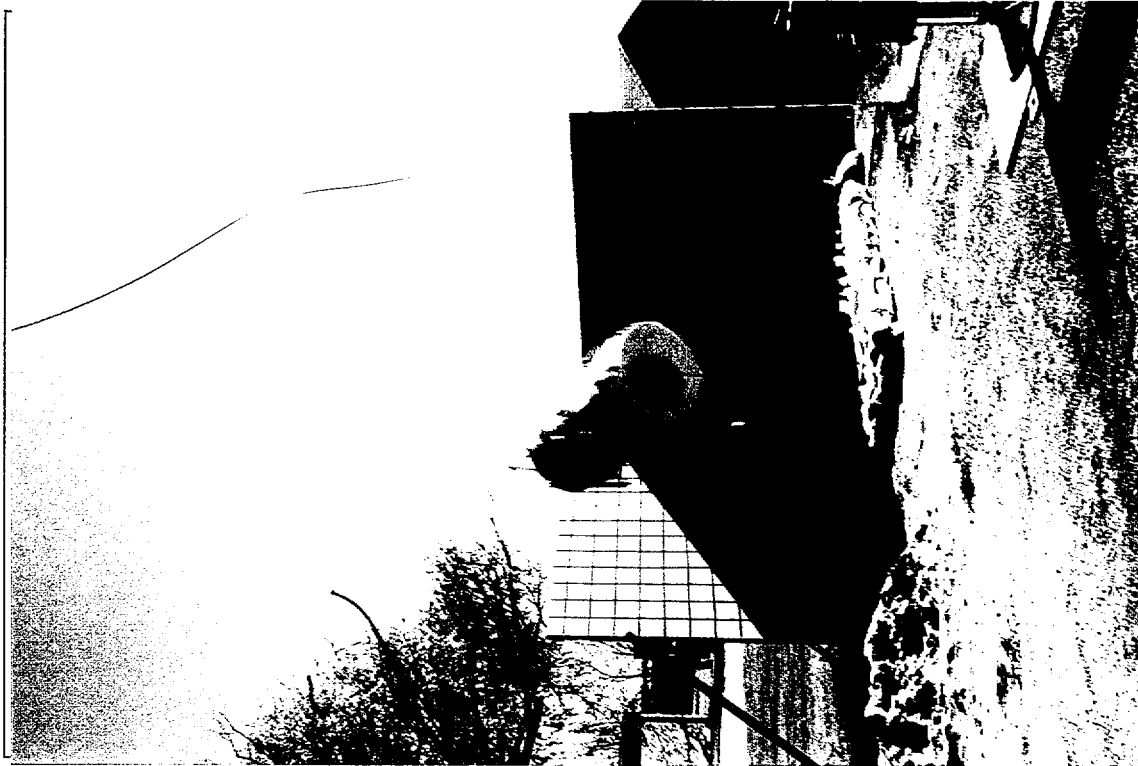
2.10.8p-13 ESP-30X Test Article #2 - 30 Foot Free Drop

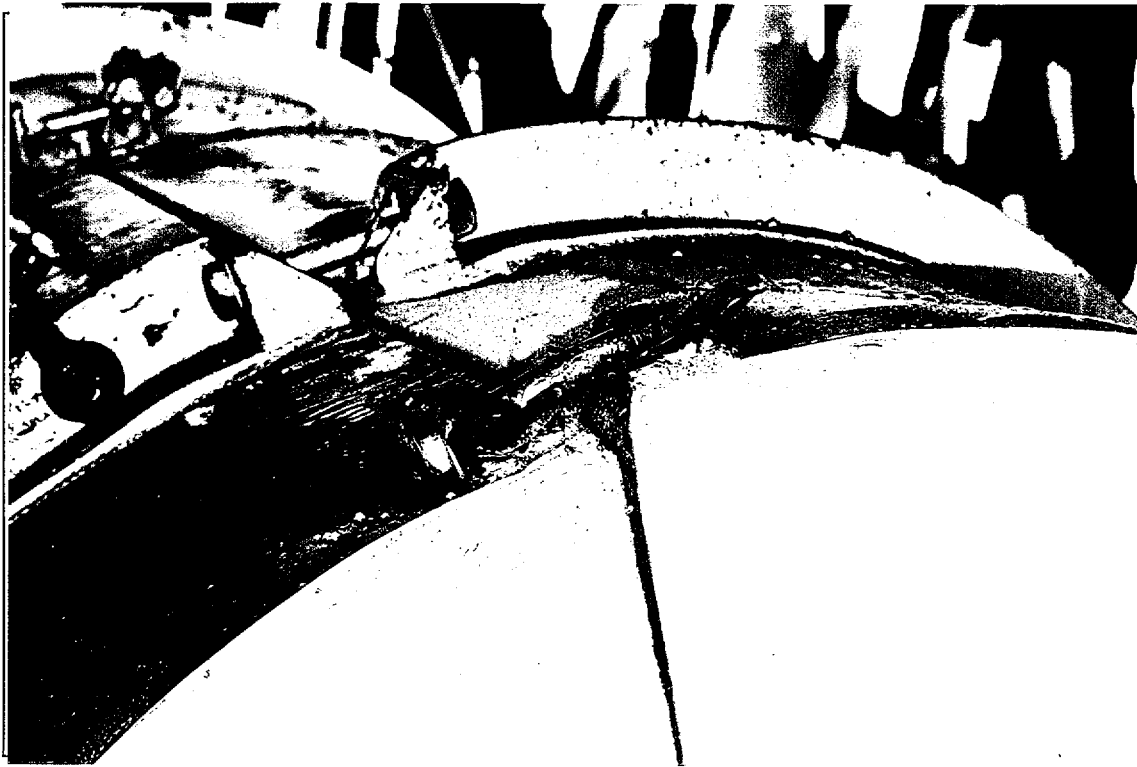
2.10.8p-14 ESP-30X Test Article #2 Damage Following 30 Foot Free Drop

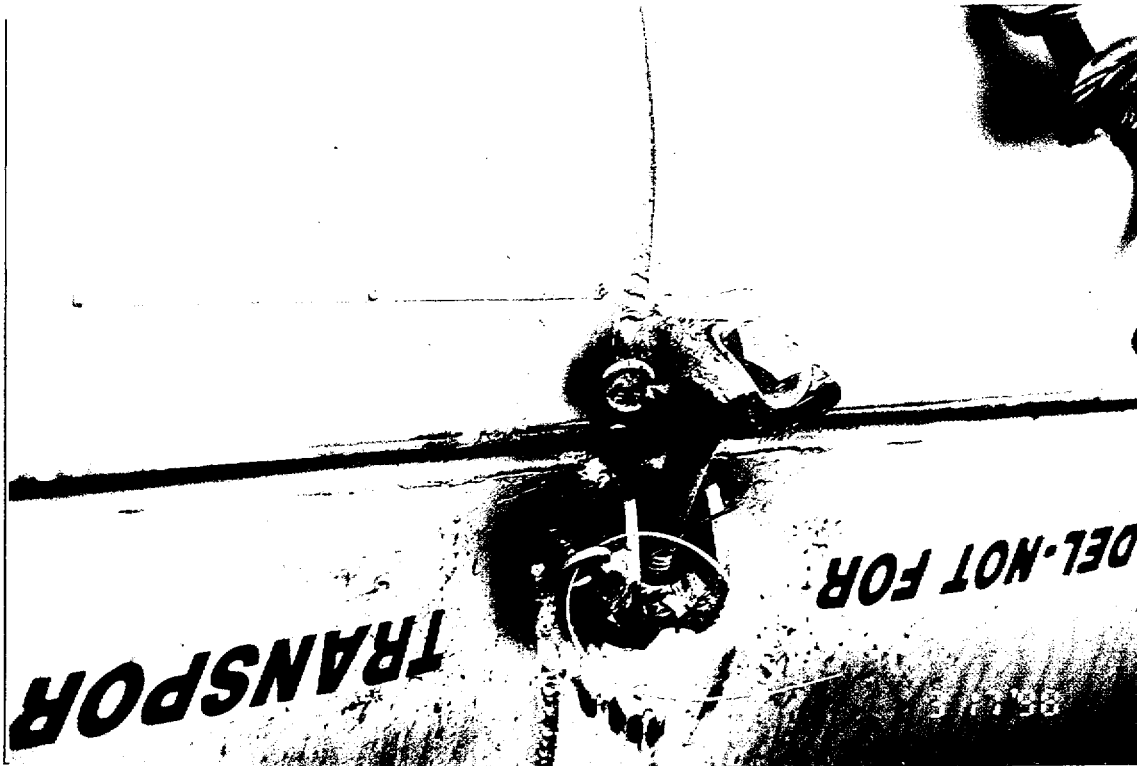
2.10.8p-18 ESP-30X Test Article #2 Damage After 40 Inch Puncture Drop

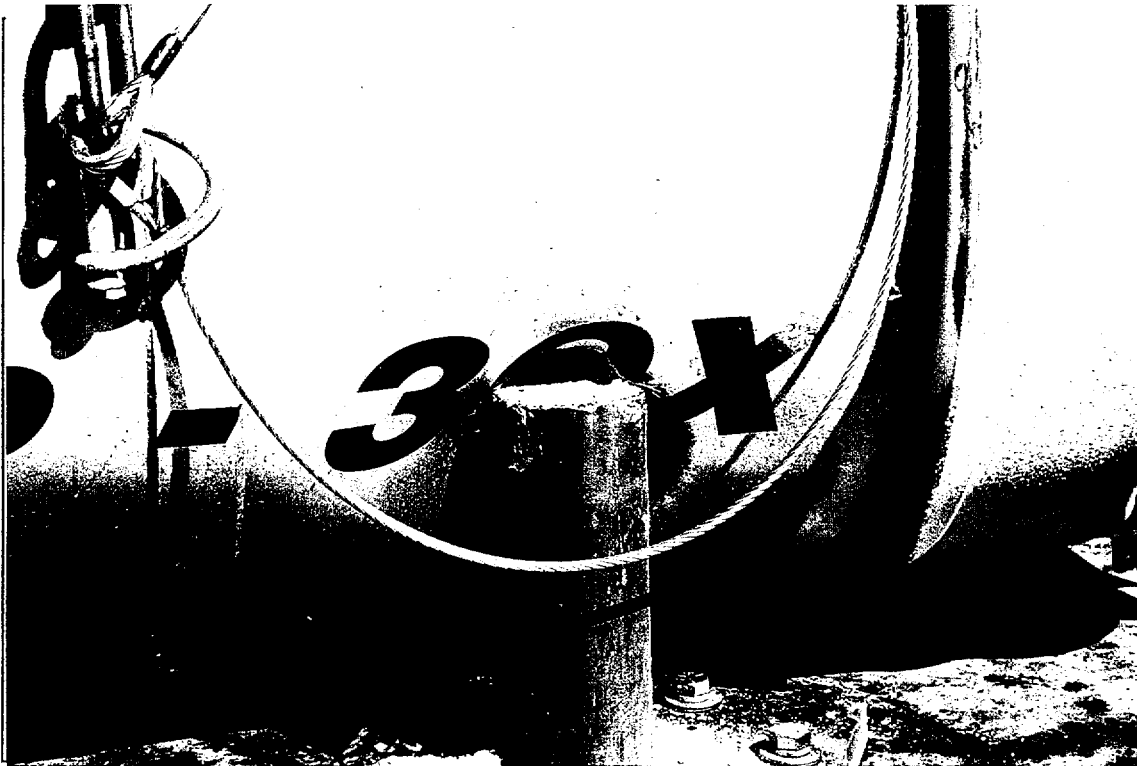
2.10.8p-20 ESP-30X Test Article #1 Damage After 40 Inch Side Puncture Drop
