Challenges and Capabilities for Inspection of Cast Stainless Steel Piping

**Structural Mechanics in Reactor Technology
(SMiRT 19)
August 12-17, 2007
Toronto, Canada**

Sponsored by: The U.S. NRC, Office of Research
Wallace Norris, Project Manager

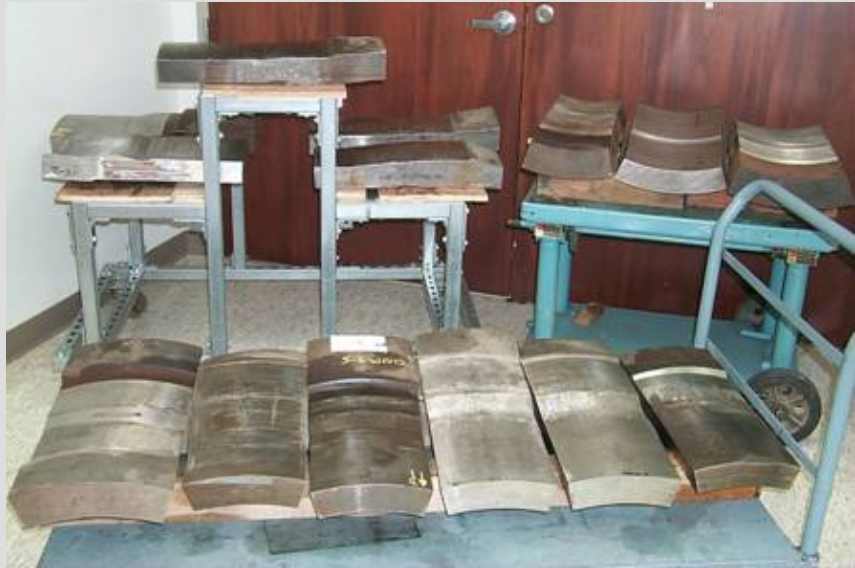
Westinghouse Owners Group Welded Specimens

- ▶ Varied OD/ID geometries and weld configurations:
 - Elbow-to-safe end
 - (SCSS – FGSS)
 - Pipe-to-safe end
 - (CCSS – FGSS)
 - Nozzle-to-safe end-to -pipe
 - (CS – FGSS – CCSS)
 - Pipe-to-elbow
 - (CCSS – SCSS)
- ▶ Mixed/coarse grain structures in pipes and elbows
- ▶ Note OD/ID geometries
- ▶ Grain size 0.2 – 16.7 mm

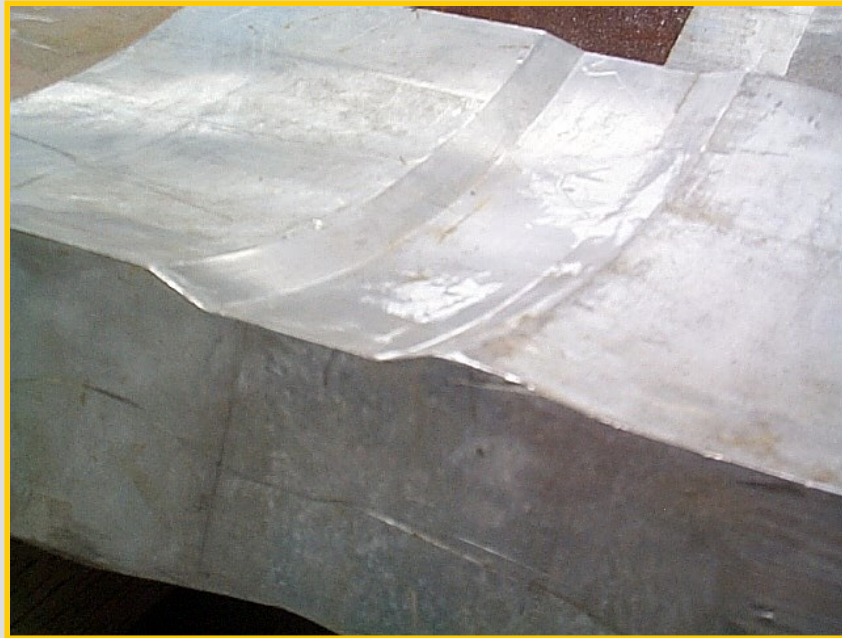
Eddy Current Inspection on the ID Using Plus-Point Probe

Eddy current testing (ET) from the inside surface of CSS pipe weld using a ZETEC MIZ-27SI instrument and a ZETEC Plus-point™ probe operating at 250 kHz; examined all WOG and selected PNNL specimens having MF and TF cracks
