Appendix C

SEM/EDS Data for Test #1, Day-30 Fiberglass and Filtrate

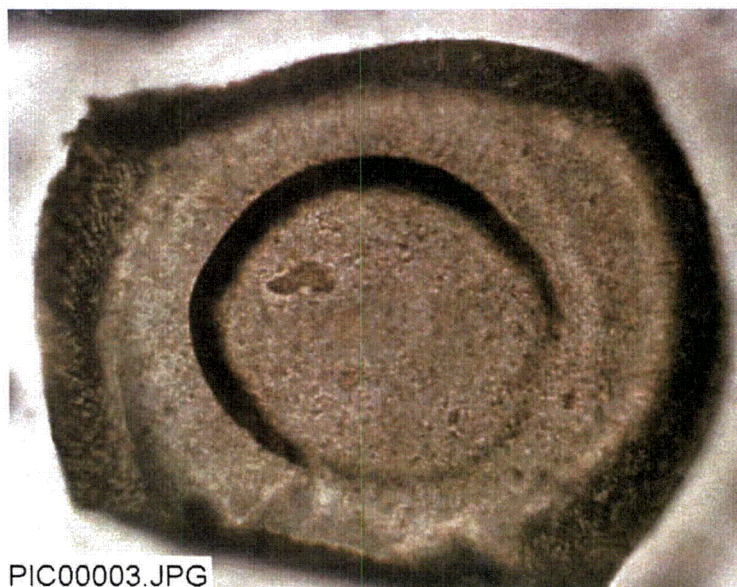
Figure C-5. Plane-polarized optical microscope photograph (PIC00003) for the Day-21 precipitation from the filtered water sample magnified 50 times on the single fragment with contraction dome, as shown in Figure C-4.

Frame	1	I.D.	PIC00001	× 10	scattered dry fragments
	2		PIC00002	× 10	desiccated fragments
	3		PIC00003	× 50	single fragment with contraction dome
	4		PIC00004	× 50	similar fragment at adjacent area
	5		PIC00005	× 10	general cracking pattern
	6		PIC00006	× 50	edge of previous area as in PIC00005 larger cracks in the interior and finer cracks near the edge

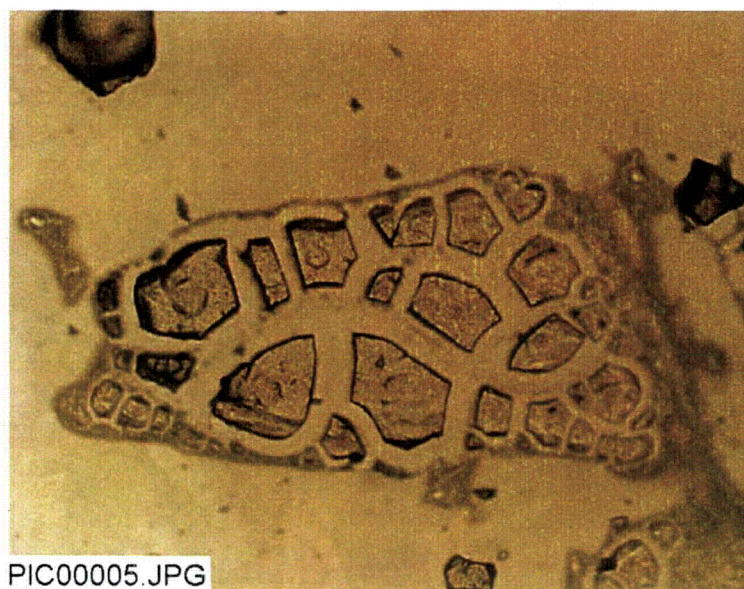
Figure C-7. Plane-polarized optical microscope photograph (PIC00005) for the Day-21 precipitation from the filtered water sample magnified 10 times on the dry fragments, showing the general cracking pattern.

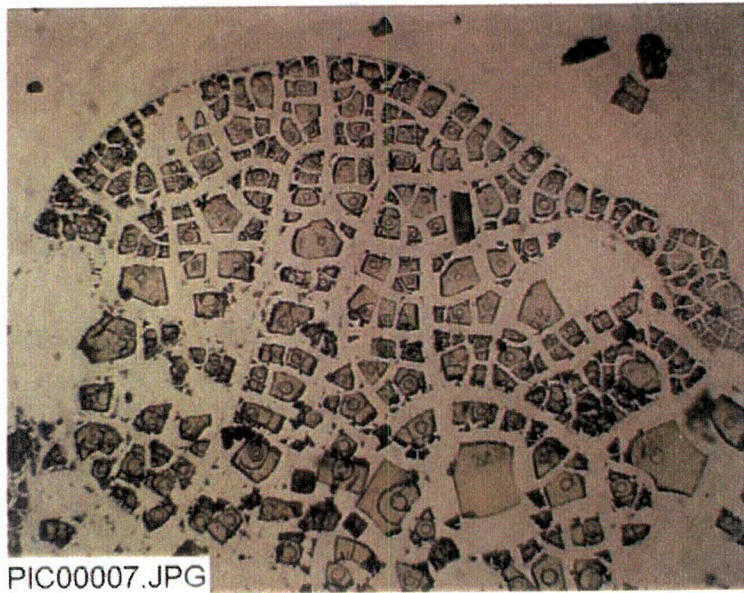
Figure C-9. Plane-polarized optical microscope photograph (PIC00007) for the Day-21 precipitation from the 46-ml high-volume filter magnified 2 times on the desiccated fragments.

Frame	7	I.D.	PIC00007	× 2	general desiccated fragments
	8		PIC00008	× 5	general desiccated fragments
	9		PIC00009	× 5	same field with cross polarized filters showing some evidence of crystal highlights
	10		PIC00010	× 5	same field with different exposure time
	11		PIC00011	× 10	similar contraction bubbles on desiccated fragments
	11b		PIC00012	× 50	zoom in on one of the contraction bubbles

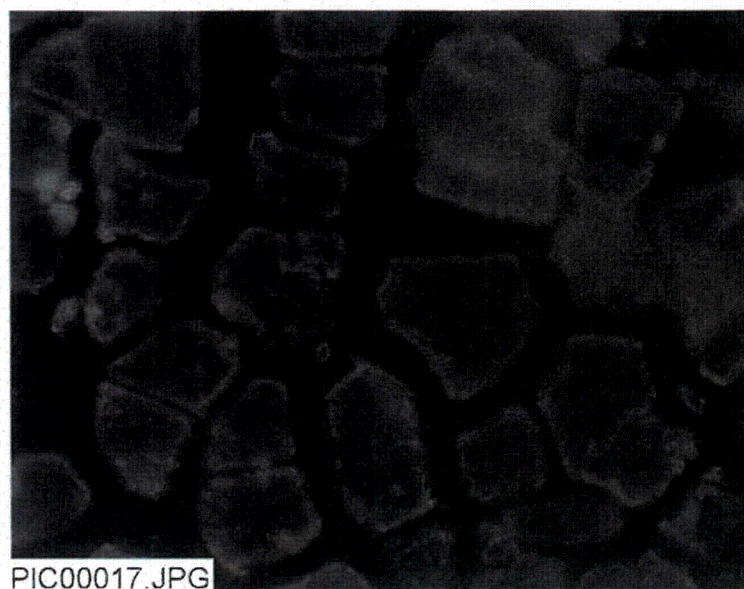
Figure C-19. Filtered optical microscope photograph (PIC00017) with a different exposure time from Figure C-18 for the Day-21 precipitation from the 1-l high-volume filter magnified 50 times on the dry flakes.

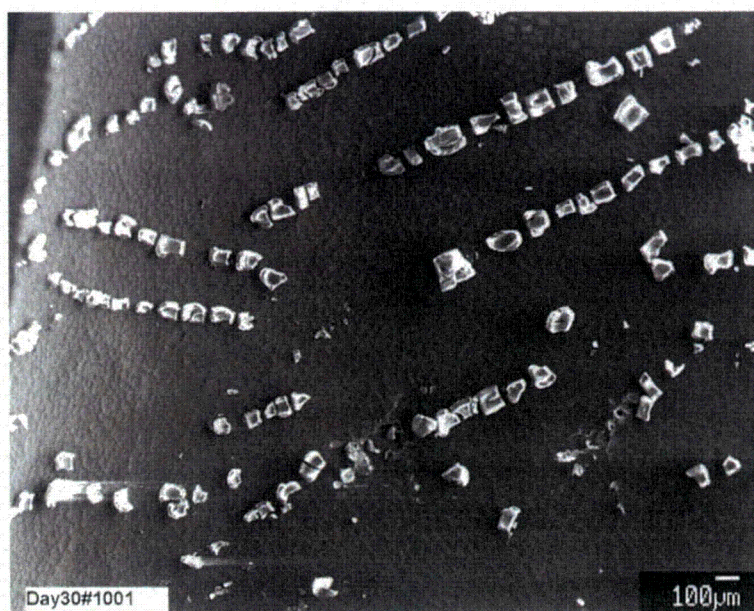
Figure C-20. Day-30, sample #1 SEM image (#1001) magnified 40 times on the string of blocky fragments.

Image:	Day-30 #1001	40 ×	on string of fragments
	Day-30 #1002	90 ×	string of blocky fragments
	Day-30 #1003	100 ×	string of blocky fragments
	Day-30 #1004	250 ×	close-up of fragments
	Day-30 #1005	500 ×	close-up of particles
	Day-30 #1006	1500 ×	surface of fragments
EDS:	1-1006		fragment in image 1006 showing Na, Al, O ₂ , Ca
	1-1006a		adjacent particles
	1-1006b		20-s exposure time—lower Na
	1-1006c		60-s scan for the same spot
Image:	Day-30 #1007	40 ×	filtrate on carbon-film substrate
	Day-30 #1008	100 ×	close-up of filtrate on carbon-film substrate
	Day-30 #1009	250 ×	close-up of filtrate on carbon-film substrate
EDS:	1-1009		carbon-film substrate in image 1009
Image:	Day-30 #1010	50 ×	area of filtrate
	Day-30 #1011	100 ×	area of filtrate
	Day-30 #1012	250 ×	area of filtrate
	Day-30 #1013	500 ×	area of filtrate
EDS:	1-1013		analysis of filtrate on carbon-film substrate
	1-1013a		analysis of filtrate on carbon-film substrate
