Integrated Chemical Effects Test Project: Test #2 Data Report

Los Alamos National Laboratory

**U.S. Nuclear Regulatory Commission
Office of Nuclear Regulatory Research
Washington, DC 20555-0001**

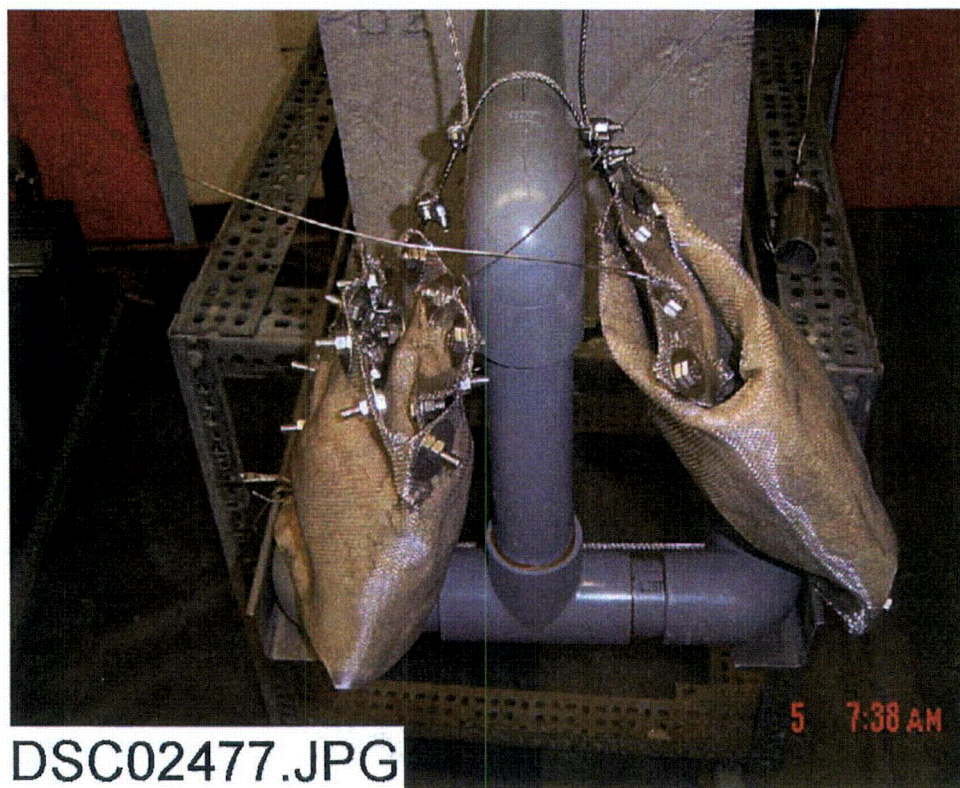
Figure 3-4. Fiberglass samples attached to the submerged coupon rack.

Several fiberglass samples were placed in the ICET tank. Samples were either submerged below the water level or held above the water level. The unsubmerged fiberglass samples were positioned so they would be exposed to sprays. The fiberglass samples were contained in stainless steel wire mesh that allowed water flow, while confining the fiberglass material. Both loosely-packed and more tightly packed samples were used. In addition, some submerged fiberglass samples were located where they would be exposed to relatively high-flow conditions and others were located in regions of the tank with quiescent conditions. Figure 3-4 illustrates the so-called sacrificial fiberglass samples in wire mesh pouches attached to the submerged coupon rack (Rack 1 in Figure 3-2). Each pouch contains approximately 5 g of fiberglass. Those samples were attached with SS wire and removed from the tank midway through the test and examined. Bigger insulation bags, those that resemble the two saddle bags in the figure, were wrapped around the sacrificial specimens during the test. See Section 3.3.1 for descriptions of other fiberglass samples.

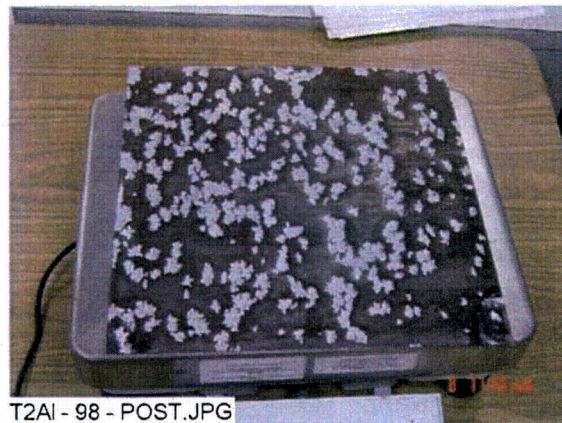
Figure 4-7. AI-98 submerged, post-test.

According to SEM/EDS results, the dominant corrosion products on the submerged aluminum coupons are likely aluminum hydroxide with other substances containing silicon, calcium, sodium, magnesium, phosphorus, carbon, and oxygen. In addition, evidence was found that some copper deposited on the submerged aluminum coupon surfaces. Comparing the redox potential (E^0) of Al^{3+} and Cu^{2+} , which is -1.662 and 0.3419 V (Ref. 6), respectively, Cu^{2+} in the solution may oxidize aluminum metal. As a result, aluminum metal may be oxidized into Al^{3+} and released to the solution. Correspondingly Cu^{2+} is reduced into metallic copper and subsequently deposits at the aluminum coupon surface.

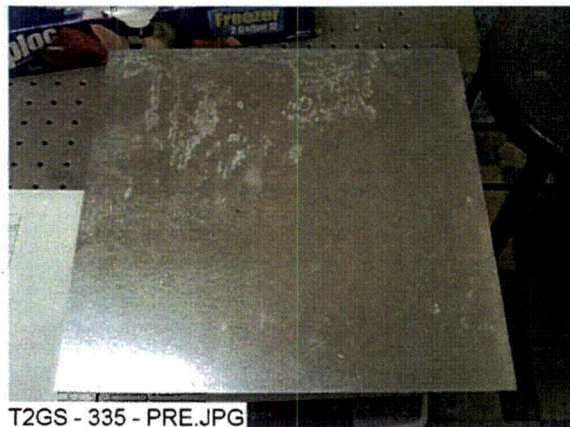
T2GS - 335 - PRE.JPG

Figure 4-8 through Figure 4-13 present the pre-test and post-test pictures of three submerged GS coupons. Each post-test GS coupon exhibits nearly identical patterns of dense gray particle deposits. The relative spatial location of these coupons, given in order from the west side of the tank to the east side of the tank, is as follows: GS-337, GS-338, and GS-335. There is no discernable relationship between the spatial location of the coupons and particle deposition patterns or density. For the submerged GS coupons, the possible corrosion products are phosphoric and carbonate compounds of zinc and calcium.

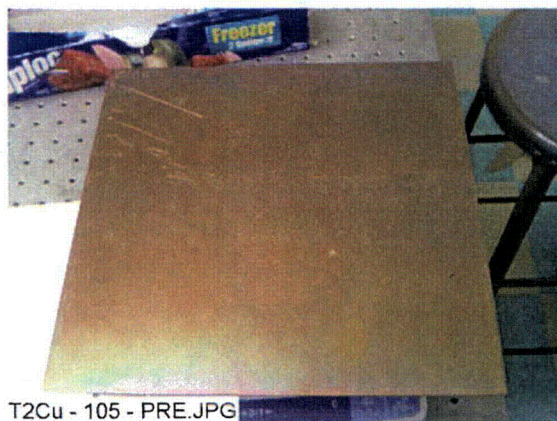
T2Cu - 105 - PRE.JPG

Figure 4-18 through Figure 4-21 present the pre-test and post-test pictures of two submerged copper coupons. Each post-test copper coupon exhibits similar patterns of white, streak-like deposits. The deposition streaks are almost perfectly horizontal and are more highly concentrated for coupon Cu-123. Different corrosion effects are visible at the contact points. The Cu-123 coupon is located on the west side of the tank in relation to the Cu-105 coupon. The Cu-105 coupon appears to have a greater distribution of these white, streak deposits. For submerged copper coupons, the possible corrosion products include CuO , $\text{Cu}_2(\text{CO}_3)(\text{OH})_2$, $\text{Mg}_3(\text{PO}_4)_2$, and substances containing magnesium, copper, sodium, aluminum, calcium, carbon, and oxygen.

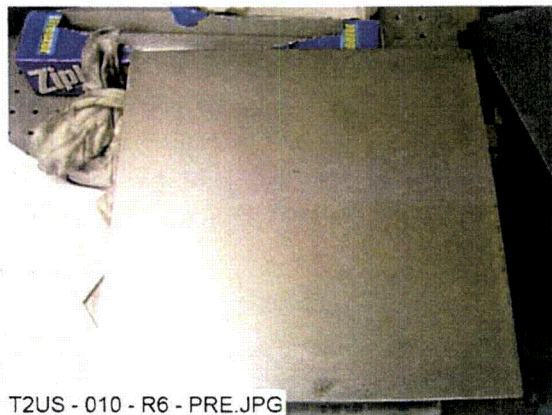
T2US - 010 - R6 - PRE.JPG

Figure 4-42 and Figure 4-43 present the pre-test and post-test pictures of one unsubmerged carbon steel coupon. The post-test carbon steel coupon exhibits a reddish-brown color and significant corrosion around the edges. The color is similar to that of the submerged carbon steel coupon, although the corrosion does not appear to be as severe as on the submerged coupon. The US-10 coupon was loaded in Rack 6, which was in the center position of the tank's top tier.

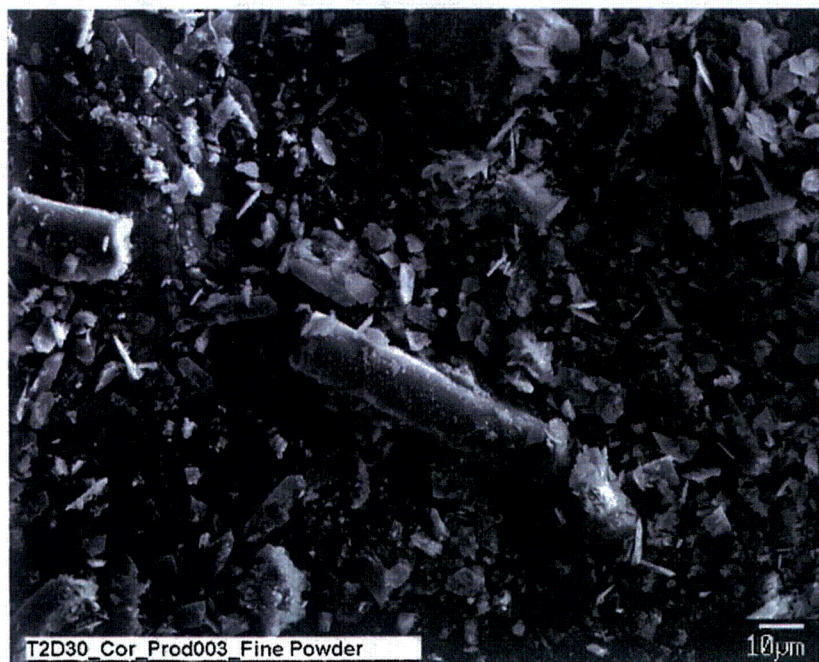
Figure B-4. Another SEM image at 650× magnification for a Test #2, Day-30 sample of fine powder on a vertical piece of the submerged PVC rack. The cylinder-shaped debris is likely to be fiberglass. (T2D30_Cor_Prod003_Fine Powder)

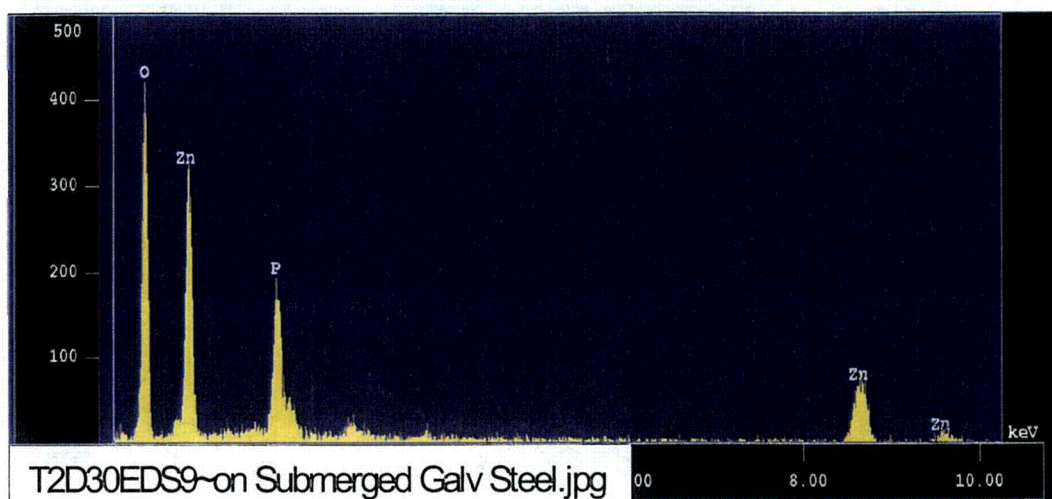
Figure B-18. EDS counting spectrum collected from the spot EDS9 indicated in Figure B-17. (T2D30EDS9~on Submerged Galv Steel)
