### **Beaver Valley Power Station, Unit No. 2 License Amendment Request No. 07-007**

# **WOG PA-MSC-0190, Revision 1: Test Results Related to TIG and Alloy 800 Sleeve Installation in 3/4 Inch and 7/8 Inch OD SG Tubing In-Service Inspection Requirements**

**SG-SGDA-05-48-NP**

**January 2006**

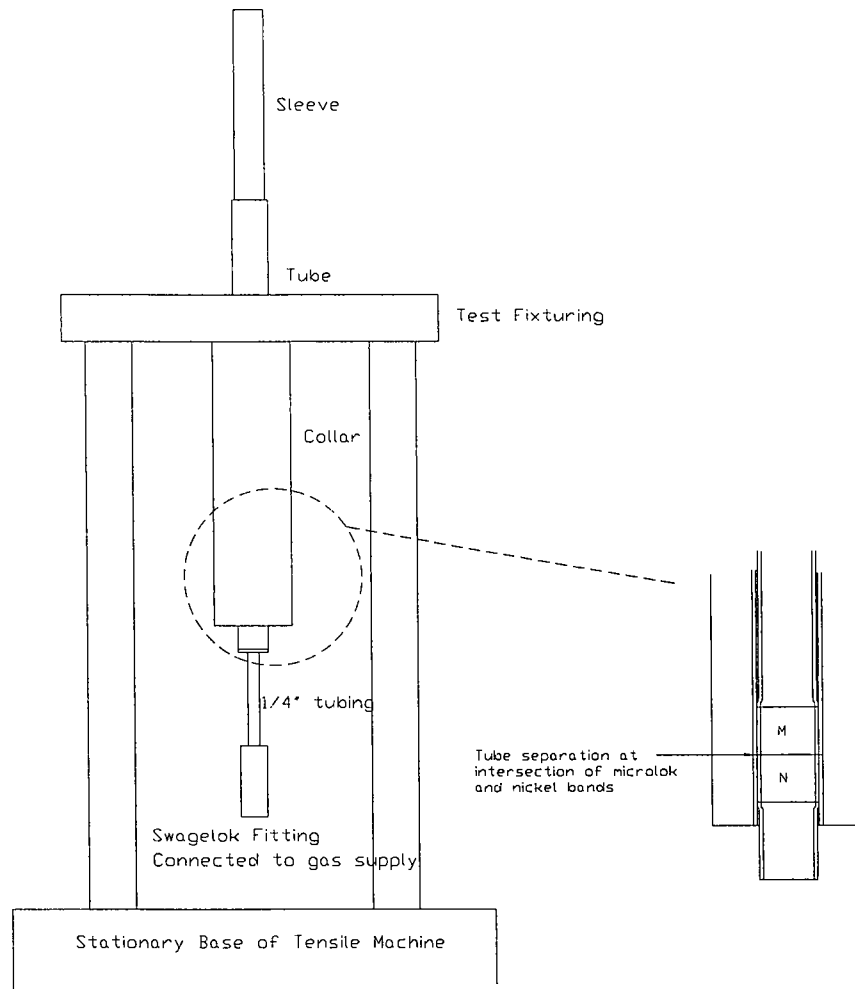
**Figure 2-1 Schematic of Tensile Test Setup**

The first of these programs involved tensile testing of Alloy 800 sleeves installed in full depth mechanical roll expanded joints using 3/4" OD x 0.043" wall thickness tubing. These specimens simulate the condition at Comanche Peak Unit 1 and Watts Bar Unit 1. These specimens were configured to simulate a complete separation of the tube adjacent to the intersection of the microlok and nickel band regions. Figure 2-1 presents a schematic of the test configuration.

The specimens were prepared by rolling a mill annealed Alloy 600 tube section into a 1018 carbon steel tubesheet simulant collar with one end of the tube inserted from the secondary side of the collar to 0.75 inch from the primary face of the collar. A second tube section was inserted into the collar to contact with the first section and rolled in place. The roller and roll torque used are consistent with the original SG manufacture. This configuration simulates a complete circumferential separation of the parent tube.

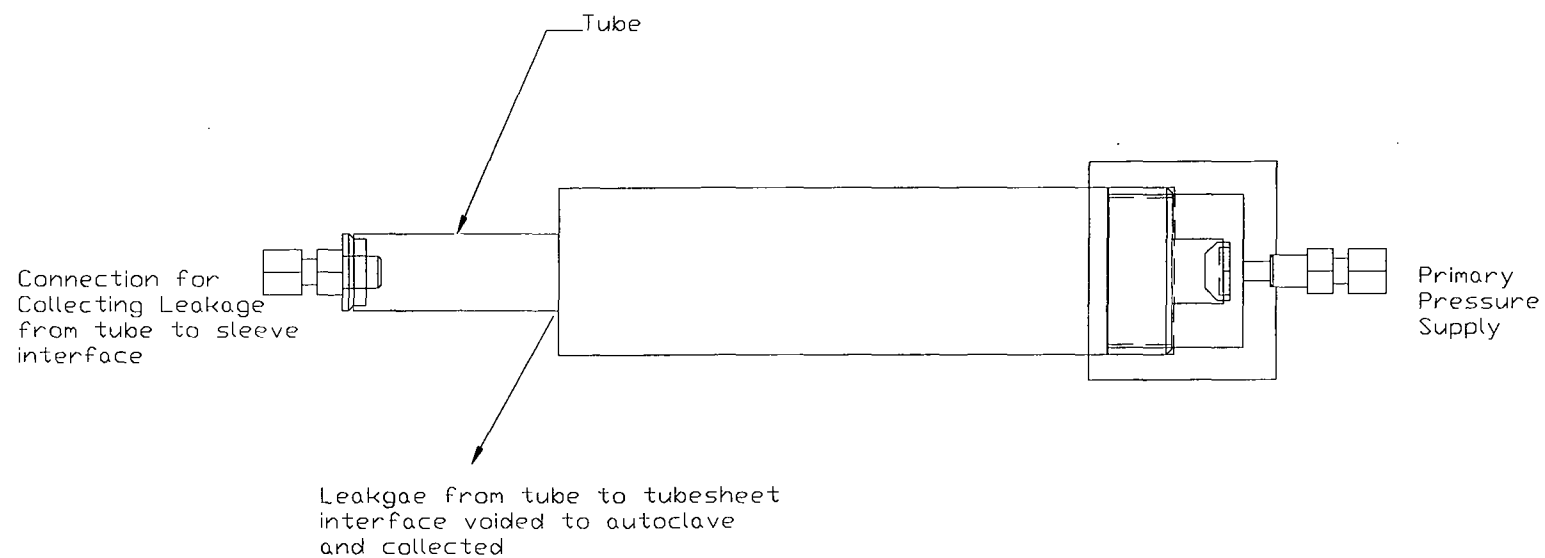
**Figure 3-1 Leak Specimen Configuration**

The leak specimen configuration is shown in Figures 3-1, 3-2, and 3-3. The specimens were configured such that the primary fluid communicated with both the tube to collar and tube to sleeve joint regions. Two 1/16 inch diameter holes were milled through the collar to the point where the full mill diameter affected the sleeve OD surface. A 1/8 inch diameter hole was milled to a depth where the full mill diameter affected the tube OD surface. The sleeve was then deformed by staking to introduce a 0.001 to 0.003 inch separation from the tube ensuring that the primary fluid had a direct path to the sleeve to tube joint interface. The hole locations were such that the edge of the hole was consistent with the microlok to nickel band interface. Leak test primary to secondary pressure differentials used were 1500 psi and 2560 psi. Figure 3-3 presents a schematic of the leak test sample modification to permit primary fluid communication with both the tube to tubesheet and tube to sleeve interfaces. In addition, the end of the sleeve inside of the end cap was plugged, thus there was no pressure inside of the sleeve. Any pressure expansion benefit upon the sleeve to tube interface was not included. Also, due to the manner in which the primary fluid was delivered to the sleeve to tube interface, the direction of the pressure developed forces act to keep the sleeve to tube interface open to the primary fluid.

The specimens were first leak tested at room temperature at pressure differentials of 1500 and 2560 psi. The primary fluid used was deaerated to prevent oxidation of the carbon steel collars in the tube to tubesheet crevice region and included additional additives to simulate reactor coolant fluid. Previous testing has shown that the thermal expansion characteristics of the sleeve in tube and tube in collar configuration will result in increased contact pressures at elevated temperature, thus resulting in a lesser leak rate at elevated temperatures. Any specimen that leaked at room temperature was also leak tested at 600°F in a high pressure autoclave.

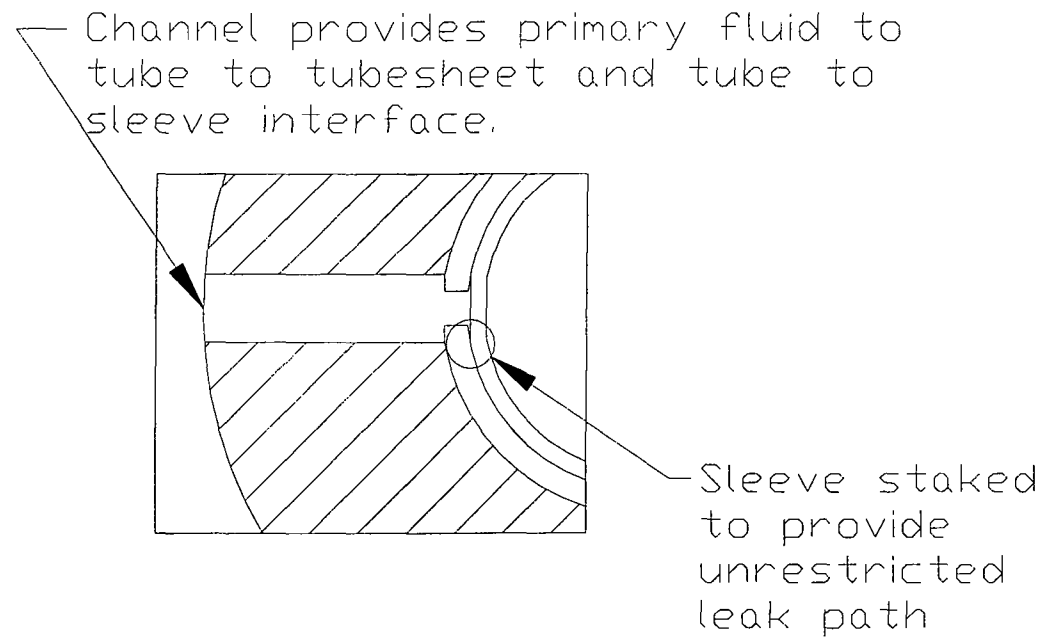
**Figure 3-3 Details of Leak Path Configuration**

Sleeve ID is capped thus applied primary fluid pressure tends to keep leak path open

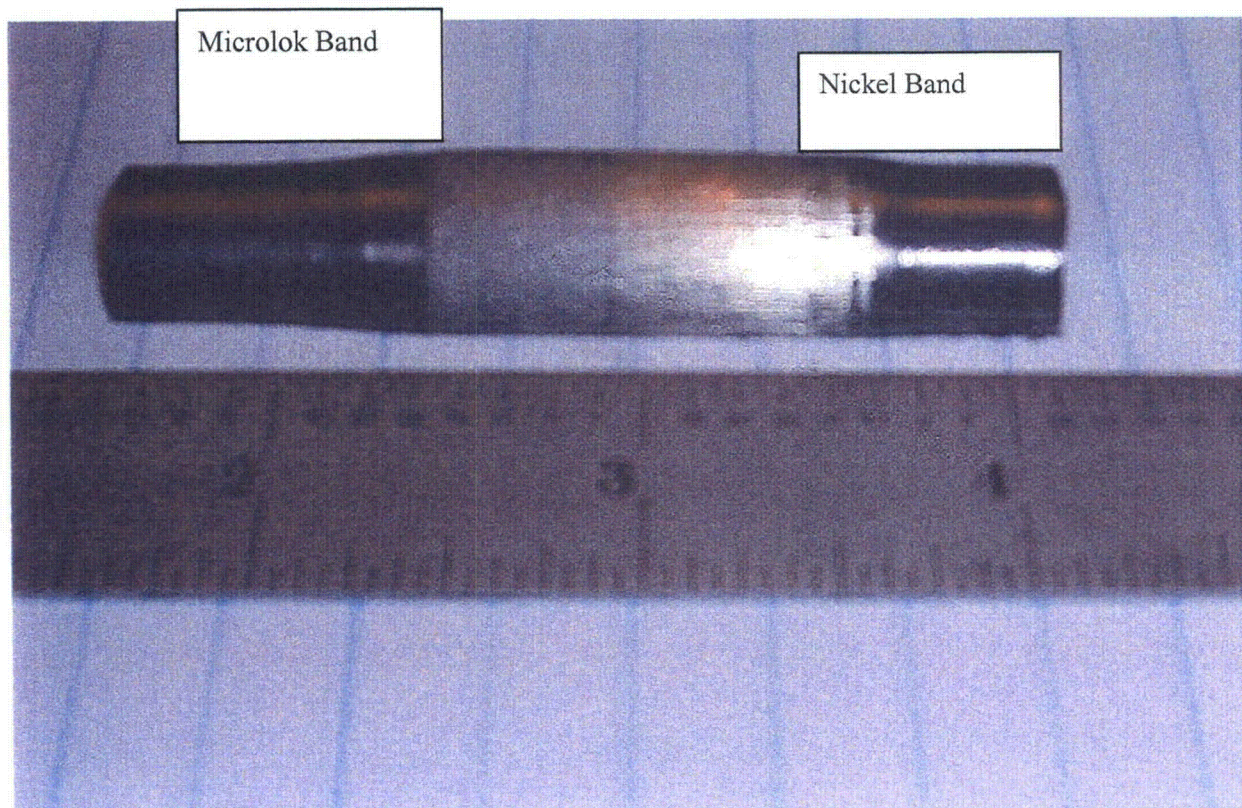
**Figure 5-2 Specimen CE Tensile-03 Post Pull Sectioning**

Following tensile testing several specimens were sectioned to examine the condition of the microlok and nickel bands after displacement within the tube. A photograph of the sleeve from C-E Tensile-03 is included as Figure 5-2. The microlok band appears to be relatively unaffected by the displacement. This helps to establish the integrity characteristics of the microlok region. A 7/8 inch OD tube specimen was also sectioned; the appearance of the microlok region is similar as shown in Figure 5-2.

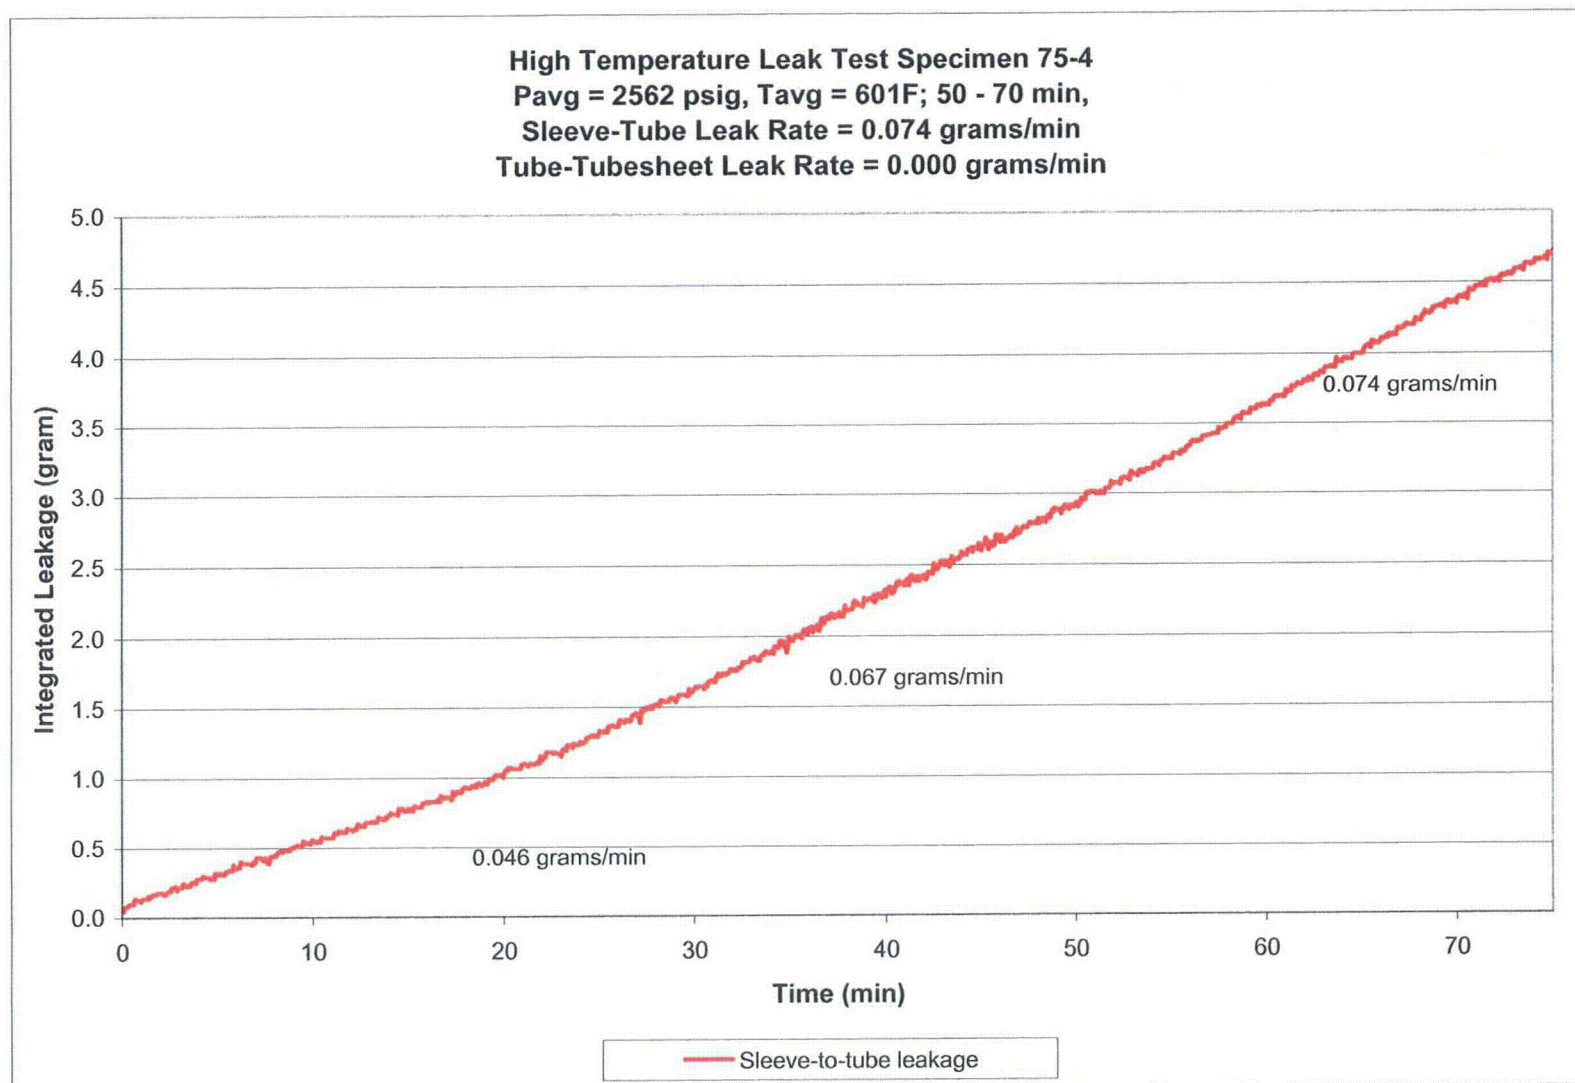
**Figure 6-1 Integrated Leak Rate History of Specimen 75 Leak-4: 2560 psi Differential Pressure**

For all room temperature leak rate tests at a pressure differential of 2560 psi, the maximum observed value of  $9 \times 10^{-5}$  gpm is so small that any postulated leakage from sleeved tubes will have no meaningful impact upon allowable leakage comparison of the operational assessment. The high temperature leak rate for this sample was reduced to  $2 \times 10^{-5}$  gpm. Note also that this specimen utilized EDM notched tubing.
