Shaw Stone & Webster Report

**LINER EVALUATION DEGRADATION
FINAL REPORT TRANSMITTAL
BEAVER VALLEY REPLACEMENT STEAM GENERATOR PROJECT**

Containment Liner Degradation
First Energy Nuclear Operating Company
Beaver Valley Unit 1
Revision 0

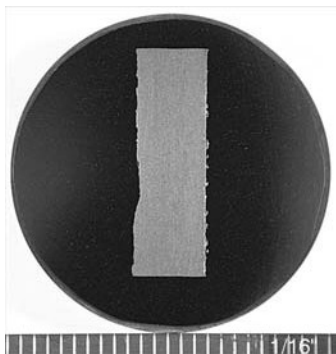
MOUNT #1
THE ESTIMATED MINIMUM
WALL THICKNESS IS $\sim 19/64$ "
(0.296").

FIGURE 14, SAMPLE "A", 1ST METALLOGRAPHIC SAMPLES, 2% NITAL MACRO-ETCH.
ALL SAMPLES ORIENTED BASED ON THE AS-RECEIVED "TOP" MARKING.
THE ESTIMATED UNAFFECTED "NOMINAL" WALL THICKNESS OF THE PLATE IS $\sim 3/8$ ".

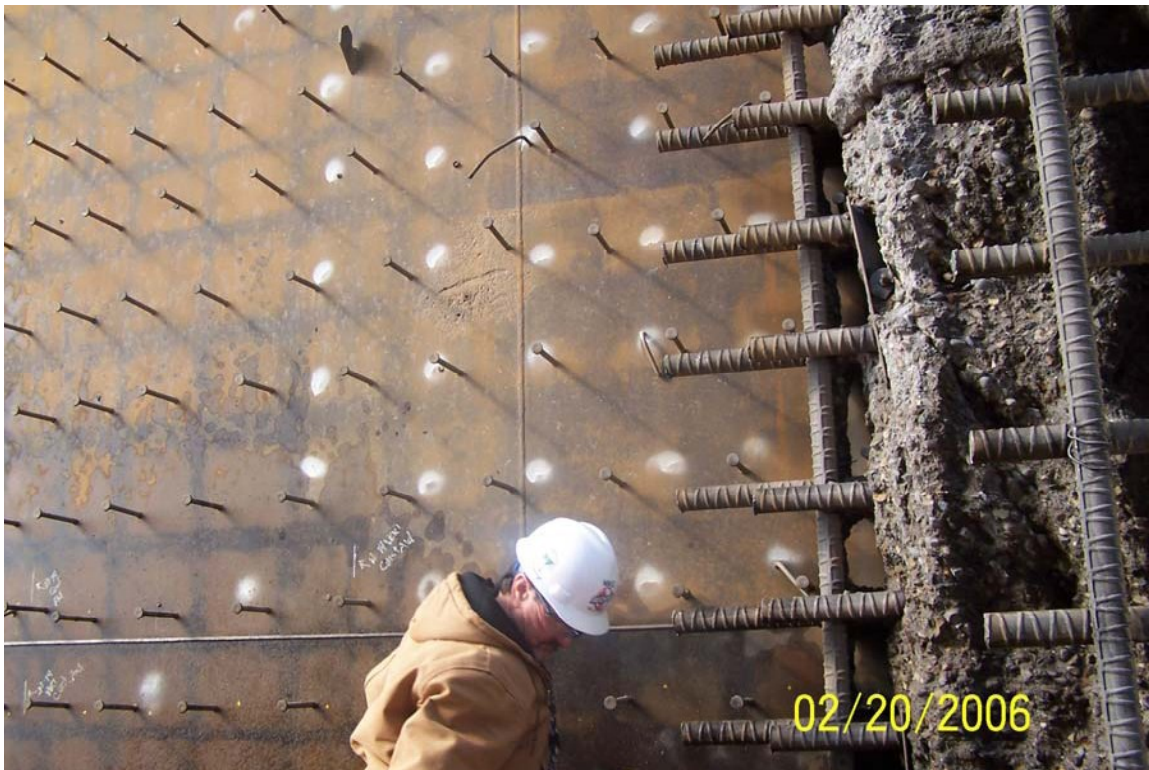
Figure 1: BV-1 Containment Construction Opening (Area 2)

The light and dark geometric patterns on the liner plate (Figures 1 and 2) appear to be the result of the hydrolasing method. The areas between the reinforcing steel were subject to the full hydrolasing blast, consisting of nozzle water pressure on the order of 20,000 psi, whereas the areas behind the reinforcing steel was shadowed from the direct blast. The shadowed area allowed for the concrete removal while minimizing the removal of surface oxidation. The lighter surface area is similar to a surface prepared using SSPC-SP6 Commercial Blast Cleaning.

“Observation of the exposed backside of the containment liner plate following hydrolasing revealed two areas of degradation. (See Figures 1, 2 and 4). The degradation comprised general surface pitting that varied in depth and diameter over each of the areas (approximately 16 inches by 18 inches each). Additionally, one area (Area 2) exhibited a continuous depression of 7 to 9 inches in length and ½ to ¾ inches in width. The areas were approximately 15 feet distant from one another, and approximately 10 feet above the work platform surface (EL. 765+).”

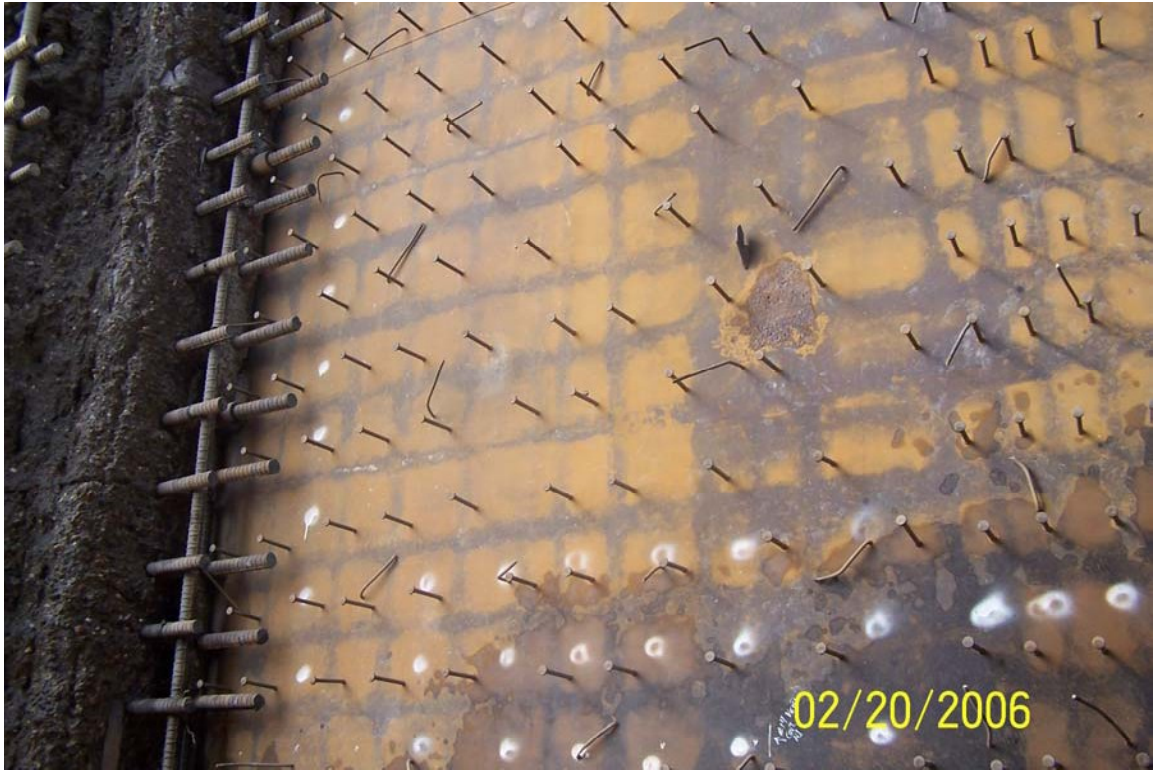
Figure 2: BV-1 Containment Construction Opening (Area 1)

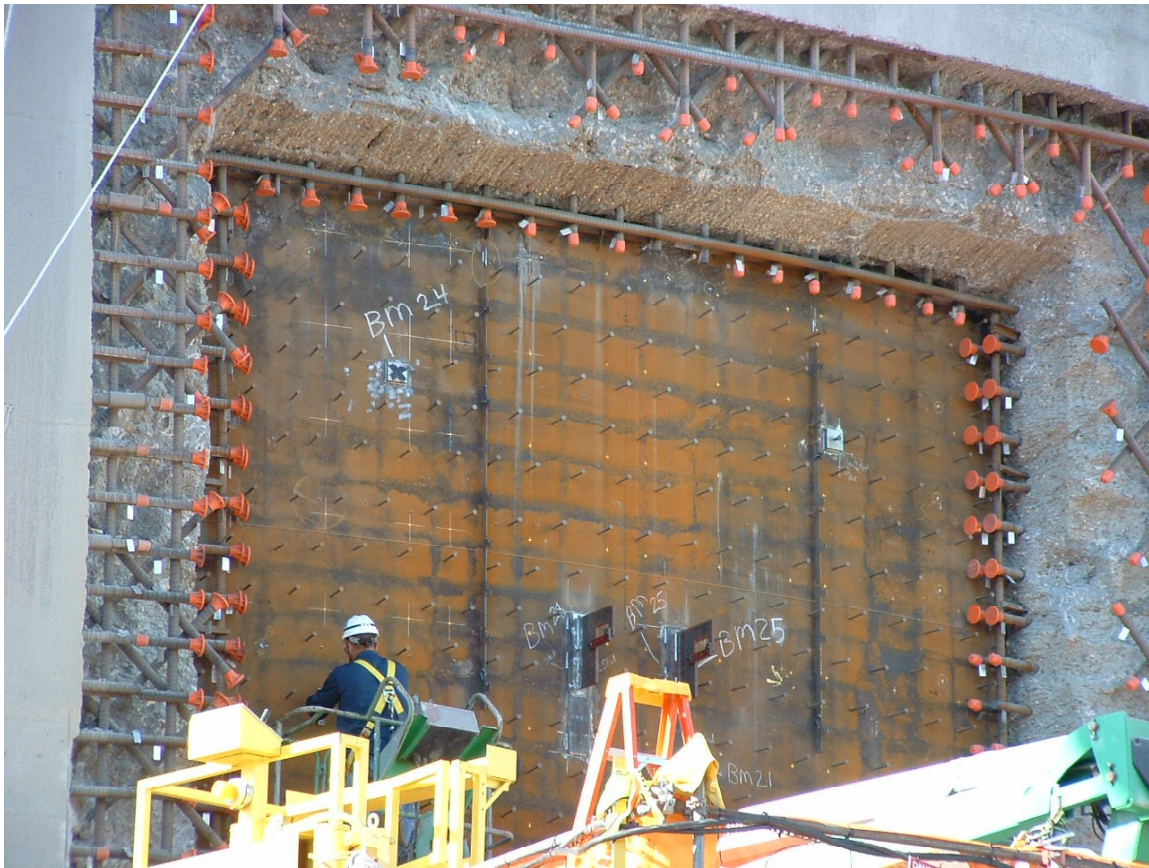
Figure 3 presents similar patterns present at another site during their NSSS component replacement. The concrete area was also removed using the hydrolasing method.

Figure 3: Containment Construction Opening at Another Site

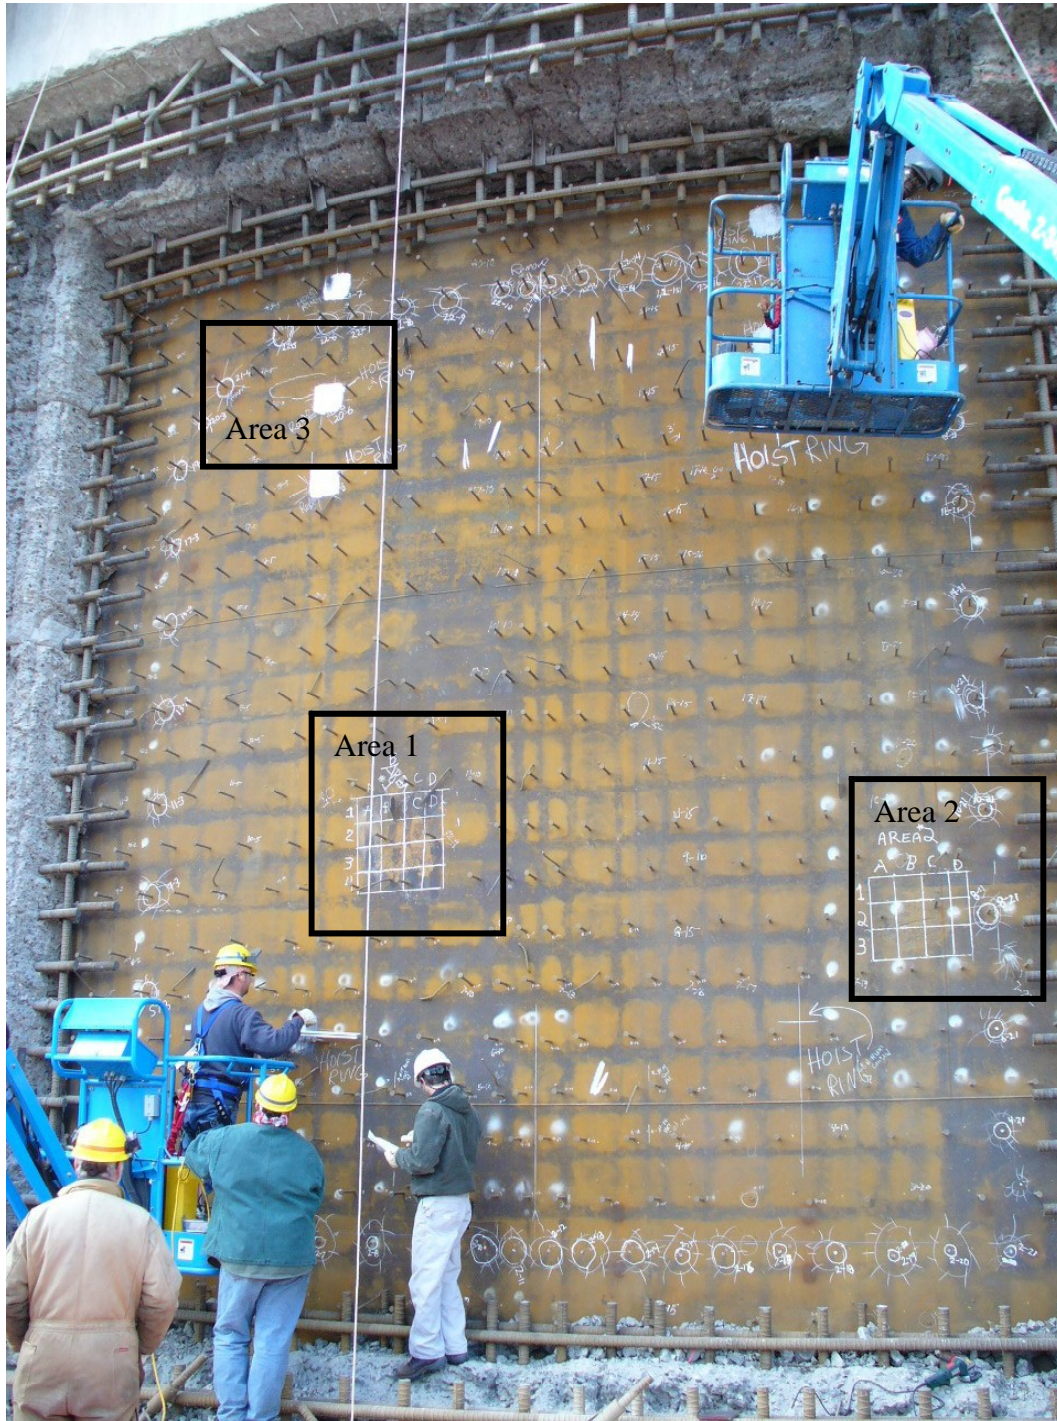
Figure 4 shows the general configuration of the construction opening and several areas where degradation was observed.

Figure 4: Layout of the Construction Opening and Areas of Interest

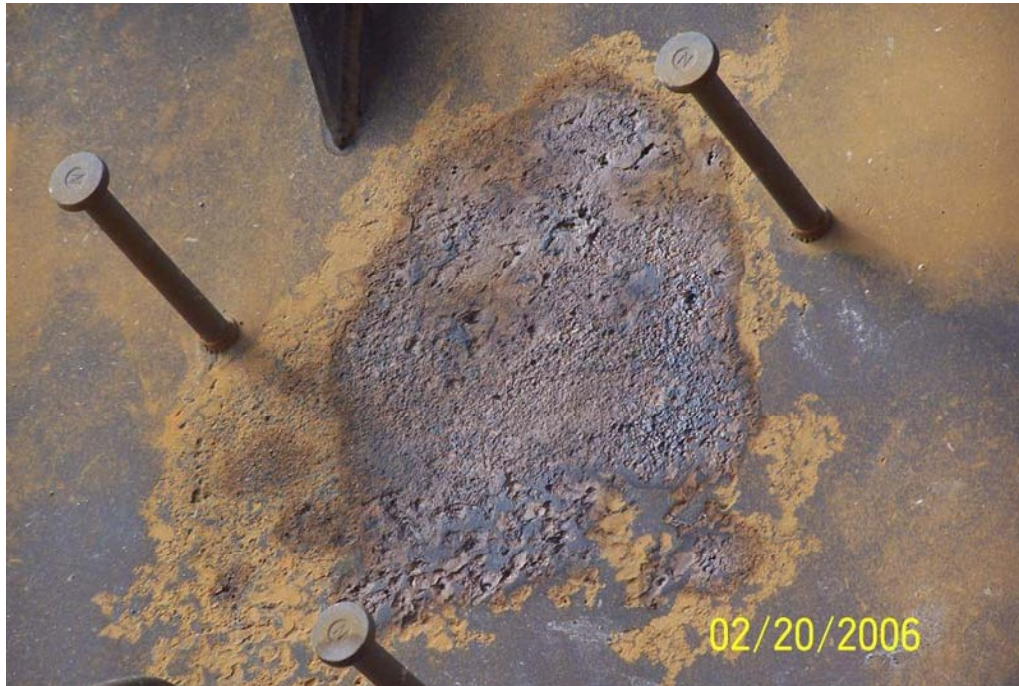
Three regions of degradation were found; of which only two areas were determined require further evaluation. Based on visual observations local pitting and general areas of liner thinning were present. The maximum pit depth was approximately one half wall thickness. These regions of degradation are presented in Figures 5 to 7.

Figure 5: Area 1, Degradation within the BV-1 Containment Construction Opening

The outside surface of the containment liner was exposed to varying environmental conditions during construction and operation, which may contribute to the conditions observed in Figures 5, 6, and 7.

Figures 5, 6 and 7 and FENOC UT Erosion/Corrosion Examination reports, BOP-UT-06-025 and 026, document the results of UT scanning of the two areas of interest. The reports show the deepest pit in Area 2 resulting in a liner thickness of 0.151 inches where the surrounding plate thickness is 0.376 inches. The deepest pit in Area 1 results in a liner thickness of 0.225 inches. Both pits are on the order of $\frac{1}{4}$ ” to $\frac{3}{8}$ ” inches in diameter as described in the two Examination Reports. The extent of the general thinning in Area 1 has bounding dimensions of 10” x 2” with a liner thickness of 0.30 inches and the continuous depression in Area 2, described in CR-06-01122 above, has a liner thickness of 0.30 inches with isolated pits having a reduced liner thickness of 0.25 inches. In general, the liner plate was essentially free of degradation as seen in Figures 1, 2, and 4, indicating that the concrete acts to mitigate corrosion of the carbon steel liner, and the corrosion processes are isolated.

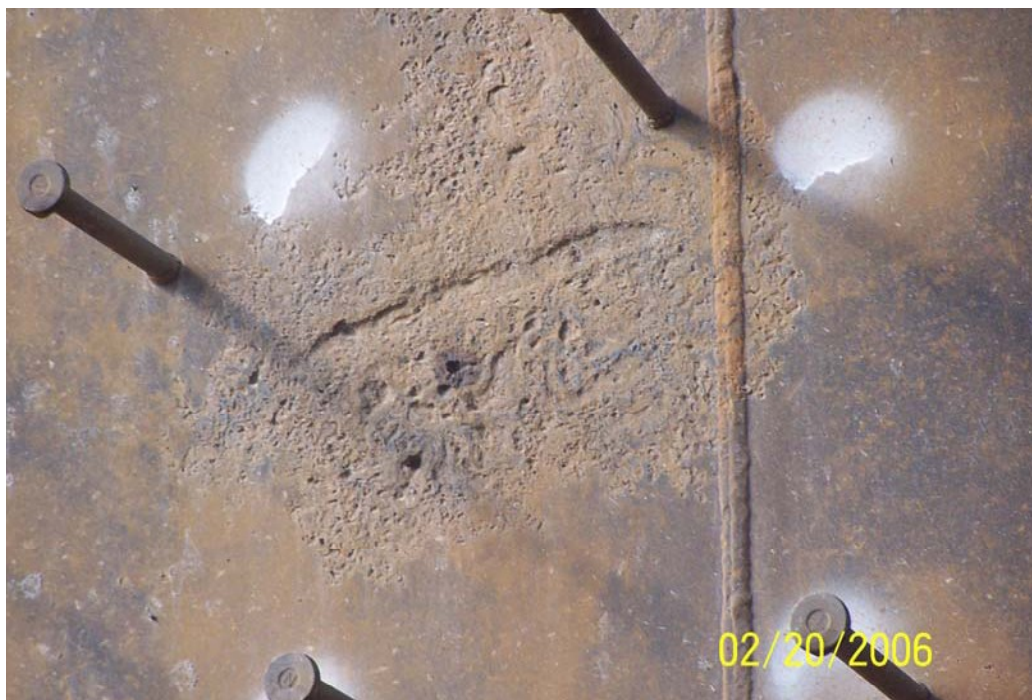
Figure 6: Area 2, Degradation within the BV-1 Containment Construction Opening

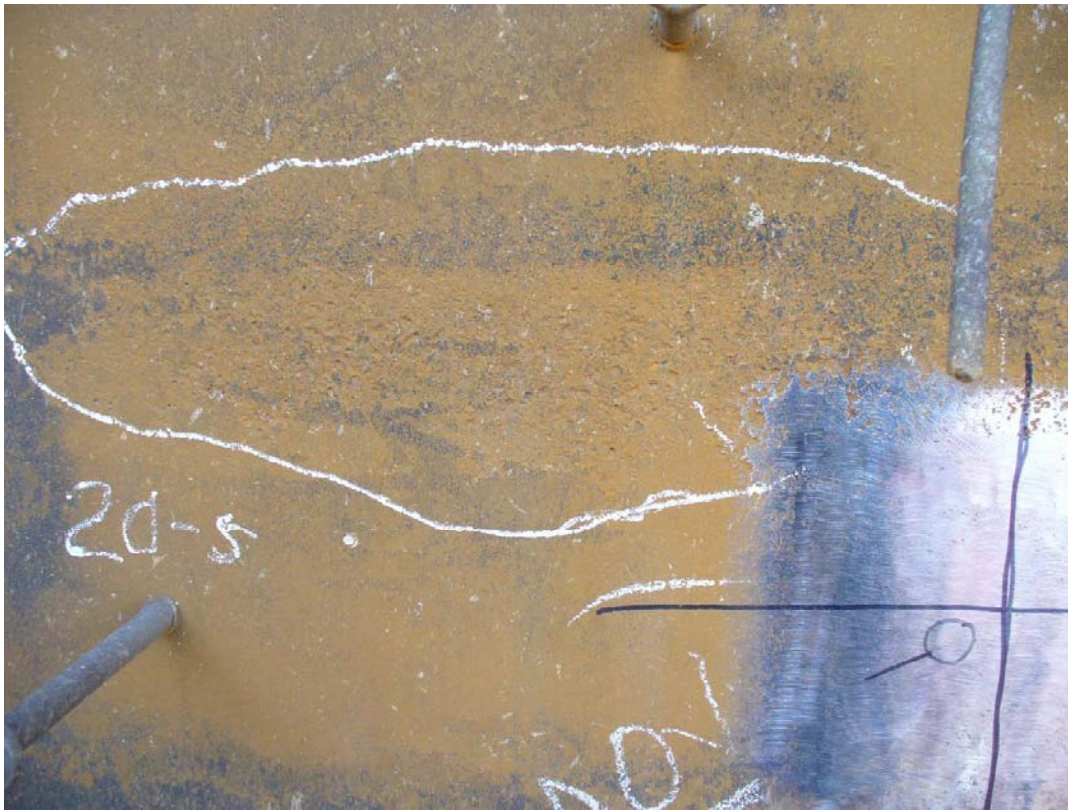
Figure 7: Area 3, Oval of General Near Surface Corrosion within the BV-1 Containment Construction Opening

Since observed areas 1 and 2 have been repaired by replacement, only degraded Area 3 should be mapped on the inside of the containment liner. As discussed above, this area is to be UT examined with the area of minimum thickness clearly marked for future examinations. The area is to be examined the next 3 inspection periods. If no change the area will require no additional inspections. If a change is noted another engineering evaluation shall be performed.
