U.S. NUCLEAR REGULATORY COMMISSION
REGION IV

Inspection Report: 70-925/95-01

Licensee: Kerr-McGee Corporation

Inspection At: Cimarron Facility, Crescent, Oklahoma

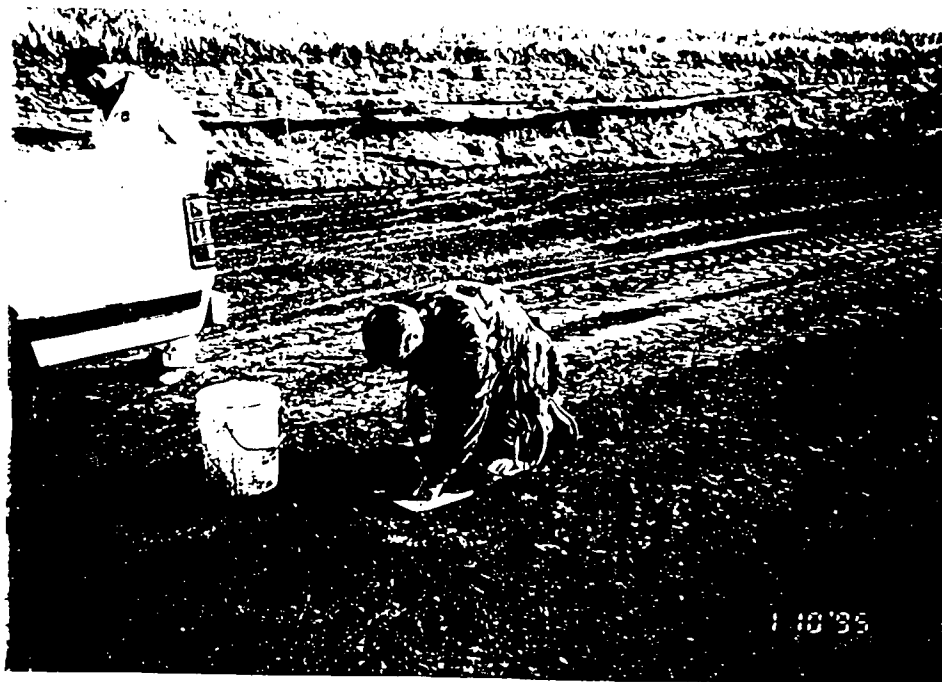
Photograph 2: Soil density testing in disposal cell (licensee supplied photograph)

License Condition 23.d requires the licensee to compact the soil in the disposal cell in lifts not to exceed one foot to 95 percent of maximum dry density. Also, density testing shall be performed over the entire lift thickness. Although soil density testing did not occur during the inspection, the licensee produced records that confirmed that each 1-foot lift met the specified requirements prior to installation of the subsequent lift.

When a 1-foot lift was completed, a contractor was used to verify that the soil was compacted to at least 95 percent of the maximum dry density for this type of soil. Testing was performed at eight locations for Lifts 1 and 2 while four tests were performed for Lift 3. Four tests per lift will be performed for subsequent lifts. Following confirmation that the soil was properly compacted, the next lift would commence. Airborne particulates were sampled using a portable aerosol detection meter. A water truck was available to spray water on the work areas as necessary to control dust. The licensee was keeping daily records of the number of dump truck loads of soil being transferred to the disposal cell.

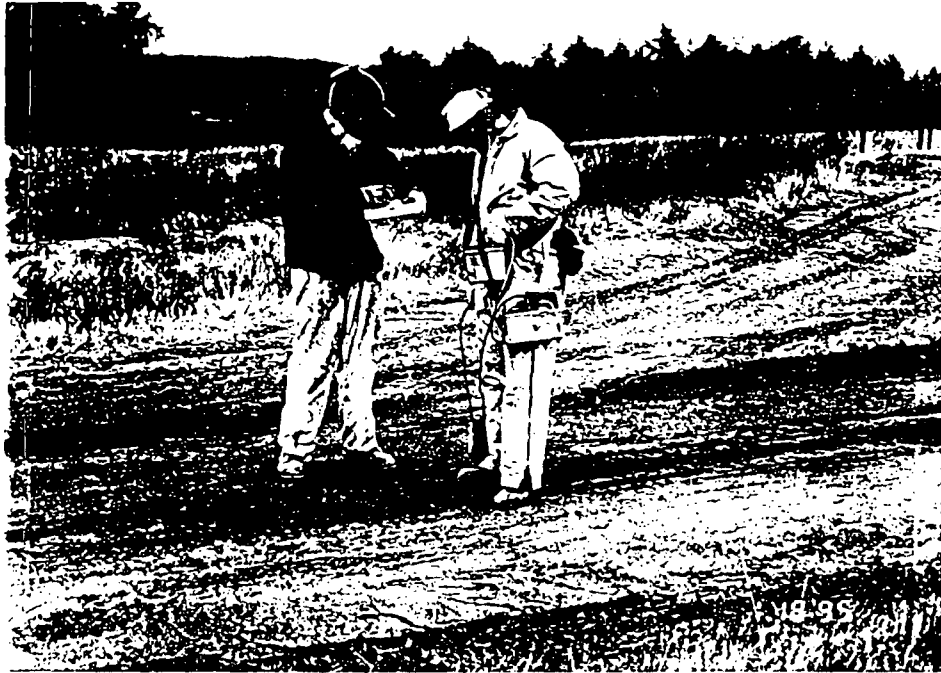
Photograph 3: Weekly survey of the road (licensee supplied photograph)

Radiological surveys were conducted within the restricted area to determine exposure rates and contamination levels. Surveys for radioactive materials included weekly surveys of the road used for the transfer of the contaminated soil, daily surveys of the radioactive exposure at the work locations using a microRoentgen per hour ($\mu\text{R/hr}$) meter, and daily equipment swipes/smears for contamination. With a background exposure rate of about 7 $\mu\text{R/hr}$, the soil being moved measured about 12 to 14 $\mu\text{R/hr}$. A weekly composite of soil samples from each dump truck's load was being collected for analysis. These sample results will be used to estimate the total activity of the contamination in the disposal pit. Split samples are being sent offsite for analysis for independent determination of the uranium, radium, plutonium, thorium, and their daughter product concentrations in the soil.

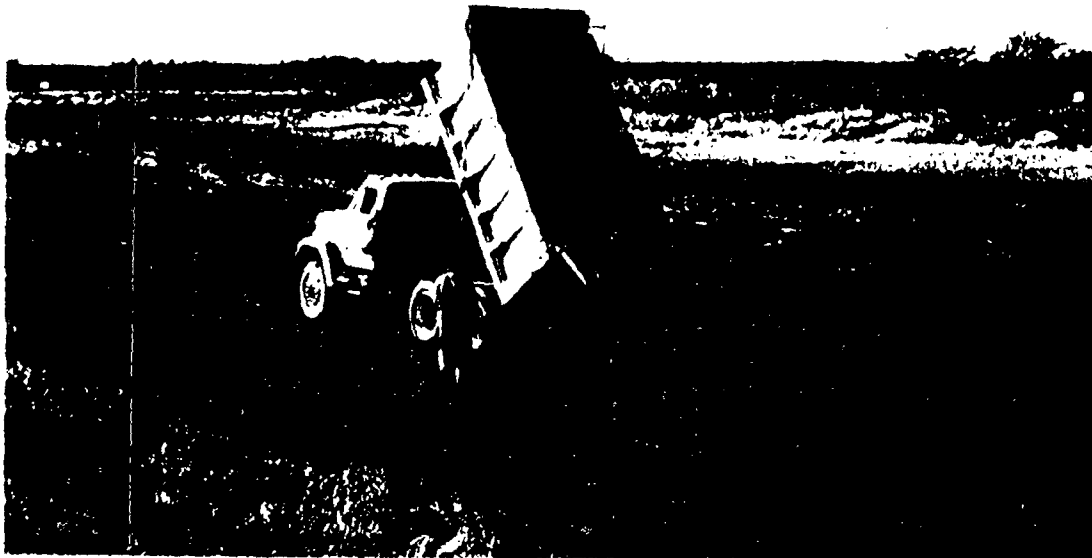
Photograph 10: Contaminated soil being unloaded into disposal cell

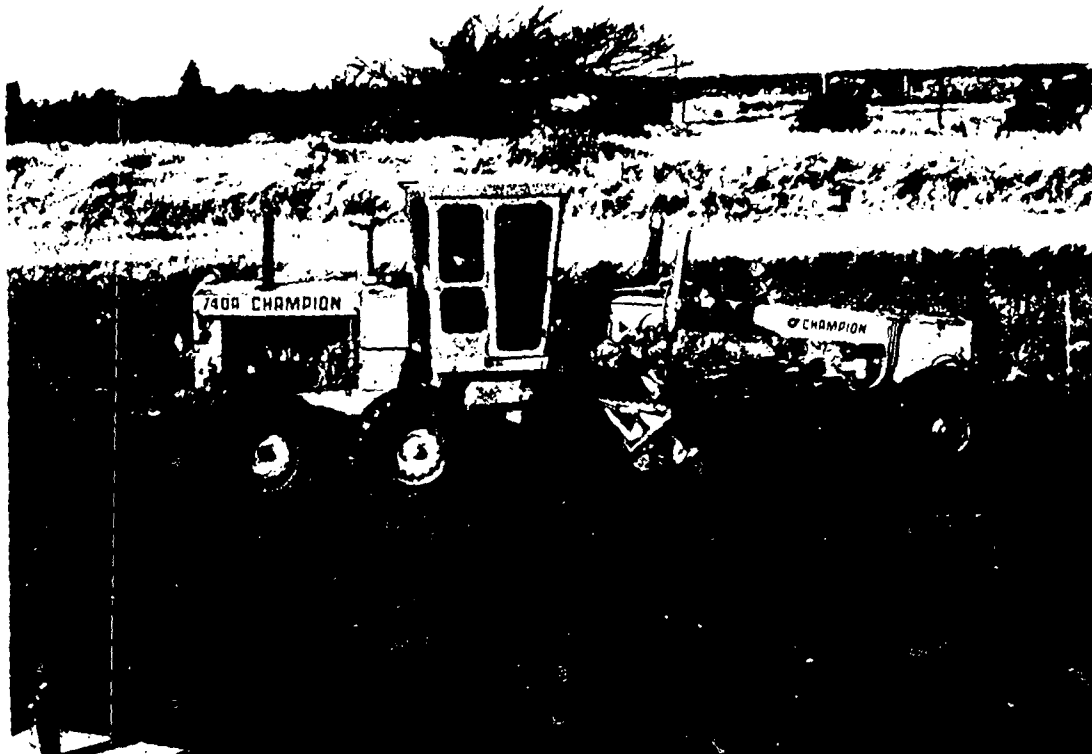
Photograph 11: Road grader spreading soil in disposal cell
