ESH-WPG-2006-00132

Z-Area Industrial Solid Waste Landfill Vault Cracking (U)

Savannah River Site Saltstone Disposal Facility Vaults 1 and 4 Overview

LWO-CES-2006-00010
Rev. 0
October 19, 2006

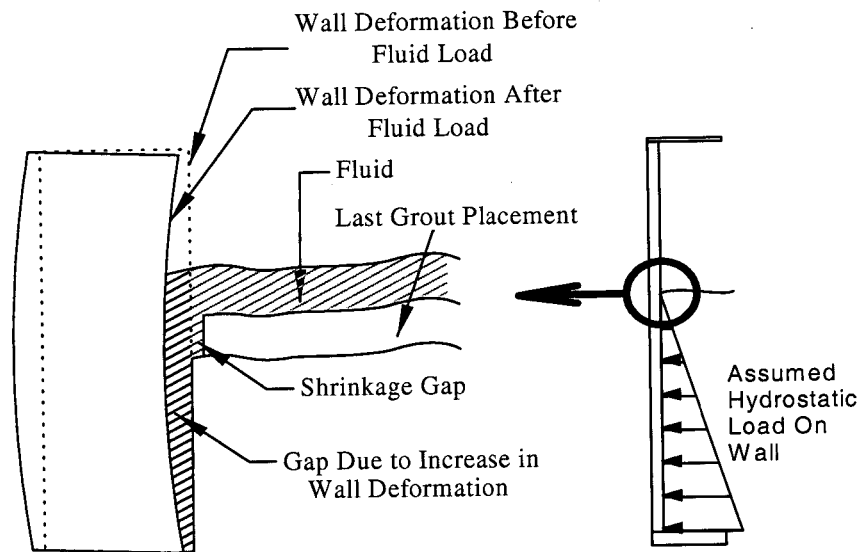
Attachment #1 Vault Cracking Mechanism

The general mechanism for water weeping from the cracks in the Saltstone Disposal Facility (SDF) vault walls stems from construction cracks and/or that of the hydrostatic head exerting a force on the vault wall from the accumulation of water in the gap that forms between the saltstone monolith and the vault wall. (See Attachment #1) The hydrostatic head exerted by the accumulated water can be up to 25-feet. The accumulated water is from rainwater intrusion (<1% as a result of leaks from roof penetrations and the roof itself) and bleed/process water (bleed/process water is the water that results from the grout curing process and flush water from cleaning the transfer lines after a grout

pour from the Saltstone Production Facility (SPF) wastewater treatment process). The accumulated water is not salt solution from the SPF. It is important to note that the saltstone grout cannot flow through the cracks as it is too viscous and sets up very quickly. The Facility monitors the SDF vault walls in accordance with Facility inspection sheets (roundsheets) on a daily basis during operation and takes appropriate action if wetness is seen from a crack. In the past, radioactive contamination has been detected from the cracks and surrounding soil. The contamination levels have never exceeded any reportable quantity. The appropriate radiological controls postings are in effect to minimize exposure to the workers and protect the environment. Some visual signs of discoloration (calcine deposits and staining due to corrosion of rebar) are seen on the SDF vault walls due to normal concrete weathering.

Therefore, a tiny gap can form between the grout and the vault wall. Bleed/process water resulting from the grout curing process, flush water used to clean portions of the transfer lines after grout runs, condensation from temperature changes, along with small amounts of rainwater intrusion can then fill the gap. The water column can create enough hydrostatic pressure to cause small cracks through which the condensate and rainwater can slowly weep. (Attachment 6.3)

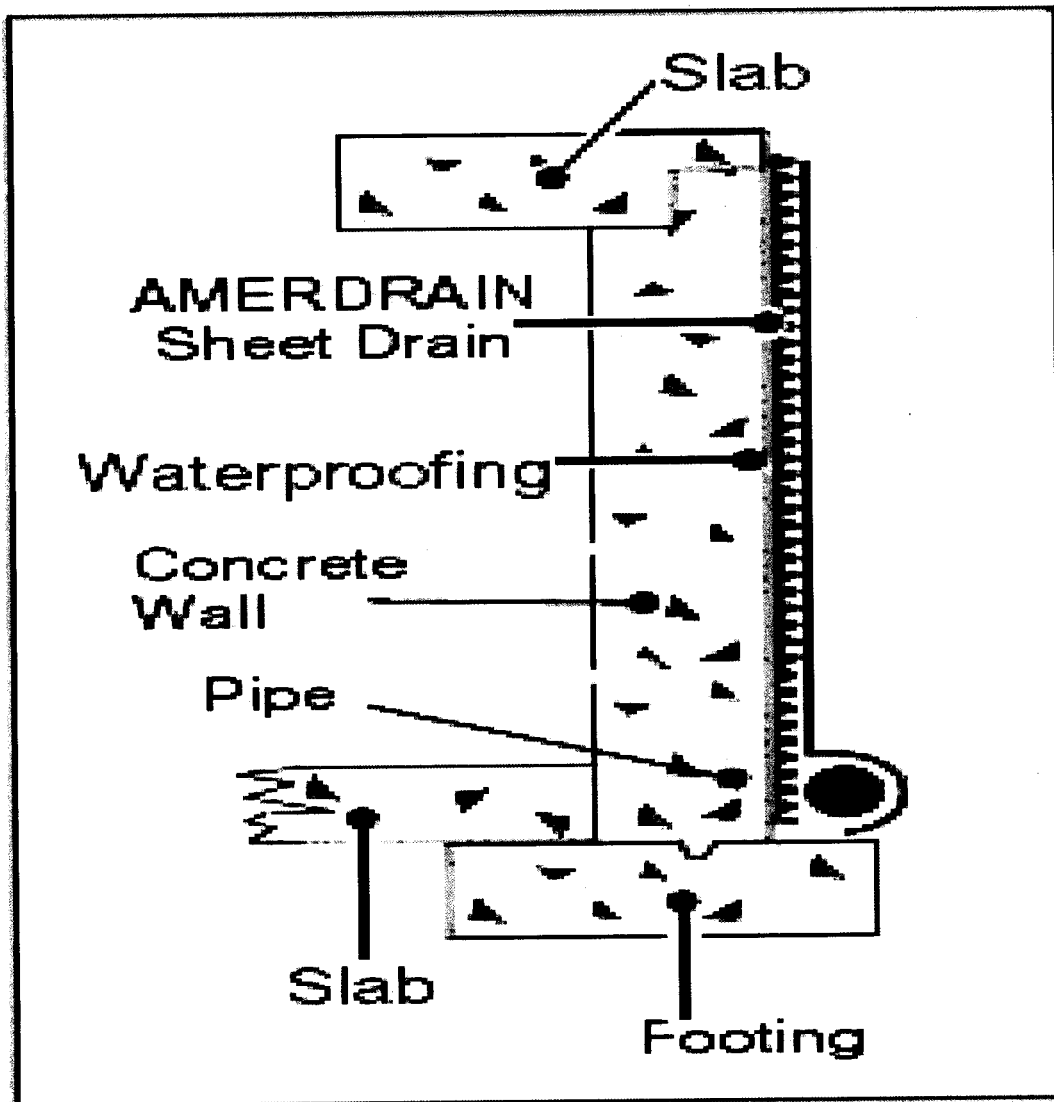
Attachment 2
Vault Water Collection System

In order to prevent weeping from vault cracks in the future the Vault Water Collection System has been installed in Vault 4 Cells B, D, E, F, H, J, K, and L. (See Attachments # 1, 2 and 3) This system is used for the collection and pumping of the excess liquid such as rainwater intrusion and bleed/process water from the Vault 4 cells back to the Salt Feed Tank in the SPF. A geotextile fabric membrane with an impervious backing is attached to the vault walls. Free liquid passes through the fabric where it is captured in the gap between the fabric and the backing. The water drains into a

PVC pipe system around the base perimeter of each vault cell. A drain line is connected to the PVC pipe through the Vault 4 wall which allows periodic draining of the liquid. The drain lines on each side of the vault are connected to a common header which is connected to a pump to transfer the excess water back to the Salt Feed Tank in the SPF. The interior surfaces of the outside walls are also coated with a waterproof coating up to a height of five feet, due to the fact that the vault walls are designed for gravity loads plus the hydrostatic pressure associated with the saltstone grout.

The eight unused cells in Vault 4 have been modified with a drainage system designed to relieve the hydrostatic pressure on the vault walls. This sheet drain system will collect any liquid that may appear between the solidified grout and the vault wall. Collected liquid will be returned through pipes to the Saltstone Production Facility and used in the production of grout.

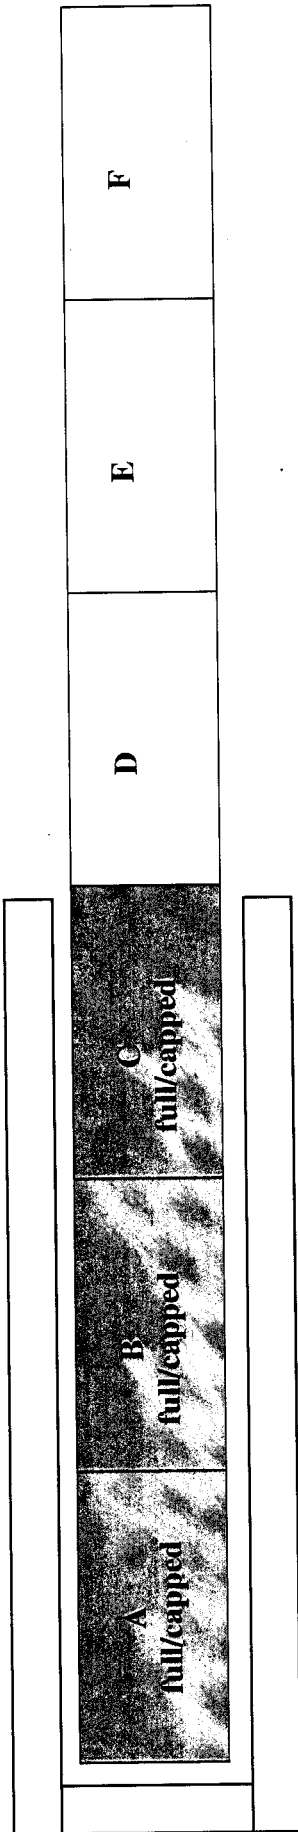
A diagram of Saltstone Vaults 1 and 4 is included in Attachment #5. Attachment #5 shows the cells which are full or partially full with grout and the empty cells.

As is shown in Attachment #5 the areas adjacent to Vault 1, Cells A, B, and C are posted as ICAs due to past operations. Periodic surveys are taken around the ICAs to confirm that there is no spread of contamination outside the posted area. Recent surveys outside the ICAs have found no spread of contamination. Plans are underway to survey inside the ICAs adjacent to Vault 1 to determine current radioactive contamination and radiation levels.

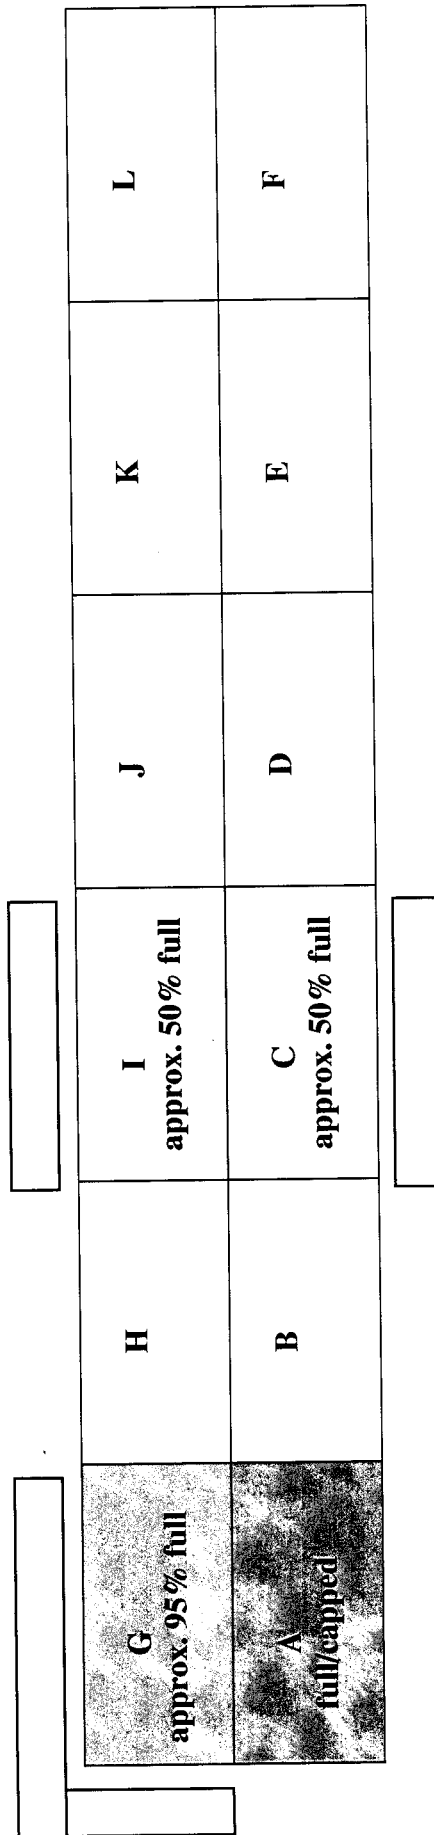
Vault 4

The area adjacent to Vault 4, Cell G is posted as an ICA. Periodic surveys are taken around the ICA to confirm no spread of contamination outside the posted area. Recent surveys outside the ICA have found no spread of contamination. (See Attachment #5) Plans are underway to survey inside the ICA adjacent to Vault 4, Cell G to determine current radioactive contamination and radiation levels.

The areas adjacent to Cells C and I are posted as ICAs due to previous operations and detection of contamination. Recent surveys outside the ICAs have found no spread of contamination. (See Attachment #5) Plans are underway to survey inside the ICAs adjacent to Vault 4, Cells C & I to determine current radioactive contamination and radiation levels.

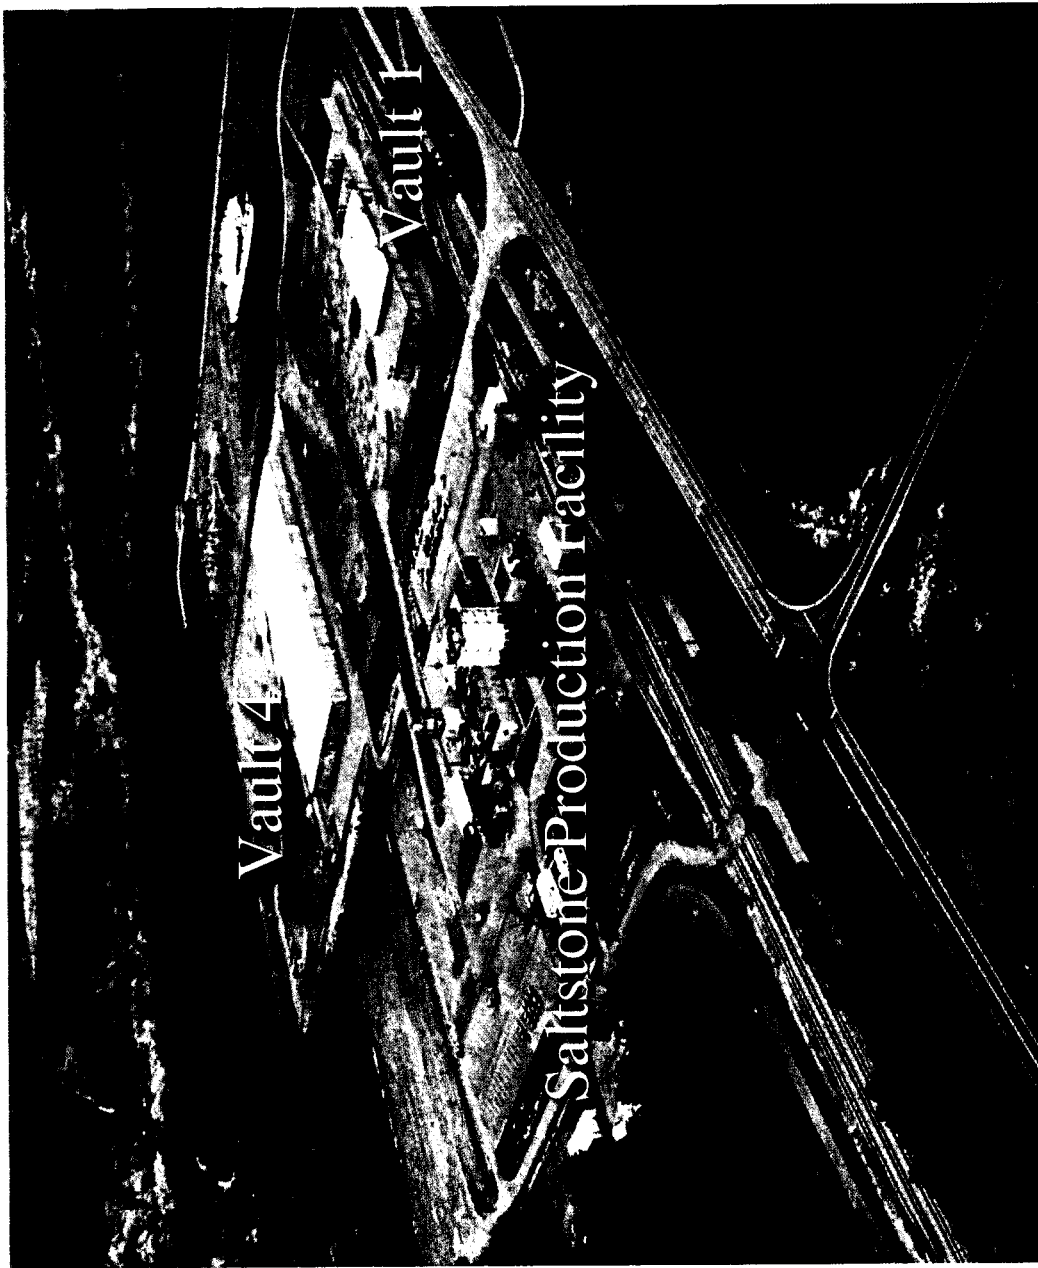
Attachment 6.1
Saltstone Facility After Installation of Permanent Roof to Eliminate Rainwater Intrusion

Vault 4 was modified with a permanent roof prior to introduction of grout to provide operational flexibility (allows more than two partially filled cells at any time) and eliminate rainwater intrusion. The roof joints, however, allowed small amounts of rainwater to enter the vault cells and condensation associated with operation continued to occur. This resulted in wall cracking similar to that experienced in Vault 1. Therefore, joint sealing and cell draining was instituted to remediate the liquid accumulation.

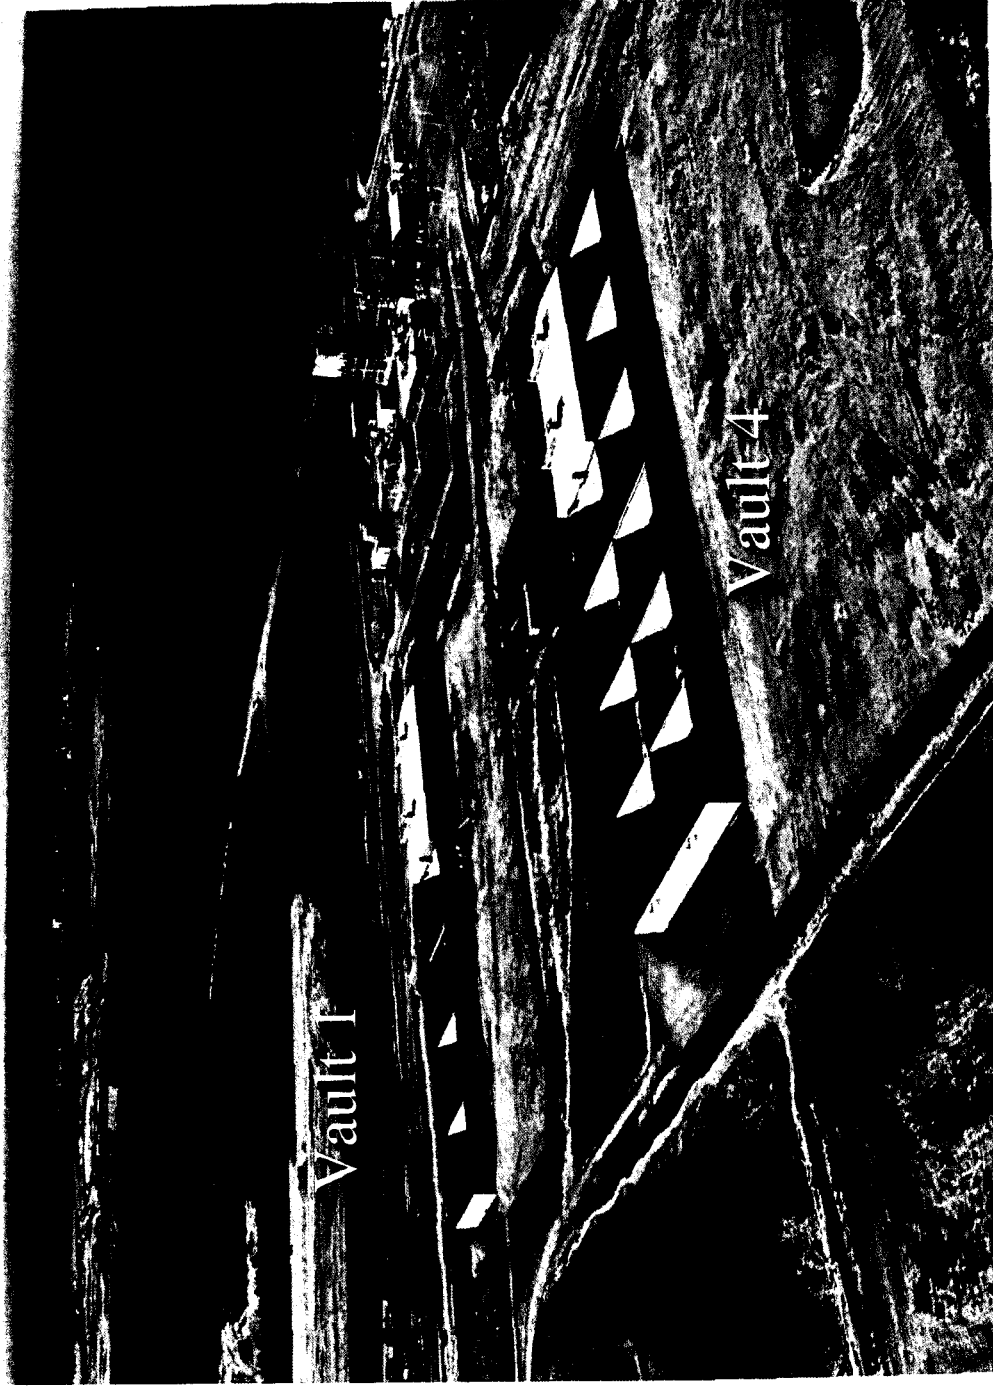
Attachment 6.2
Saltstone Facility Showing Vaults 1 and 4 Cell Arrangement After Initial Construction

The Saltstone Disposal Facility is composed of two above-grade vaults, Vault 1 and Vault 4, built between 1986 and 1988. Vault 1 is rectangular (600 feet x 100 feet) and contains six 100 feet x 100 feet cells. (Attachment 6.2) The walls (18 inches thick) and slab (24 inches thick) of the vault are of reinforced concrete construction and are designed for gravity loads plus the hydrostatic pressure associated with the saltstone grout. Vault 1 was designed with a rolling, sheet metal roof that covered two cells at a time.

Similarly, Vault 4 is rectangular (600 feet x 200 feet), but contains twelve 100 feet x 100 feet cells. (Attachment 6.2) Like Vault 1, the walls (18 inches thick) and slab (24 inches thick) of the vault are of reinforced concrete construction and are designed for gravity loads plus the hydrostatic pressure associated with the saltstone grout. Vault 4 has a permanent concrete roof (a minimum of 4 inches thick) which is painted with a dura-cool coating to help heat dissipation.

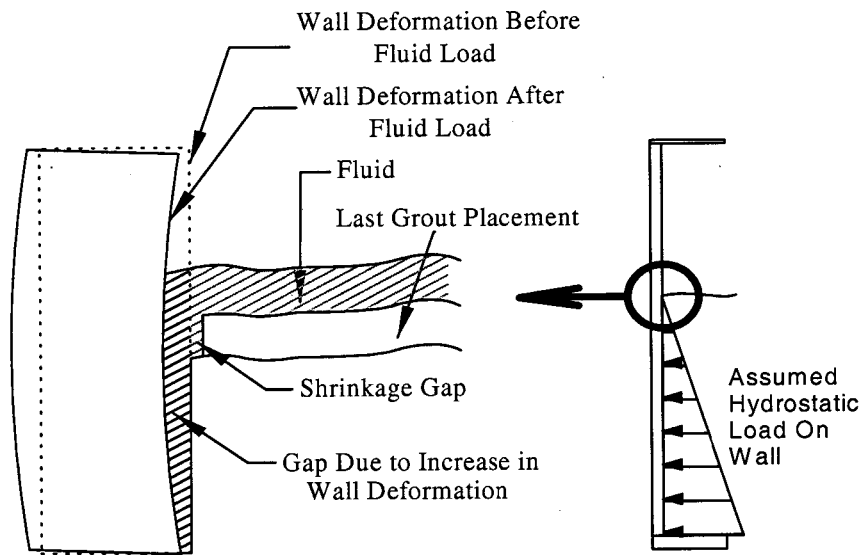
Attachment 6.3 Vault Cracking Mechanism

Saltstone operations have been successful in producing and disposing of saltstone grout in accordance with design requirements. However, minor cracks have been observed in some of the vault walls. Some of the cracks are attributable to vault construction in Vault 1. Another phenomenon that can initiate cracks stems from the fact that grout shrinks slightly as it solidifies.
