ADDENDUM 3.4-A WETLANDS DELINEATION

JURISDICTIONAL WETLANDS DELINEATION FOR THE PROPOSED ROSS ISR PROJECT, OSHOTO, WYOMING

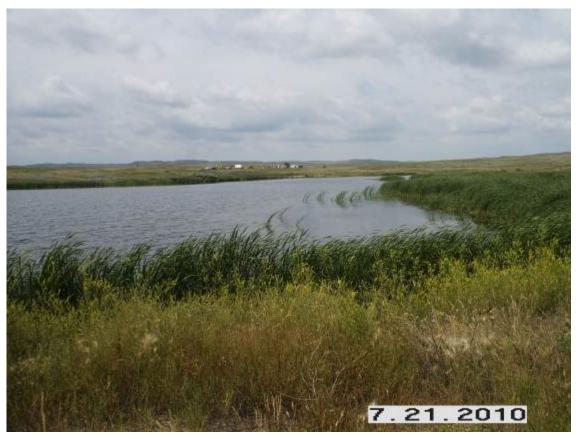
Photo 04. A2 (Lower Portion) Site R5

Site R5 is located at latitude 44.5815° and longitude -104.9503° (Exhibit 1). This site is associated with the main body of the Oshoto Reservoir and is within a Water/Gullied Land soil map unit. *Typha latifolia* and *Scirpus maritimus* dominate the area. *Carex praegracilis, C. nebrascensis, Eleocharis palustris, Potamogeton richardsonii, Rumex martimus,* and *T. angustifolia* were also noted in the area but not within the vegetation

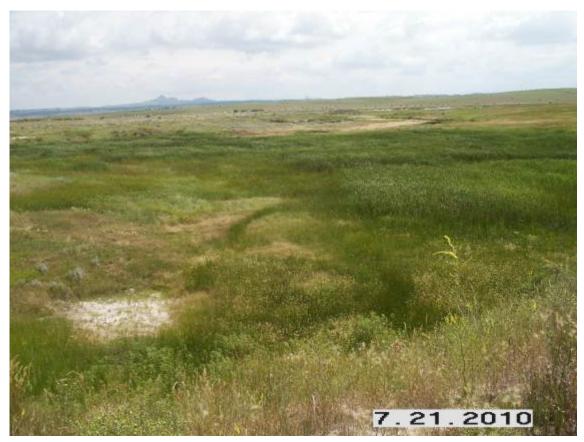
Photo 07. A4 (Upper Portion) Site R6

Site R6 is located at latitude 44.5811° and longitude -104.9495° (Exhibit 1). This site is directly below the Oshoto Reservoir and likely receives seepage from the reservoir and also is receiving some water from a groundwater source and is within a Gullied Land soil map unit. *Typha latifolia, T. angustifolia,* and *Carex lanuginosa* dominate the area. Positive indicators of hydrophytic vegetation, hydric soil, and wetland hydrology are associated with the area. This area meets all three diagnostic environmental characteristics of a wetland as defined by the COE (COE 2008) and it appears to be a wetland (Appendix A, Sample Point R6 and Appendix B, Photo 07).

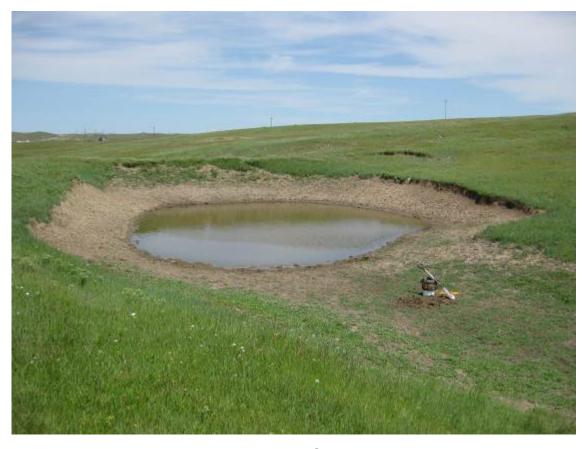
Photo 12. B2 (Site R1)

Site R1 is located at latitude 44.5640° and longitude -104.9522° (Exhibit 1). This site is associated with a small man made stock pond located on an ephemerally-flowing tributary to the Little Missouri drainage and is within a Fort Collins Loam (6-10% Slope) soil map unit. It appears to be typical of an impoundment situation in that is has a relatively large amount of bare ground (approximately 98 percent) associated with the site. *Equisetum variegatum* dominates the vegetation within the area. Positive indicators of hydrophytic vegetation, hydric soil, and wetland hydrology are associated with the area. This area meets all three diagnostic environmental characteristics of a wetland as defined by the COE (COE 2008) and it appears to be a wetland (Appendix A, Sample Point R1 and Appendix B, Photo 12).

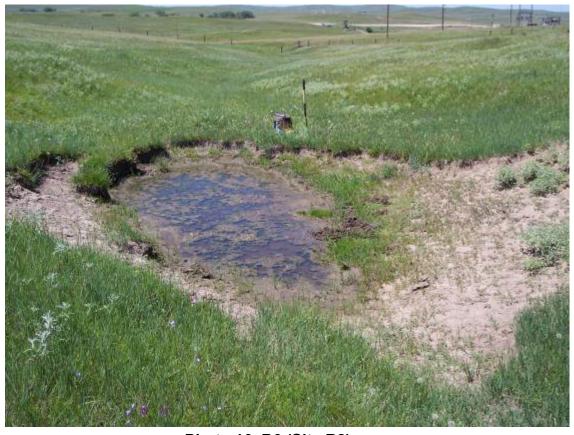
Photo 16. B6 (Site R2)

dominant vegetative types include *Marsilea vestiita* and *Equisteum Variegatum*. Positive indicators of hydrophytic vegetation, hydric soil, and wetland hydrology are associated with the area. The site may be receiving water from a groundwater source (seep), which helps maintain saturated conditions longer than the site location (higher on the drainage) would indicate. This area meets all three diagnostic environmental characteristics of a wetland as defined by the COE (COE 2008) and it appears to be a wetland (Appendix A, Sample Point R2 and Appendix B, Photo 16).

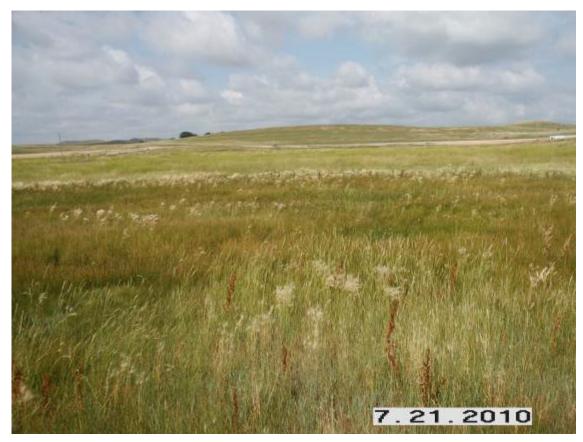
Photo 23. D2 (Site R3)

Site R3 is located at latitude 44.5716° and longitude -104.9601° facility (Exhibit 1). This site is located on an ephemerally-flowing tributary within is an excavated depression that is associated with a decommissioned uranium processing facility and is within an Absted-Bone Complex (0-3% Slope) soil map unit. *Eleocharis palustris* dominates the area. Positive indicators of hydrophytic vegetation, hydric soil, and wetland hydrology are associated with the area. This area meets all three diagnostic environmental characteristics of a wetland as defined by the COE (COE 2008) and it appears to be a wetland (Appendix A, Sample Point R3 and Appendix B, Photo 23).

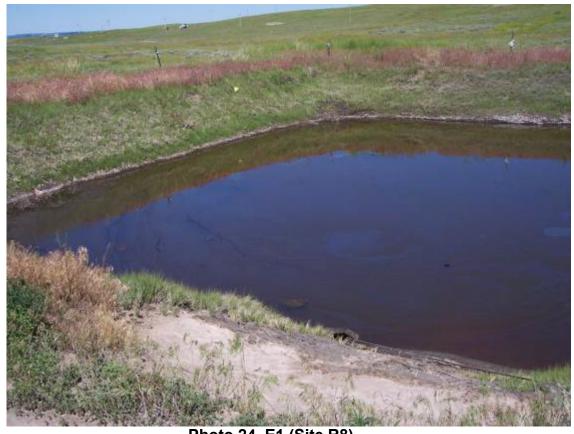
Photo 24. E1 (Site R8)

Site R8 is located at latitude 44.5723° and longitude -104.9601° (Exhibit 1). This site is associated with a man made oil well production pit and is within an Absted-Bone Complex (0-3% Slope) soil map unit. *Agropyron smithii* and *Hordeum jubatum* dominate the area. Although positive indicators of wetland hydrology are associated with the area, it does not meet all three diagnostic environmental characteristics of a wetland as defined by the COE (COE 2008). It does not appear to be a wetland (Appendix A, Sample Point R8 and Appendix B, Photo 24).

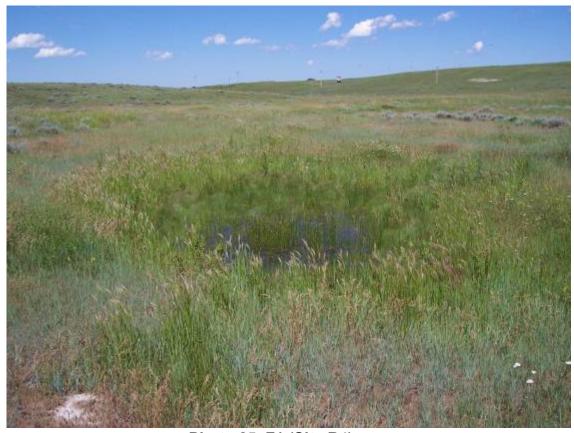
Photo 25. F1 (Site R4)

Site R4 is located at latitude 44.5734° and longitude -104.9599°. This site is within a small depression located on an ephemerally-flowing tributary to the Little Missouri drainage and is within an Absted-Bone Complex (0-3% Slope) soil map unit. *Eleocharis palustris* and *Hordeum jubatum* dominate the area. Positive indicators of hydrophytic vegetation, hydric soil, and wetland hydrology were present at the sample point. The site may be receiving water from a groundwater source. This area meets all three diagnostic environmental characteristics of a wetland as defined by the COE (COE 2008) and it appears to be a wetland (Appendix A, Sample Point R4 and Appendix B, Photo 25).

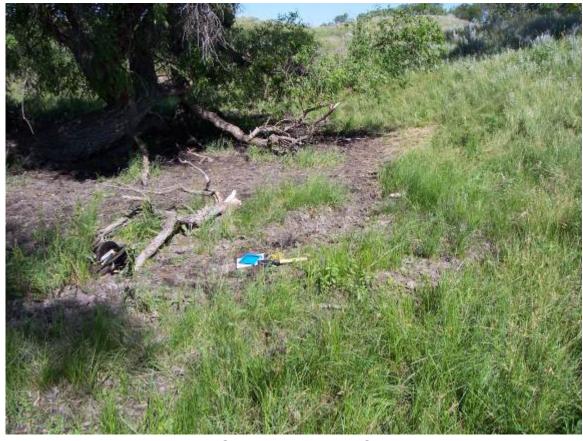
Photo 39. G2 Lower Portion (Site R7)

Site R7 is located at latitude 44.5675° and longitude -104.9640° (Exhibit 1). This site is within a depression above a road fill that has restricted flow down the drainage and is within a Bidman-Bone Loams (2-6% Slope) soil map unit. *Sporobolis airoides* and *Hordeum jubatum* dominate the area. *Carex praegracilis, C. nebrascensis, Sagittaria cuneata, Potamogeton nodosus*, and *Phleym pretense* were also noted in the area but not within the vegetation plot. Positive indicators of hydrophytic vegetation, hydric soil, and wetland hydrology are associated with the area. This area meets all three diagnostic environmental characteristics of a wetland as defined by the COE (COE 2008) and it appears to be a wetland (Appendix A, Sample Point R7 and Appendix B, Photo 39).

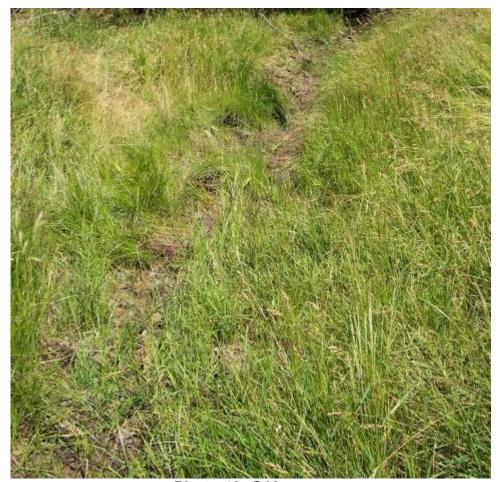
Photo 48. G10

No Photo of G11 (Similar to G10)

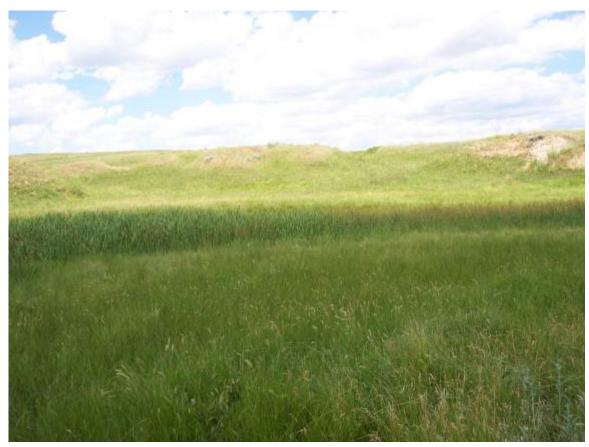
Photo 53. H3

No Photo for H4 (Similar to H3)

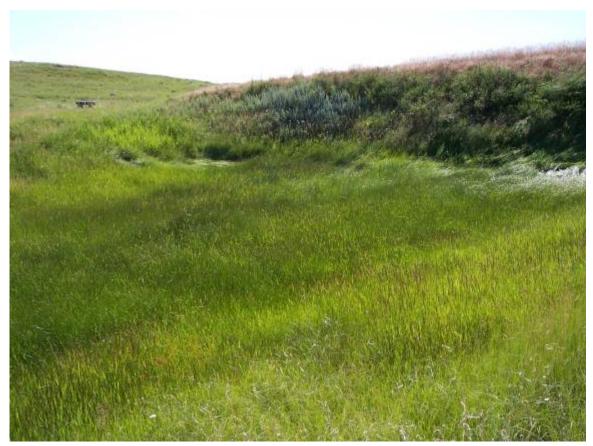
Photo 56. I4

No Photos for I3 & I5 (Similar to I4)

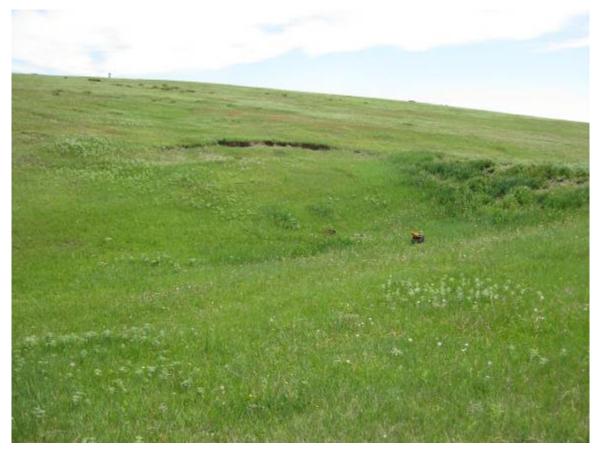
Photo 64. Site R9

Site R9 is located at latitude 44.5642° and longitude -104.9522° (Exhibit 1). This site is directly below a small stock pond (Site r1) and is within a Fort Collins Loam (6-10% Slope) soil map unit. *Agropyron smithii* and *Poa pratensis* dominate the area. Positive indicators of hydrophytic vegetation, hydric soil, or wetland hydrology are not associated with the area. This area does not meet any of the three diagnostic environmental characteristics of a wetland as defined by the COE (COE 2008) and it does not appear to be a wetland (Appendix A, Sample Point R9 and Appendix B, Photo 64). This site was evaluated since it represented an area that had the potential to be a wetland (possibly receiving seepage from the stock pond) but did not exhibit classic wetland characteristics.
