A COMPLETE HISTORY OF THE HIGH-LEVEL WASTE PLANT AT THE WEST VALLEY DEMONSTRATION PROJECT

Lawrence L. Petkus, James Paul, Paul J. Valenti, Helene Houston,
West Valley Nuclear Services, WVNSCO
and
Joseph May
U.S. Department of Energy

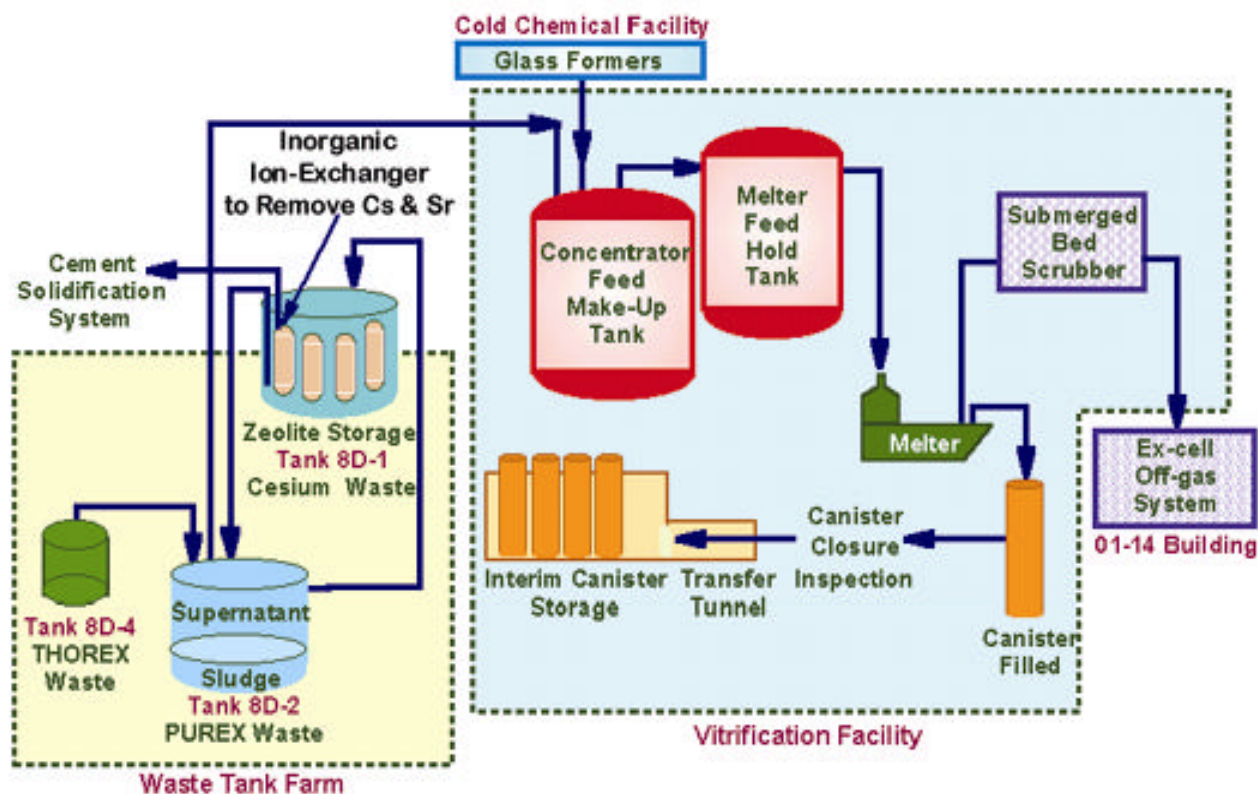
Fig. 2 HLW Process

The overall method developed for processing HLW involved preparing the HLW for processing by separating (removing) the majority of the radioactive species (Cs-137 and Sr-90) from the waste liquid, combining the resulting HLW with the waste sludge, and processing the HLW mixture into the approved glass waste form. After removing HLW from the waste liquid, the resulting low-level waste (LLW) liquid also was processed into an approved waste form, cement encapsulated LLW. The basic overall method and systems used to process liquid HLW into approved HLW and LLW forms are illustrated in Fig. 2.

The methods used to remove HLW from waste liquid and prepare the HLW mixture for vitrification are briefly summarized here, followed by a more detailed description of the vitrification process, including a brief summary of the FACTS program and a description of the Vitrification System.
