Onset of Fatigue Cracking in Through Wall SG Flaws

An Evaluation of Time Dependent Leak Rates

Jim Begley – TCA Solutions

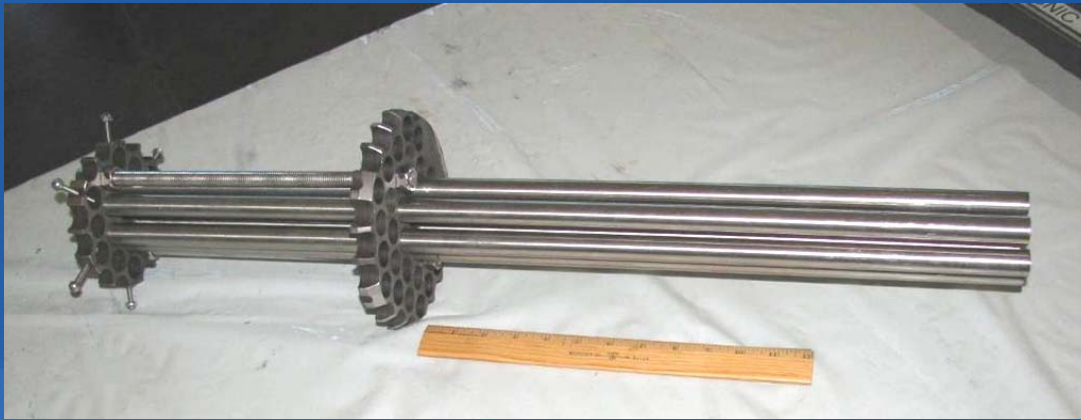
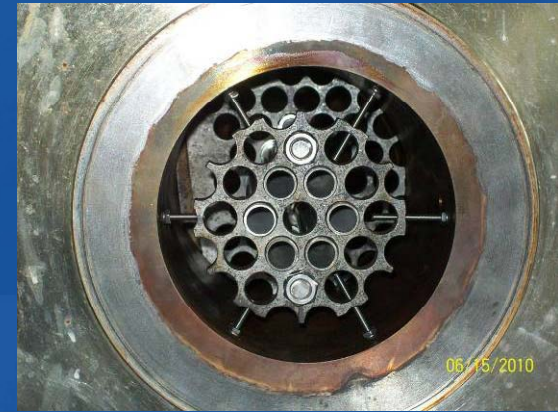
- Alloy 600 tube specimen is surrounded by six neighboring tubes.
- Tube support plates are holding the neighboring tubes.
