From: Gambone, Kimberly
Sent: Tuesday, March 22, 2011 10:54 AM
To: PMT02 Hoc
Subject: Fukushima accident progression presentation
Attachments: Fukuchima_eng_20110320.pps

The Fukushima Daiichi Incident

Matthias Braun
PEPA4-G, AREVA–NP GmbH
Matthias.Braun@AREVA.com

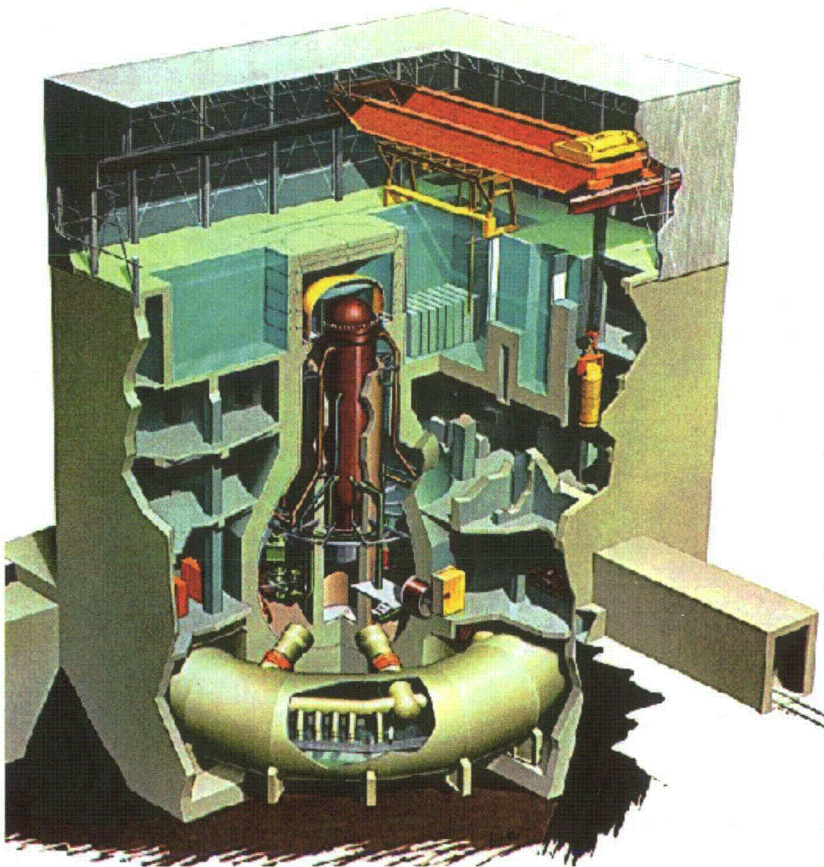
► Building structure

- ◆ Concrete Building
- ◆ Steel-framed Service Floor

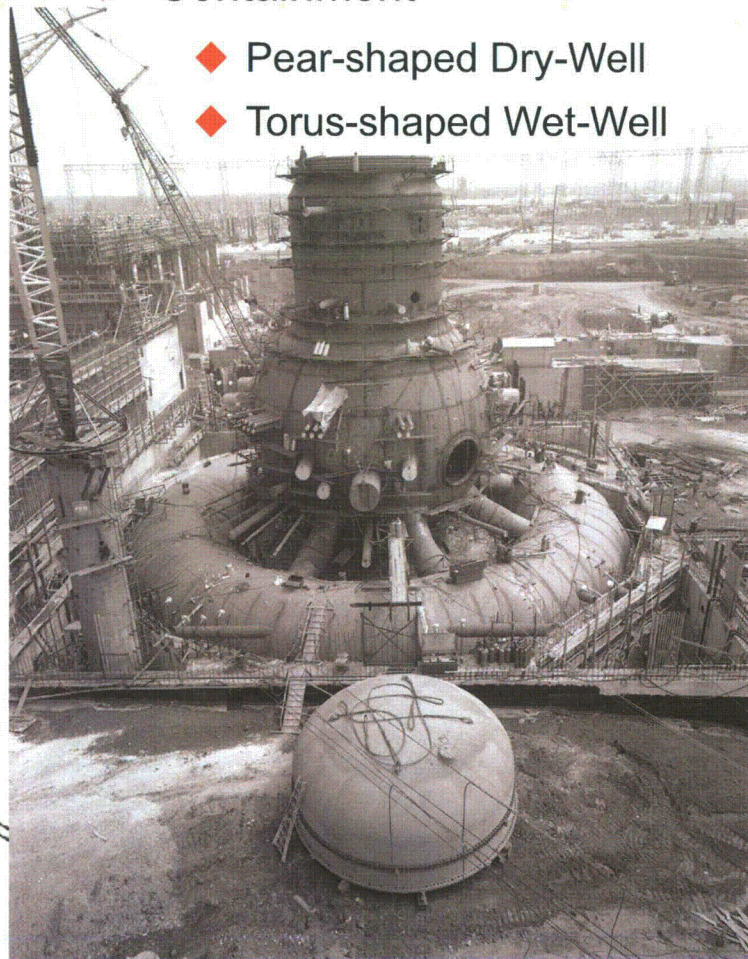
► Containment

- ◆ Pear-shaped Dry-Well
- ◆ Torus-shaped Wet-Well

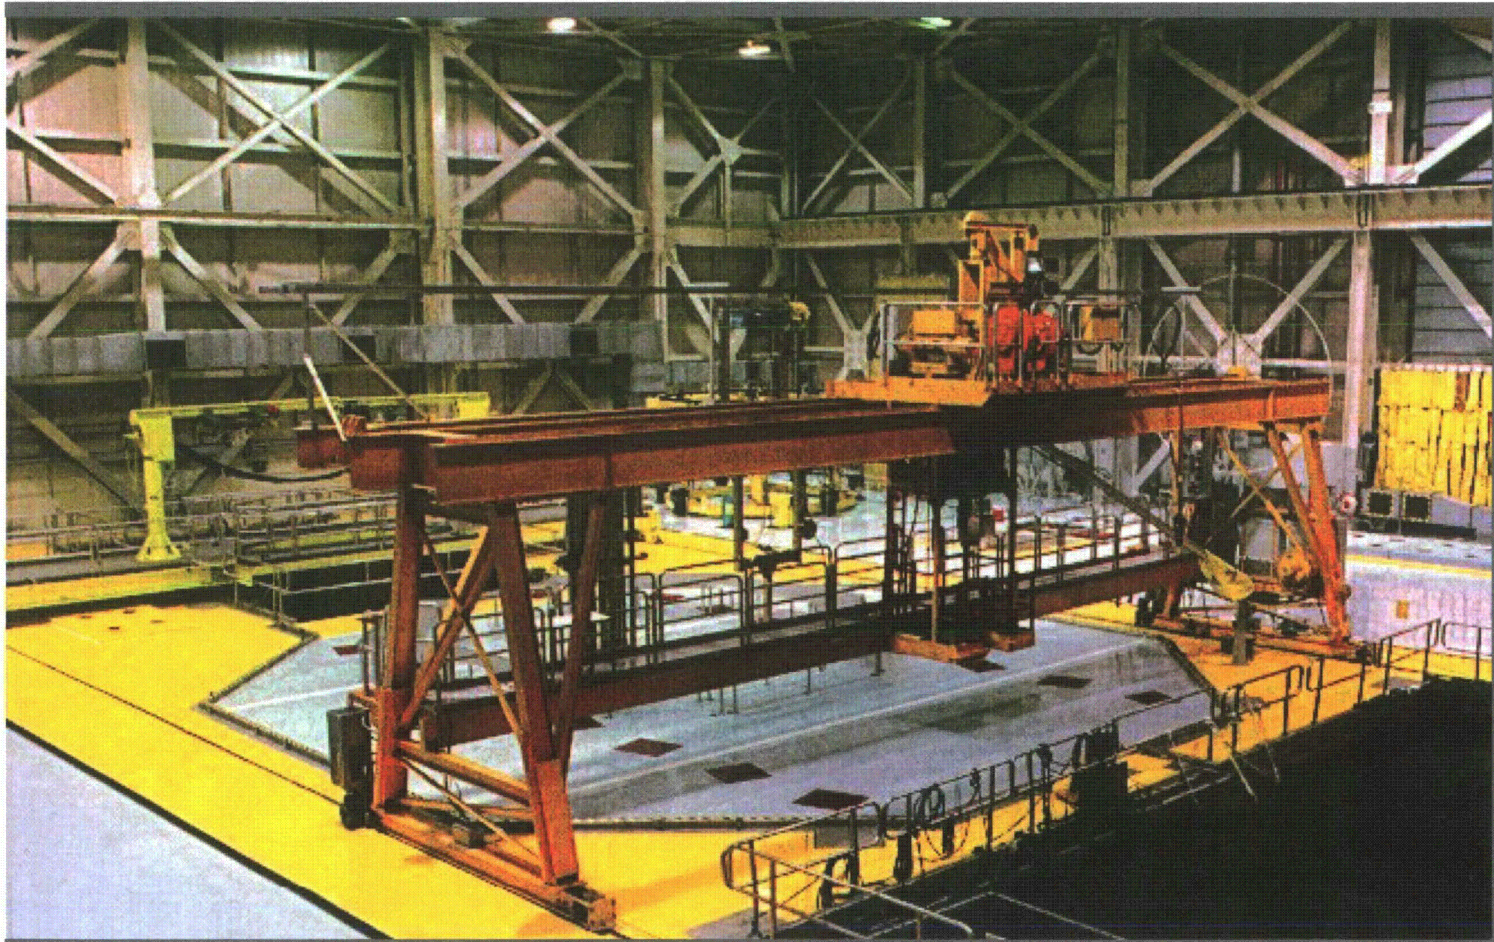
► Service Floor

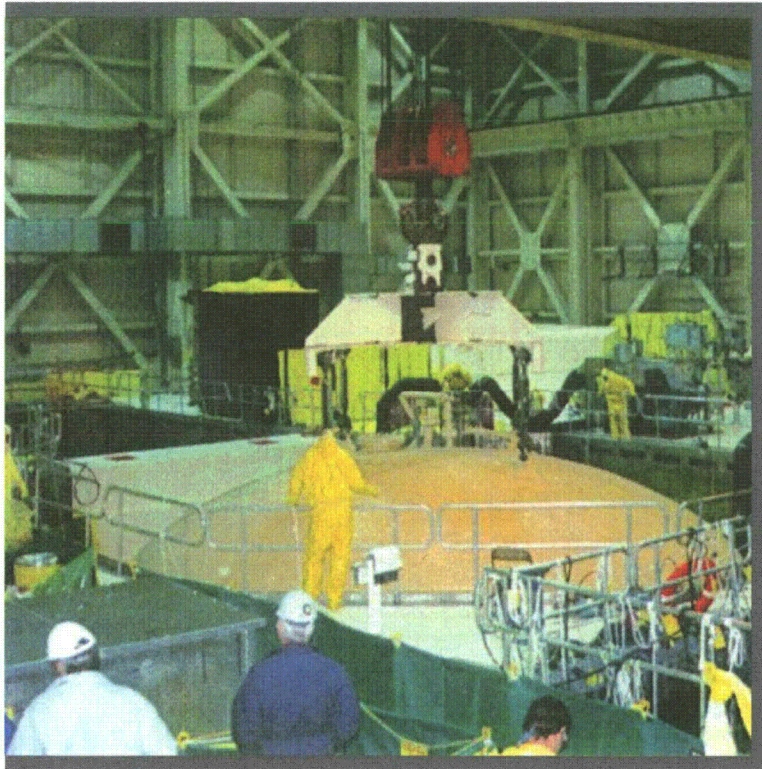
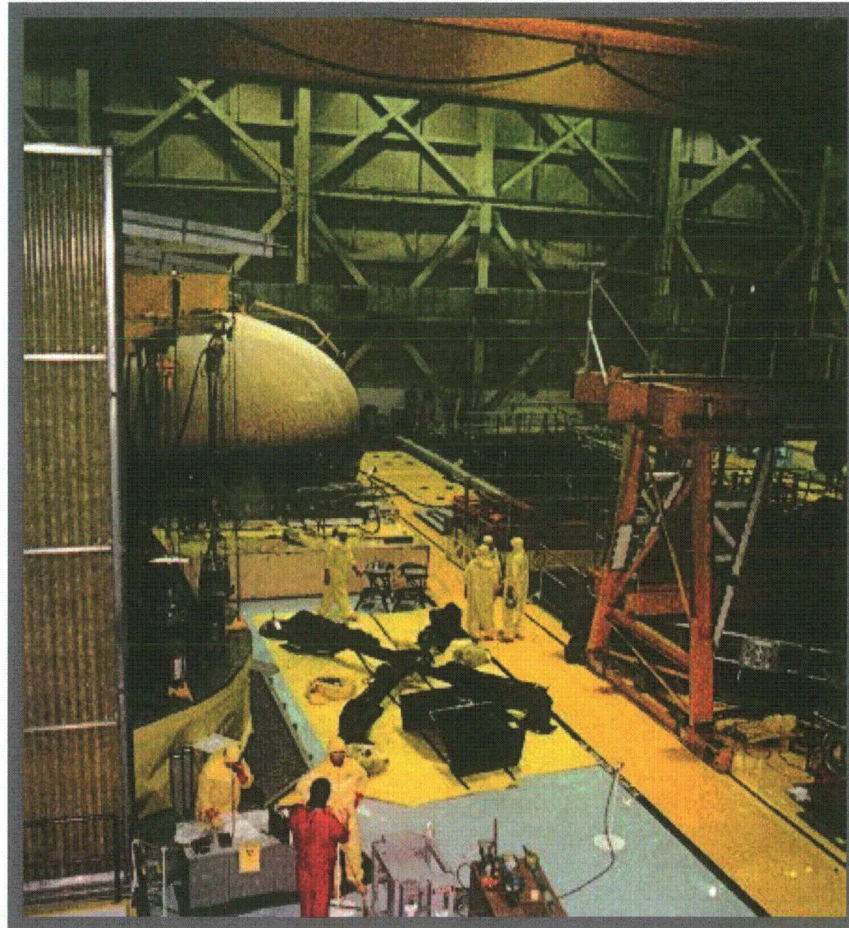
- ▶ Lifting the Containment closure head

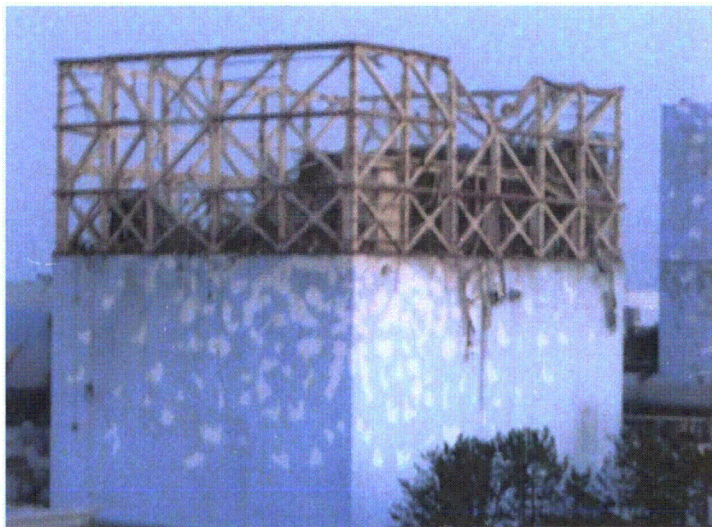
► Unit 1 und 3

- ◆ Hydrogen burn inside the reactor service floor
- ◆ Destruction of the steel-frame roof
- ◆ Reinforced concrete reactor building seems undamaged
- ◆ Spectacular but minor safety relevant
