CORROSION OF BORATED STAINLESS STEEL IN WATER AND HUMID AIR

**U.S. Nuclear Regulatory Commission
Contract NRC-02-07-006**

**¹Center for Nuclear Waste Regulatory Analyses
San Antonio, Texas**

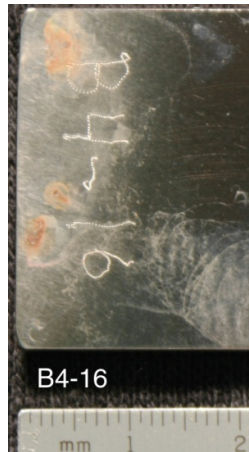
3-D Laser Profile Around the Deepest Pit Area

2-D Line Profile Across the Pit

Figure 3-7. Optical Photos and 3-D Laser Profilometer Scans of Areas With Pitting Corrosion for Specimens 304B4-16 and 304B4-17.
(The Unit in the 3-D Profile Images Is μm .)

- The top surface of specimens B4-14 and B4-15 exposed in liquid was covered with tightly adhered white deposits. However, no visible corrosion was observed for all specimens exposed in liquid.
- All the specimens exposed in liquid showed weight gain before cleaning with acid. Only one specimen (B4-18) exposed in vapor showed weight loss. The other two (B4-16 and B4-17) showed weight gain.
- The average corrosion rate from the liquid appeared to be higher than that from the vapor.
- Specimens B4-16 and B4-17 exposed in vapor suffered pitting corrosion. The deepest penetration depth was ~60 μm [~2.4 mil] for B4-16 and ~70 μm [~2.8 mil] for B4-17.
