CORROSION OF STAINLESS STEEL TYPE 316L IN A SEEPAGE WATER DRIPPING ENVIRONMENT

**U.S. Nuclear Regulatory Commission
Contract NRC-02-07-006**

September 2011

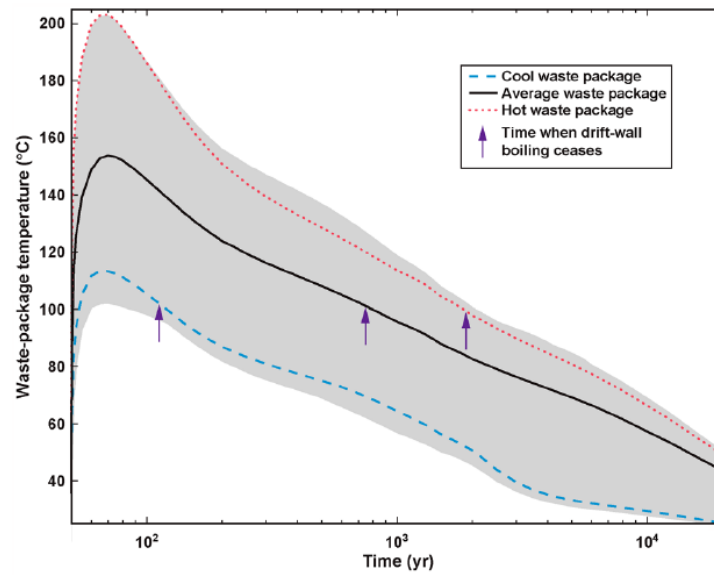
Figure 1-1. Range of Waste Package Temperature Versus Time Modeled for the Proposed Yucca Mountain Repository (Sandia National Laboratories, 2008)

Figures 1-1 and 1-2 show the modeled ranges of temperature and relative humidity versus time for all waste packages in the proposed Yucca Mountain repository, accounting for uncertainty of host-rock thermal conductivity and percolation flux (Sandia National Laboratories, 2008). During the first 10,000 years, the waste package temperatures could have a wide range from a peak of 203 °C [398 °F] to room temperature. In the time period of 1,500 to 10,000 years, there

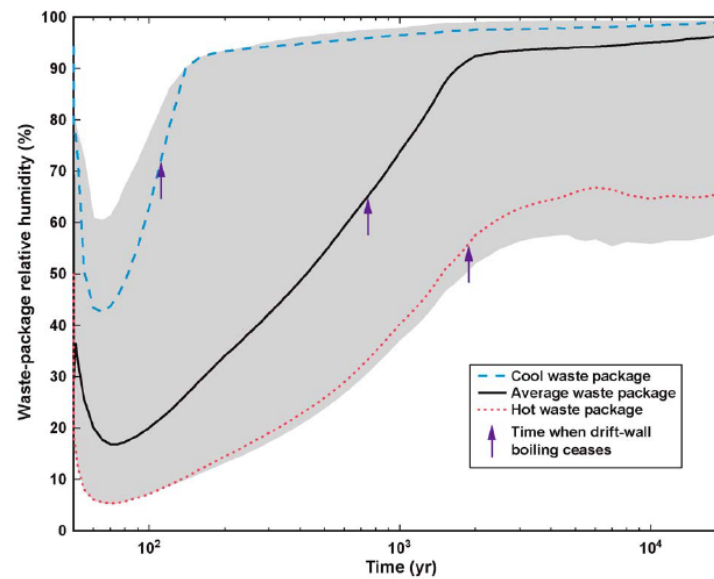
Figure 1-2. Range of Relative Humidity Versus Time Modeled for the Proposed Yucca Mountain Repository (Sandia National Laboratories, 2008)

Under storage conditions, details of the relative humidity on the hot canister have not been assessed, although atmospheric relative humidity is tabulated at various coastal areas (EPRI, 2006). Some considerations have been presented on the relative humidity on hot canister surfaces (Shirai, et al., 2011a,b). Compared to the data presented in Shirai, et al. (2011a,b), relative humidity on the hot canister surface is likely similar to the lower portion of Figure 1-2 at higher temperatures.

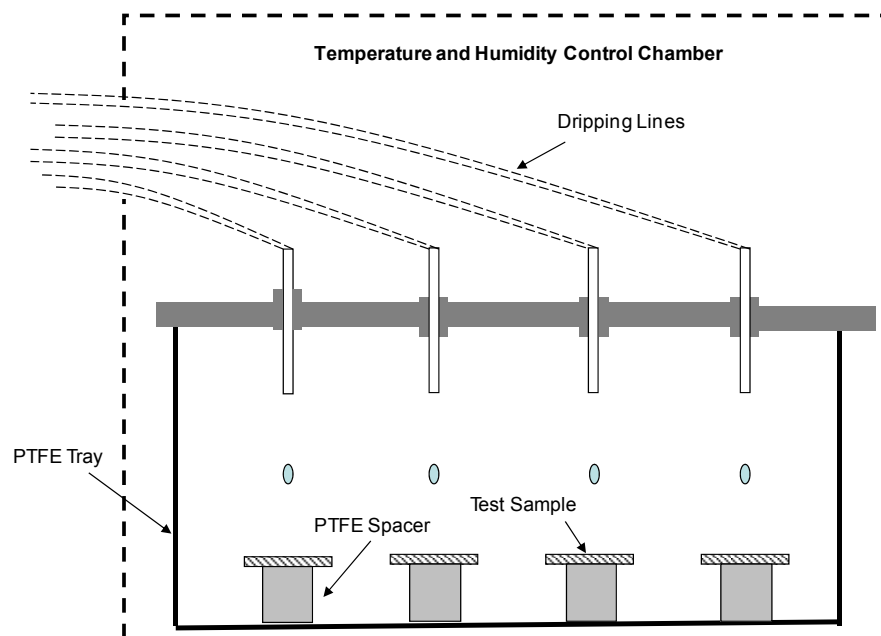
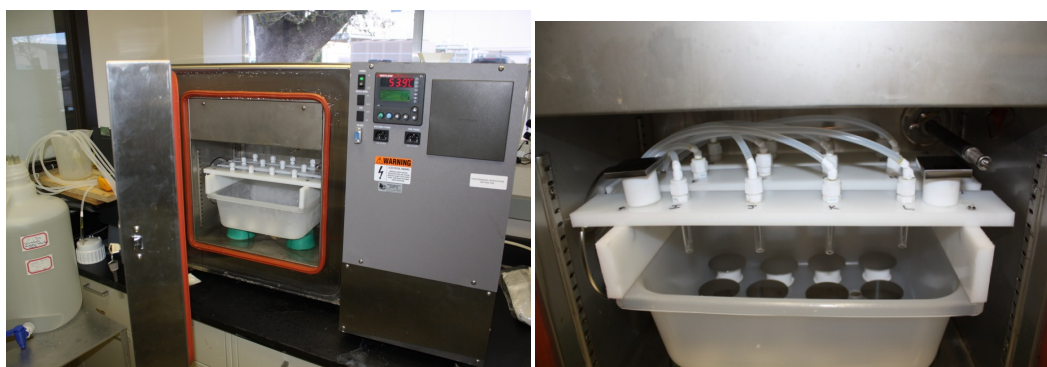
Figure 2-1. Experimental Setup for Dripping Test

The dripping corrosion tests of stainless steel were conducted inside a chamber with controlled temperature and relative humidity as shown in Figure 2-1. Each test specimen was set on a 3.4-cm [1.3-in] outer diameter polytetrafluoroethylene cylinder spacer. The polytetrafluoroethylene cylinders with the test specimens were placed inside a polytetrafluoroethylene tray in the chamber. The top of the dripping tubes was located about 10 cm [4 in] above the test specimen. The dripping water was simulated seepage water with the chemical composition shown in Table 2-2. Dunn, et al. (2006) used the same composition to represent neutral-type seepage waters in experiments to evaluate the effect of environmental conditions on the performance of Alloy 22 waste package material. The water was pumped from a reservoir outside of the chamber through polytetrafluoroethylene tubing into the chamber and allowed to drip on the test specimen. The temperature and relative humidity were controlled and maintained to be constant through the testing periods. The temperature and relative humidity near the test specimens were monitored by using additional measurement probes from the outside. The probes of the thermocouple and humidity gauge were extended to be located close to the test specimens. Because the chamber's temperature and humidity sensors were located at the edge on the ceiling inside the chamber, it was necessary to confirm the actual temperature and relative humidity directly exposed to the test specimens that was located on the chamber floor.

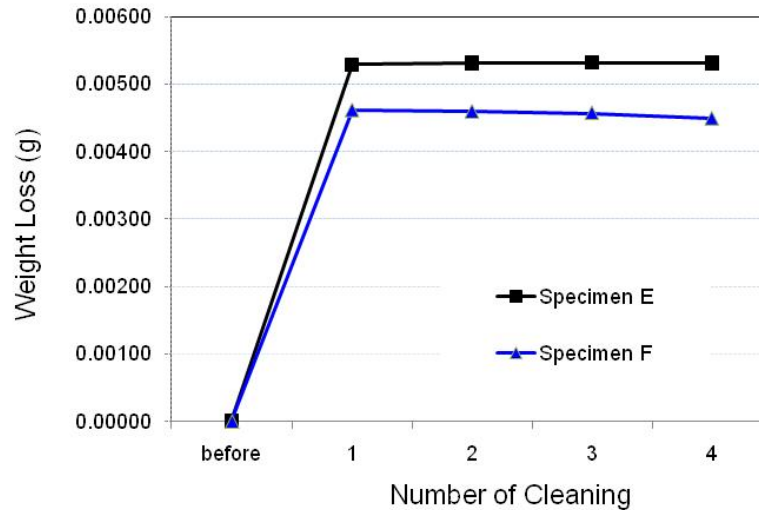
Figure 2-2. Weight Losses of the Corroded Test Specimens Resulting From Repetitive Cleaning Cycles in an ASTM HNO₃ Solution (ASTM International, 2003). The Weight Loss After the Third Cycle of Cleaning Was Used in the Weight Loss Analysis.

for 20 minutes at 60 °C [140 °F]. Then, the specimens were ultrasonically cleaned in acetone and dried. Before measuring the weight loss of the posttest specimens, the cleaned surface was observed by optical microscope to confirm the absence of any remaining deposits on the surface. The weight change was measured using a microbalance with a precision of $\pm 2.5 \times 10^{-5}$ g [8.82×10^{-7} oz]. Figure 2-2 shows a typical plot for weight loss measurements as a function of the number of cleanings. The four test specimens were exposed at 95 °C [203 °F] and 75 percent relative humidity for 67 days. The weight loss plateaued after two or three

cycles of cleaning. Therefore, the weight losses after the third cycle of cleaning were used to calculate the corrosion rate in accordance with the equation defined in ASTM G1-03 (ASTM International, 2003). Table 2-3 shows the test matrix of stainless steel for two batches: (i) at 80 °C [176 °F] and 85 percent relative humidity and (ii) at 95 °C [203 °F] and 75 percent relative humidity. The table also provides information on the test duration and sample identification number for each batch. The temperature and humidity selected were close to the mean values of modeled temperature and relative humidity at times of ~2,500, and ~1,500 years for the first and second batches, respectively, as shown in Figures 1-1 and 1-2. The water dripping rates for each set were selected based on the modeled seepage water flow rates for each repository time and were adjusted a focused flow to be equivalent to the test specimen size, as discussed in Jung, et al. (2011).

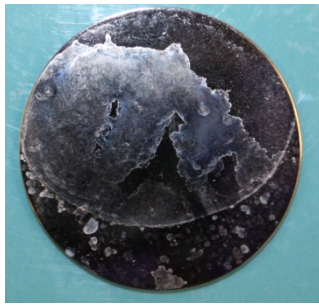
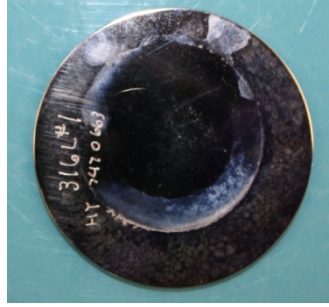
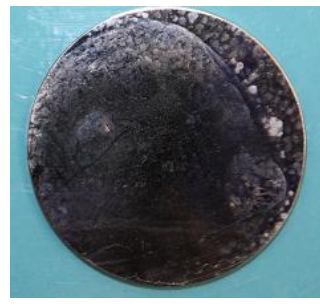
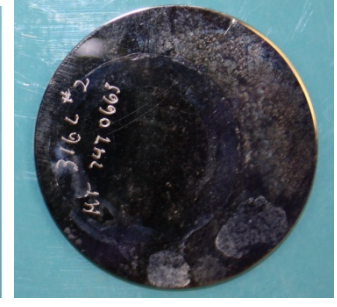
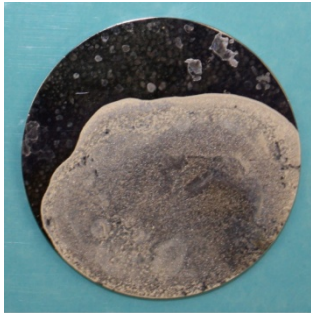
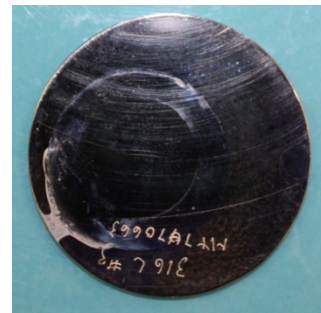
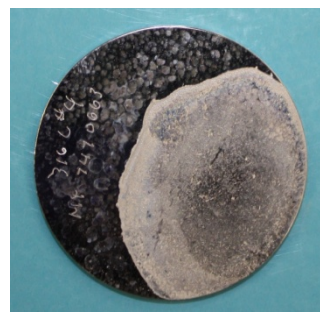
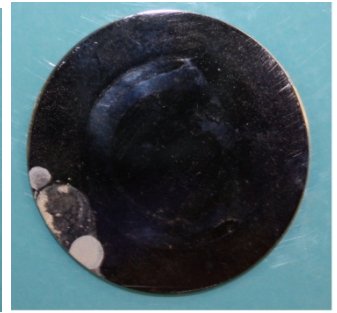
Figure 3-1. Photos of Posttest Surfaces of 316L Stainless Steel After 37 Days of Dripping at 80 °C [176 °F] and 85 Percent Relative Humidity

Figure 3-1 shows optical photos of the posttest specimens after 37 days of dripping tests at 80 °C [176 °F] and relative humidity of 85 percent. Most of the surface area on the front upper side subjected to water dripping was covered with white salt deposits. The white deposits were also observed on the lower back side, particularly the outside area of the polytetrafluoroethylene-spacer-covered inner area as seen in Figure 3-1.

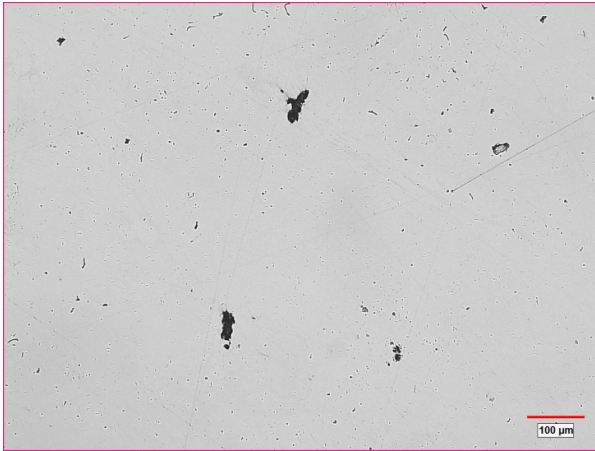
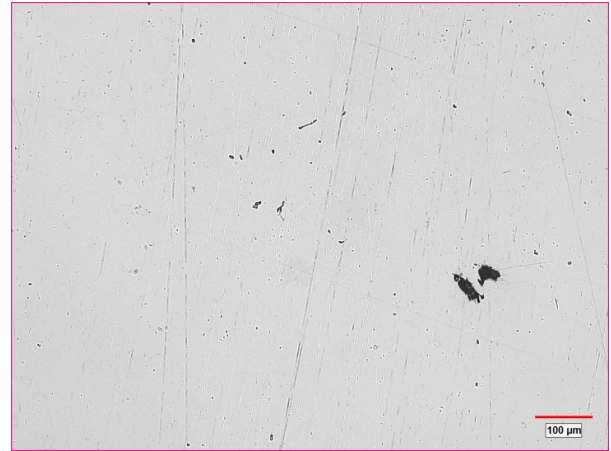
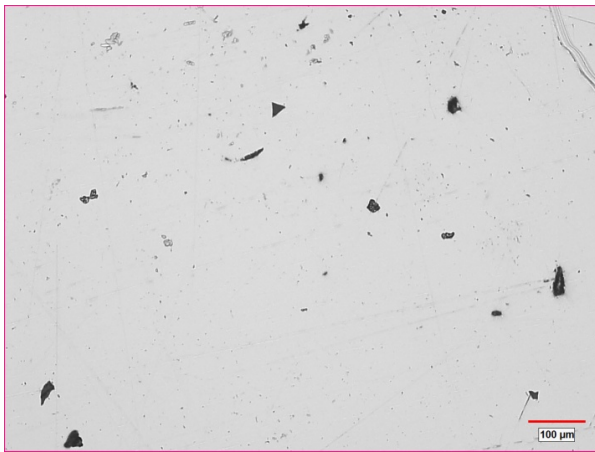
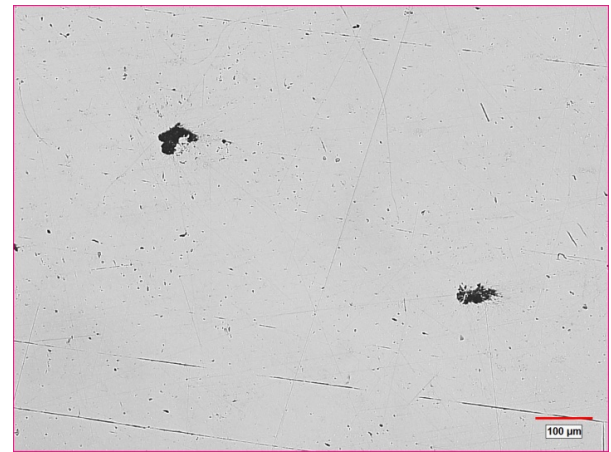
Figure 3-2. Optical Micrographs of 316L Stainless Steel Surfaces After 37 Days of Dripping at 80 °C [176 °F] and 85 Percent Relative Humidity

After removing the salt deposits followed by sample cleaning with HNO₃ solution, the specimens were examined with an optical microscope. Figure 3-2 shows typical morphologies of the corroded surface of stainless steel. After 37 days of dripping tests, as shown in Figure 3-2, corrosion pits were observed throughout the areas exposed to the dripping water for all tested specimens. Many small-sized pits {about 1 μm [3.94×10^{-5} in]} were also present. Caseres and Mintz (2010) also observed salt deposit formation and localized corrosion (i.e., pitting) on 304 stainless steel. In these tests by Caseres and Mintz (2010), 304 stainless steel was exposed to different chloride deposits, including a simulated sea salt, sodium chloride, and magnesium chloride deposits. The 304 stainless steel with the various salt deposits was exposed to different atmospheric conditions, including 50 °C [122 °F] at 65 percent relative humidity, 50 °C [122 °F] at 50 percent relative humidity, and 50 °C [122 °F] at 40 percent relative humidity. Under all of these conditions, pitting was observed for the samples exposed to simulated sea salt and magnesium chloride. Pitting was not observed on the samples exposed to sodium chloride, because the relative humidity used for the testing was not high enough to cause the salt to deliquesce. The pitting depth was not measured for these tests. One additional test was conducted for 304 stainless steel exposed to a simulated sea salt deposit at 65 °C [122 °F] at 70 percent relative humidity. Large pits were observed to form on the samples exposed to this environment. The pits were measured with laser profilometry, which provided a corrosion rate on the order of 4.5 mm/yr [0.180 in/yr].

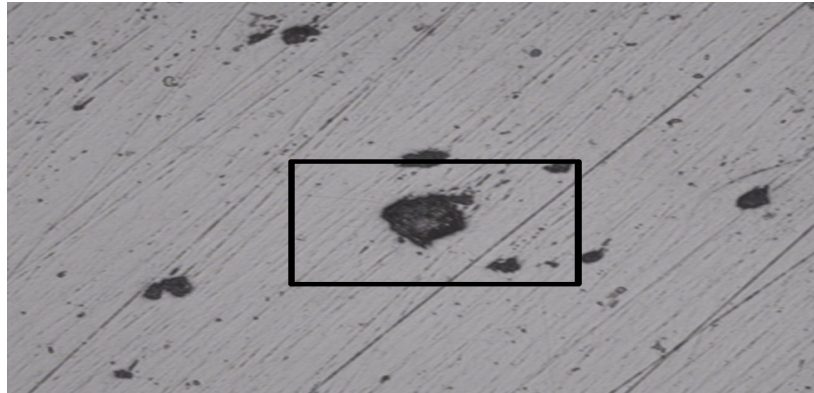
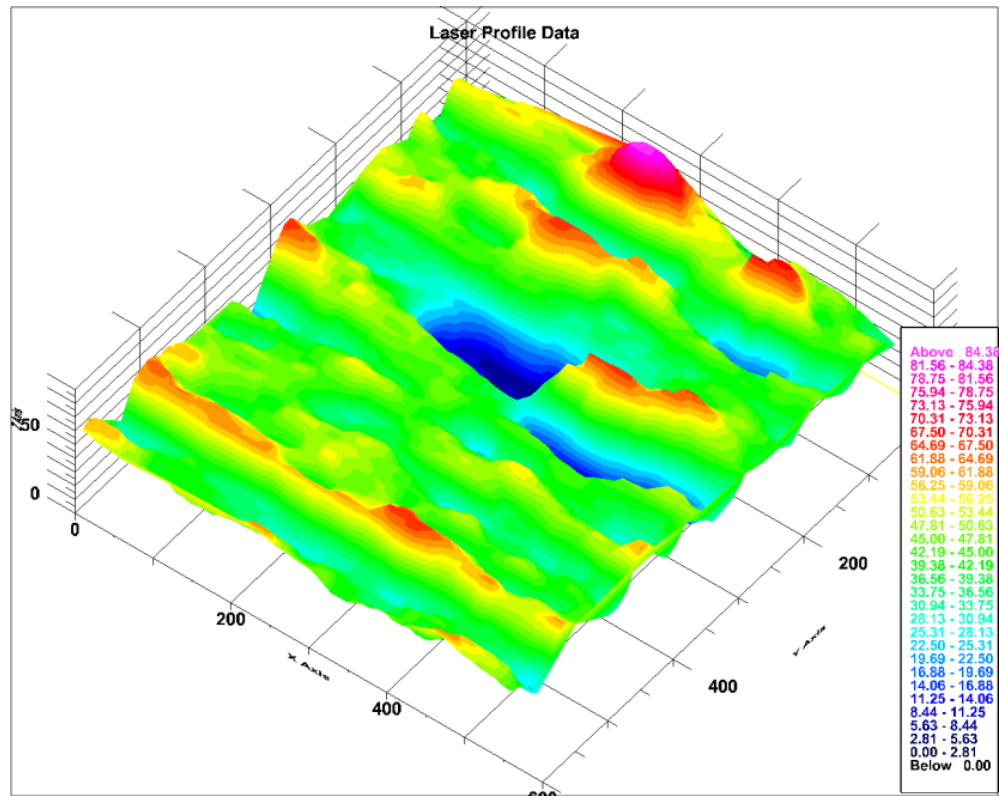
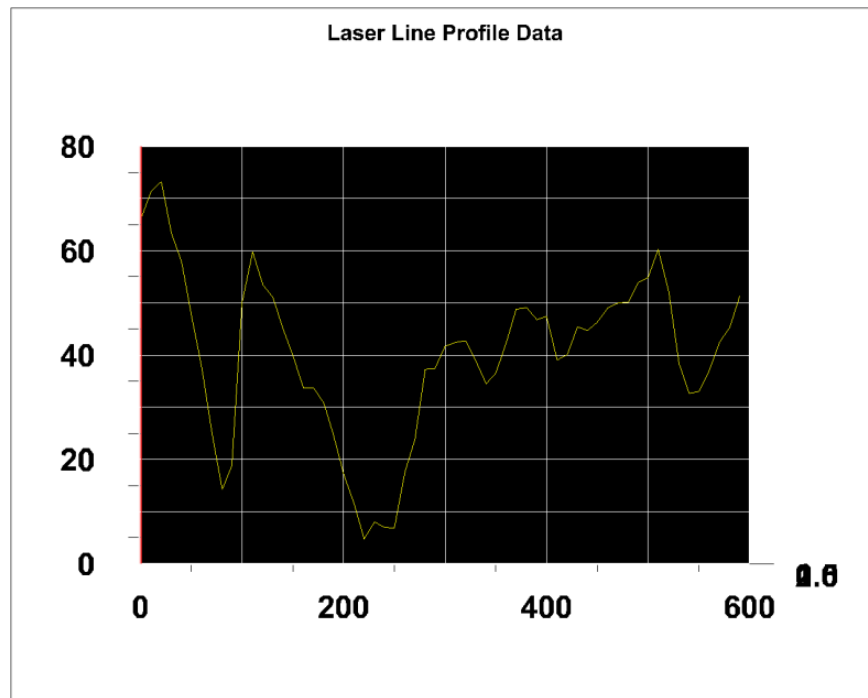
Figure 3-3. Surface Topography of 316L Stainless Steel Specimen after 37 Days of Dripping At 80 °C [176 °F] and 85 Percent Relative Humidity: (a) Optical Micrograph, (b) 3-D Laser Scan Profiles of the Pit Area, and (c) 2-D Profiles. Note: the Square Box in (a) Indicates the Laser Scanning Area. The Units in (b) and (c) Indicate x, y, and z axes Are in Micrometers.

Figure 3-3 (continued). Surface Topography of 316L Stainless Steel Specimen after 37 Days of Dripping At 80 °C [176 °F] and 85 Percent Relative Humidity: (a) Optical Micrograph, (b) 3-D Laser Scan Profiles of the Pit Area, and (c) 2-D Profiles. Note: the Square Box in (a) Indicates the Laser Scanning Area. The Units in (b) and (c) Indicate x, y, and z axes Are in Micrometers.

The observed pits were further analyzed by using laser profilometry to estimate the pit depth. Figure 3-3(a) shows a typical pit morphology of the corroded surface of stainless steel exposed to dripping conditions. As can be seen from both the three-dimensional and two-dimensional profiles in Figure 3-3(b) and 3-3(c), respectively, the pit has a width of roughly 150 μm [5.91×10^{-3} in] and a depth of roughly 40 μm [1.58×10^{-3} in]. These results are similar to those observed from optical microscopy.

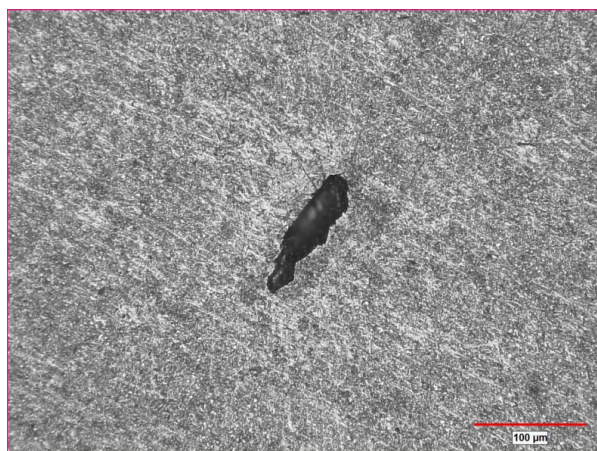
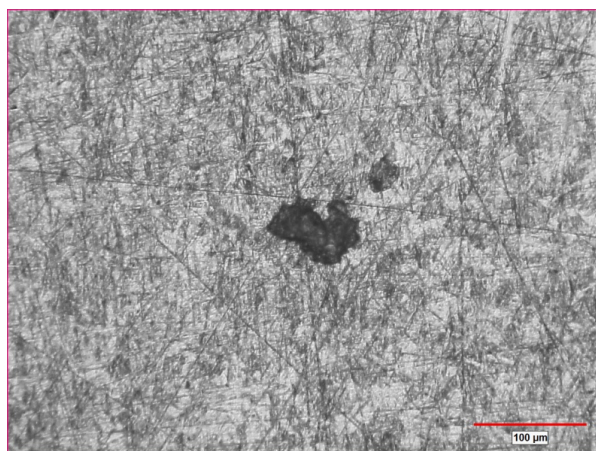
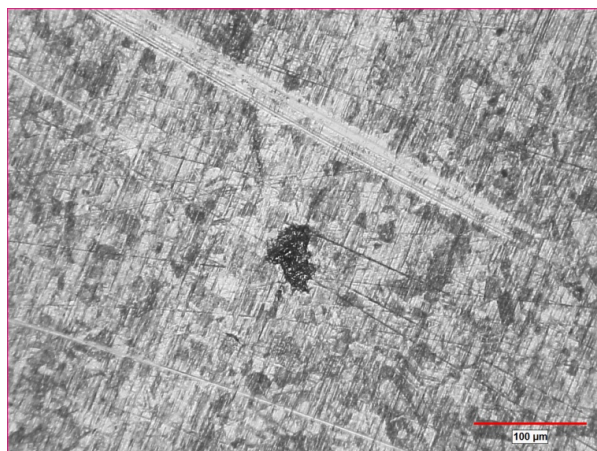
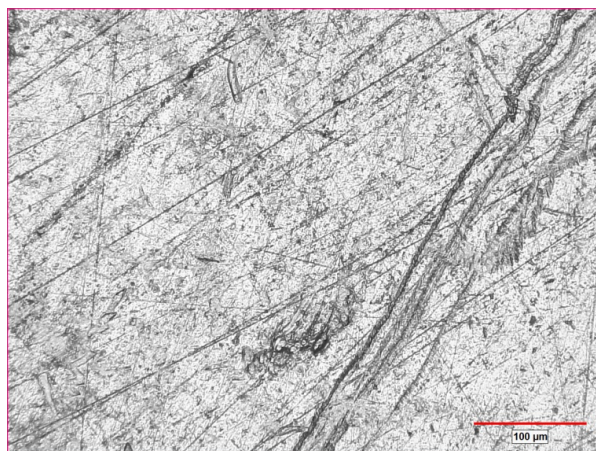
Figure 3-4. Optical Micrographs of 316L Stainless Steel Surfaces after 67 Days of Dripping at 95 °C [203 °F] and 75 Percent Relative Humidity

and relative humidity of 75 percent (not shown here). After removing the deposits, as seen in Figure 3-4, the stainless steel surface exhibited several corrosion pits and the surface was heavily corroded. There was also evidence of grain boundary attack [see Figure 3-4(b) and 3-4(c) on specimen F]. With a slightly higher test temperature of 95 °C [203 °F] compared to the first batch, it appeared there was active dissolution without passivation under the test condition.

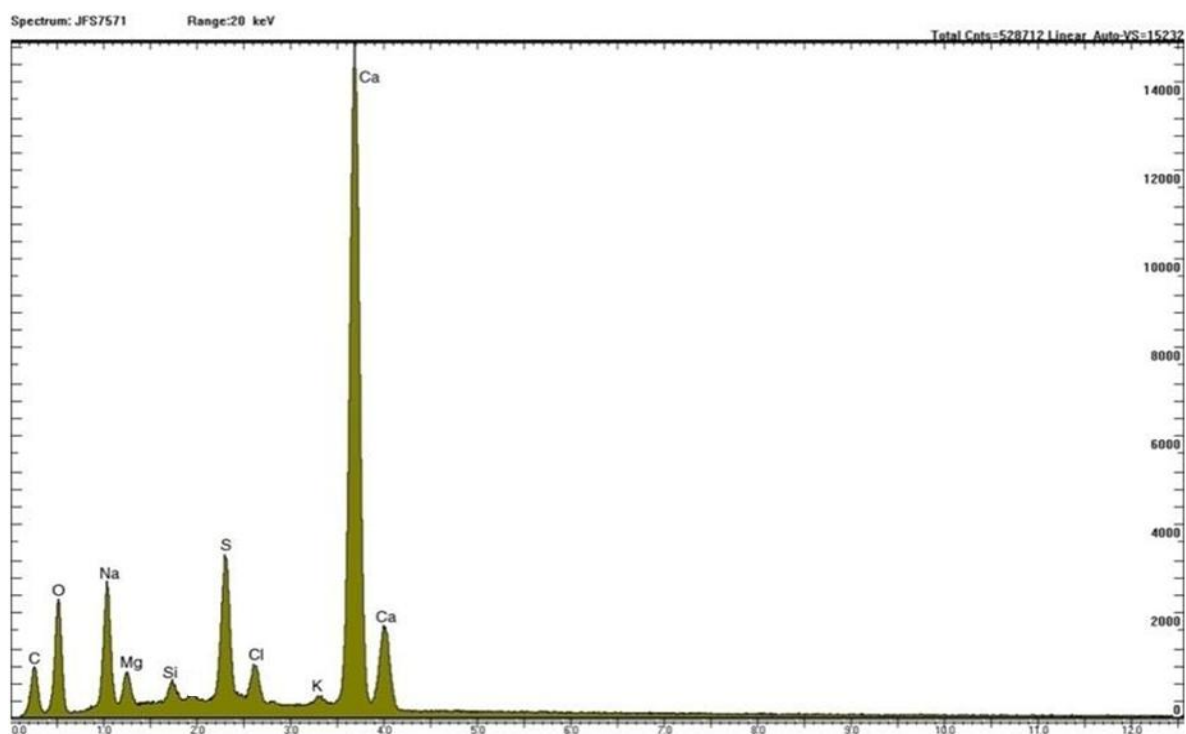
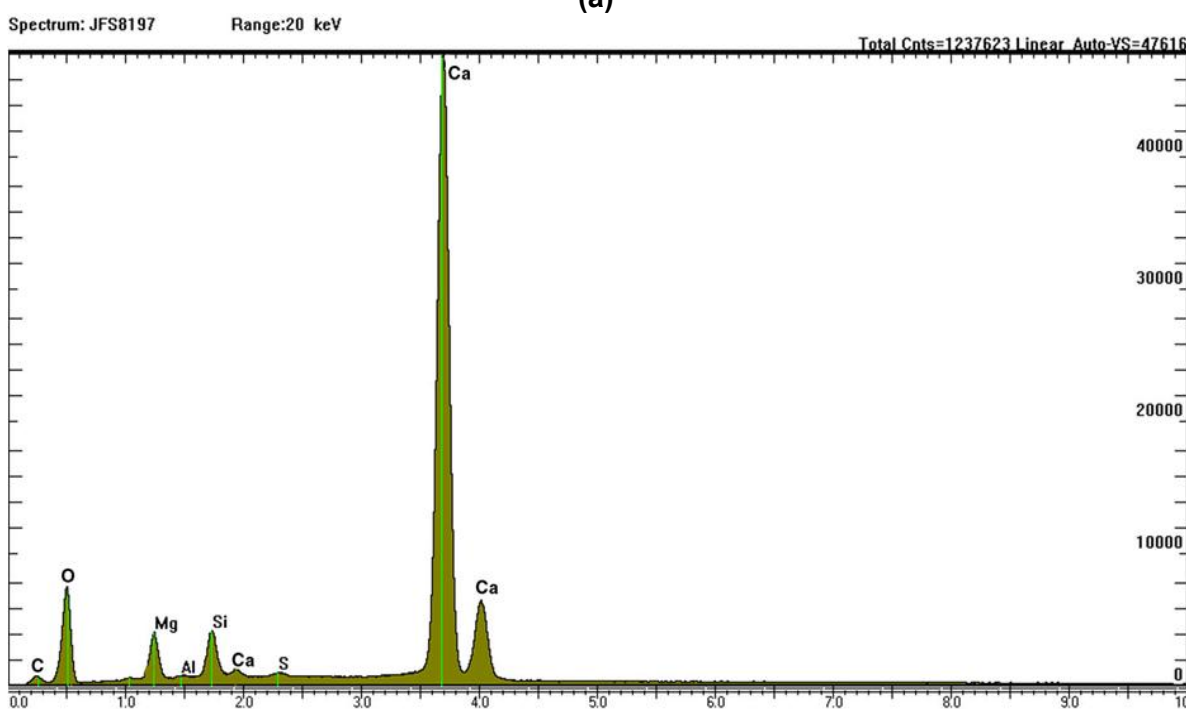
Figure 3-5. Energy-Dispersive X-ray Spectroscopy of the Salts Deposited on the 316L Stainless Steel Specimen Tested (a) at 80 °C [176 °F] and 85 Percent Relative Humidity and (b) at 95 °C [203 °F] and 75 Percent Relative Humidity

The energy dispersive x-ray spectroscopy analysis results of salt deposits from the first and second batches are shown in Table 3-3 and Figure 3-5. Figure 3-5 shows that the white deposits consist of calcium, carbon, oxygen, sodium, magnesium, aluminum, silicon, sulfur, and chloride. The higher concentrations of calcium, carbon, and oxygen suggest that the white deposit is primarily calcium carbonate, deposited from the evaporation of the dripping water. This salt was also confirmed from the x-ray diffraction analysis data shown in Figure 3-6, which indicates that the salts are dominantly calcium carbonate. Sodium, magnesium, sulfur, and chloride came from the dripping water. Aluminum and silicon are likely from residual deposits from the specimen surface preparation process before the test and/or possibly from the stainless steel matrix by dissolution. In particular, a significant amount of silicon (more than 5 weight percent) appeared on the salt formed in the second batch compared to the silicon concentration in the first batch.

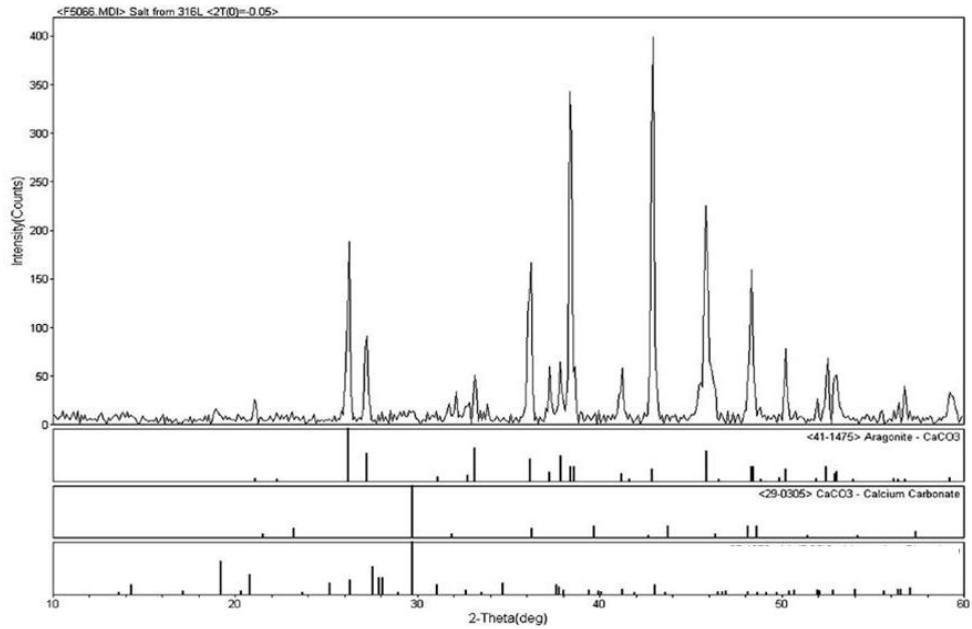
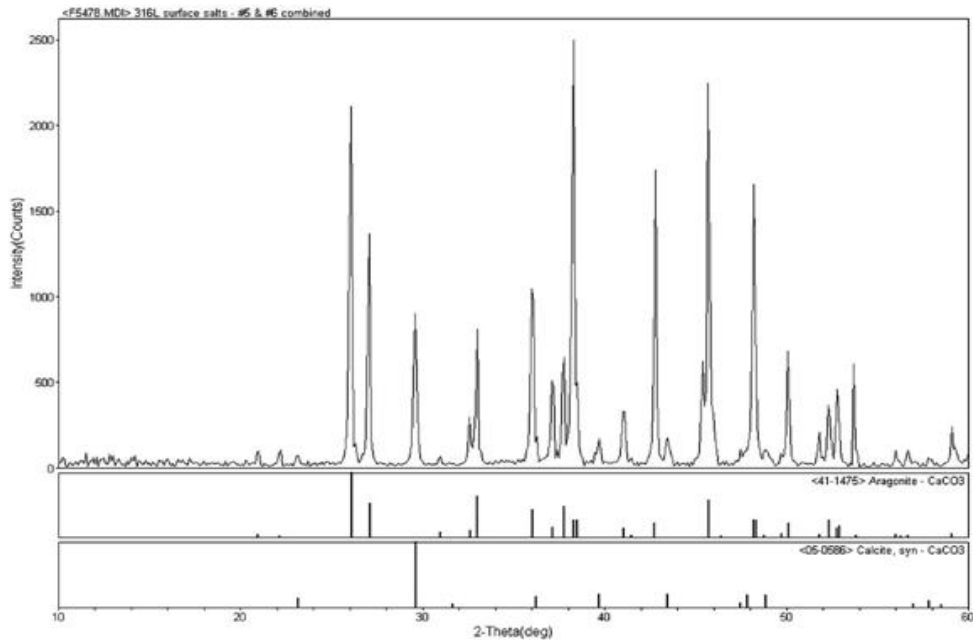
Figure 3-6. X-ray Diffraction Spectra of Salts Deposited on the 316L Stainless Steel Specimens Tested (a) at 80 °C [176 °F] and 85 Percent Relative Humidity and (b) at 95 °C [203 °F] and 75 Percent Relative Humidity. Also Shown Are the Reference Spectra of Salts That Best Match the Salt Deposit Spectra.

Previous thermodynamic calculation results from an OLI Analyzer Studio evaporation simulation (OLI Systems Inc., 2010) indicated the possible formation of calcium carbonate, magnesium carbonate, sodium sulfate, and sodium-calcium sulfate for the salts formed by evaporation under the two batch test conditions (Jung, et al., 2011). Based on the energy dispersive x-ray spectroscopy results, silicate compounds and sodium chloride also could be present in the salt deposit but in amounts less than the detection limit of the x-ray diffraction analysis.
