**INITIAL INVESTIGATION**

**Troubleshooting Plan for H-3 investigation, Storm Drain System A, March/April 2009**

CR-IP3-2009-01609 (3/25/9) identified unexpectedly high H-3 results in A system storm drains.

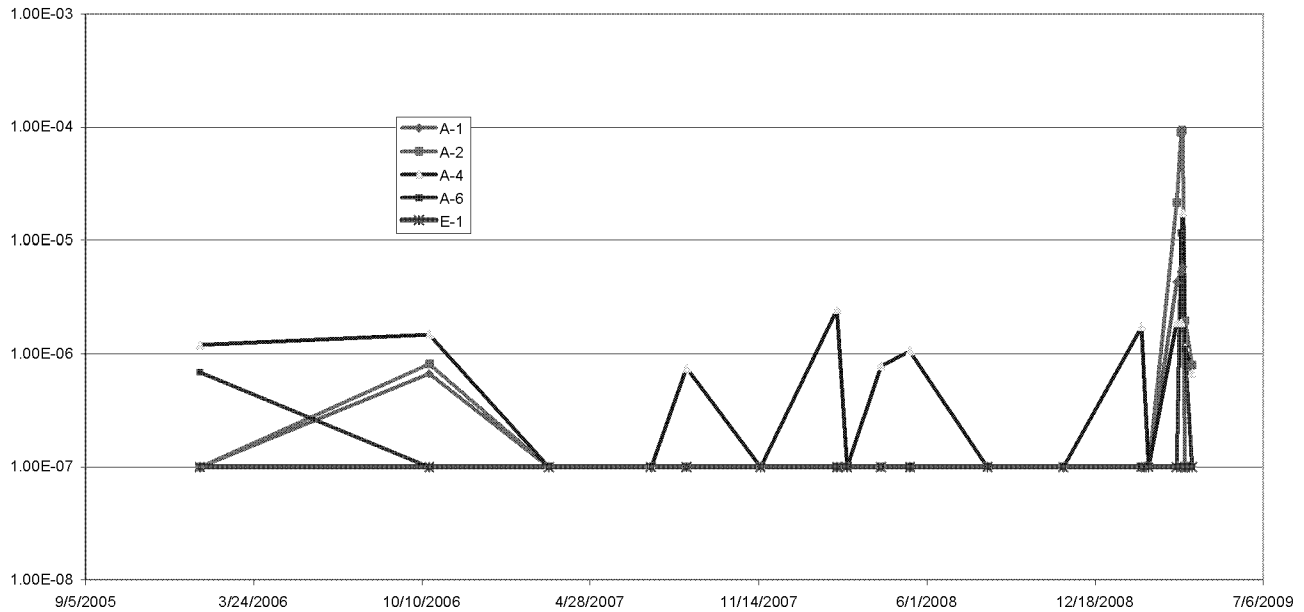
U3 Storm Drain A series, 2006-2009

Graphical representations of H-3 in A series storm drains are shown on the following pages. Drain A-4 indicates that there may have been a historical presence of washout in this system, perhaps connected to atmospheric conditions in the FSB. While we may consider altering sample collection periodicity to better observe this phenomenon in the future, the collective data continues to indicate that (probably due to dilution down E series), there is no EFFLUENT concern as all samples into the canal are <mda.

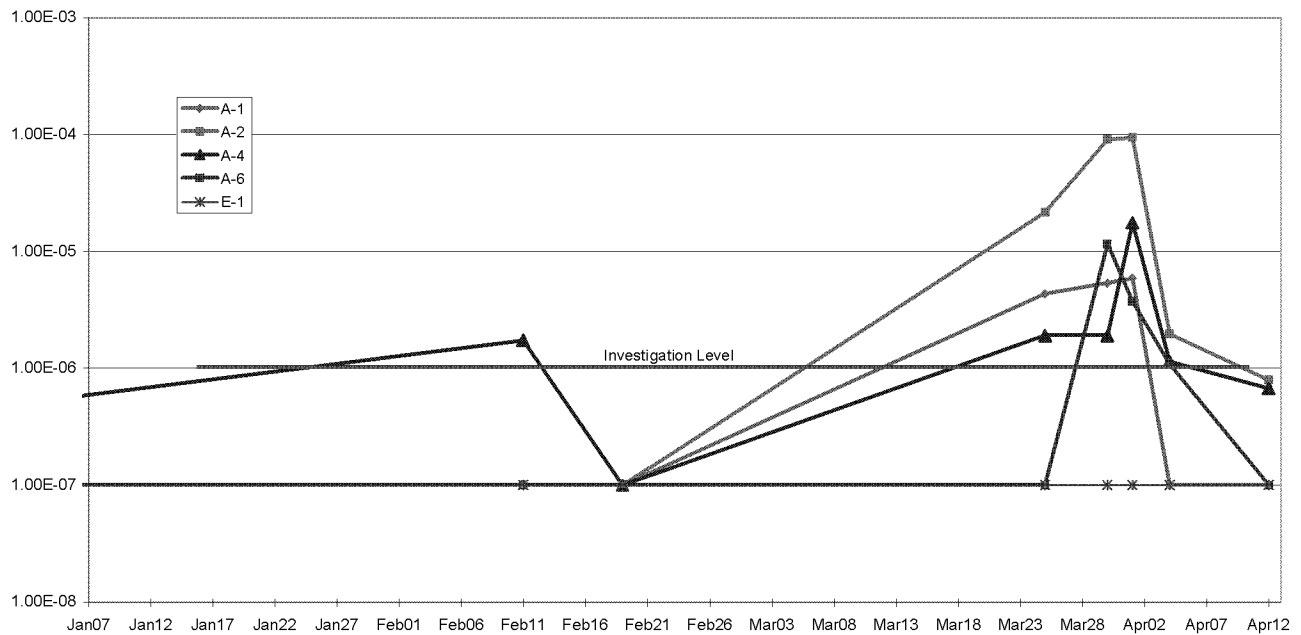
U3 Storm Drain A series, 2009

In all cases, H-3 in the "E" series was less than minimum detectable levels.

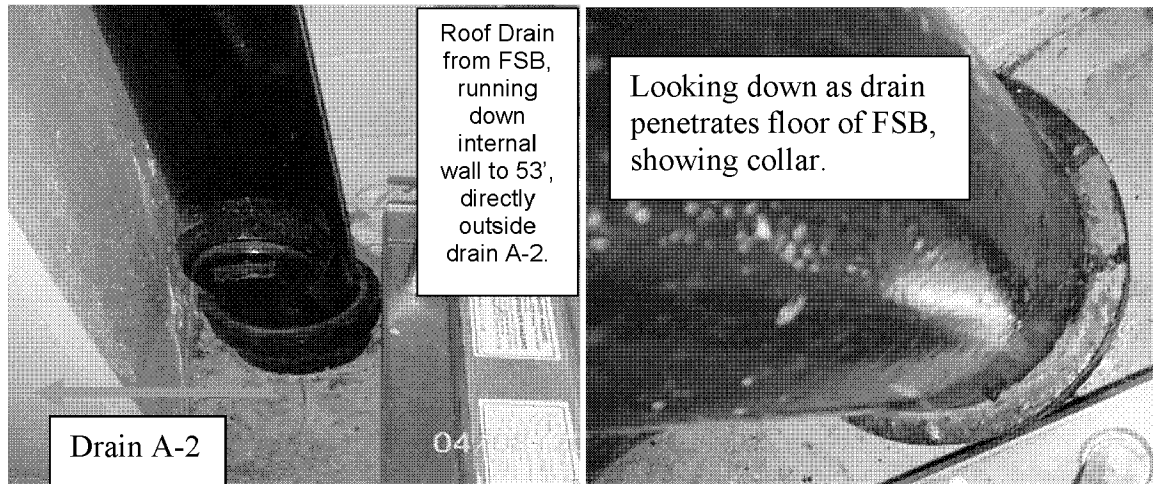
Two views of the FSB roof drain pipe, inside the FSB, 53' near manhole A-2

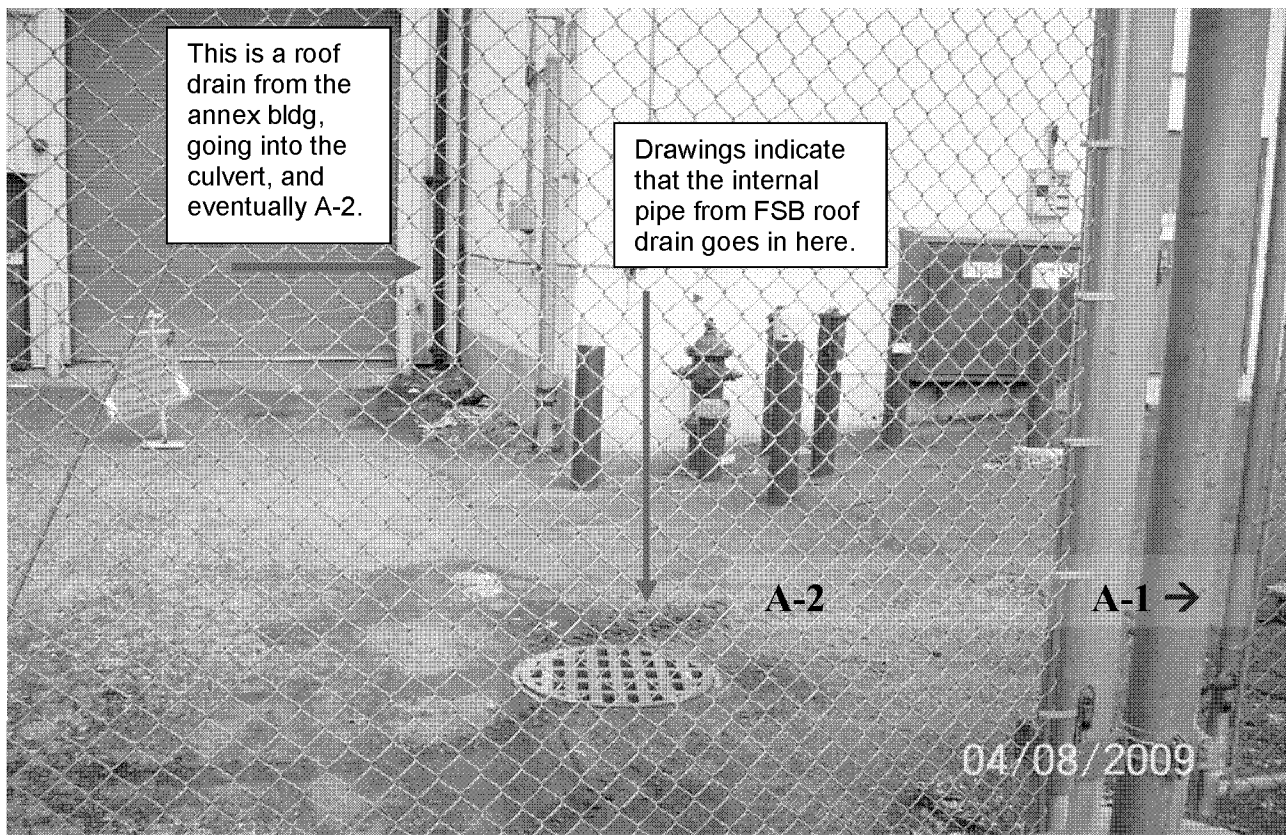
Manhole A-2 from outside, looking at Annex and FSB on right.

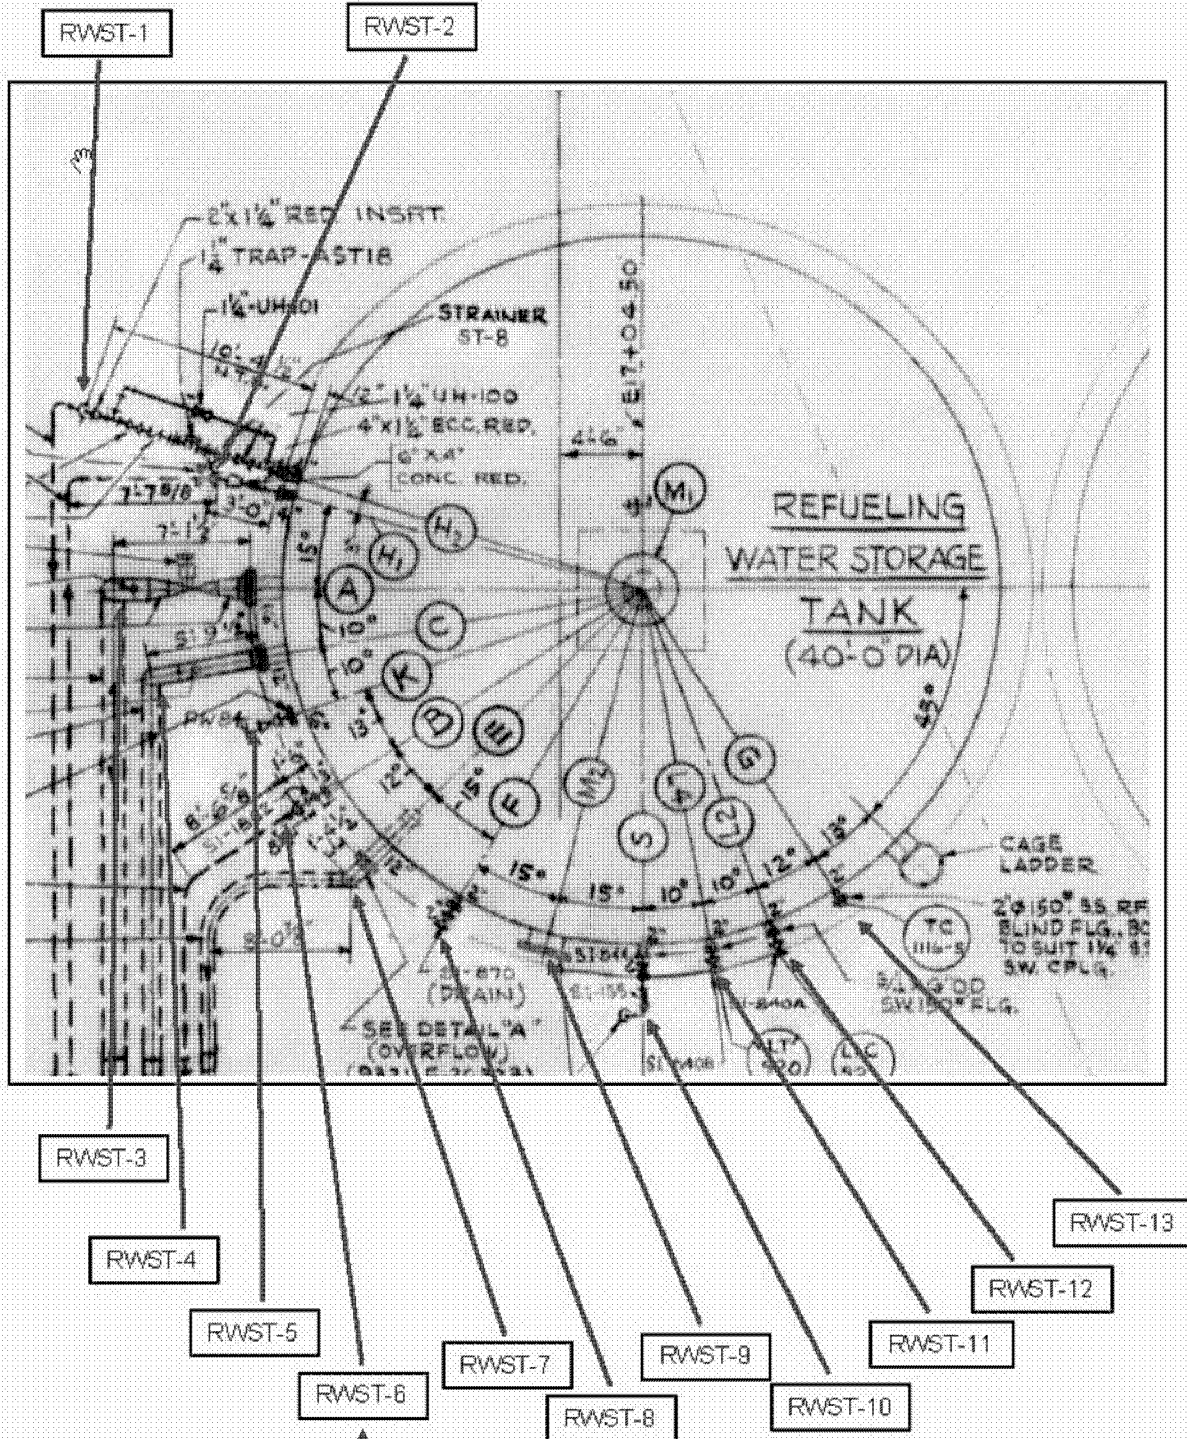
RWST Soil Samples Collected On 04/06/09

Most dirt samples were <MDA for gamma, or had some trace Cs-137 consistent with our 75g program. One area (sample 6) showed trace Co-58. This area required more detailed investigation. Additional samples of the very specific area were taken, and samples of soil were collected at 6" and 1 foot below the surface. The Co-58 was very small, and mostly on the surface. None was detected at a depth of 12". This contamination was traced back to work performed on the valve directly above the area, a week before. The Co-58 is indicative of approximately 82 mls of water and could not possibly suggest the volume necessary to contribute to the H-3 in the A system storm drains. Therefore, a leak from the RWST atop the hill, down into the drains is NOT considered a likely source of the H-3 found in the storm drains in late March. See the data and maps on the following pages:

Two additional samples were taken around point RWST-6, called 6A and 6B. Later, 4 more samples were taken, 6C and 6D at 6" into the soil, and 6E and 6F at 12" depth.
