RE: East Evaporation Pond Leak, Cameco Resources, Smith Ranch-Highland Uranium Project, Permit to Mine No. 633

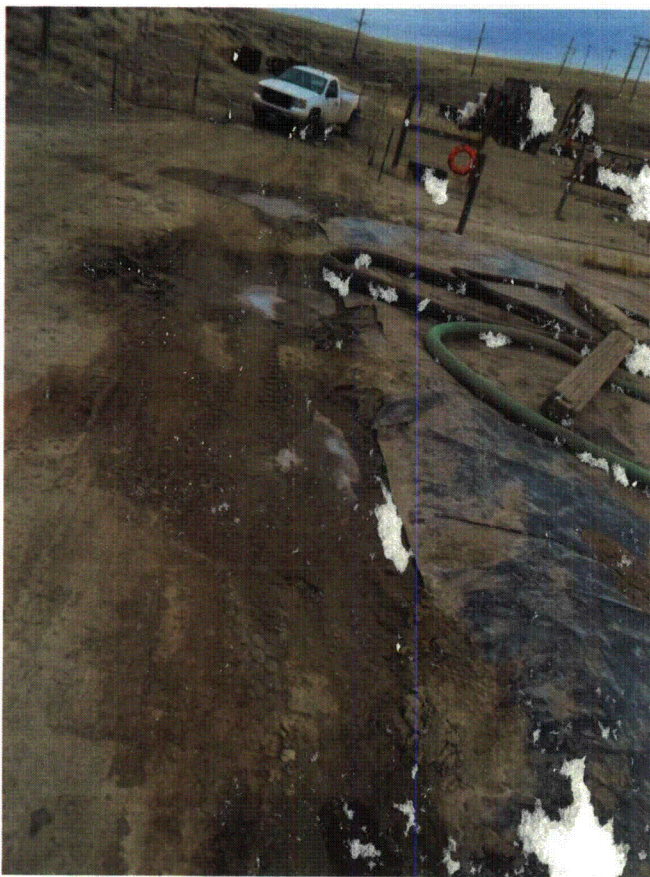
North side of pond looking East

Work to find and repair any tear in the pond liner has been postponed due to weather. The snow and ice on the pond make it difficult to visually find tears at the present time. Additionally, in November Cameco concluded that there was a possibility the sump could have been collecting runoff water. The top of the liner was inspected and in November visible voids were found. Cameco repaired the roadway and sloped the road away from the pond. These repairs were made the week of December 12th, 2011. Attached are before and after photos. However, these repairs have not eliminated periodic water in the sump.

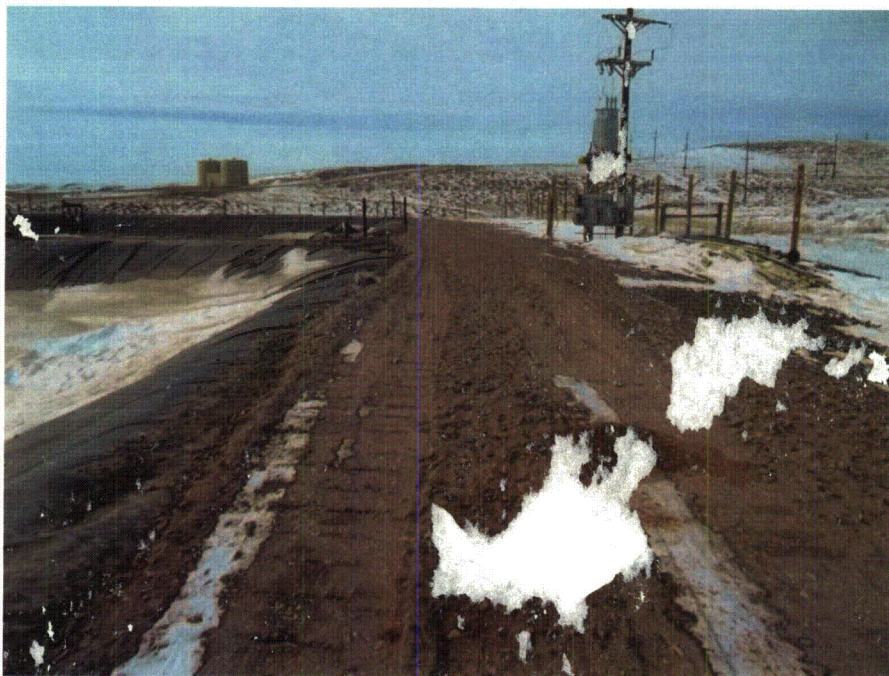
North side of pond looking West
