**Prototype SAFKEG LS 3979A/0002**  
**NCT and HAC Regulatory Test Report**

Title	Prototype Safkeg LS 3979A/0002 NCT and HAC Regulatory Test Report	Number	CTR 2009/21
		Issue	B
		File Ref	CTR 2009-21-B-v1-SAFKEG 3979A- Regulatory Test Report.docx
Compiled.

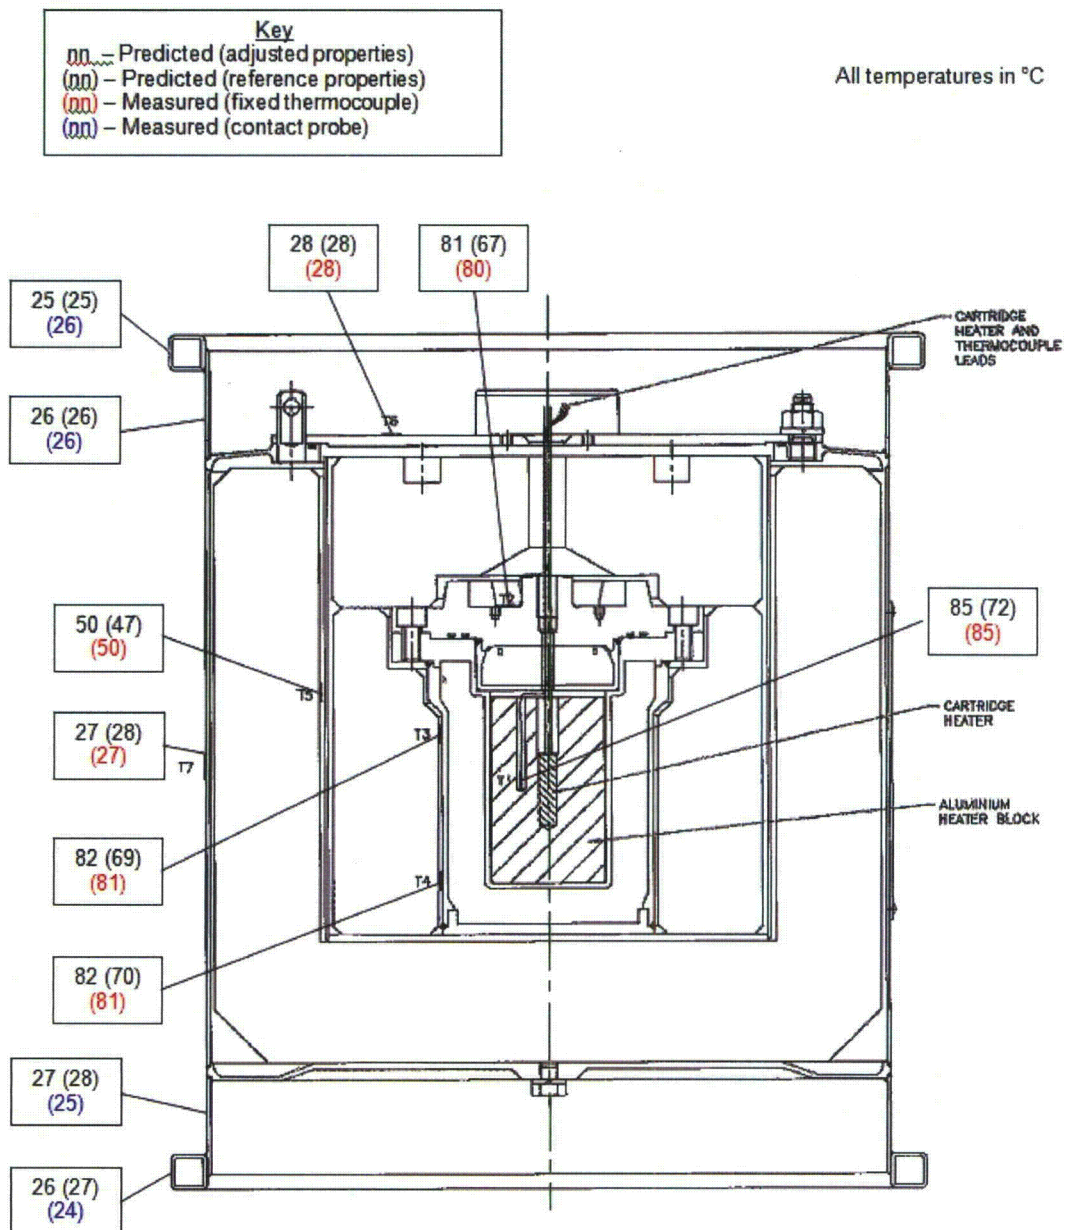
**Figure 3-3 Comparison of Measured and Predicted Temperatures in the Steady-State Heating Test**

Heat load 10W  
Ambient temperature 24.1°C

The predicted temperatures in the repeat calculation are in good agreement with those measured in the test. The predicted temperature profile is shown in report SERCO/TAS/5388/001 Figure 5 (Section 3.5.2) and it can be seen that, as expected, the highest temperatures occur in the heater block and inner containment vessel and high temperature gradients are generated in the cork. The temperatures measured in the steady state test and the predicted temperatures are summarised in Figure 3-3 (report SERCO/TAS/5388/001 (Section 3.5.2)). The temperatures initially predicted by the model are also shown on this Figure. The predicted temperatures agree with the temperatures measured by the fixed thermocouples to within 1.2°C. The predicted temperature on the outside of the keg, at the bottom, is around 2°C higher than the measured values. This is probably due to the board on which the container was sitting being modelled as perfectly insulating whereas, in practice, there was some heat loss through the board.
