Trip Report for the 27 April-2 May 2008 Lee Nuclear Site Field Audit

G. Stirewalt

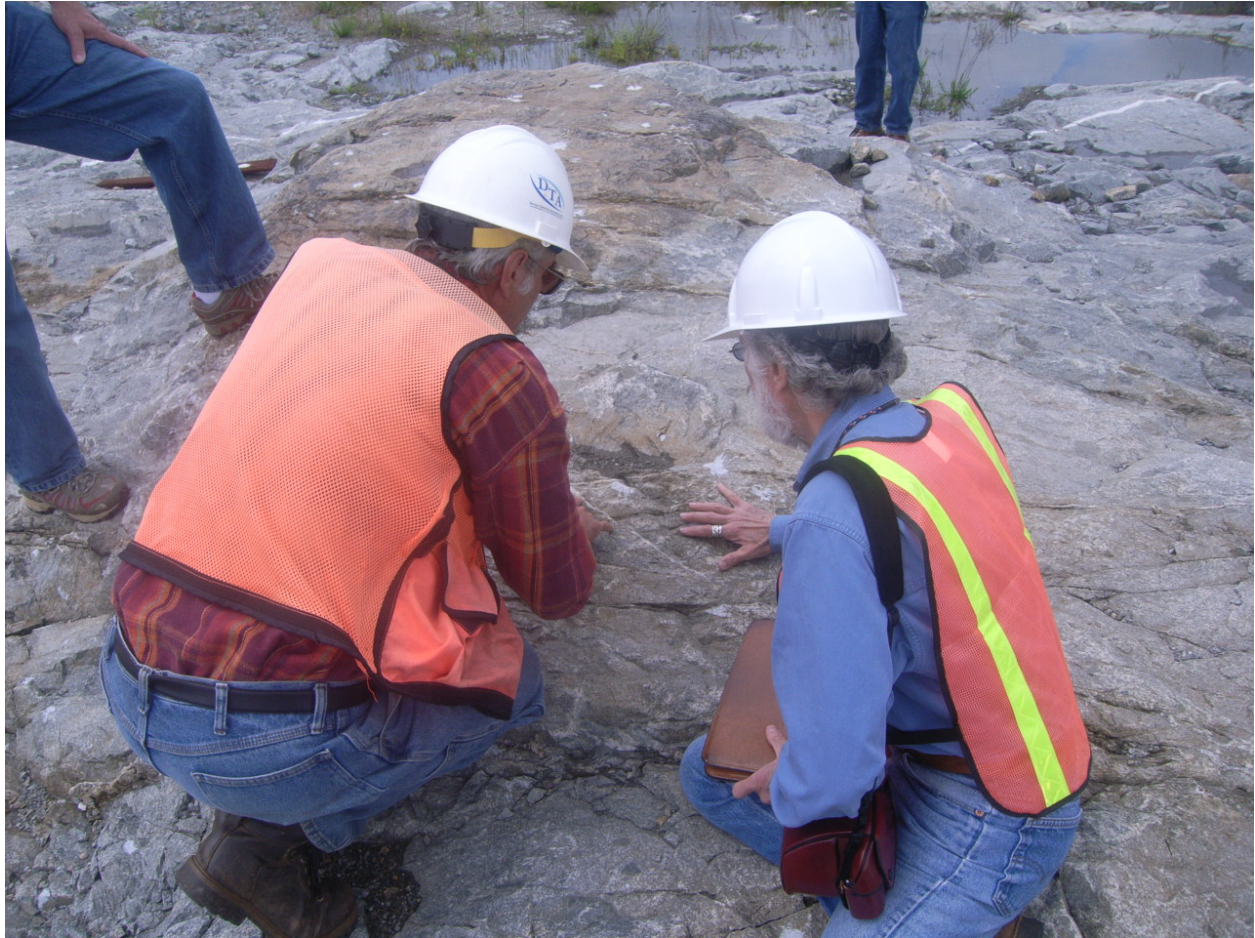
Figure 1. April-May 2008 Lee Nuclear Site Field Audit: NRC Senior Geologist, Dr. Gerry L. Stirewalt, and the applicant's geologic consultant, Dr. Malcolm Schaeffer, examining rock units and old deformation fabrics in foundation grade level bedrock in the original CNS Unit 2 excavation, which is located between Lee Nuclear Site Units 1 and 2. Dr. Schaeffer was the lead geologist involved with the original geologic mapping of all excavations at the former CNS site in the 1970s.

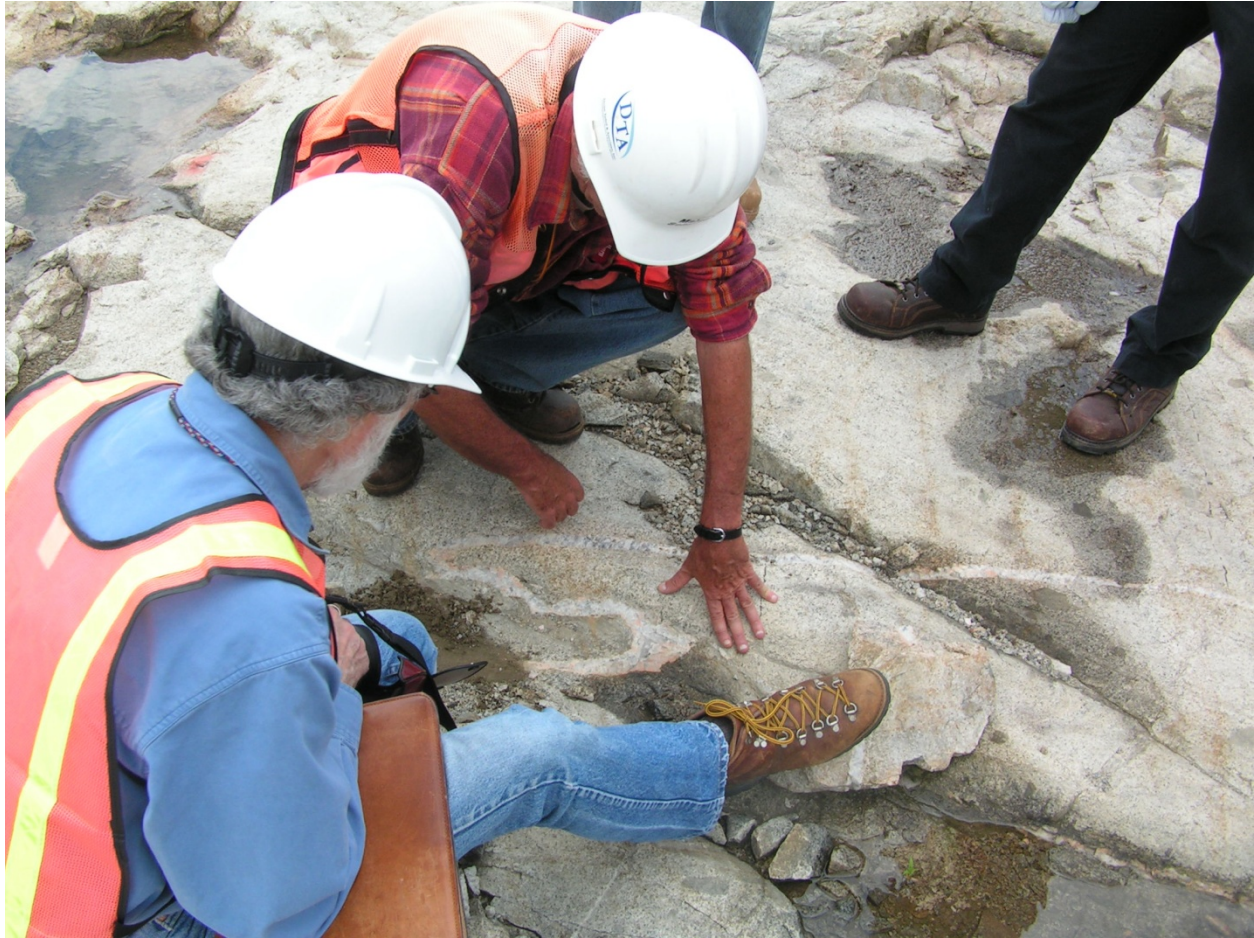
Figure 2. April-May 2008 Lee Nuclear Site Field Audit: NRC Senior Geologist, Dr. Gerry L. Stirewalt, and the applicant's geologic consultant, Dr. Malcolm Schaeffer, examining a folded igneous vein, an old deformation feature, in foundation grade level bedrock in the original CNS Unit 2 excavation.

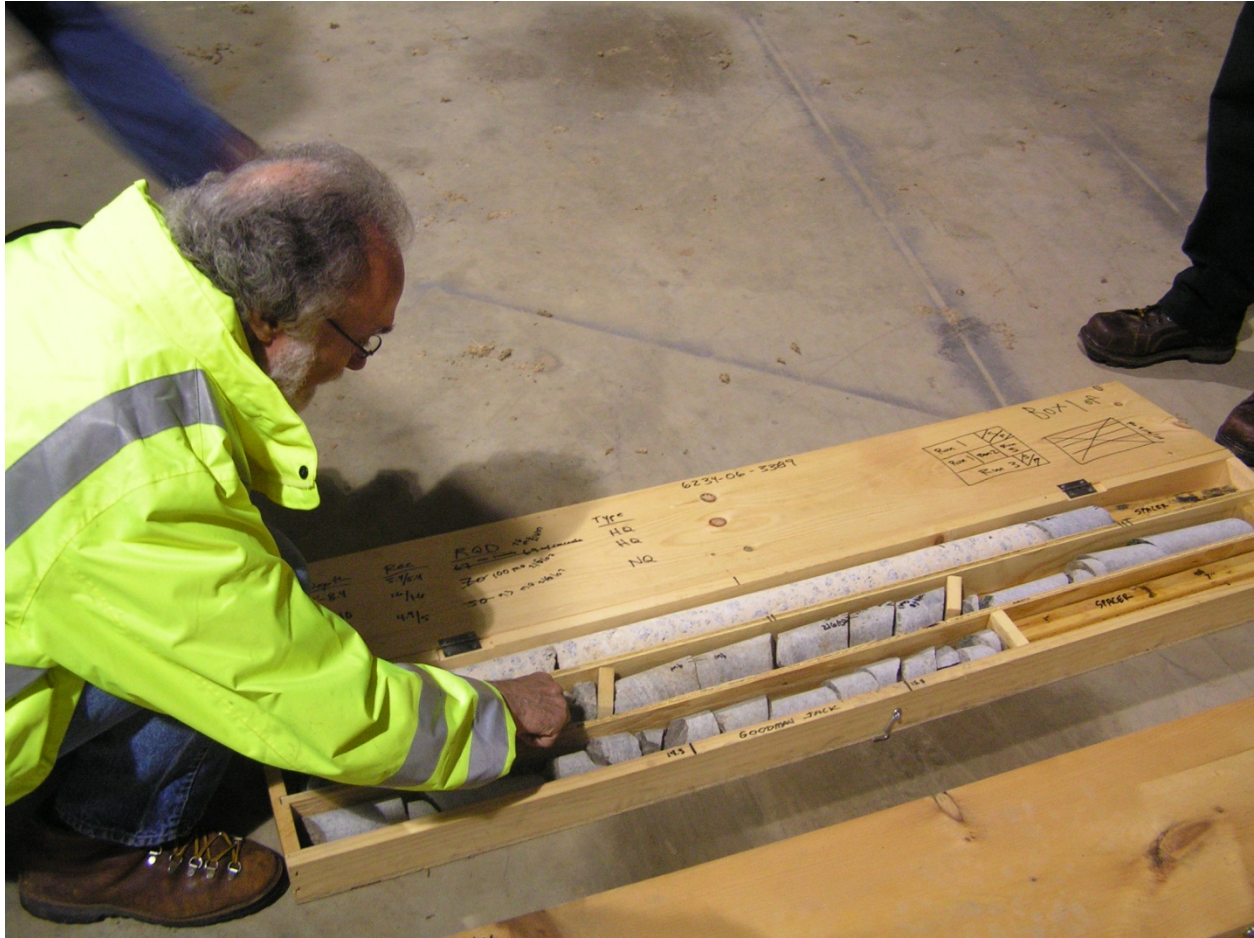
Figure 3. April-May 2008 Lee Nuclear Site Field Audit: NRC Senior Geologist, Dr. Gerry L. Stirewalt, examining core from CNS Unit 1 (Lee Nuclear Site Unit 1), including foundation bedrock (darker-colored core in the center and on the right side of the core box) and old concrete (lighter-colored core on the left side of the core box) currently covering the excavation for former CNS Unit 1 (Lee Nuclear Site Unit 1). The contact between the old concrete and bedrock is shown by the color change in the core at the upper left side of the core box. This core was taken during site characterization investigations for the Lee Nuclear Site COL application specifically to penetrate the old concrete and extend into foundation bedrock.

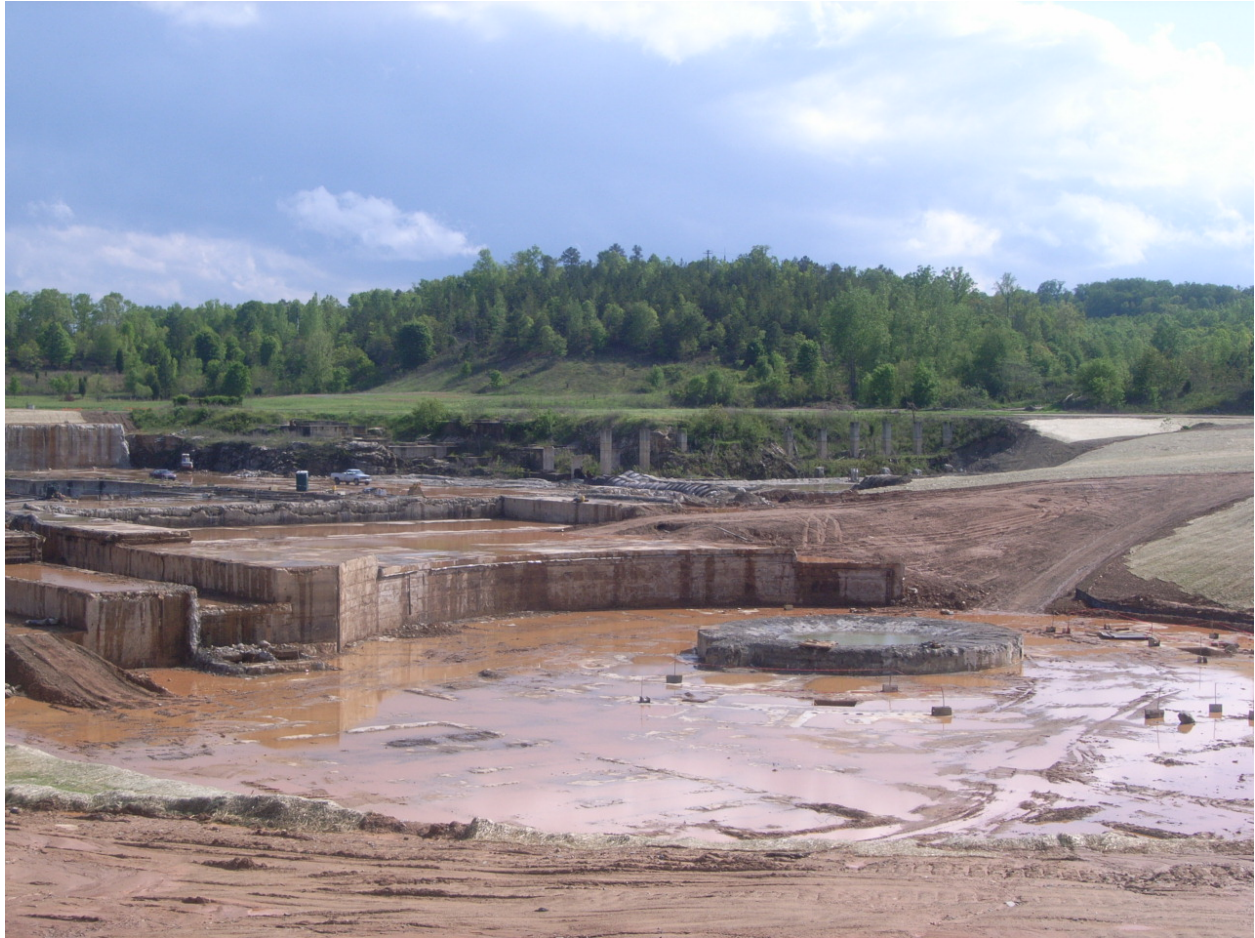
Figure 4. April-May 2008 Lee Nuclear Site Field Audit: View of concrete poured during initial construction activities at CNS Unit 1 (Lee Nuclear Site Unit 1).
