March 21, 2011

Nuclear and Industrial Safety Agency

Seismic Damage Information (the 39th Release)
(As of 15:30 March 21st, 2011)

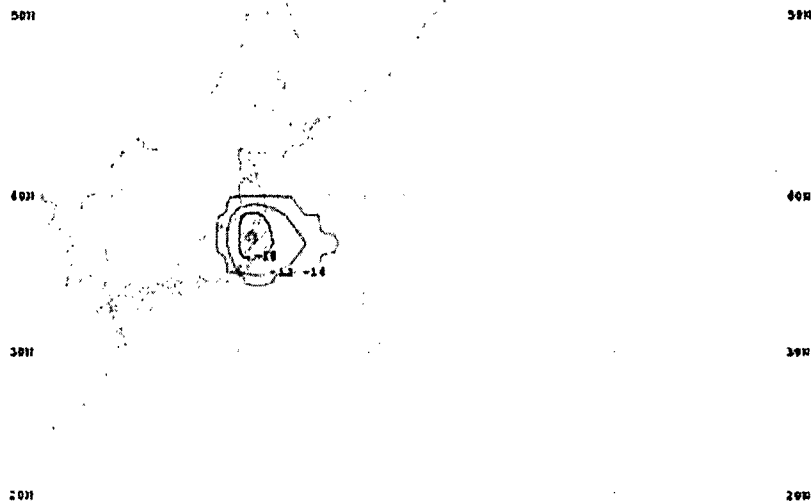
TIME INTEGRATED SURFACE - 500M LAYER CONCENTRATION

INTEGRATED FROM 07UTC 20 MAR 2011
TO 00UTC 21 MAR 2011

150E 140E 130E 120E 110E
(ISSUED 0955UTC 20 MAR 2011)

ASSUMED POLLUTANT RELEASED : 1 -131
START OF THE EMISSION : 0730UTC 20 MAR 2011
END OF THE EMISSION : 0730UTC 23 MAR 2011
SOURCE LOCATION : LATITUDE 37.42N
LONGITUDE 141.03E
NAME FUKUSHIMA DAIICHI

There would be a hazard around eastern part of Japan and western part of the North Pacific Ocean.

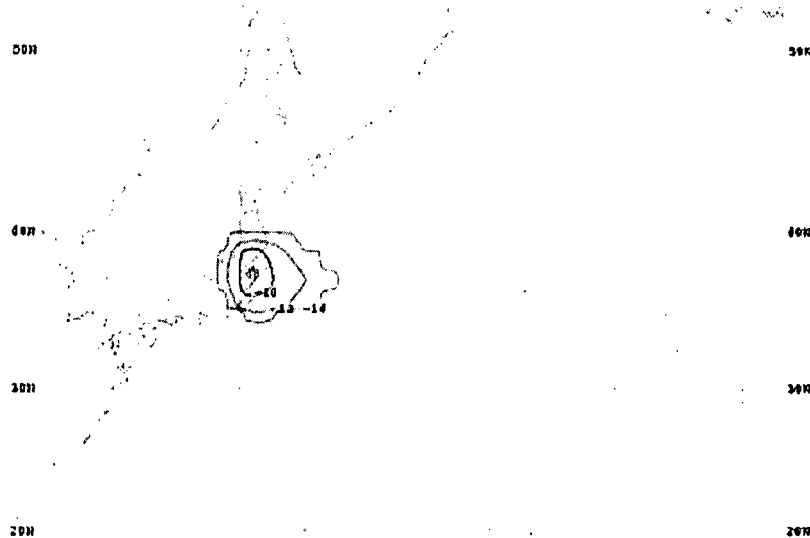
TIME INTEGRATED SURFACE - 500M LAYER CONCENTRATION

INTEGRATED FROM 0700 UTC 20 MAR 2011
TO 0000 UTC 21 MAR 2011

130E 140E 150E 160E 170E 180
(ISSUED 0955 UTC 20 MAR 2011)

ASSUMED POLLUTANT RELEASED : 1 -123
START OF THE EMISSION : 0730 UTC 20 MAR 2011
END OF THE EMISSION : 0730 UTC 23 MAR 2011
SOURCE LOCATION : LATITUDE 37.42N
LONGITUDE 141.03E
NAME FUKUSHIMA DAIICHI
