Regulatory Issue Resolution Protocol (RIRP) Pilot: Marine Atmosphere Stress Corrosion Cracking (SCC)

Sara DePaula, Materials Engineer, NMSS/SFST

Greg Oberson, Materials Engineer, RES/DE

April 12, 2012

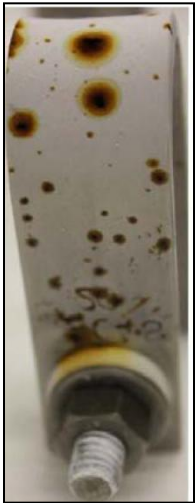
- Within 3 months, as-received and sensitized specimens with 1 or 10 g/m² salt showed intergranular cracking. No welded specimens have cracked yet, but there may be interdendritic attack.
- Some specimens with 0.1 g/m² salt at 35°C have minor pitting.
- Preliminary results are consistent with Japanese reports on threshold chloride ion concentration for SCC of 0.8 g/m².^{12,13}
