## 5000. Concrete Structures and Construction

## 5500. Durability, NDE & Masonry

- Objective and Scope
  - Provide introductory level review of concrete durability, NDE methods and masonry basics
  - Present and discuss
    - Durability of Nuclear Power Plant Concrete Structures
    - Non Destructive Evaluation Methods for Concrete
    - Masonry Basics

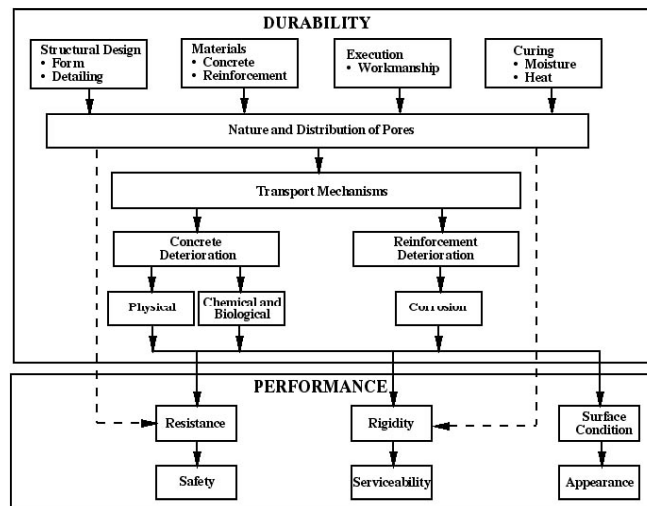
## Relationship between the concepts of concrete durability and performance

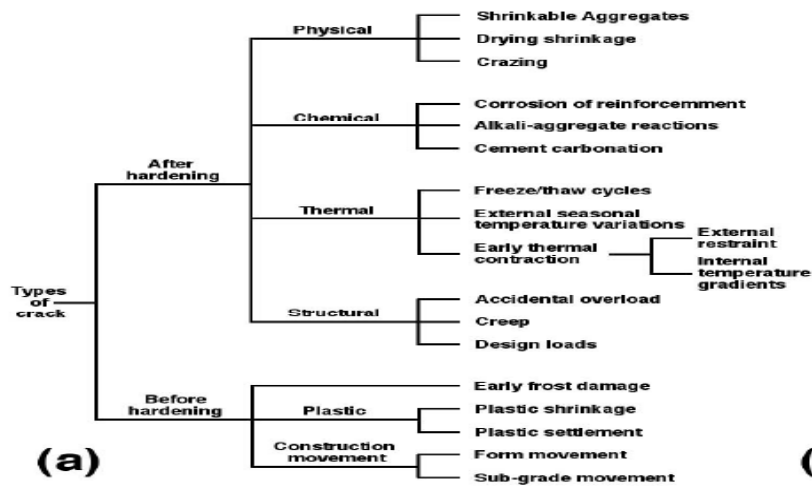
## Relationship between Primary Causes and Types of Cracks in Concrete

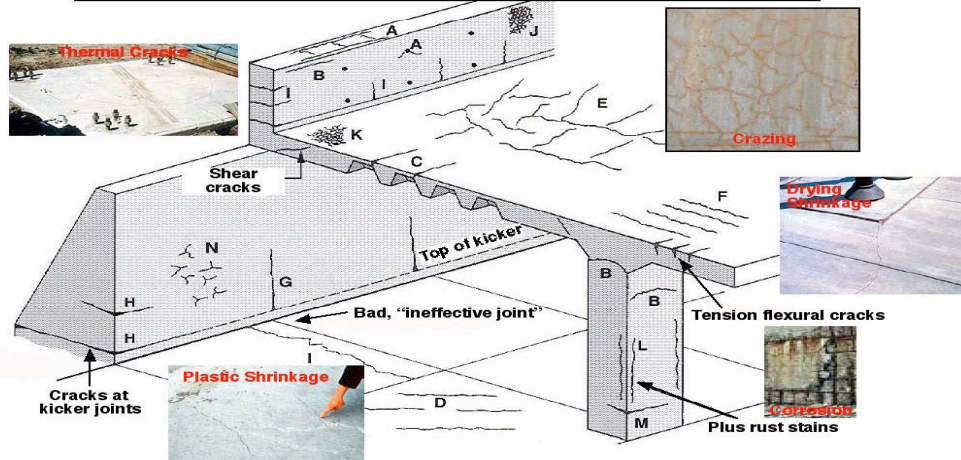
## Examples of Cracks in a Hypothetical Structure

Type of Cracking	Designation	Time of Occurrence
Plastic settlement	A, B, C	Ten minutes to three hours
Plastic shrinkage	D, E, F	Thirty minutes to six hours
Early thermal contraction	G, H	One day to two to three weeks
Long-term drying shrinkage	I	Several weeks or months
Crazing	J, K	One to seven days - sometimes much later
Corrosion of reinforcement	L, M	Several years, but may be sooner
Alkali-aggregate reaction	N	More than five years

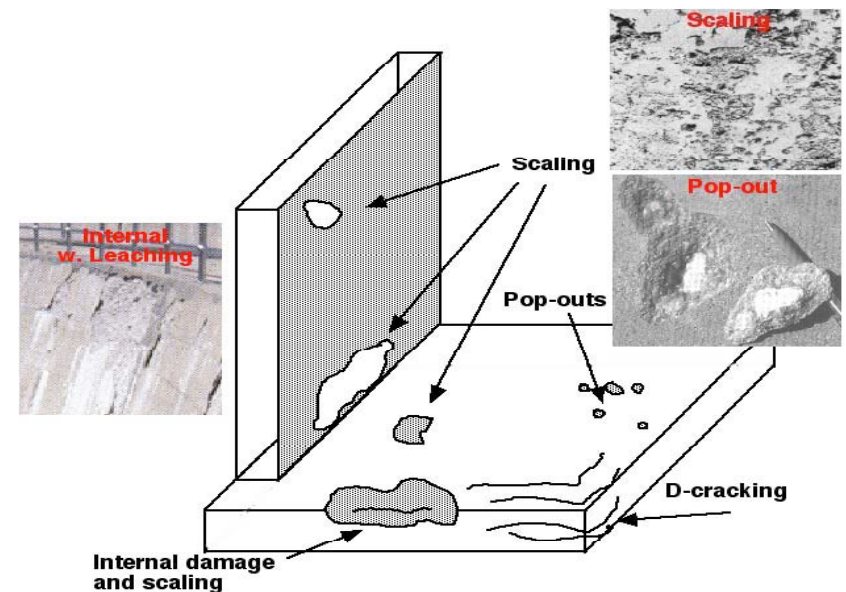
## Types of freeze-thaw damage

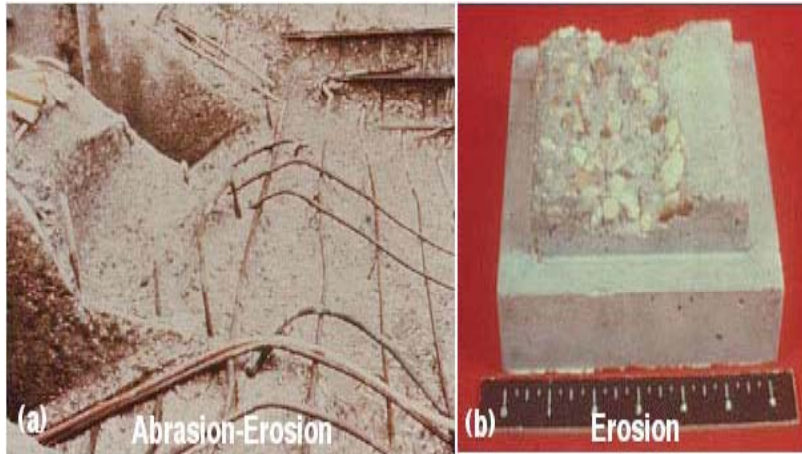
## Abrasion-erosion of Concrete

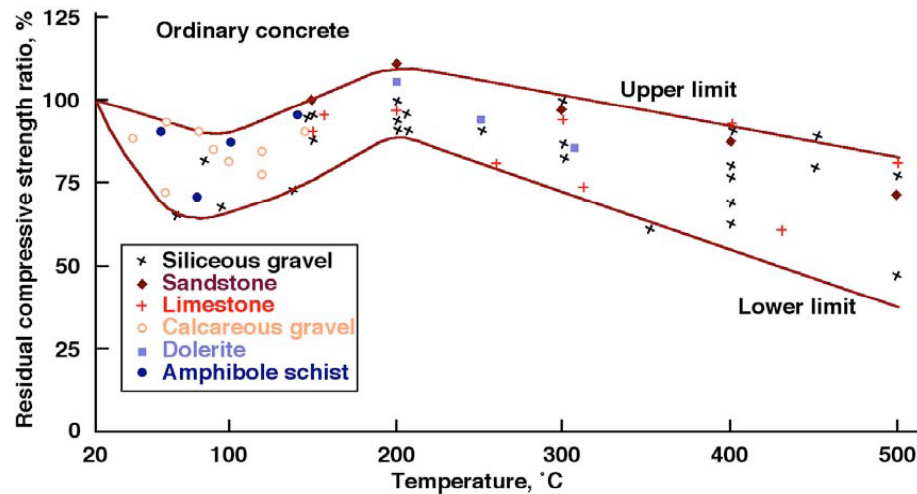
## Effect of Temperature on Residual Compressive Strength: Unsealed Specimens

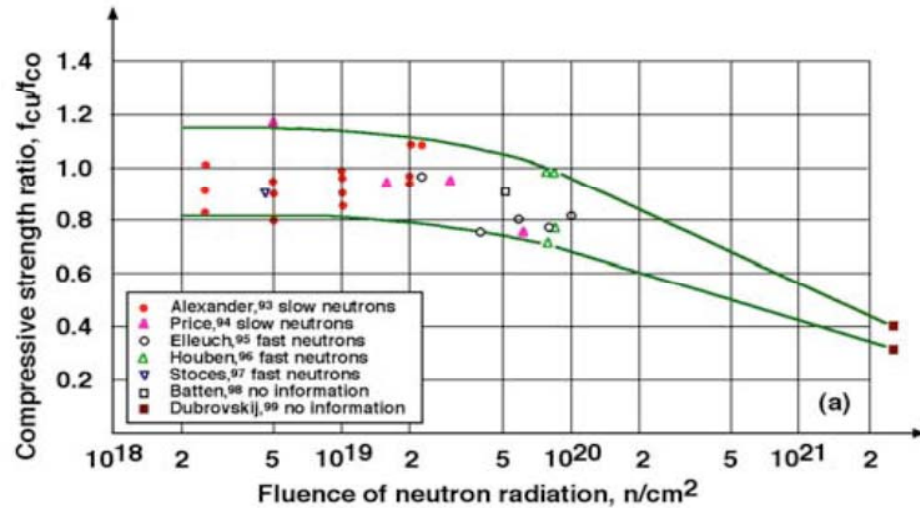
## Effect of Neutron Radiation on Compressive Strength Relative to Unirradiated and Unheated Control Specimens

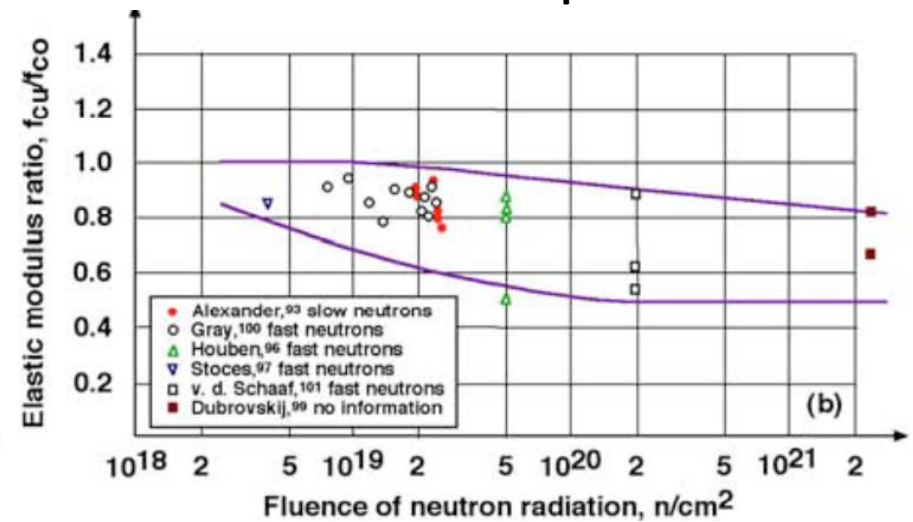
## Effect of Neutron Radiation on Modulus of Elasticity Relative to Unirradiated and Unheated Control Specimens

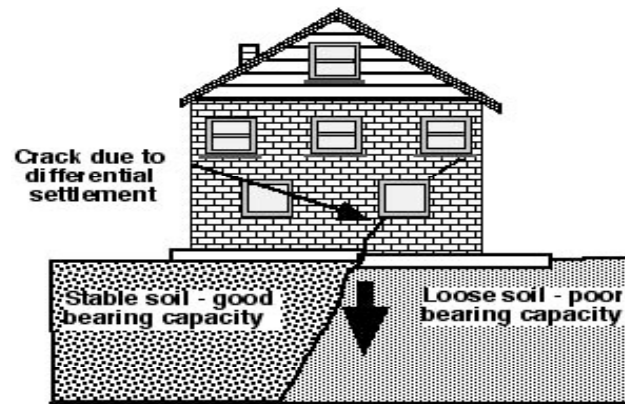
## Inadequate Foundation Design

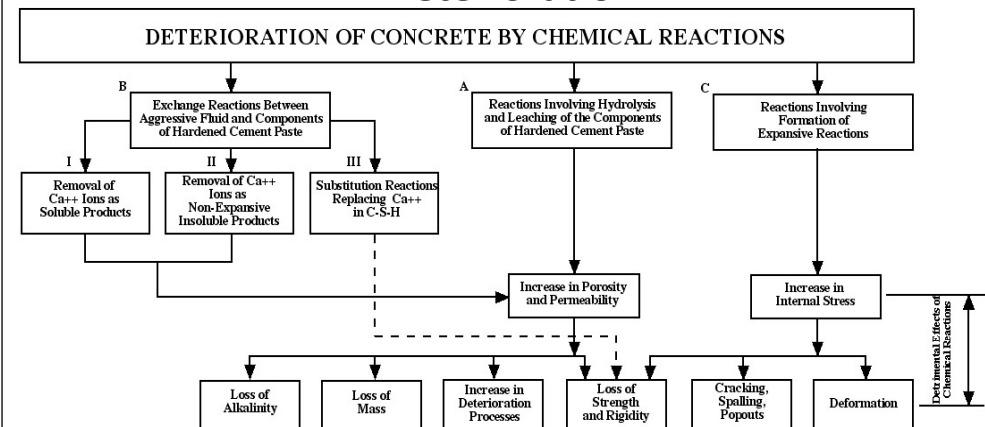
## Chemical Reactions Responsible for Concrete Deterioration

A: Softwater attack on calcium hydroxide and C-S-H present in hydrated portland cements;  
 B(I): acidic solution forming soluble calcium compounds such as calcium sulfate, calcium acetate, or calcium bicarbonate;  
 B(II): solutions of oxalic acid and its salts, forming calcium oxalate;  
 B(III): long-term seawater attack weakening the C-S-H by substitution of  $Mg^{++}$  for  $Ca^{++}$ ;  
 C(1): sulfate attack forming ettringite and gypsum;  
 C(2): alkali-aggregate attack;  
 C(3): corrosion of steel in concrete; and  
 C(4): hydration of crystalline  $MgO$  and  $CaO$ .

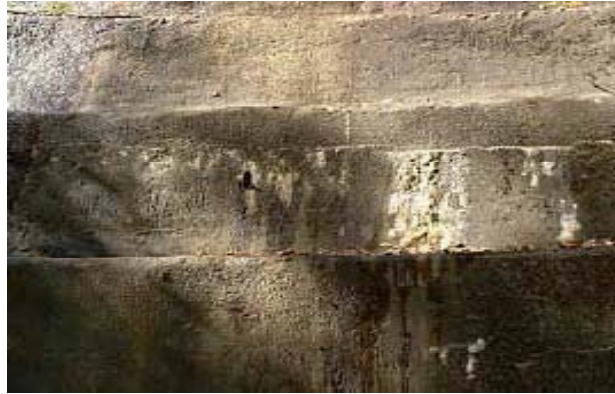
## Efflorescence in Water Structure

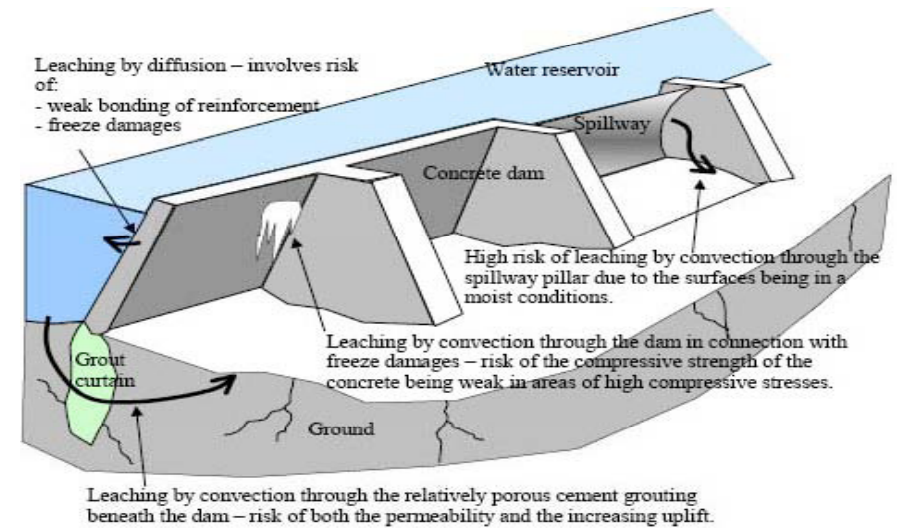
## Leaching Types in Concrete Hydraulic Structures

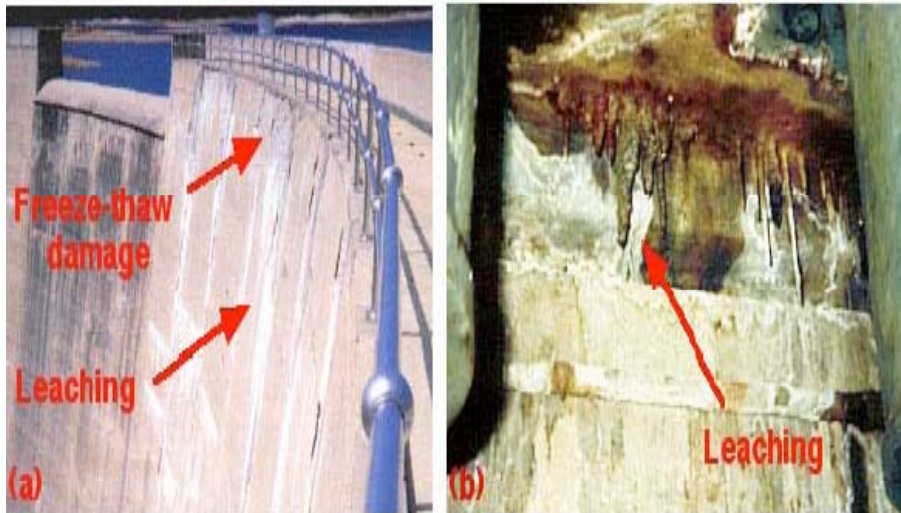
## Leaching: (a) Dam with Freeze-thaw Damage and Leaching, (b) Nuclear Power Plant Tendon Gallery Leaching

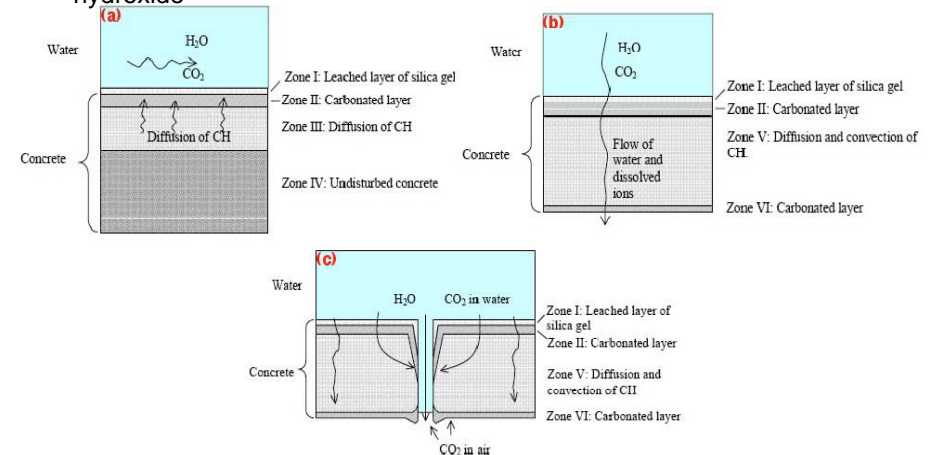
## Conceptual Models for Concrete Leaching Mechanisms

(a) leaching from free surfaces, (b) homogeneous percolation through porous concrete, and (c) leaching from surfaces of cracks. CH = calcium hydroxide

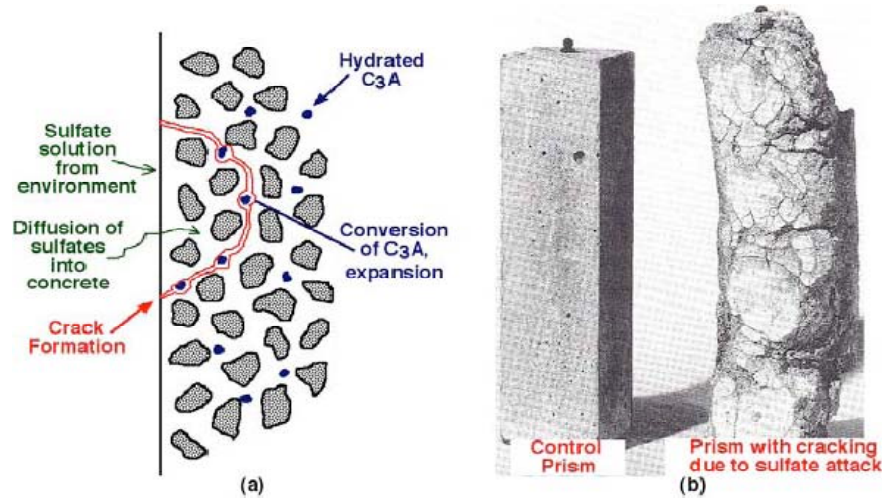
# Concrete Cracking due to Sulfate Attack

(a) mechanism, (b) example of concrete cracking due to sulfate attack

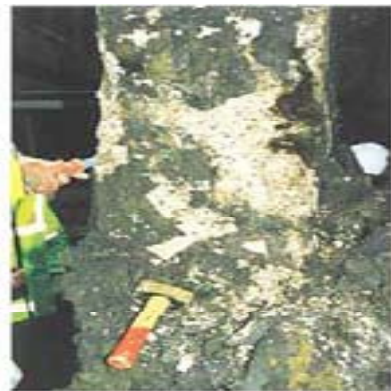
## Thaumasite Sulfate Attack

(a) Subsurface concrete pier affected by thaumasite sulfate attack

(b) Scanning electron micrograph showing thaumasite formation

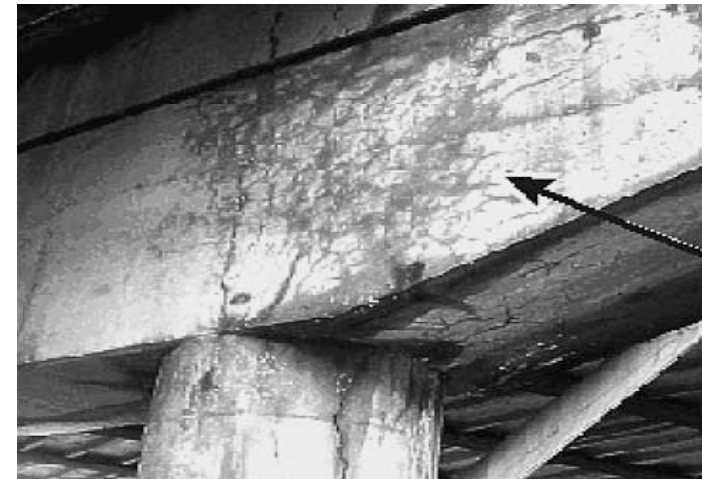
## Cracking damage in a concrete structure due to Delayed Ettringite Formation

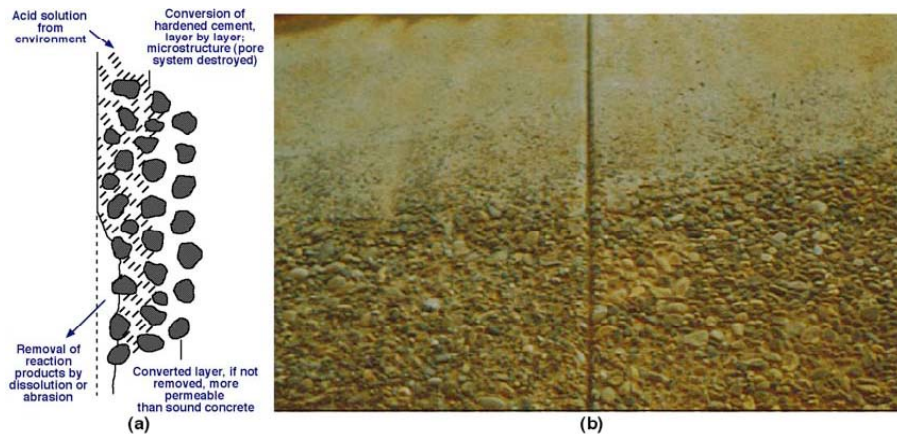
## Surface Loss due to Acid Attack

(a) mechanism, (b) example of acid attack on concrete wall

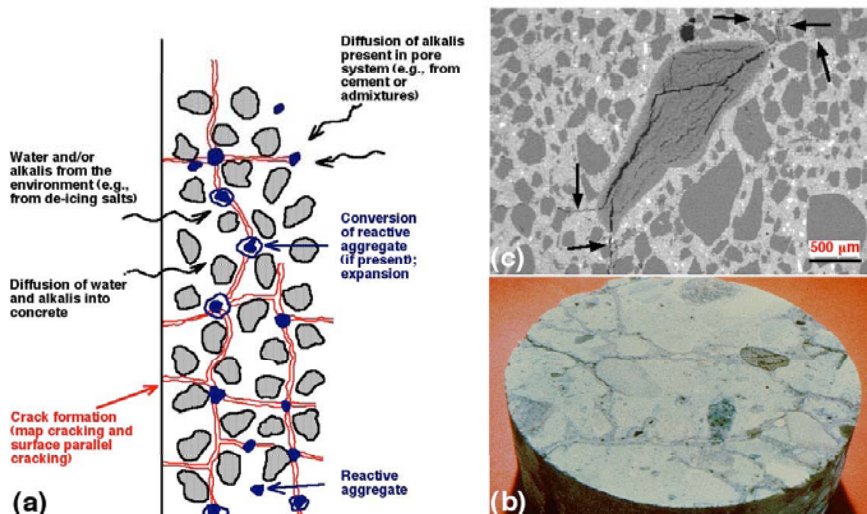
## Concrete Cracking due to Alkali-silica Reaction

(a) mechanism, (b) resulting gel that causes expansion and cracking, (c) polished section showing extensive internal cracks

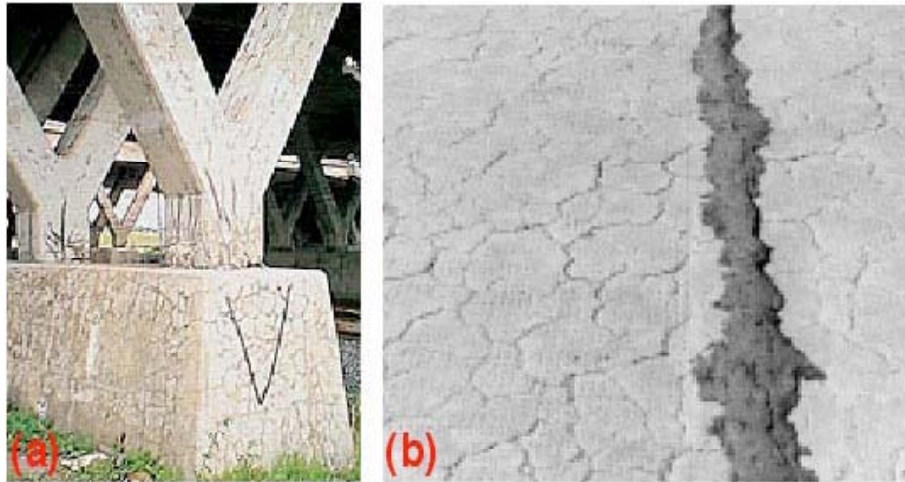
## Examples of Concrete Cracking

(a) alkali-silica reaction in bridge pier, (b) alkali-carbonate reaction in sidewalk with exudation of joint material

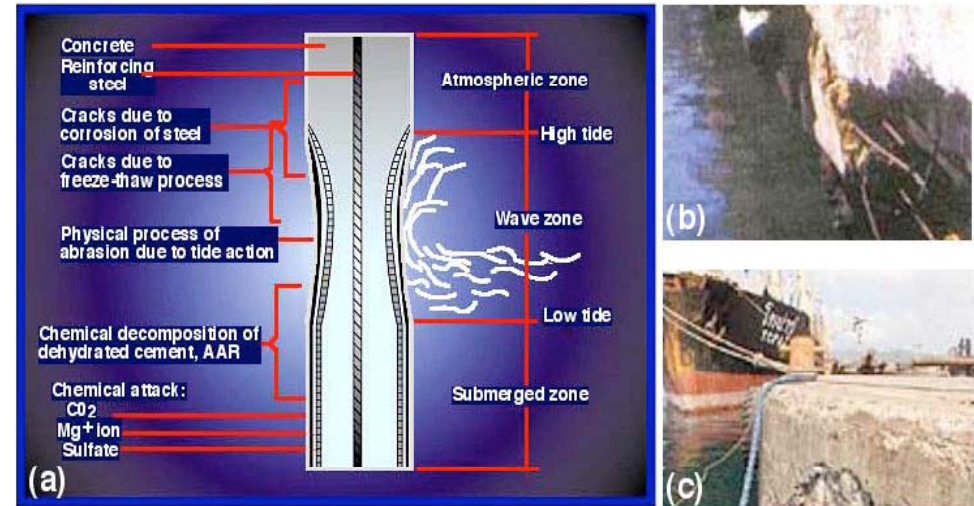
## Sea Water Attack of Concrete

(a) mechanism, (b) and (c) examples of attack

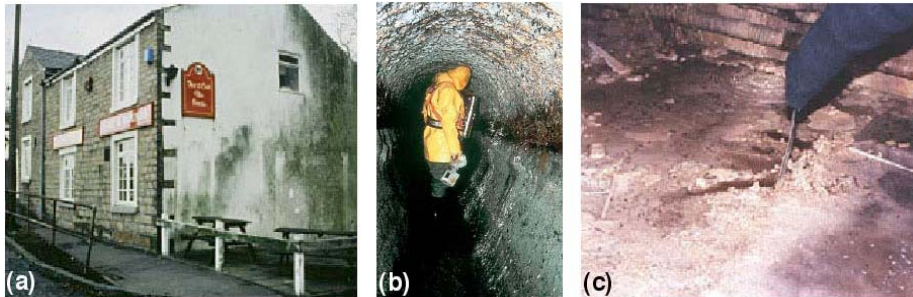
## Concrete Biological Attack

(a) algae growth on outside wall of house, (b) biogenic sulfuric acid attack in sewer system, (c) decaying concrete floor in flooded cellar

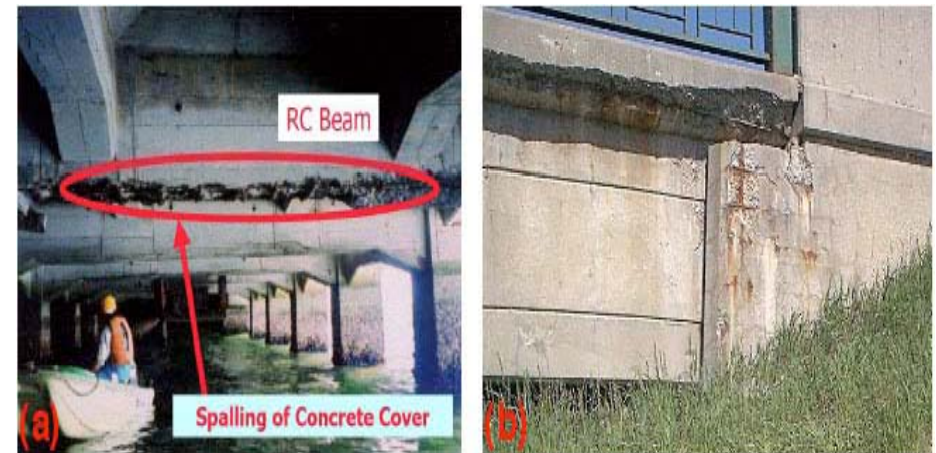
## Corrosion in Reinforced Concrete

(a) sea water structure, (b) bridge structure

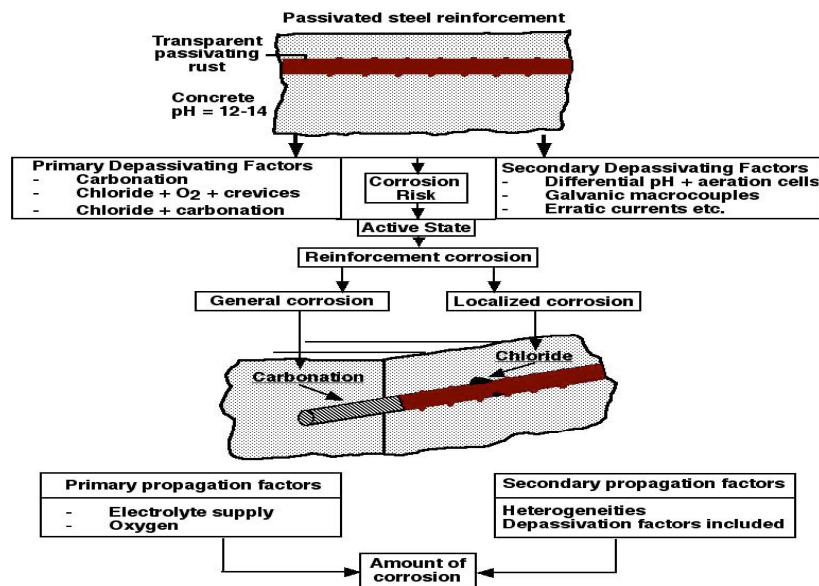
## Factors Leading to Depassivation of Steel in Concrete

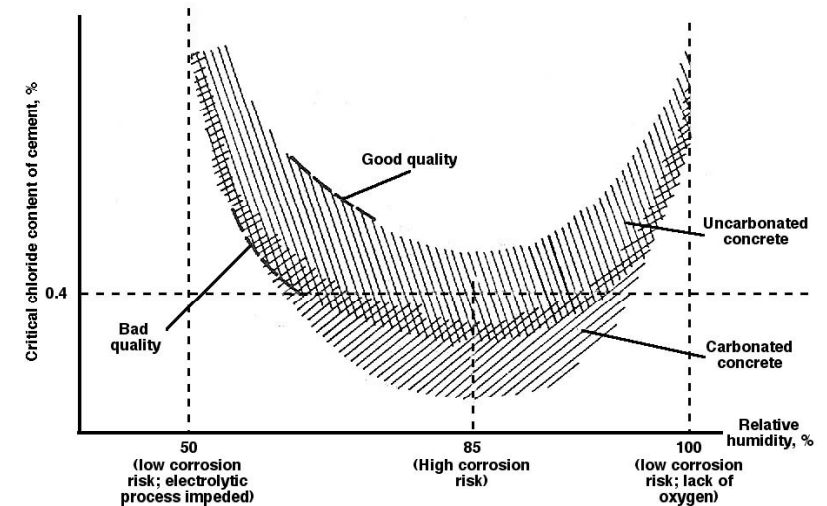
## Variation of Critical Chloride Content with Environment

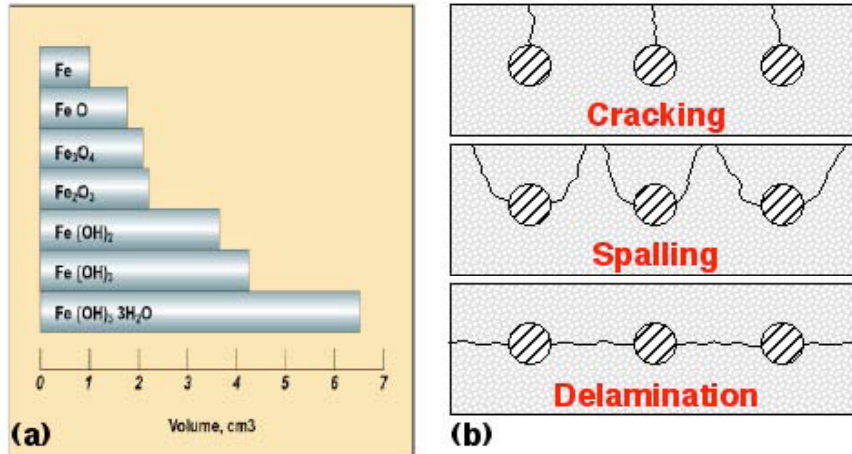
## Oxidation States of Iron and Representations of Visible Forms of Corrosion

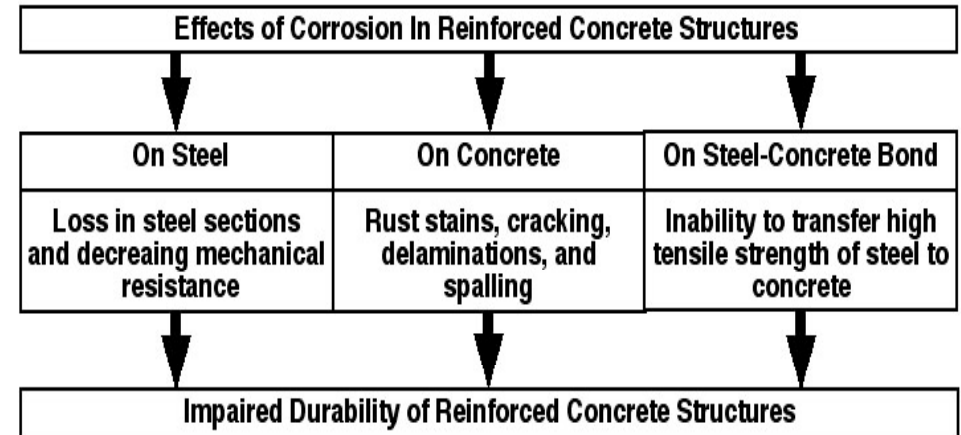
## Effects of Corrosion on Reinforced Concrete Structures

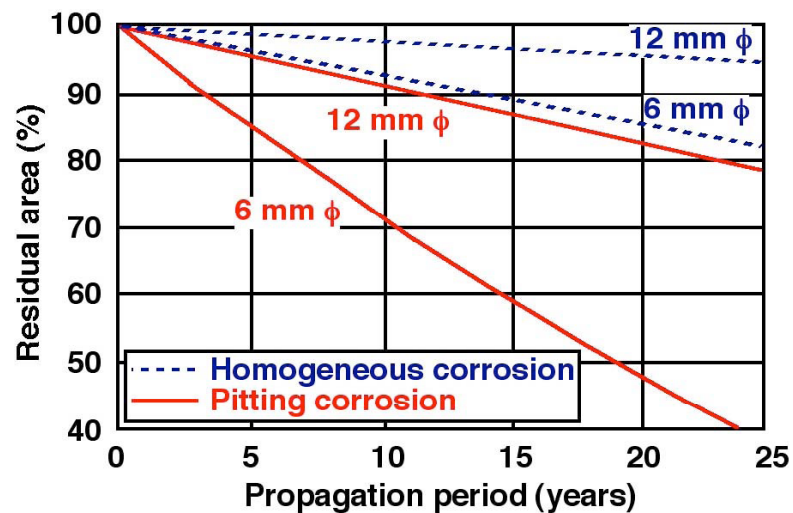
## Residual Steel Reinforcement Area as a Function of Type and Longevity of Corrosion

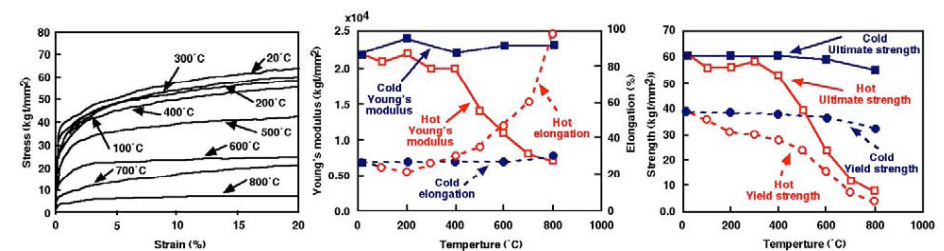
## Effect of Temperature on a 3,500 kgf/cm<sup>2</sup> Minimum Specified Yield Strength Steel Bar

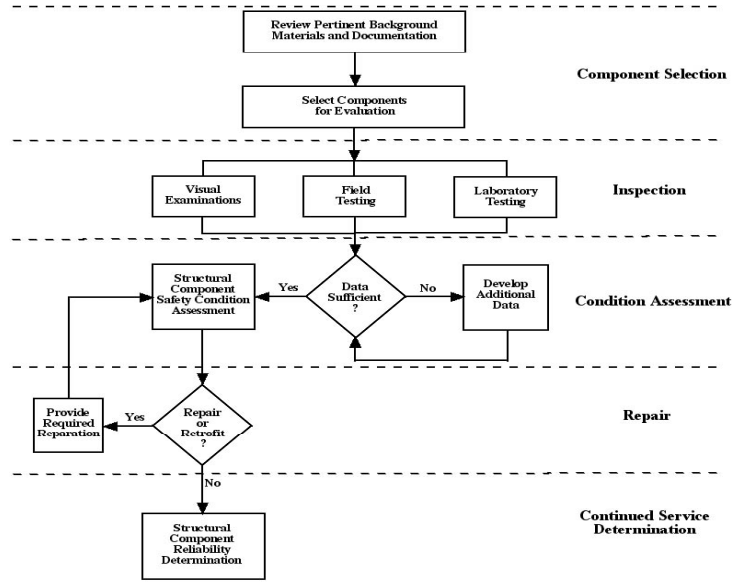
## Evaluation Methodology for Nuclear Power Plant Concrete Structures

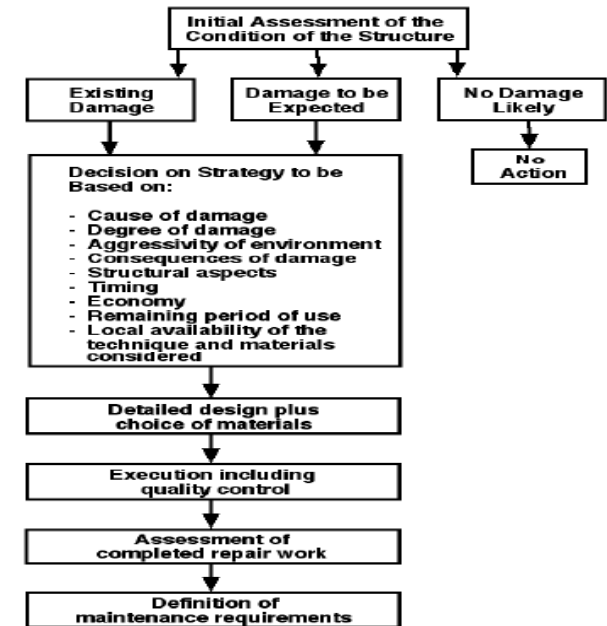
## Steps to be taken in a Repair Process

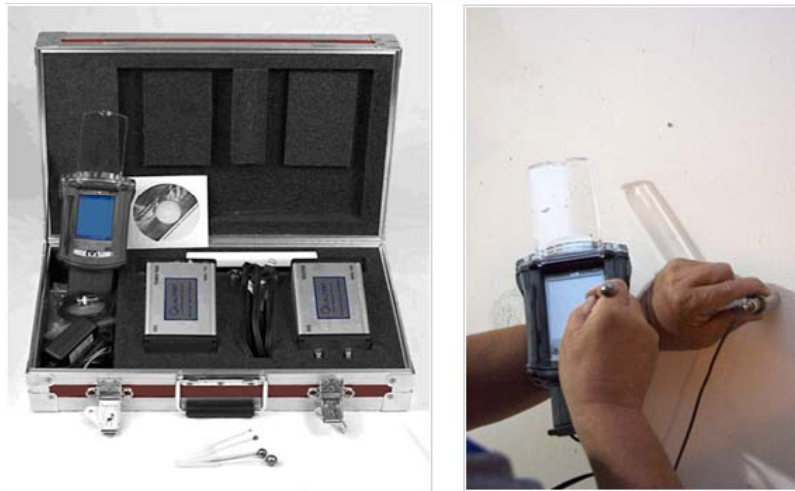
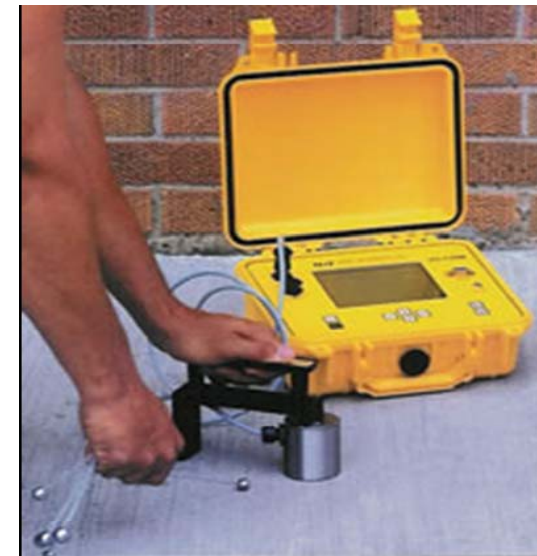
- Uses impact generated stress waves that propagate through concrete and are reflected by both the material's external surfaces and internal flaws
- The typical system consists of transducers, impactor set, transducer spacer, PC software and battery charger

## The Impact Echo Method (Cont'd) Portable IE System

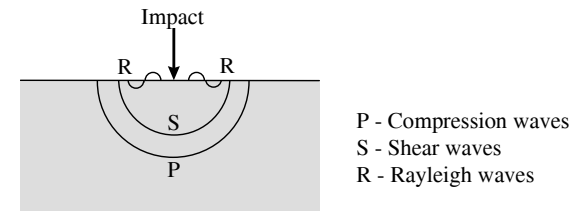
- The impact-echo method is a technique for flaw detection in concrete based on stress wave propagation
- Compression (P), Shear (S) and surface/Rayleigh (R) waves are generated

- Reflected waves are received by a transducer
- Displacement waveform is dominated by P-wave arrival

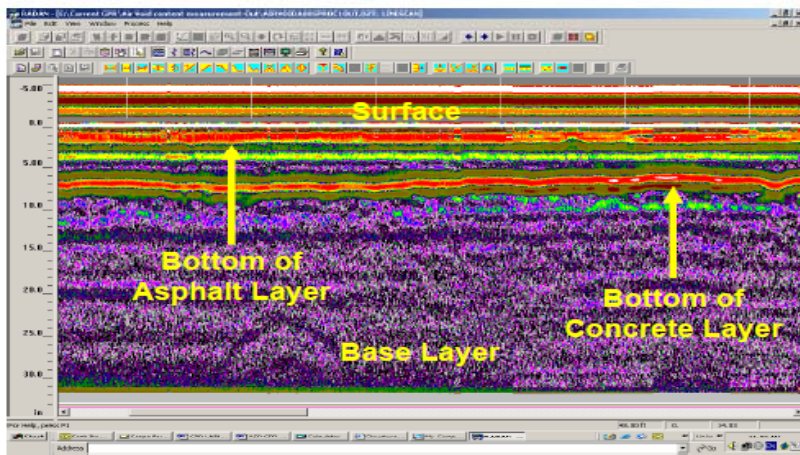
## GPR – Typical Scan

A typical GPR Scan showing layers of pavement and air voids between top layer of asphalt and the asphalt layer below it

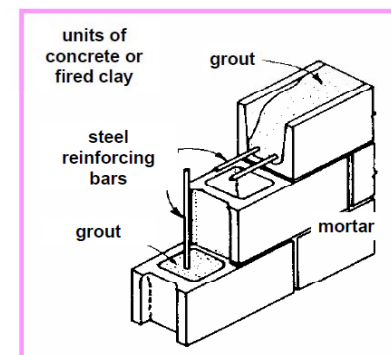
... typical materials in reinforced masonry

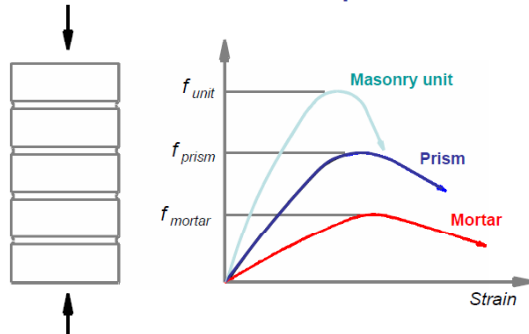
**Masonry Behavior Stress-Strain Curve for Prism Under Compression**

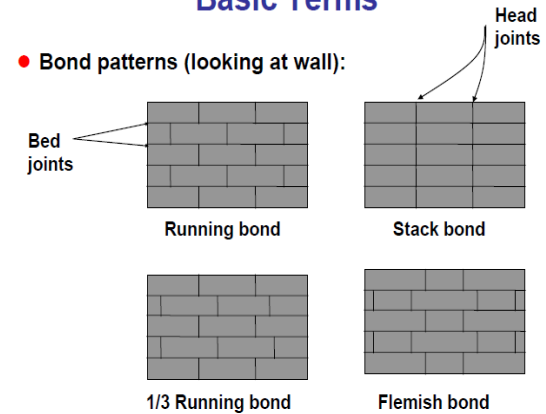
#### • Bond patterns (looking at wall):

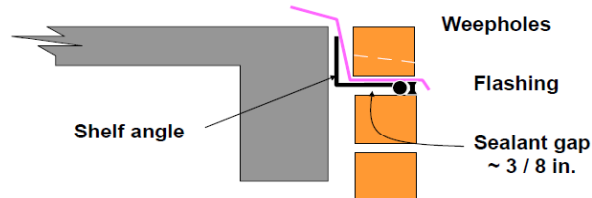
Horizontally oriented expansion joint under shelf angle:
