FUKUSHIMA DAI-ICHI UNITS 1-6

FUKUSHIMA DAI-ICHI NUCLEAR POWER PLANT

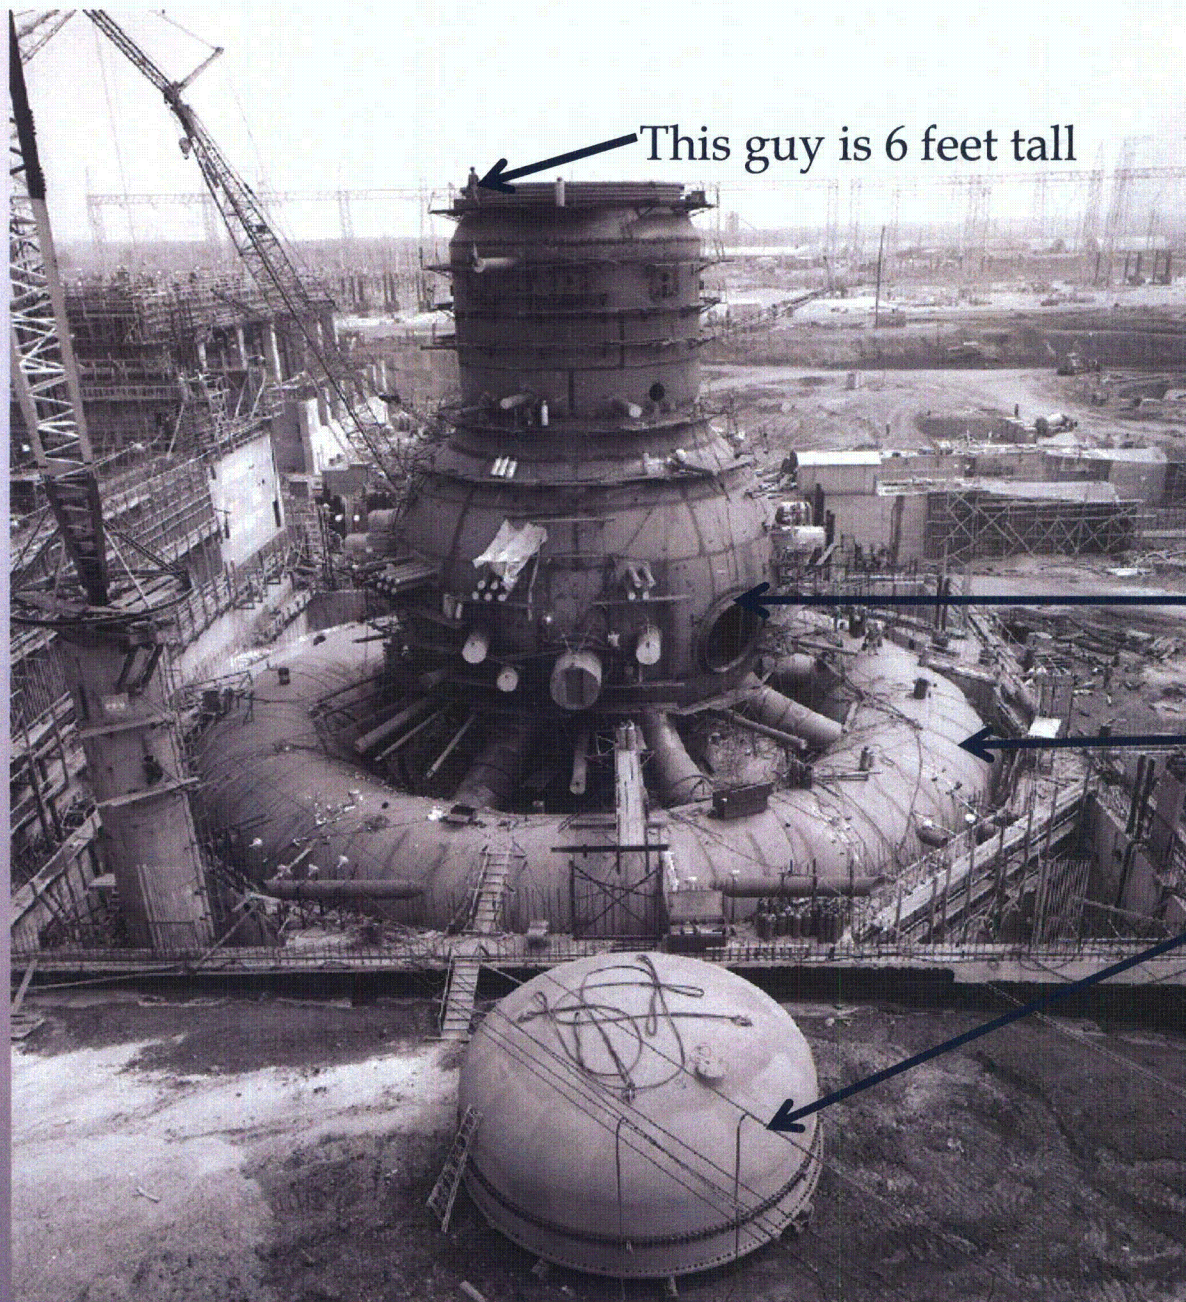
TYPICAL BWR MARK 1 CONTAINMENT

Mark I construction may be either of :

- Free Standing Steel
- Concrete with internal steel liner

Drywell

Suppression Chamber (Torus)

Drywell Head

Typical Volumes ~
Drywell: 1.2 Million Gallons
Torus Air: 900,000 Gallons
Torus Water: 800,000 Gallons

23 in the US

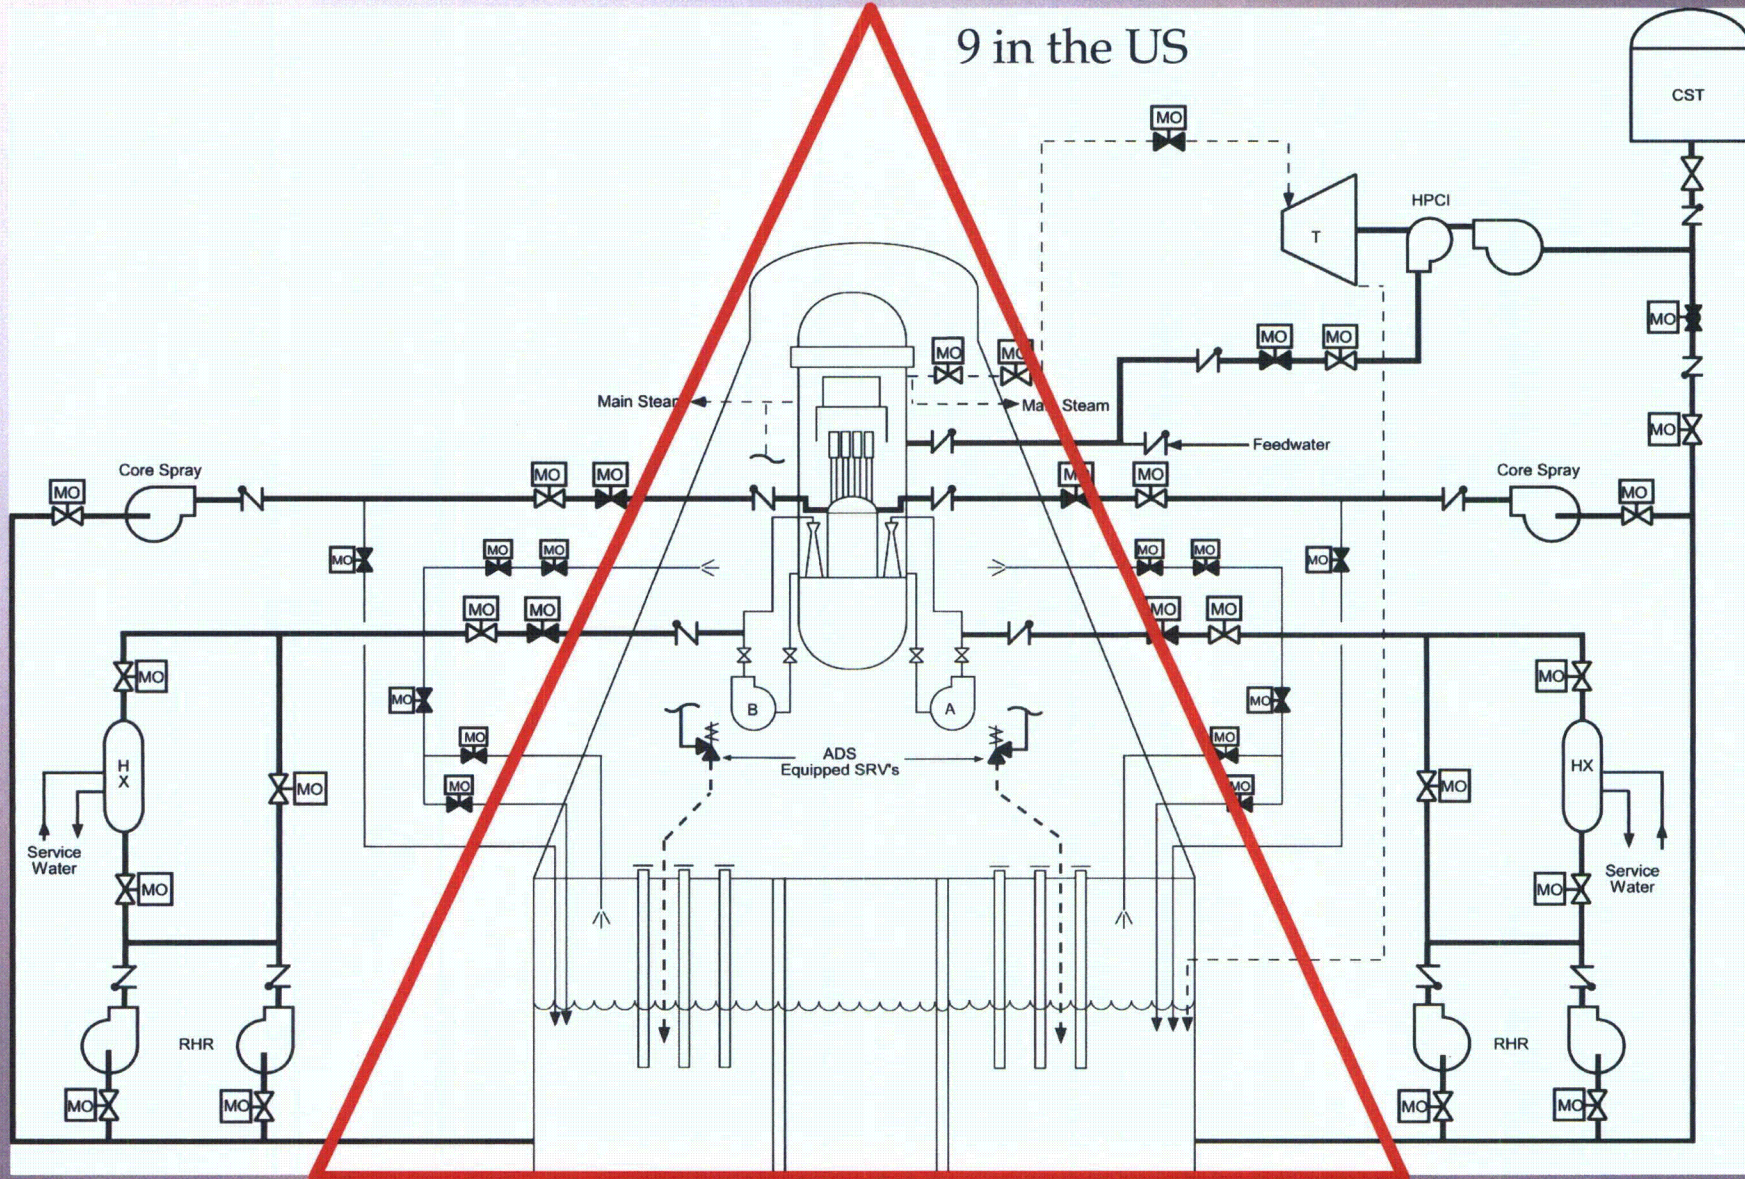
MARK II CONTAINMENT

9 in the US

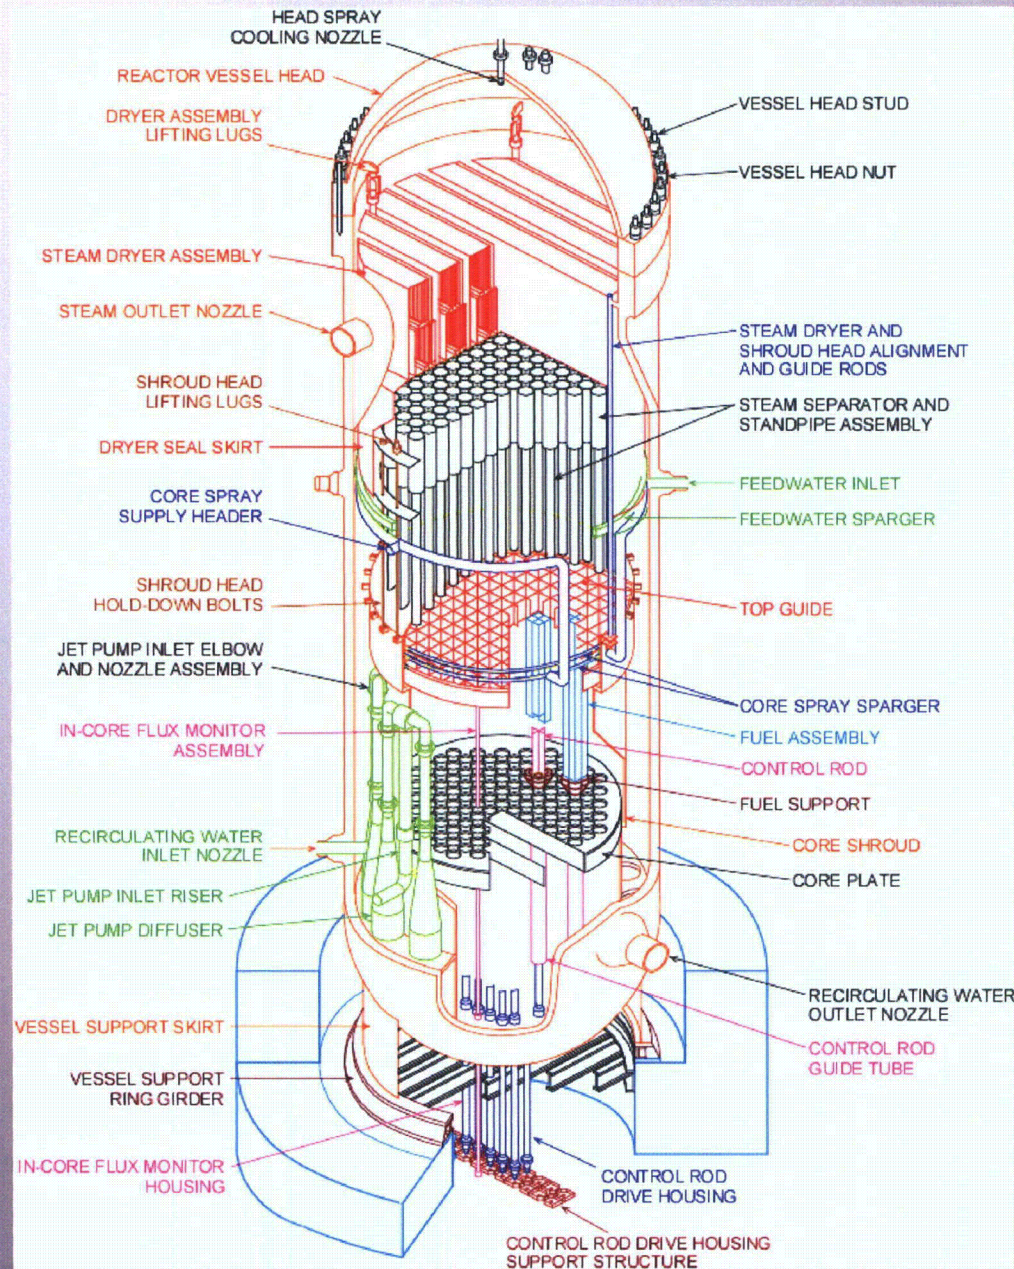
TYPICAL BWR REACTOR PRESSURE VESSEL INTERNALS

RPV DIMENSIONS

- ~ 70 FEET TALL
- ~ 18 FEET INSIDE DIAMETER
- ~ 7 INCH THICK CARBON STEEL
