REPORT OF PETROGRAPHIC EXAMINATION

Re: Petrographic Examination of Concrete Core Samples, [REDACTED]

CTLGROUP PROJECT NO.: [REDACTED]
CLIENT: [REDACTED]
STRUCTURE: Concrete slab-on-grade
LOCATION: Carlsbad, New Mexico

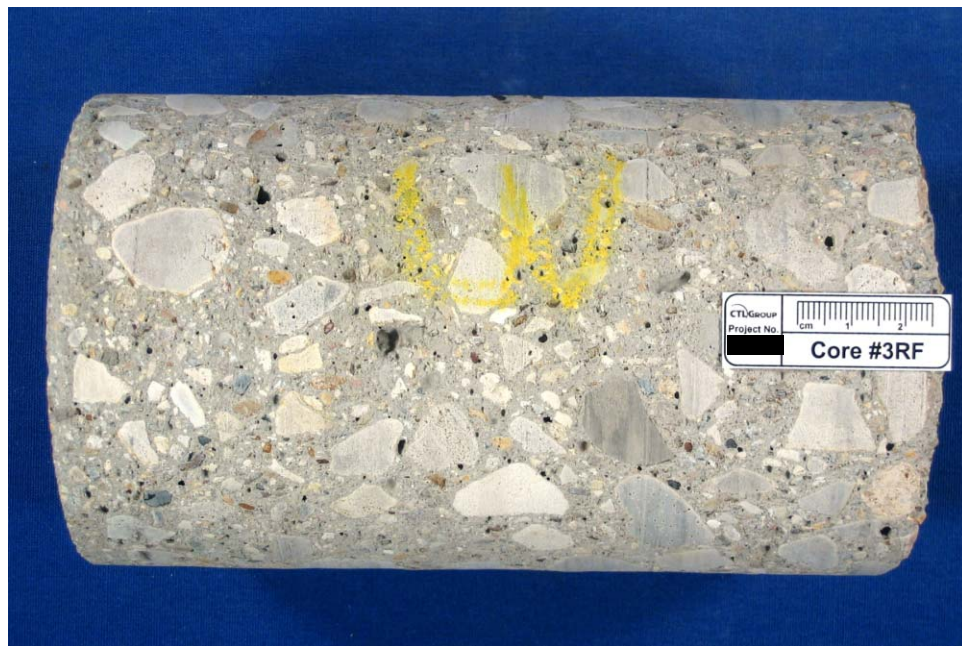
Fig. 1 Core #3RF, as received for examination.

1a. Top surface.

1b. Side view, top surface at left.

Two concrete core samples, designated as #3RF (Fig. 1) and #4TP (Fig. 2), were received on April 28, 2006, from Ms. [REDACTED], [REDACTED], Hobbs, New Mexico. The core samples were reportedly extracted from a concrete floor slab in Carlsbad, New Mexico, that exhibited cracking within 24 hours of placement. Core #4TP exhibits cracking, while Core #3RF does not. According to information provided by Ms. [REDACTED], the core samples were extracted within 1.5 ft. of each other. Petrographic examination (ASTM C 856) of the submitted samples was requested to characterize and determine a possible cause for the cracking.

Top Surface: Flat, slightly rough surface exhibits light broom finish. Surface is partially coated with orange paint but appears paste-rich, medium gray in color, and moderately soft. When wetted, surface exhibits numerous, closely-spaced craze cracks.

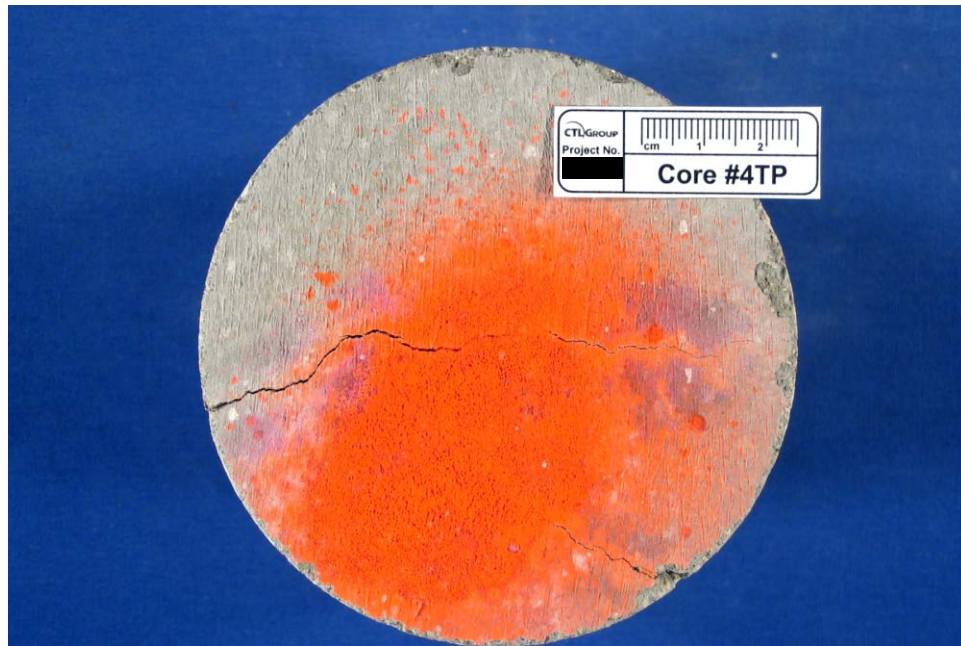
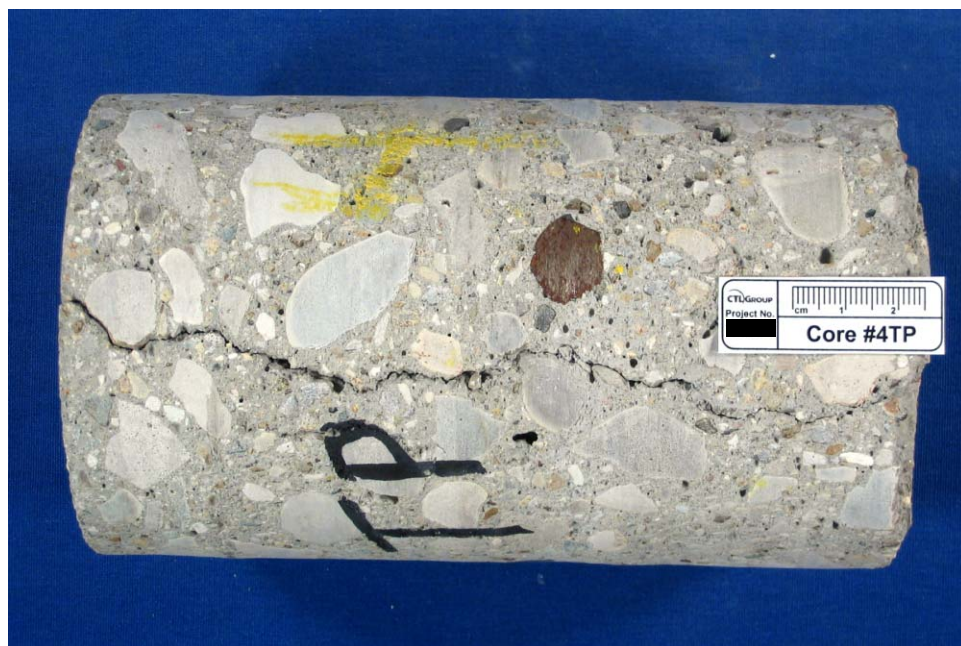
Fig. 2 Core #4TP, as received for examination.

2a. Top surface.

2b. Side view, top surface at left. Note crack extends through full length of core.

Plastic shrinkage cracks typically extend only a short distance into the concrete. Cracks observed in Core #4TP, however, extend through the full depth of the slab (Figs. 2b and 4b). It is likely that, after the plastic shrinkage cracks formed along the surface, the concrete set but

Top Surface: Flat, slightly rough surface exhibits light broom finish. Surface is partially coated with orange paint but appears paste-rich, medium beige-gray in color, and moderately soft. One main crack, 0.13 to 0.38 mm (0.005 to 0.015 in.) wide, extends across surface, through center of core. A second crack, approximately 0.25 mm (0.010 in.) wide, partially extends across surface from edge, generally oriented subparallel to main crack. When wetted, surface exhibits numerous, closely-spaced craze cracks.

Cracks, Joints, Large Voids: Cracks described on top surface extend through full depth of core, passing mainly around aggregate particles and narrowing with depth to hairline width. Concrete exhibits a few fairly large entrapped air voids measuring up to 9 mm (0.35 in.) across. No joints observed.

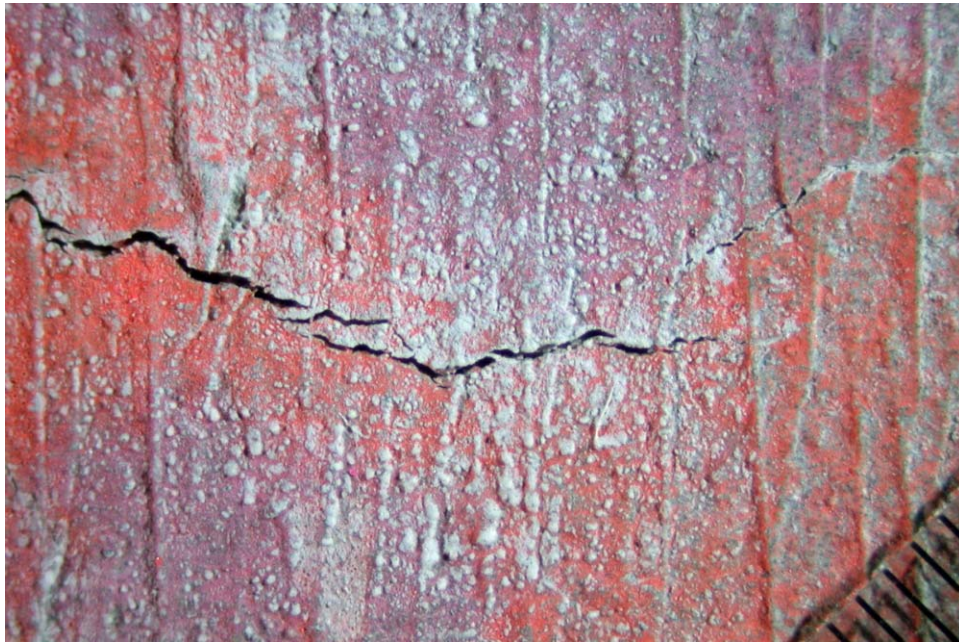
Fig. 3 Magnified view of crack on top surface of Core #4TP. Note discontinuous, tear-like appearance of crack.

Cracks observed on the top surface of Core #4TP have a tear-like appearance (Fig. 3) and are oriented parallel to each other. Additionally, within the upper portion of the core, crack surfaces exhibit paste-coated aggregate particles. These characteristics are consistent with plastic shrinkage cracks, which form before the concrete has set (hardened). Plastic shrinkage cracking typically occurs in hot, dry, and/or windy conditions when water evaporates from the concrete surface faster than it is replenished by the bleeding process. This rapid drying of the surface creates tensile stresses which are then relieved by tearing of the fresh paste within the concrete.

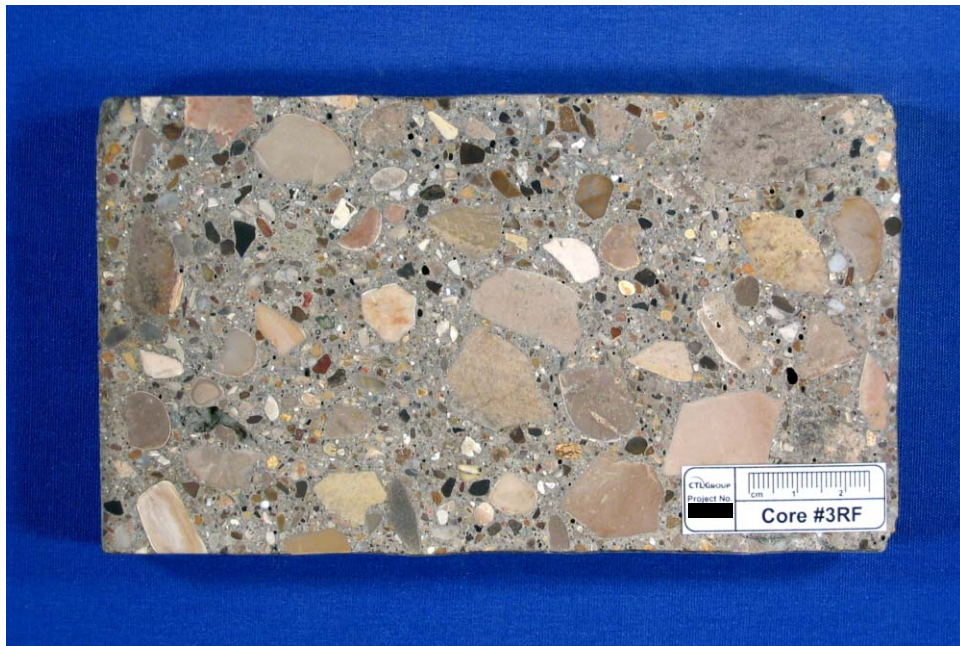
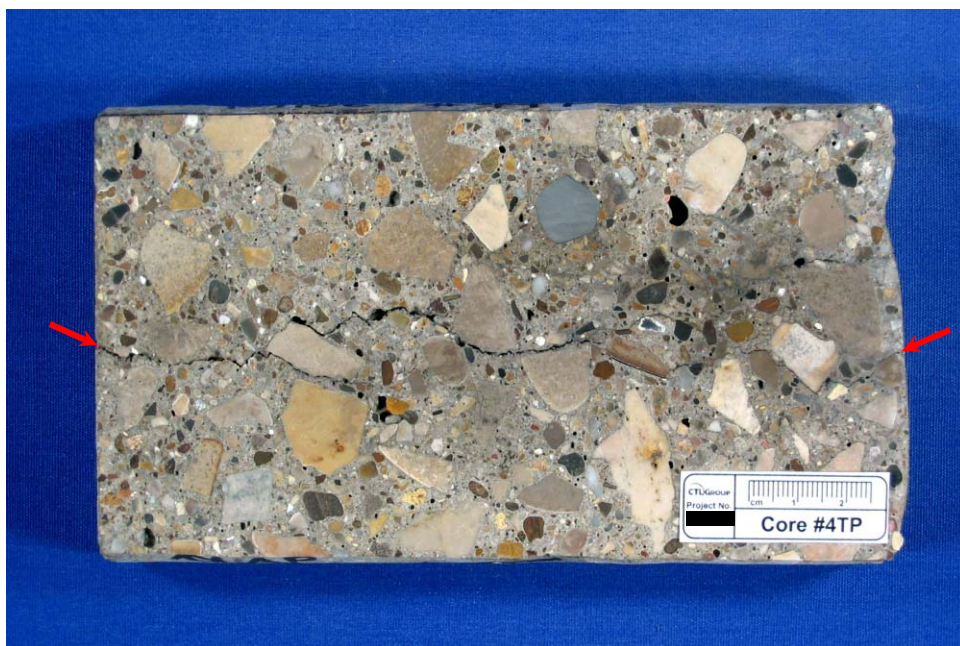
Fig. 4 Lapped, longitudinal cross-sections of core samples, top surfaces at left.

4a. Core #3RF.

4b. Core #4TP. Note crack (arrows) extends through full length of core.

Concrete represented by each of the submitted samples exhibits very similar composition and properties. The concrete consists of calcareous and siliceous rock coarse and fine aggregate distributed in a hardened paste of portland cement and fly ash (Figs. 4 and 6). Additional findings and descriptions of the samples are provided in the attached data sheets.

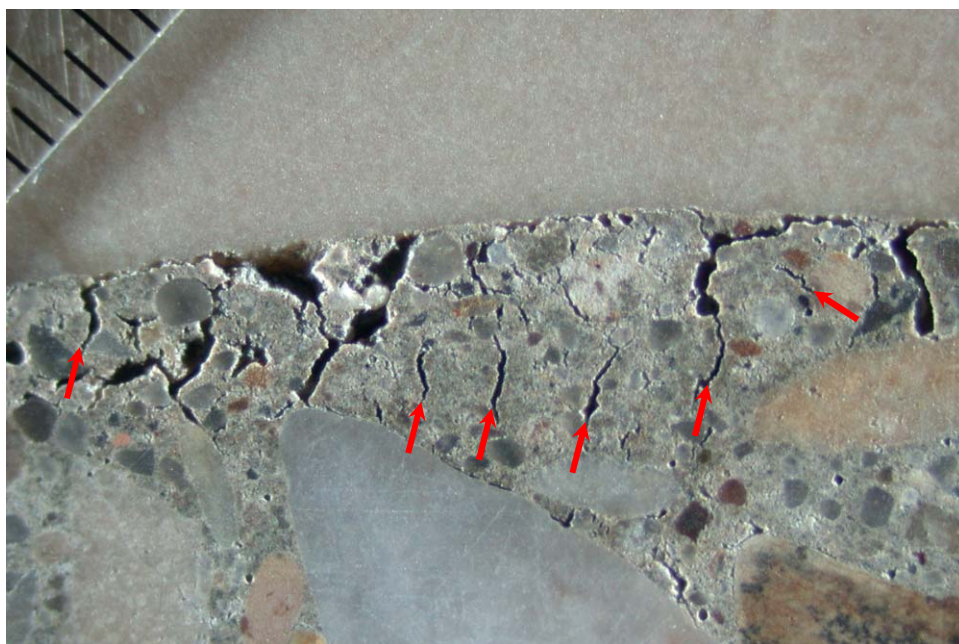
Fig. 5 Magnified views of lapped longitudinal cross-sections of core samples showing discontinuous plastic deformation tears (arrows) within body of concrete.

5a. Core #3RF.

5b. Core #4TP.

Both of the submitted core samples exhibit characteristics which suggest that the concrete may have been fairly stiff at the time of placement. Plastic deformation tears are observed in the lower portions of both cores (Figs. 5). These tears can form if the fresh concrete is disturbed after its initial placement. In a more fluid mix, the concrete would flow back into place, effectively repairing the tears. In a stiff mix, the tears remain in place. The water-cementitious materials ratio (w/cm) of the concrete is judged to be moderately low to low, indicated by a high volume of unhydrated portland cement in the paste (Fig. 6). Without the addition of admixtures to modify workability, concrete with a low w/cm will be more stiff than concrete with a high w/cm. Furthermore, a stiff concrete mix will usually bleed less, which can exacerbate the occurrence of plastic shrinkage cracking.
