## **Cameco Resources Marsland Expansion Area Uranium Project Class III Cultural Resource Investigation Dawes County, Nebraska**

ARCADIS Project No. WY002368.0001.0001

**April 28, 2011**

### **Cultural Resource Inventory**

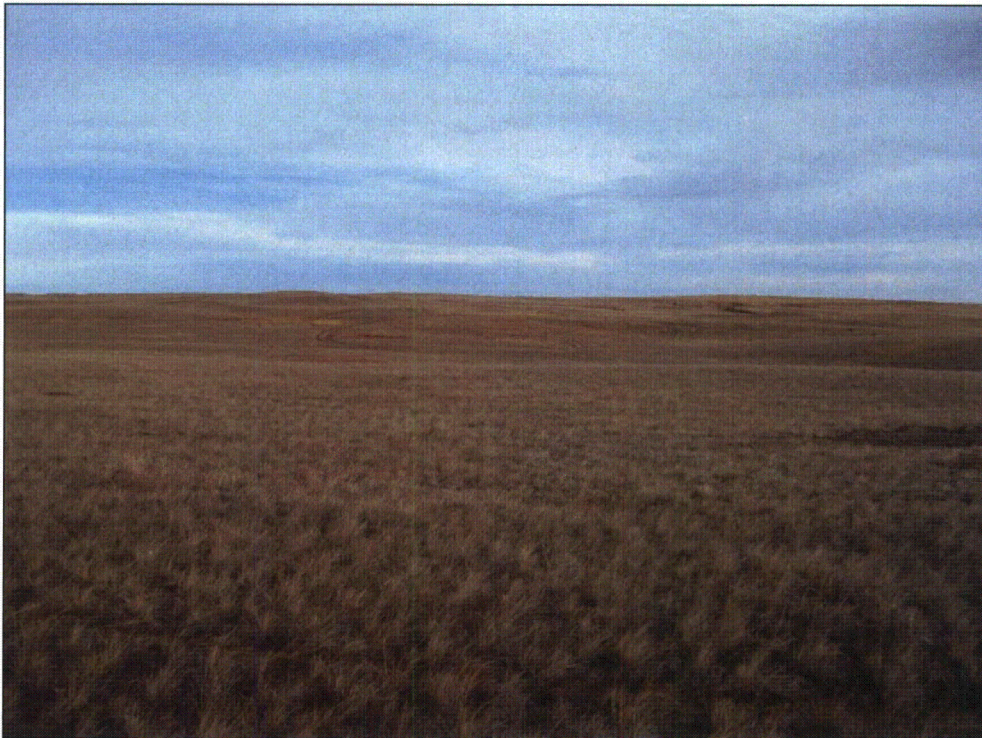
Factors which may have affected the discovery and preservation of cultural resources include uranium testing locations (**Figure 8**), logging and drag scars, slash piles (**Figure 9**), fencing, general farming activities, plowing, two-track roads, fires, stock tanks, irrigation, lighting conditions, mud, snow cover, erosion (**Figure 10**), erosion control, dumps, monitoring wells (**Figure 11**), livestock, cultivation, and construction. Access to all portions of the project area by crown-and-ditch roads was very good. Overall, conditions were very good for the discovery of cultural materials and fair for the documentation of cultural materials in northwestern Nebraska.

Figure 8. Disturbance (two-track road and uranium testing) in Section 29 T29N R50W, facing north. Photograph taken by A. Graves on 11/18/2010.

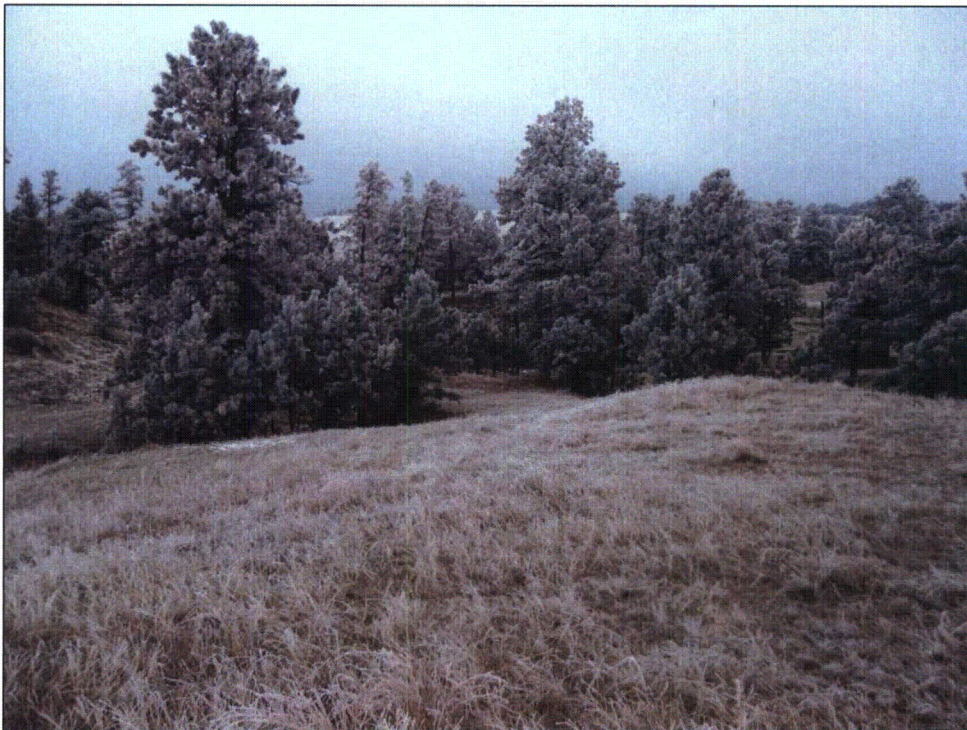
Figure 9. Disturbance (slash pile center of photo) in Section 35 T30N R51W, facing south. Photograph taken by S. Rosenthal on 11/21/2010.

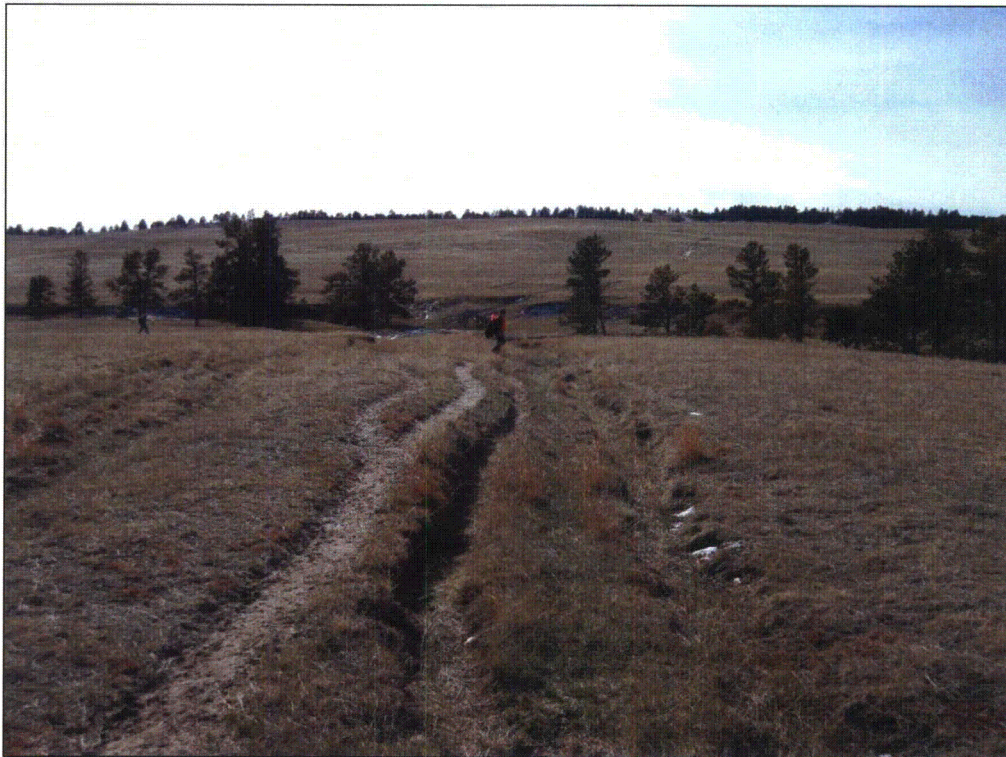
Figure 10. Disturbance (erosion, animal trails, cultivation) in Section 2 T29N R51W, facing south. Photograph taken by N. Graves on 12/02/2010.

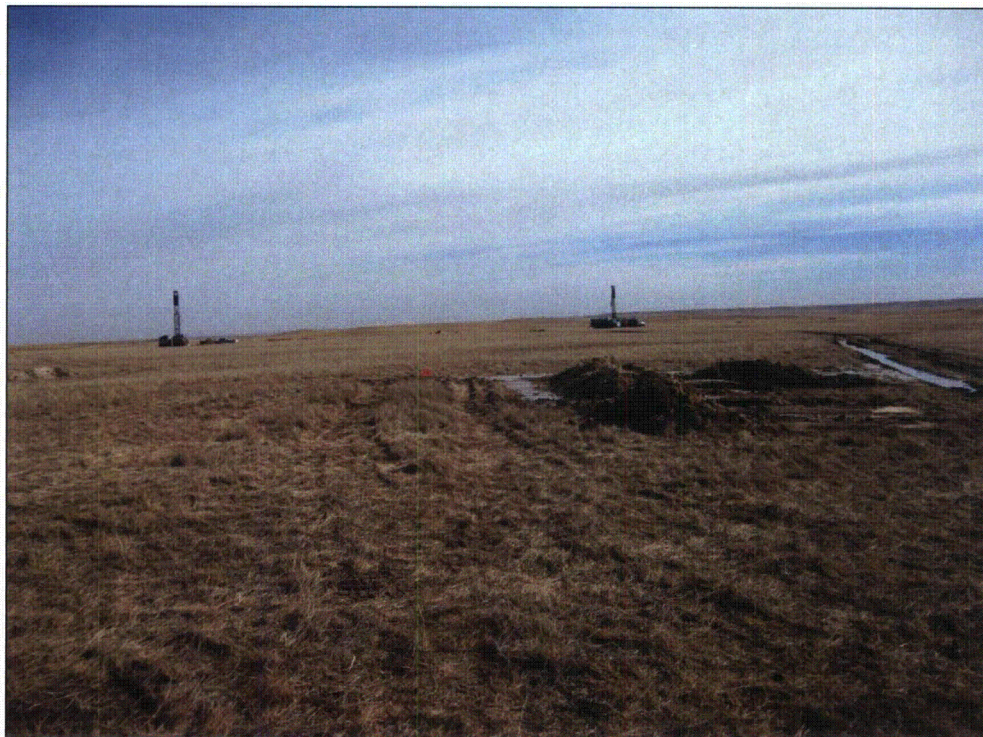
Figure 11. Disturbance (monitor wells) in Section 18 T29N R50W, facing southeast. Photograph taken by A. Howder on 12/17/2010.

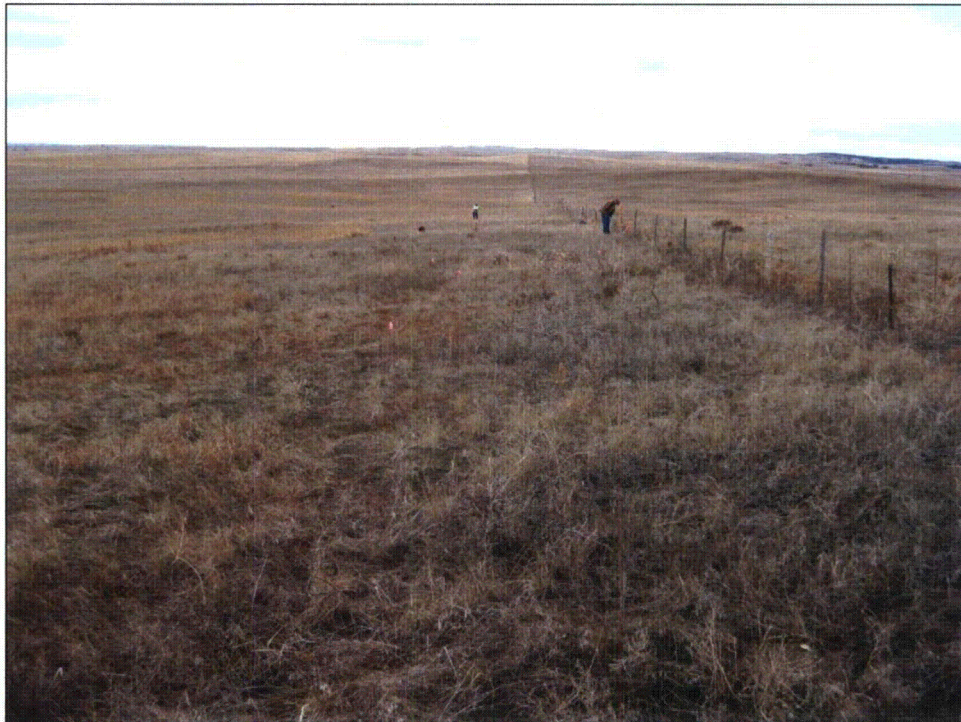
Cultural materials consist of a historic debris scatter located along an east to west trending fence line. Additional materials were observed north of the fence line, but are not located within the current project boundary and were not recorded as part of this undertaking. Materials observed include one bottle finish (**Figure 13**), three fragments of a purple dinner plate with diamond hatching and floral embossed rim design, 17 pieces of undecorated white bone china, five clear glass fragments, five whiteware fragments, two milk glass bottle base fragments from two separate bottles, one green glass fragment with a double ring finish, four aqua glass fragments, one gold-decorated china fragment with rose decoration (**Figure 14**), one clear bottle glass fragment, one aqua bottle based fragment which reads "D. NEBR. S", one red brick fragment, one machine-cut nail, one metal spring, and several pieces of scrap metal of unknown origin. Diagnostic debris materials at this site include purple or amethyst glass, aqua glass, milk glass, and green glass. During the late 19th century, some of the glass sand brought to the United States tended to produce pale green colored glass (Adkison 2002; Fike 2002). In order to make the pale green glass items clear, manganese was added during glass production. Unknown to the manufacturers, manganese reacts to ultra-violet rays and over time causes the clear glass to turn purple. Manganese was primarily imported from Germany so by World War I supplies were restricted and, by 1917; alternative methods for producing clear glass were being used (Adkison 2002; Fike 2002; IMACS 1984). Amethyst glass dates from approximately 1880 to 1917 (Fike 2002; Horn 2005; IMACS 1984). White milk glass was commonly used for medicine, cosmetic, toiletry, food and specialty containers, and dates from the 1890s to 1960 (Fike 2002; IMACS

Figure 12. Overview of site 25DW357, facing west. Photograph taken by Shane Rosenthal, on 11/18/2010.

This historic debris scatter represents a secondary context for artifacts commonly recorded in the area, but the National Register criteria does not dismiss resources as insignificant simply because there are numerous examples of the type. National Register eligibility for any property, including historic period archeological sites, depends on integrity and significance. Integrity for a historic period archaeological site is based on the presence of features and whether or not they can tell us something about the location. Based on the artifacts recorded, site 25DW357 is a single dump event with materials dating to from the early to mid 1900s. Historic debris site 25DW357 does not retain enough integrity to qualify for the National Register. Lack of integrity alone, however, does not automatically exclude this site as eligible for the National Register. Significance was assessed following intensive survey and a historic records search that included a files search and architectural/structures property search conducted through the Nebraska SHPO; review of the National Register of Historic Places (NRHP) database for Dawes County, Nebraska; review of the National Historic Landmark inventory (NHL); review of General Land Office (GLO) Plats; and local literature review; that revealed sustained Euro-American historic occupation in this area occurred between 1890 to present day, and no leases or purchasers were found that can be associated with an important person or persons of "significance in history" or having an uncommon ethnic affiliation. Finally, there are no features associated with site 25DW357. Therefore, site 25DW357 does not possess enough significance to qualify for the National Register. Site 25DW357 is a common historic site likely associated with historic and early modern ranching or farming activities in the region that ARCADIS recommends **not eligible for listing on the NRHP and no further work is necessary.**

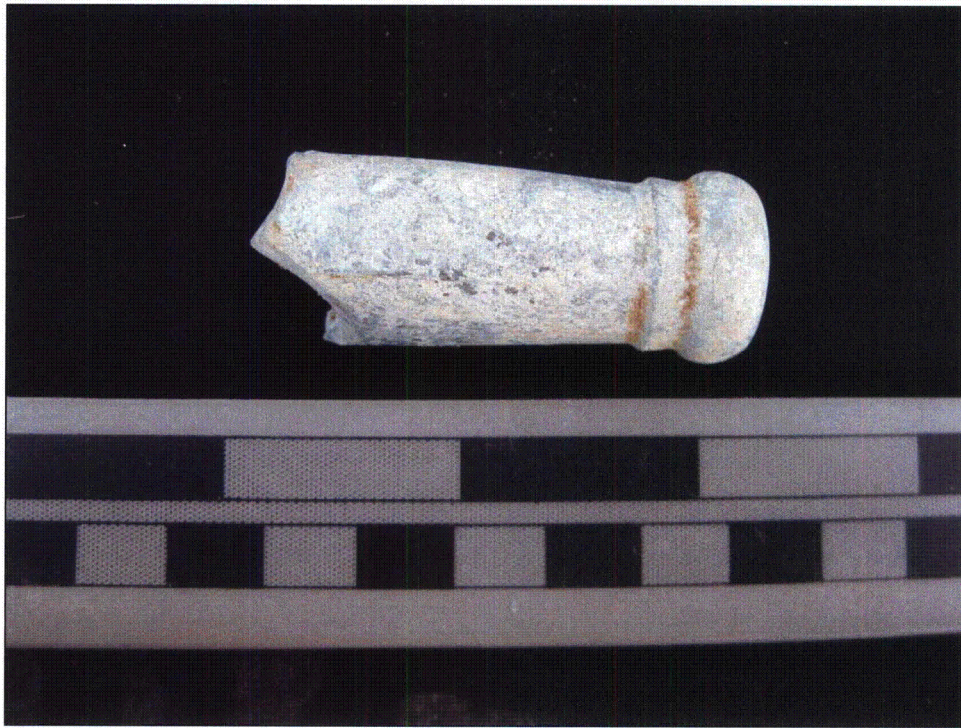
Figure 13. Site 25DW357, bottle finish. Photograph taken by Shane Rosenthal, on 11/18/2010.

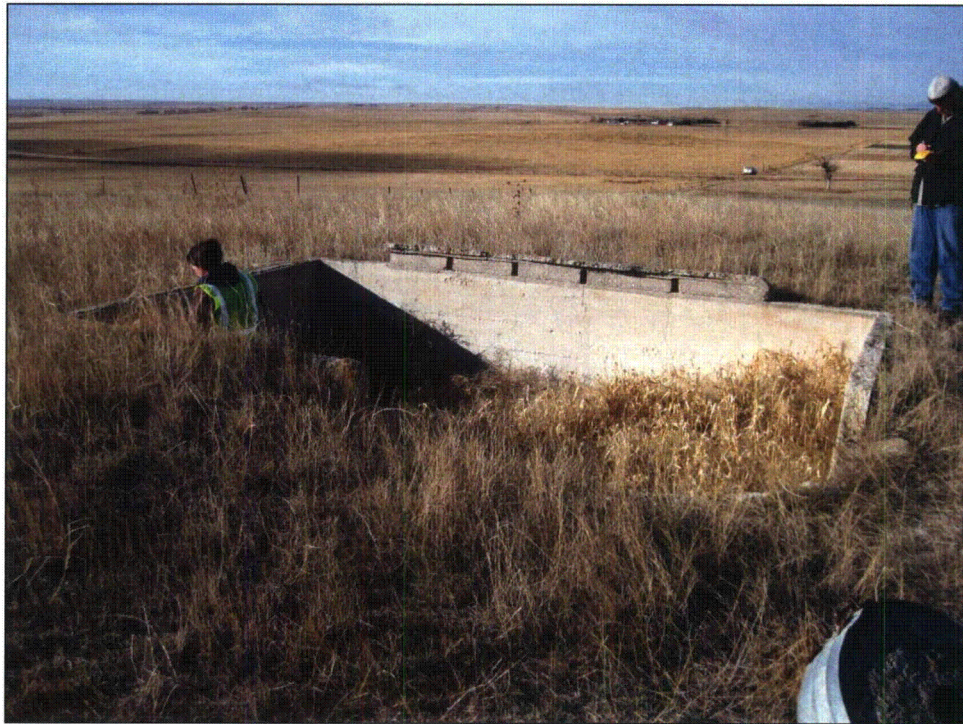
Cultural material consists of one cistern foundation (Feature F1) located 26 feet east of one well collar (Feature F2) (**Figures 16 and 18**). Feature F1 is a poured concrete cistern that measures 16 feet north to south and 9.5 feet east to west. The foundation is constructed from a wooden-planked form with no cold seams. The walls of the feature measure approximately five inches in width. A hooked metal bar protrudes from the eastern wall, but it is unclear if this signifies concrete reinforcement or a wall anchor. The cistern walls sit flush with the ground surface and are badly deteriorated. The northeast corner has partially collapsed. A partial wall support sits on the western wall and was separately poured with cold joists. Feature F1 is located 131 feet north of a standing fence. Feature F2 is a galvanized metal culvert with a central pipe and concrete fill that is likely a well collar (**Figures 17 and 18**).

Figure 16. Site 25DW358, Feature F1, cistern. Photograph taken by Shane Rosenthal, on 11/18/2010.

This historic cistern consists of two features commonly recorded in the area, but the National Register criteria does not dismiss resources as insignificant simply because there are numerous examples of the type. National Register eligibility for any property, including historic period archeological sites, depends on integrity and significance. Integrity for a historic period archaeological site is based on the presence of features and whether or not they can tell us something about the location. Site 25DW358 is a single ranch cistern and intensive survey of the area did not reveal other features such as a habitation foundation. Historic cistern site 25DW358 does not retain enough integrity to qualify for the National Register. Lack of integrity alone, however, does not automatically exclude this site as eligible for the National Register. Significance was assessed following intensive survey and a historic records search that included a files search and architectural/structures property search conducted through the Nebraska SHPO; review of the National Register of Historic Places (NRHP) database for Dawes County, Nebraska; review of the National Historic Landmark inventory (NHL); review of General Land Office (GLO) Plats; and local literature review; that revealed sustained Euro-American historic occupation in this area occurred between 1890 to present day, and no leases or purchasers were found that can be associated with an important person or persons of "significance in history" or having an uncommon ethnic affiliation. Finally, the features associated with site 25DW358 lack a unique design and any other unusual physical characteristic. Therefore, site 25DW358 does not possess enough significance to qualify for the National Register. Site 25DW358 is a common historic site likely associated with historic and early modern ranching or farming activities in the region that ARCADIS recommends **not eligible for listing on the NRHP and no further work is necessary**.

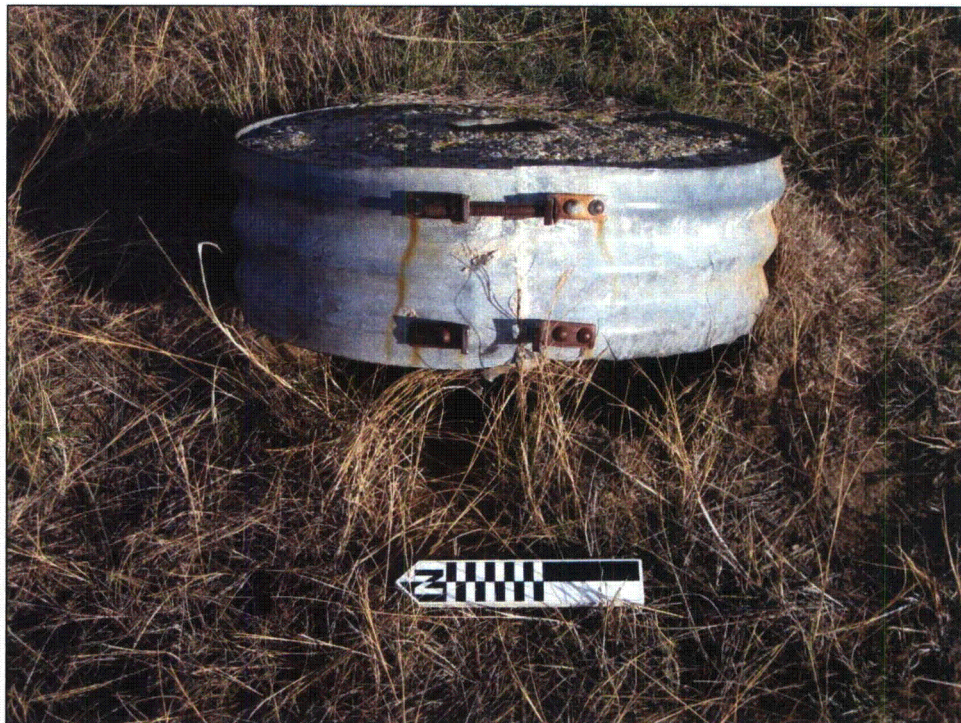
Figure 17. Site 25DW358, Feature F2, well collar. Photograph taken by Shane Rosenthal, on 11/18/2010.

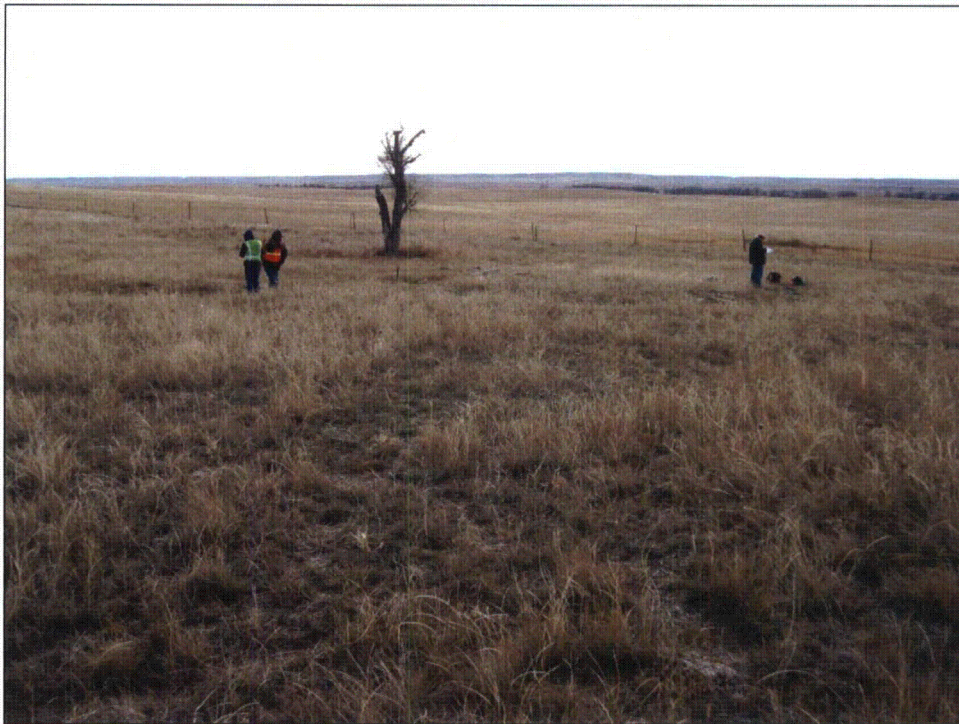
Site 25DW359 is a historic foundation and associated dugout and debris located in Section 19 T29N R50W, ten meters east of Hollibough Road (**Figures 20 and 25**). The site measures 50 feet by 50 feet and covers an area of 2,500 square feet. Vegetation consists of mixed grasses affording a 70 percent bare ground visibility. Sediments are composed of fine sandy loam as observed along slopes, road cut, and in dugout feature. Impacts to the site include historic ranching and farming activities throughout the area, wind and water erosion, and grazing. The site datum is a GPS point taken at the southwest corner of the foundation feature.

Figure 20. Site 25DW359, Site overview, facing southeast. Crew members on left at Feature 2. Crew member on right at Feature 1. Photograph taken by Shane Rosenthal, on 1/19/2011.

National Register eligibility for any property, including historic period archeological sites, depends on integrity and significance. Integrity for a historic period archaeological site is based on the presence of features and whether or not they can tell us something about the location. Site 25DW359 is probably an early historic homestead that does not retain enough integrity to qualify for the National Register. Lack of integrity alone, however, does not automatically exclude this site as eligible for the National Register. Significance was assessed following intensive survey and a historic records search that included a files search and architectural/structures property search conducted through the Nebraska SHPO; review of the National Register of Historic Places (NRHP) database for Dawes County, Nebraska; review of the National Historic Landmark inventory (NHL); review of General Land Office (GLO) Plats; and local literature review; that revealed sustained Euro-American historic occupation in this area occurred between 1890 to present day, and no leases or purchasers were found that can be associated with an important person or persons of "significance in history" or having an uncommon ethnic affiliation. Finally, the features associated with site 25DW359 lack a unique design and any other unusual physical characteristic. Therefore, site 25DW359 does not possess enough significance to qualify for the National Register. Site 25DW359 is a common historic site likely associated with historic and early modern ranching or farming activities in the region that ARCADIS recommends **not eligible for listing on the NRHP and no further work is necessary.**

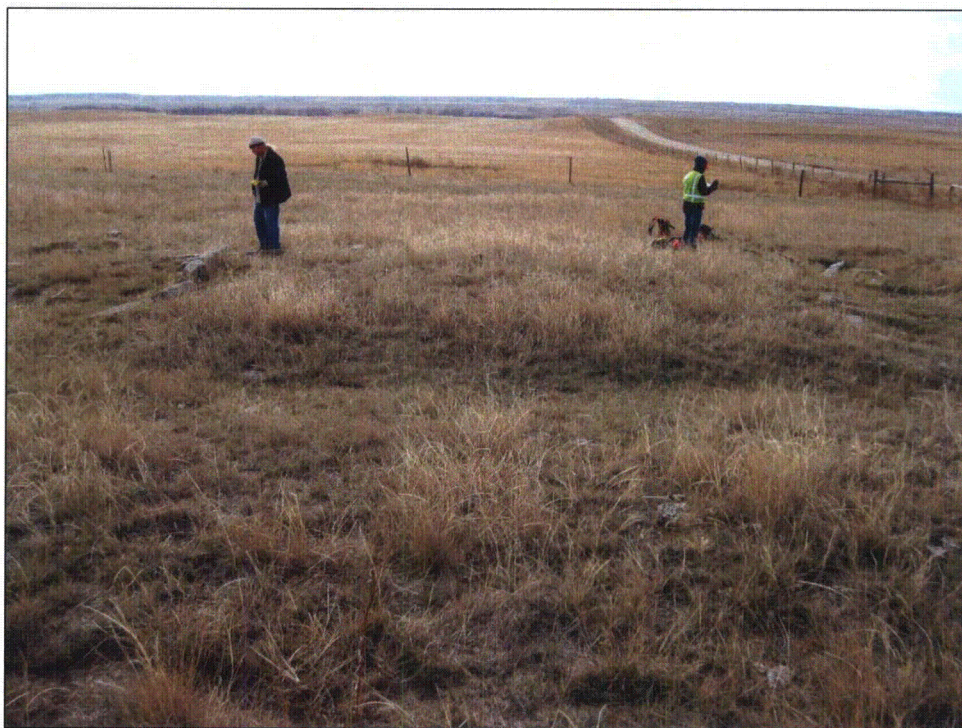
Feature F1 is a historic foundation composed of non-reinforced poured concrete measuring 23 feet east to west and 21 feet north to south (**Figures 21-23**). The foundation is poorly preserved, and the concrete has degraded into smaller blocks. Linear alignments of concrete blocks form the north and west walls, with no concrete alignment observed along the south portion. The east foundation concrete slabs remain largely upright. The foundation is surrounded on the north, east, and west sides by a shallow depression measuring five feet in average width. Aqua and milk glass fragments were observed along the east wall near two upright one inch and  $\frac{3}{4}$  inch diameter pipes. The bed frame, a large brick scatter, barbed wire, and milled lumber fragments were observed within the depression at the southwest corner of the foundation. Additionally, concrete blocks and a large milled lumber board are scattered southeast of the southeastern foundation corner. The concrete scatter discontinues 55 feet southeast of the foundation at a cottonwood tree.

Figure 21. Site 25DW359, Feature F1, facing south. Photograph taken by Shane Rosenthal, on 1/19/2011.

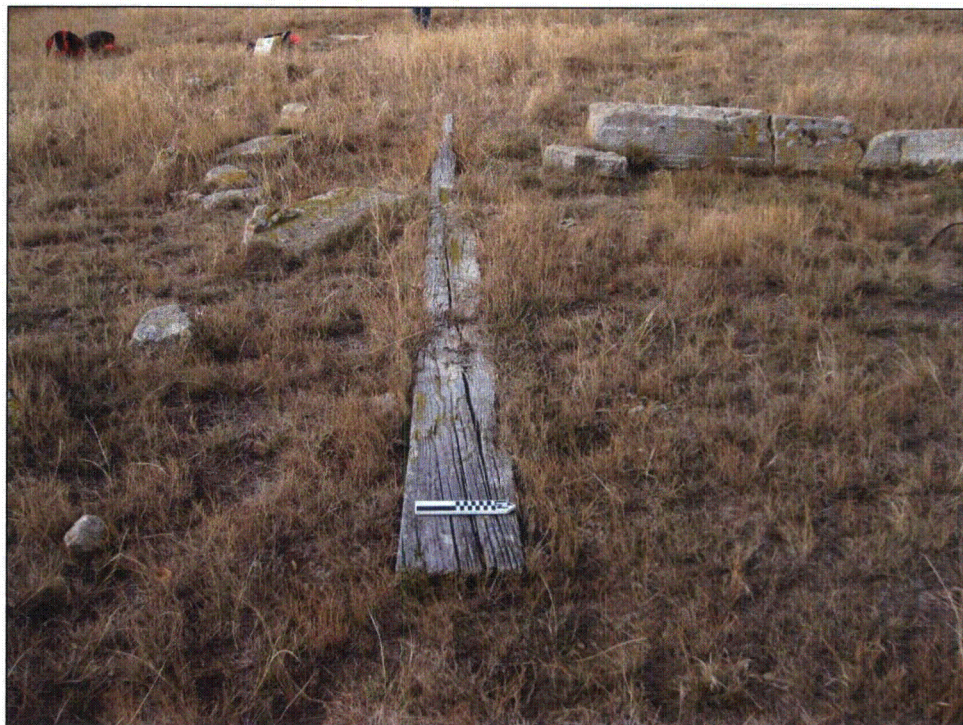
Figure 22. Site 25DW359, Feature F1, debris scatter with concrete foundation and milled lumber, facing west. Photograph taken by Shane Rosenthal, on 1/19/2011.

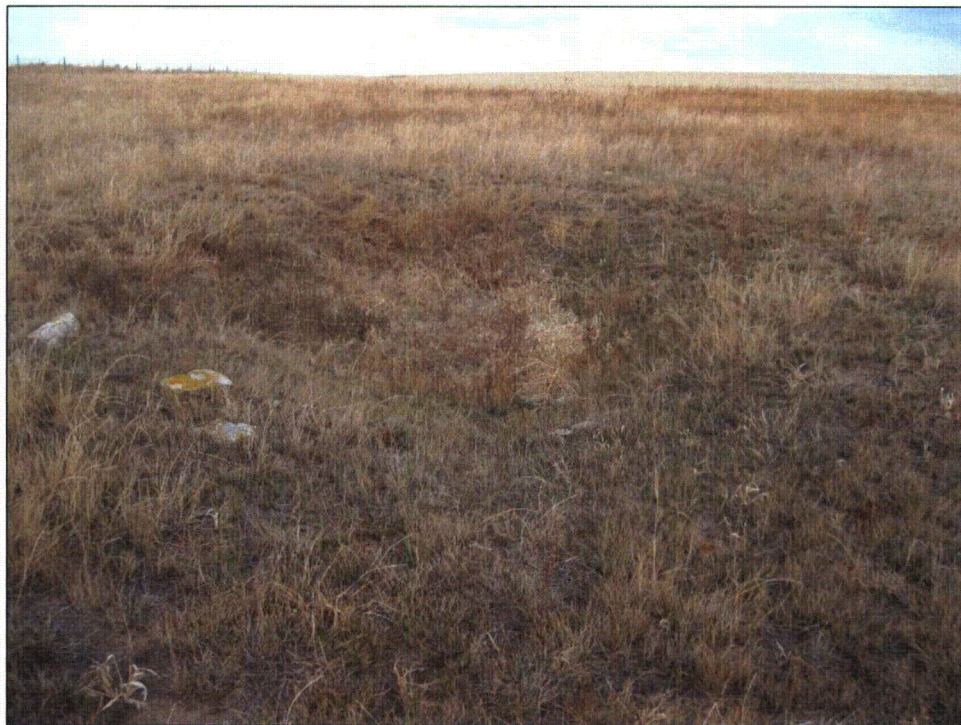
Feature F2 is a dugout feature located five feet northeast of the northeastern foundation corner of F1 and is a continuous expansion of the depression which surrounds F1 (**Figures 23 and 24**). The dugout measures 18 feet southwest to northeast, 15 feet northwest to southeast, and is approximately 3.5 feet at its deepest depth. The site's location is currently used for ranching activities, and two fence lines run 50 feet west of the foundation and 92 feet south of the foundation.

Figure 24. Site 25DW359, Feature F2 dugout, facing north. Photograph taken by Shane Rosenthal, on 1/19/2011.

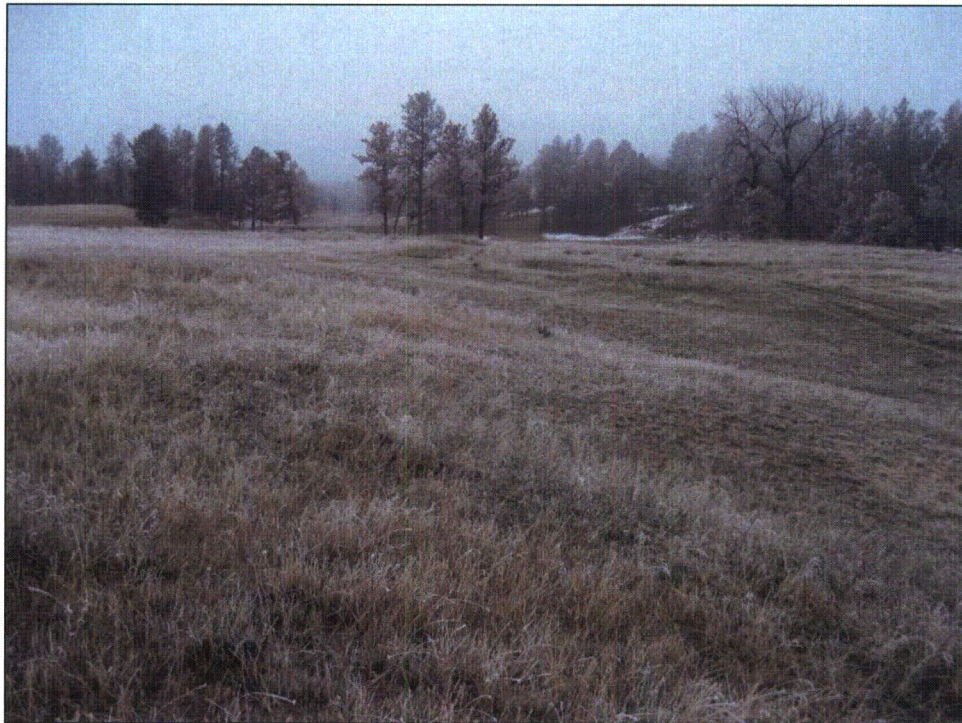
Site 25DW360 is a historic homestead located in Section 26 T30N R51W on the northeastern slope of a drainage cut (**Figures 26 and 46**). An ephemeral drainage runs through the site. The site measures 840 feet by 410 feet and covers an area of 261,200 square feet. Vegetation consists of ponderosa pine forest and mixed grasses affording variable visibility that averaged between 50 to 80 percent bare ground visibility. Impacts to the site include historic ranching and farming activities throughout the area, wind and water erosion, and grazing. The site datum is a GPS point taken at the SE corner of the Feature F1.

Figure 26. 25DW360, site overview from Feature F6, facing south. Photograph taken by Shane Rosenthal, on 11/20/2010.

that revealed sustained Euro-American historic occupation in this area occurred between 1890 to present day, and no leases or purchasers were found that can be associated with an important person or persons of "significance in history" or having an uncommon ethnic affiliation. Finally, due primarily to their poor condition, the features associated with site 25DW360 lack a unique design and any other unusual physical characteristic. Therefore, site 25DW360 does not possess enough significance to qualify for the National Register. Site 25DW360 is a common historic site likely associated with historic and early modern ranching or farming activities in the region that ARCADIS recommends **not eligible for listing on the NRHP and no further work is necessary.**

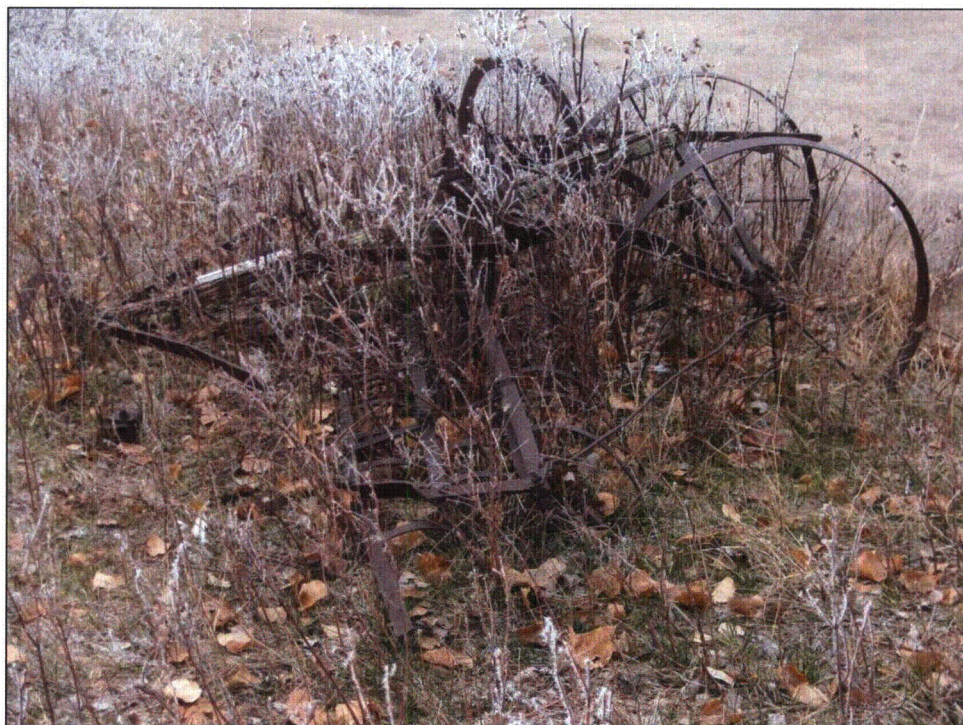
Cultural materials consist of four historic foundations (Features F1, F4, F8, and F9), two depression features (Features F5 and F7), one dugout (Feature F3), one cellar (Feature F2), one cistern (Feature F6), and an extensive historic debris scatter. Artifacts and features were observed within the drainage bottom, along the northeast slope, and across the ridge top to the north and northeast of the features. Domestic, ranching, and farming, debris is scattered across the site, and includes over 100 common red fired-clay bricks, three water pumps bearing the company stamps "Barnes MFG. Co.," "Dempster Mill MFG. Co.," and "Red Jacket," a lawn mower, a bed frame, wash room items that included a bath tub, toilet, and sink, poultry cage wire, numerous barbed wire rolls, a ripper (**Figure 27**), and other assorted household goods.

Figure 27. 25DW360, ripper, facing west. Photograph taken by Shane Rosenthal, on 11/20/2010.

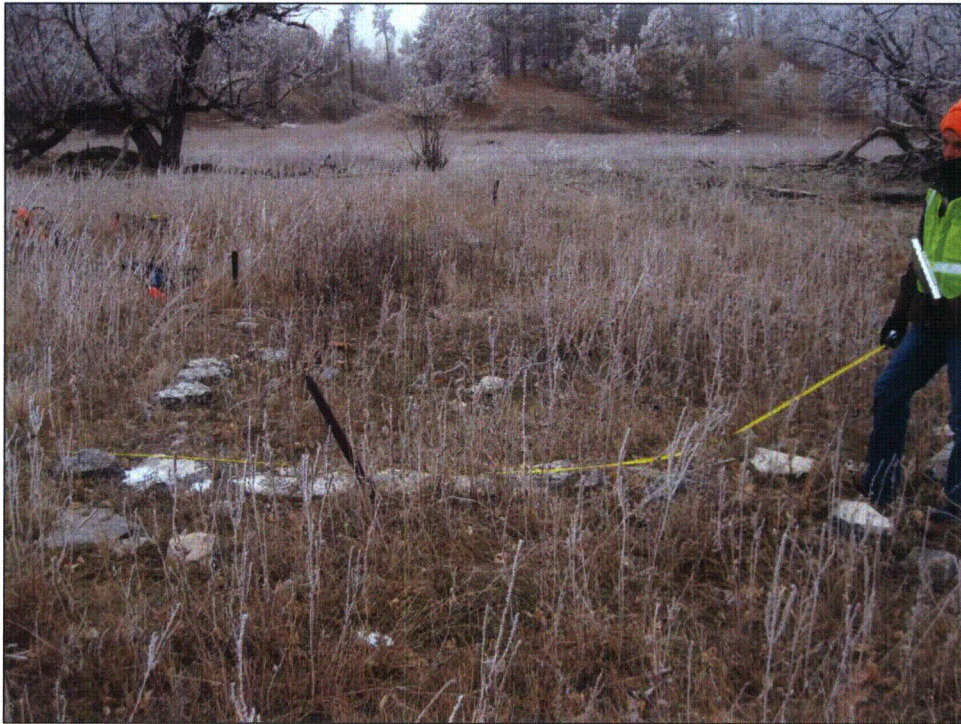
Feature F1 is a house foundation composed of at least two rooms measuring 20 feet east to west and 25 feet north to south, with a single room extending west from the center of the primary rooms measuring 18 feet east to west and 10 feet north to south (**Figures 28 and 29**). The foundation walls consist of linear arrangements of sandstone stones that were locally acquired undressed sandstone boulders and cobbles. The remnants of a brick chimney are located along the south wall of the largest southeastern room, and a low dirt berm running north from the chimney divides this room into two shallow depressions. Brick scatters are concentrated within these depressions, though it is unclear if erosion or architectural elements caused these depressions. A third brick concentration is located in the western room. Few artifacts were observed within the foundation, though a three inch-diameter upright pipe was buried in the southwest corner of the west room. Another six inch-diameter pipe, scrap metal, and a "Barnes MFG. Co." water pump (**Figure 30**) were observed northwest and north of the foundation. A poured concrete sidewalk measuring four feet wide intersects the west room from the south, and continues south for 41 feet, where a cottonwood tree and the remains of a sink and toilet tank were observed (**Figures 31 and 32**). Additionally, a metal concrete-filled ring and a concrete-filled spoked wagon wheel are located to the east of the foundation, and may have been used as a well cover.

Figure 29. 25DW360, Feature F1, facing west. Photograph taken by Shane Rosenthal, on 11/20/2010.

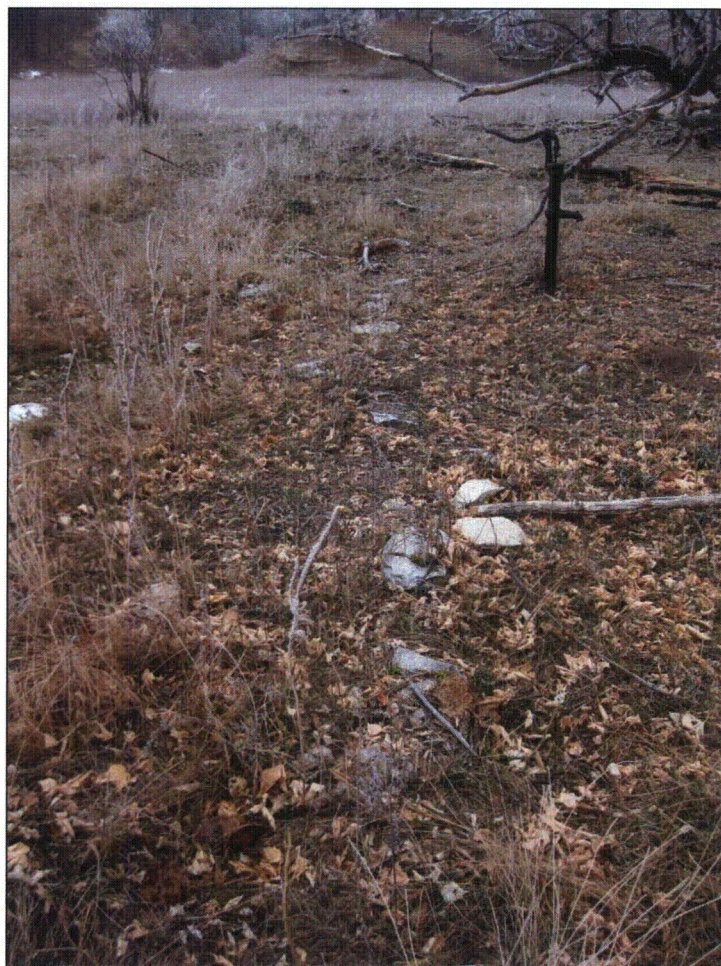
Figure 30. 25DW360, Feature F1, north wall with water pump, facing west. Photograph taken by Shane Rosenthal, on 11/20/2010.

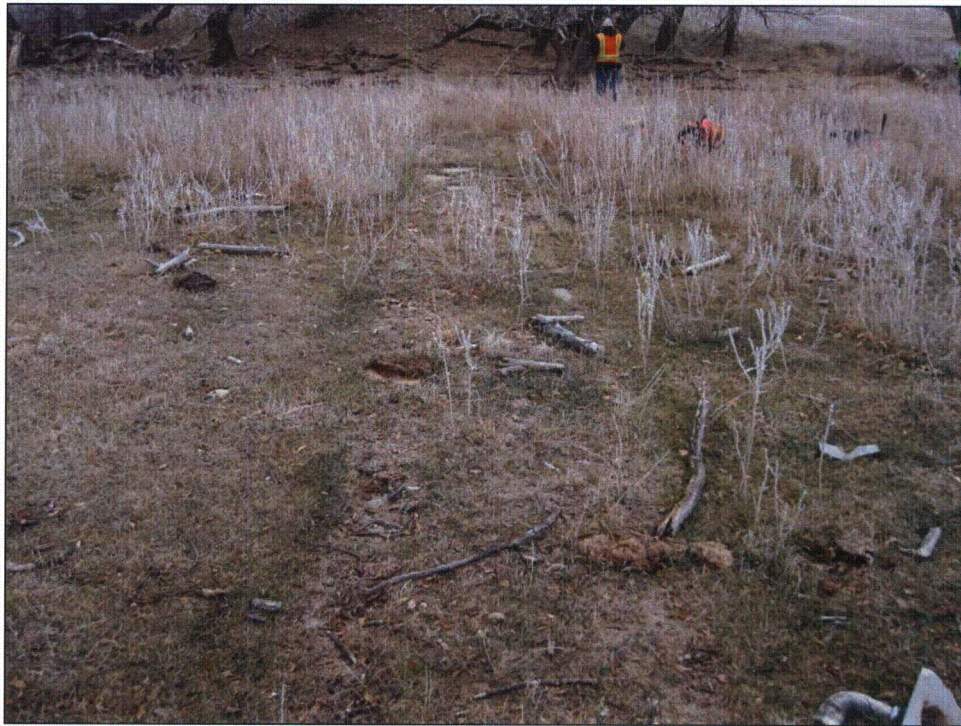
Figure 31. 25DW360, sidewalk from Feature F1, facing west. Photograph taken by Shane Rosenthal, on 11/20/2010.

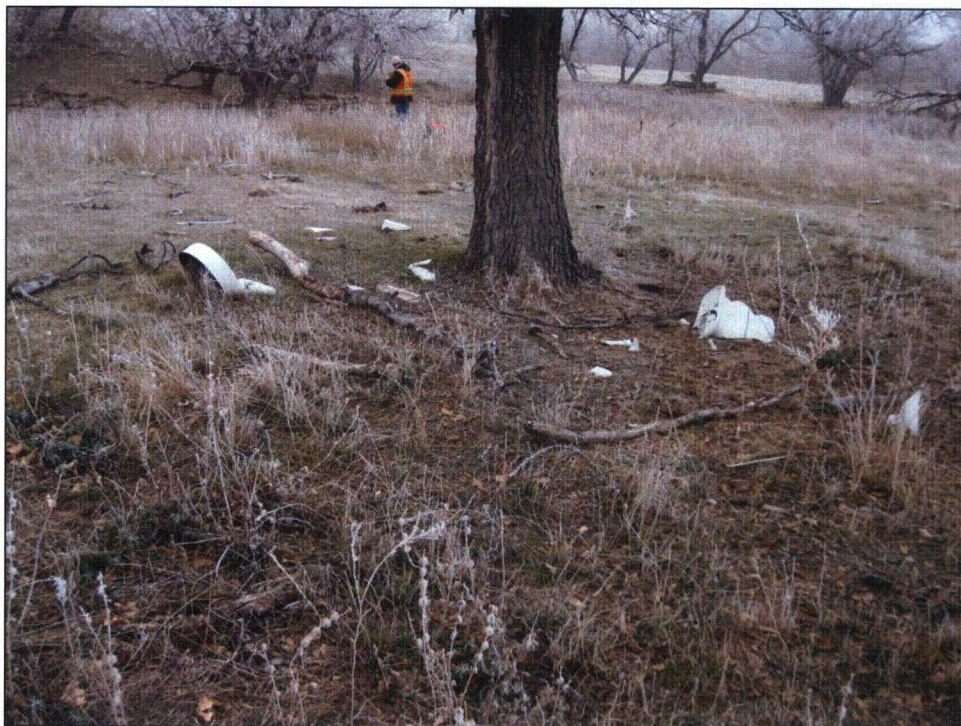
Figure 32. 25DW360, Debris scatter at south end of sidewalk. Photograph taken by Shane Rosenthal, on 11/20/2010.

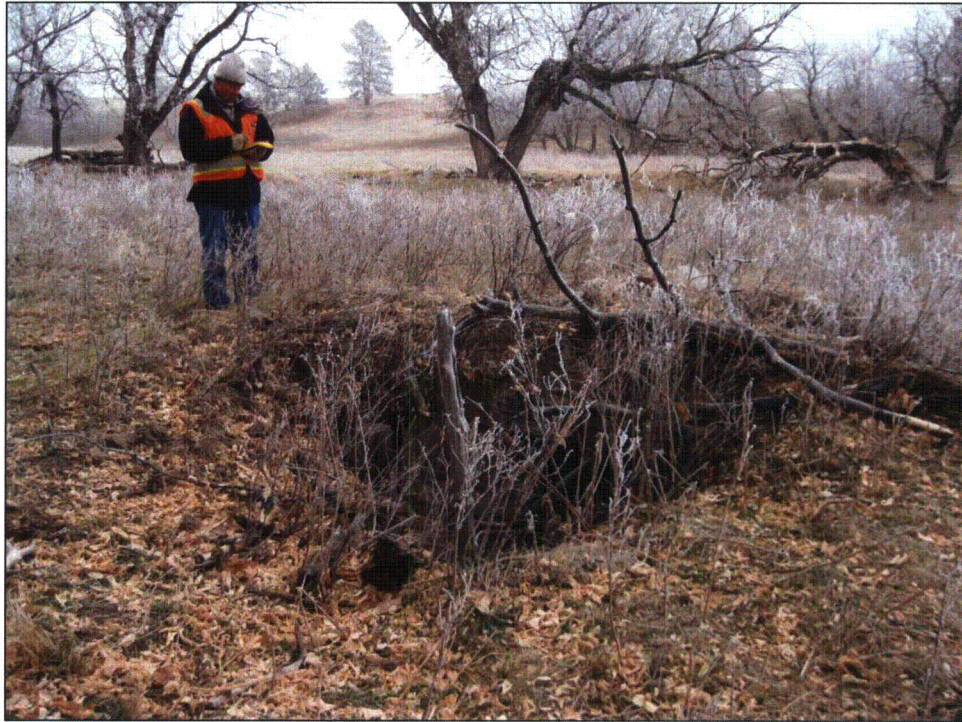
Feature F2 is a root cellar measuring nine feet by eight feet (**Figures 33 and 34**). Feature F2 is located 80 feet north of Feature F1. The cellar consists of a rough dugout, with horizontal eight inch-square hewn wooden beams laying perpendicular to large complete support poles. The ceiling is supported by vertical eight inch-square hewn wooden posts. The roof beams have been covered with soil, and access is by a south-facing door constructed of milled lumber with a clothes iron handle. The feature is estimated to have been six feet deep. A five inch-diameter terra cotta pipe remained upright in the dirt roof, and an identical pipe was observed on the south entrance slope. These pipes likely worked to provide ventilation and indicate that the structure was used as a vegetable or root cellar.

Figure 33. 25DW360 Feature F2, root cellar, facing south. Photograph taken by Shane Rosenthal, on 11/20/2010.

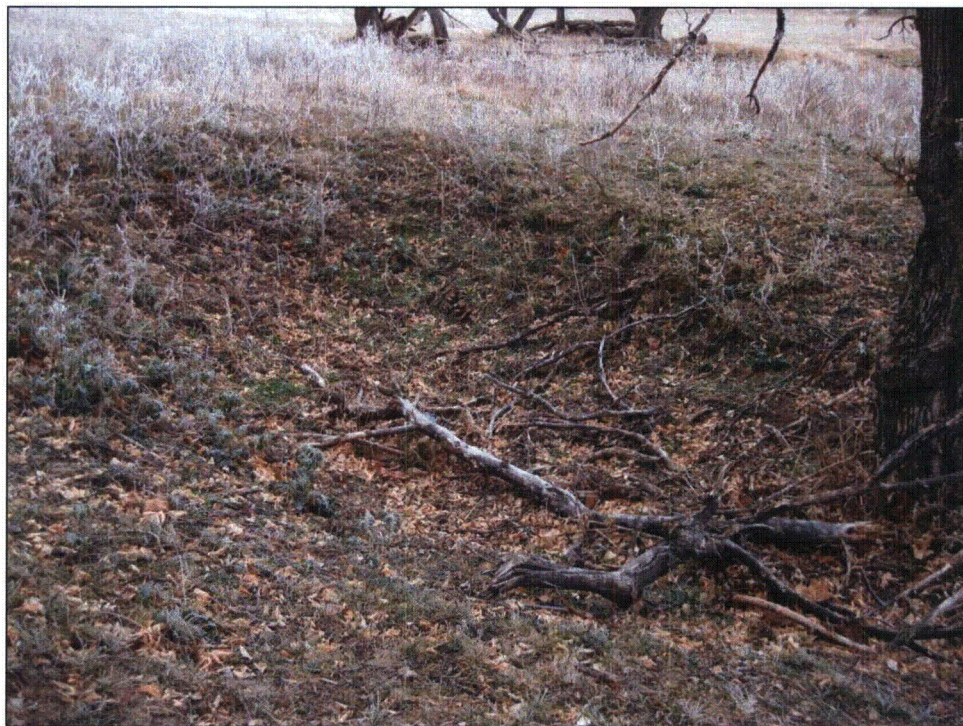
Feature F3 is a dugout feature located on the east slope of the ridge 28 feet northwest of Feature 2 (**Figure 35**). The feature measures 12 feet east to west and 18 feet north to south, with a mature cottonwood tree at the southeast edge. The depth of the feature averages four feet at the deepest. No artifacts were observed in association with the feature.

Figure 35. 25DW360 Feature F3, dugout, facing east. Photograph taken by Shane Rosenthal, on 11/20/2010.

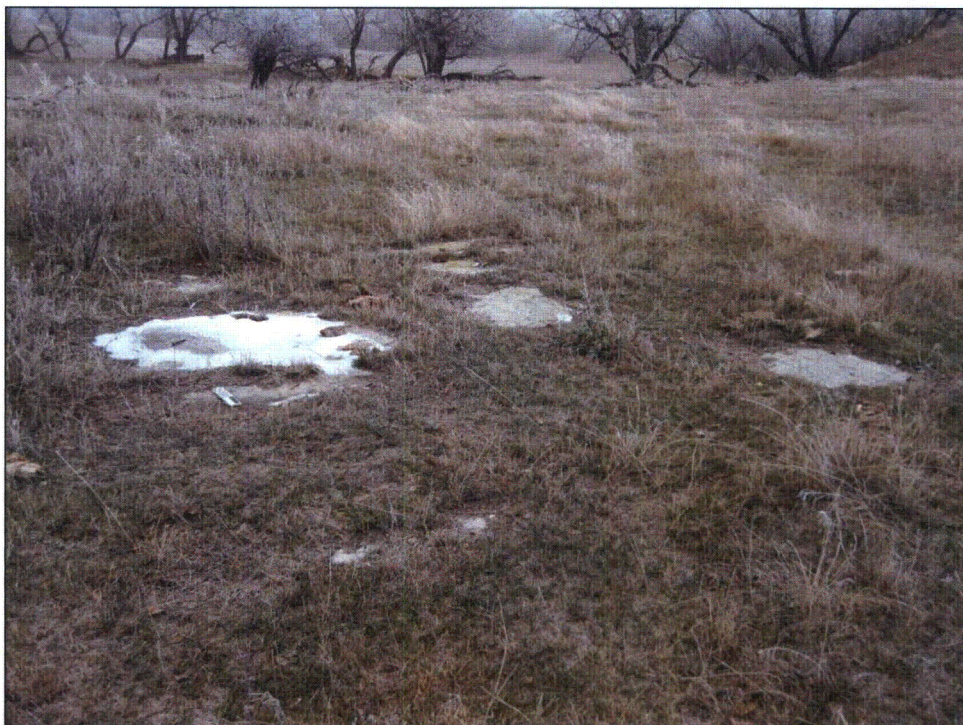
Feature F4 is a poured concrete slab foundation measuring 15 feet by 15 feet (**Figure 36**). The foundation is located 128 feet south of Feature 1. No artifacts were observed in association with this feature.

Figure 36. 25DW360 Feature F4, concrete slab foundation, facing northeast. Photograph taken by Shane Rosenthal, on 11/20/2010.

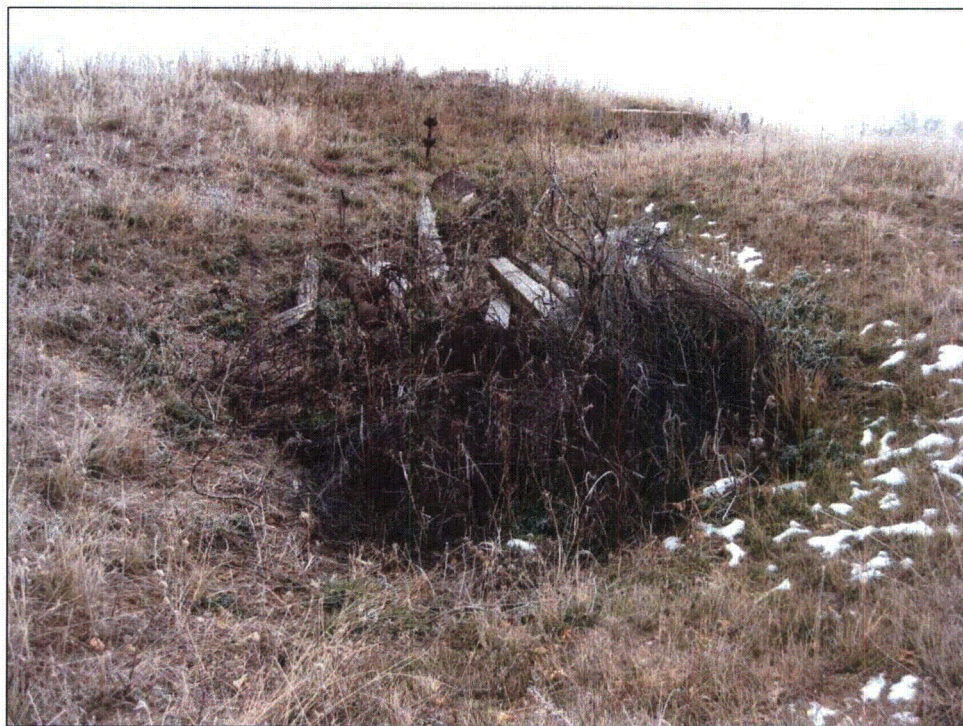
Feature F5 is a debris-filled depression located 182 feet southeast of Feature F1 (**Figures 37 and 39**). The depression measures 25 feet north to south, 16 feet east to west, and is approximately eight feet deep. Within the feature is a historic debris pile consisting of chicken wire, barbed wire, wooden poles, milled lumber, and a "Dempster Mill MFG Co." windmill motor. A water pump stamped with "Red Jacket" was observed at the south edge of the depression, and another water pump of unknown make was located within the depression.

Figure 37. 25DW360 Feature F5, dugout with cistern (Feature F6) in background, facing east. Photograph taken by Shane Rosenthal, on 11/20/2010.

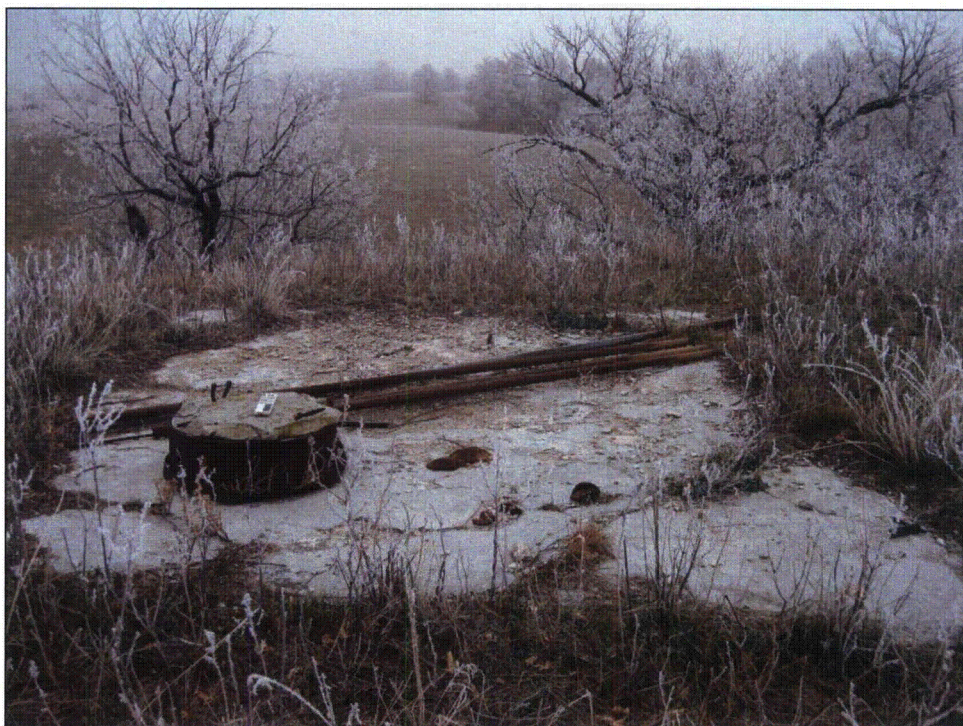
Feature F6 is a poured concrete cistern located on the ridge top 36 feet east of Feature F5 and measures 12 feet square (**Figures 38 and 39**). A raised metal ring acts as rooftop access to the cistern's contents, with a poured concrete slab acting as a cap. Within this cap, scrap metal and bolts were used as concrete reinforcement and handles. The letters "E H" were pressed into the concrete cap (**Figure 40**). Four long, narrow windmill pipes rest along the east half of the cistern. To the northwest is a four feet square poured concrete slab with a six inch-diameter upright pipe in the center. This small slab may have been a foundation support for a windmill.

Figure 38. 25DW360 Feature F6, cistern, facing north. Photograph taken by Shane Rosenthal, on 11/20/2010.
