## **Cameco Resources Marsland Expansion Area Uranium Project Class III Cultural Resource Investigation Dawes County, Nebraska**

ARCADIS Project No. WY002368.0001.0001

**April 28, 2011**

### **Cultural Resource Inventory**

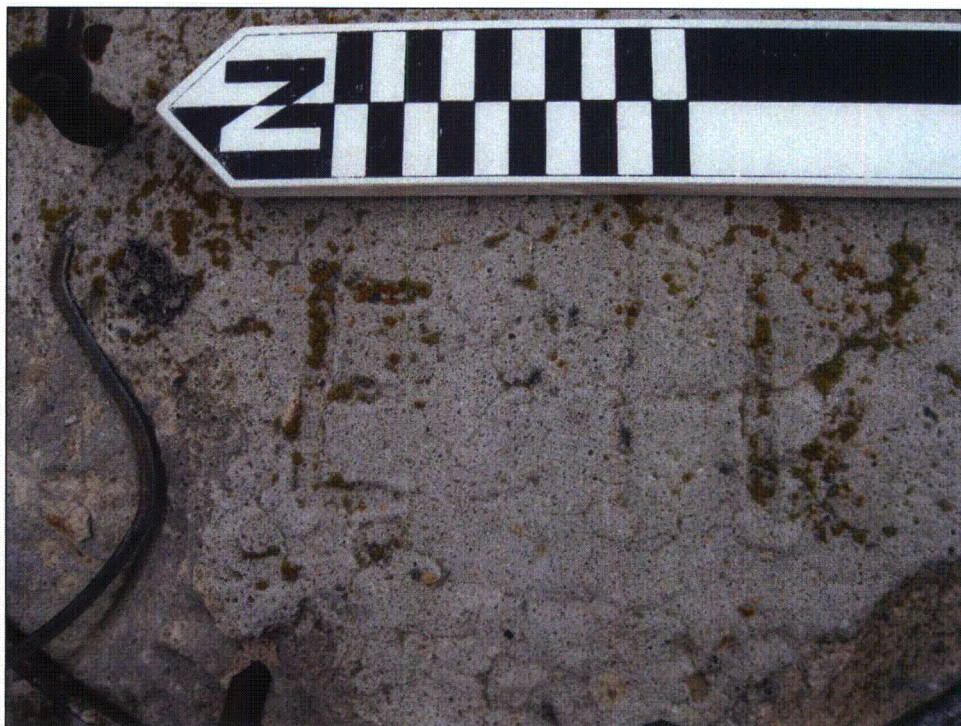
Feature F6 is a poured concrete cistern located on the ridge top 36 feet east of Feature F5 and measures 12 feet square (**Figures 38 and 39**). A raised metal ring acts as rooftop access to the cistern's contents, with a poured concrete slab acting as a cap. Within this cap, scrap metal and bolts were used as concrete reinforcement and handles. The letters "E H" were pressed into the concrete cap (**Figure 40**). Four long, narrow windmill pipes rest along the east half of the cistern. To the northwest is a four feet square poured concrete slab with a six inch-diameter upright pipe in the center. This small slab may have been a foundation support for a windmill.

Figure 40. 25DW360 Feature F6, cistern stamp "EH". Photograph taken by Shane Rosenthal, on 11/20/2010.

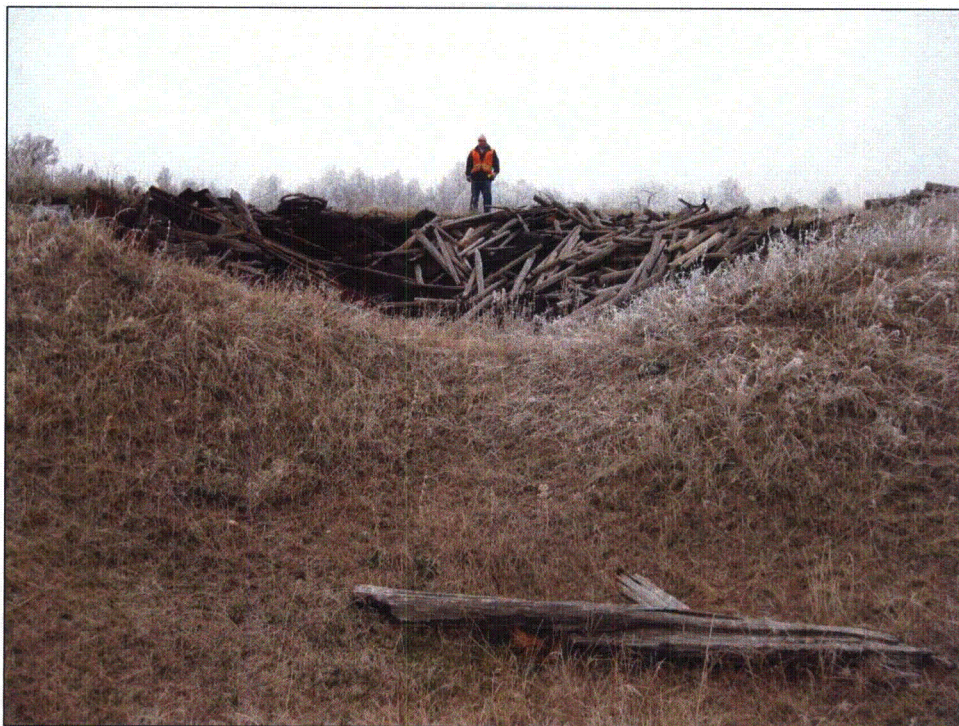
Feature F7 is a large depression located within a finger ridge of a south facing slope 300 feet southeast of Feature 8 (**Figures 41 and 42**). The depression measures approximately 40 feet northwest to southeast and 30 feet southwest to northeast. Debris, consisting mostly of fence posts, various wire bales, and corrugated sheet metal, has been placed into the depression.

Figure 41. 25DW360 Feature F7, dugout, facing north. Photograph taken by Shane Rosenthal, on 11/20/2010.

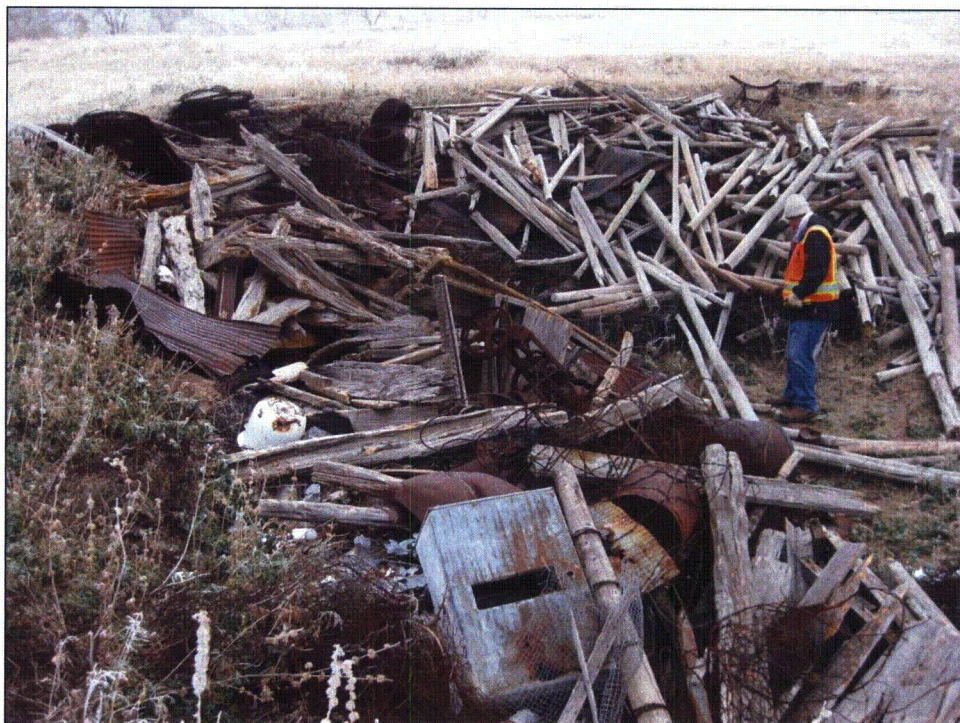
Figure 42. 25DW360 Feature F7, dugout contents, facing south. Photograph taken by Shane Rosenthal, on 11/20/2010.

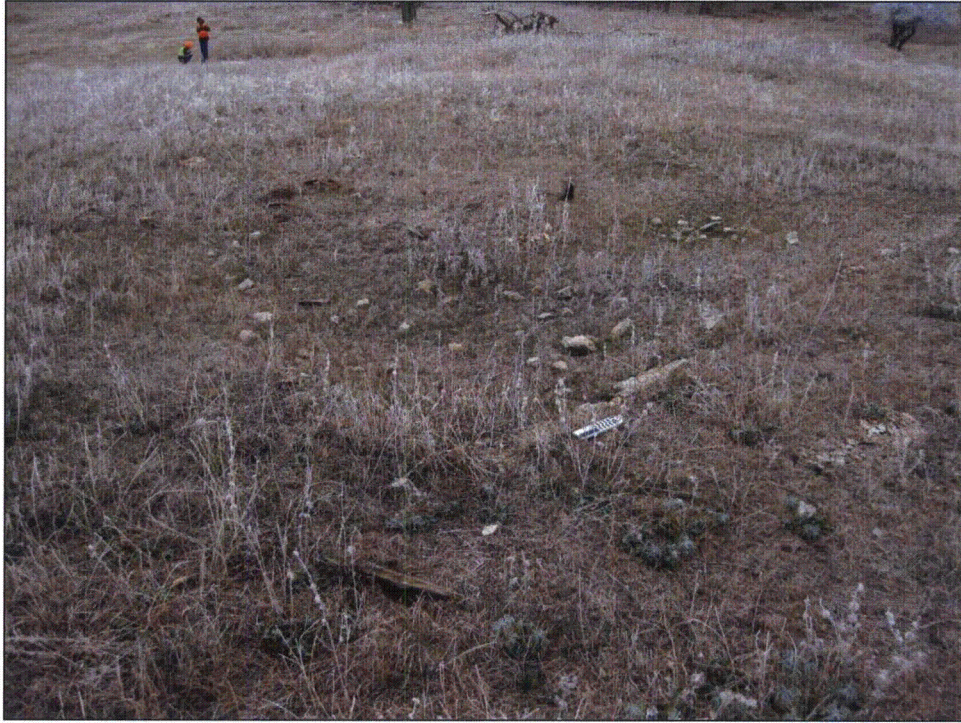
Feature F8 is a foundation of five inch-wide poured concrete measuring 18 feet square (**Figures 43 and 44**). It is located 117 feet southeast of Feature 4. A metal barrel ring band and a small depression with a concentration of crumbling foundation pieces were observed within the feature, and several larger pieces of degraded foundation are located at the southwest corner of the feature. The foundation is in very poor condition.

Figure 43. 25DW360 Feature F8, foundation, facing northwest. Photograph taken by Shane Rosenthal, on 11/20/2010.

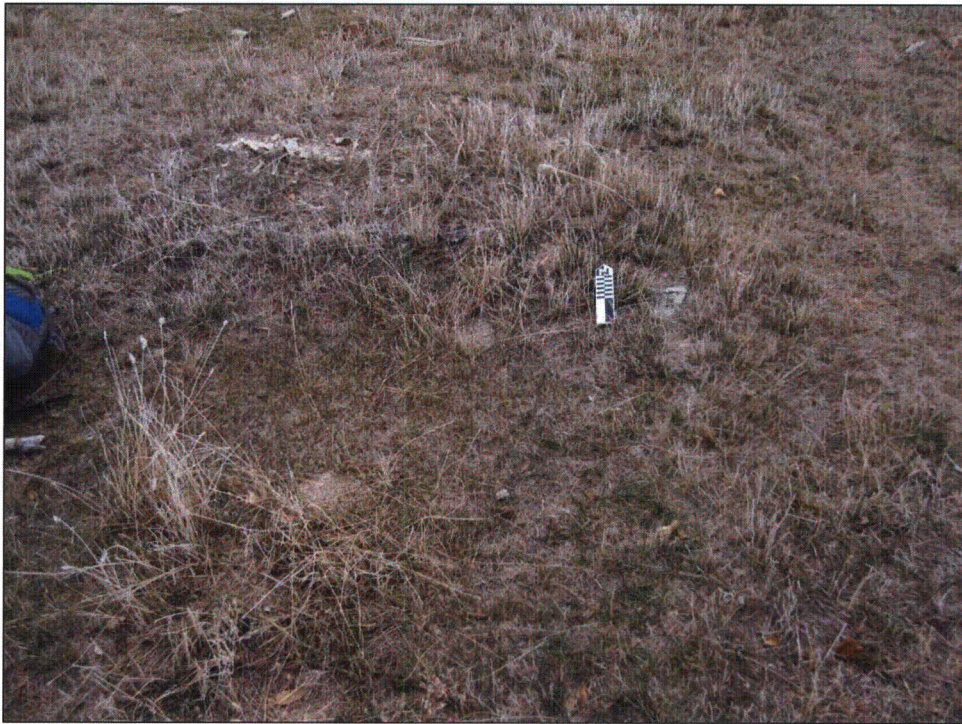
Feature F9 is located on the western side of a two-track road 69 feet west of Feature F4. Feature F9 is a partial foundation of five inch-wide poured concrete measuring three feet long on the east wall and five feet long on the north wall (**Figure 45**). However, a shallow depression measuring 22 feet east to west and 10 feet north to south delineates the original structure's dimensions. No artifacts were observed in association with this feature.

Figure 45. 25DW360 Feature F9, partial foundation, facing north. Photograph taken by Shane Rosenthal, on 11/20/2010.
