# Comparison of Non-Destructive and Destructive Examination Findings for a Leak Path Assessment of a Pressurized Water Reactor Control Rod Drive Nozzle

P.G. Oberson<sup>1</sup>, D.S. Dunn<sup>1</sup>, J. Collins<sup>1</sup>, A.D. Cinson<sup>2</sup>,  
S.L. Crawford<sup>2</sup>, P.J. MacFarlan<sup>2</sup>, B.D. Hanson<sup>2</sup>

EPRI International Boiling Water Reactor and Pressurized Water Reactor  
Materials Reliability Program Conference and Exhibition 2012

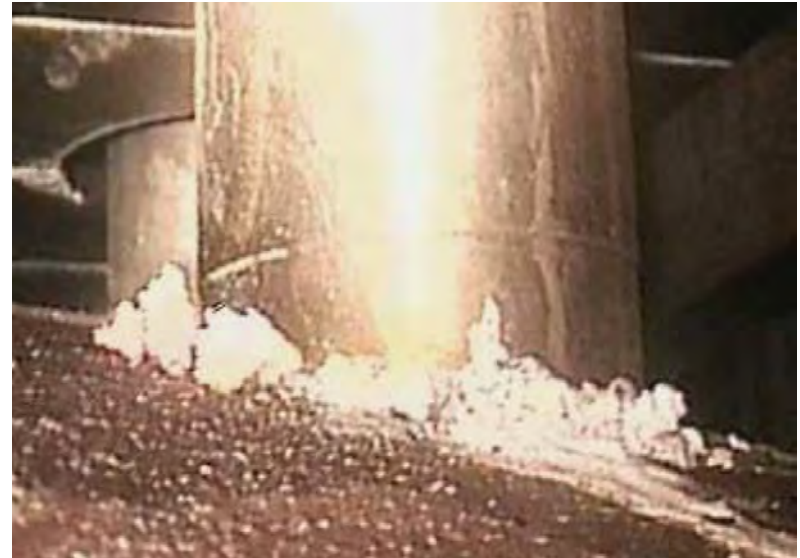
# Leakage Through PWR Upper Head Penetrations

- Primary water stress corrosion cracking (PWSCC) of J-groove weld
- Leakage path through annulus of interference fit between nozzle and RPV head
- Title 10 Code of Federal Regulations, Part 50.55(a) requires demonstrated surface or volumetric leak path assessment for PWR upper head penetrations

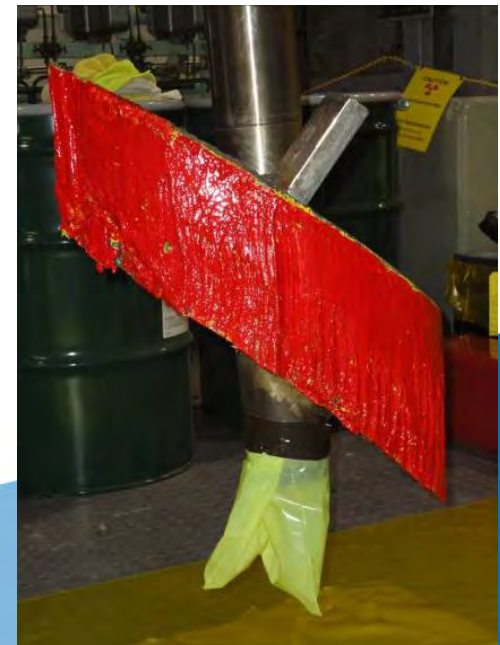
# Overview of NRC-Sponsored Research

- Conducted at Pacific Northwest National Laboratory
- Evaluated efficacy of ultrasonic testing (UT) methodology for leak path assessments of PWR upper head penetrations
- Compared UT findings to destructive examination
- Utilized Nozzle 63 from North Anna Unit 2:
  - Peripheral CRDM nozzle fabricated from Alloys 600/82/182
  - J-groove weld overlaid with Alloys 52/152 following indications of cracking and leakage in 2001 outage
  - RPV head replaced in 2002 following further indications of leakage

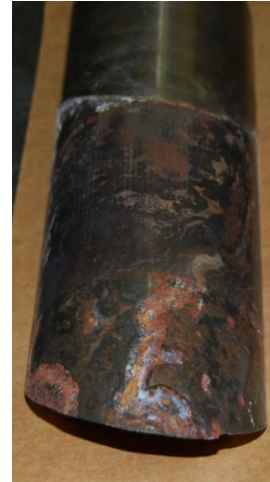
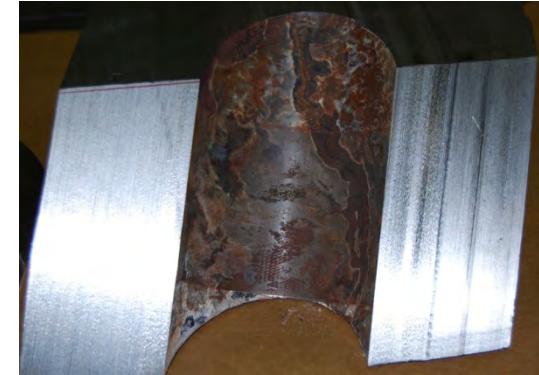
Separation of  
nozzle pieces  
from RPV head  
to reveal annulus  
of interference fit

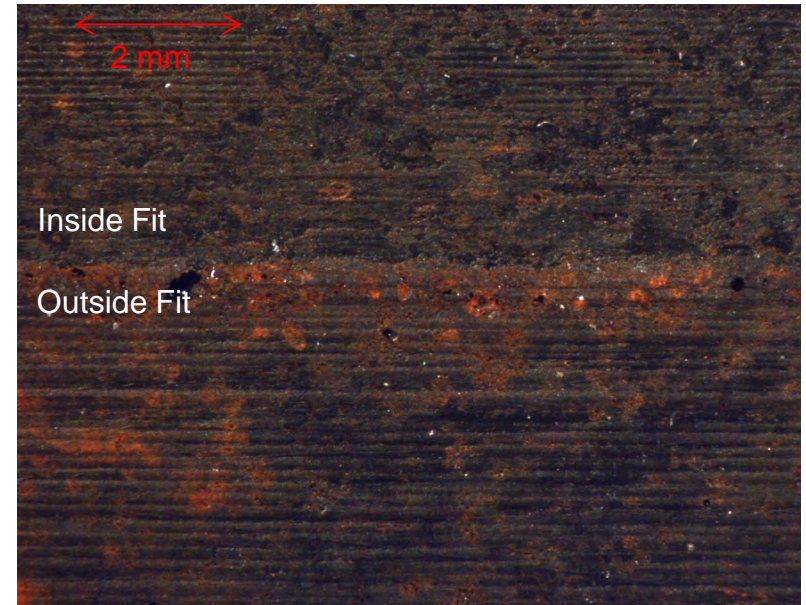
# Surface Replication of Leakage Path Area on RPV Head

- Microset replicant shows machining marks still visible in leak path
- Only minor corrosion or wastage visible near top side of RPV head
- Suggests minimal loss of material in leak path
