**93046-30.4**

**AERIAL PHOTOGRAPHIC MONITORING,  
FLORIDA POWER CORPORATION,  
CRYSTAL RIVER POWER PLANT  
SALT DRIFT STUDY**

**FINAL REPORT 1995 AERIAL PHOTOGRAPHY**

January 18, 1996

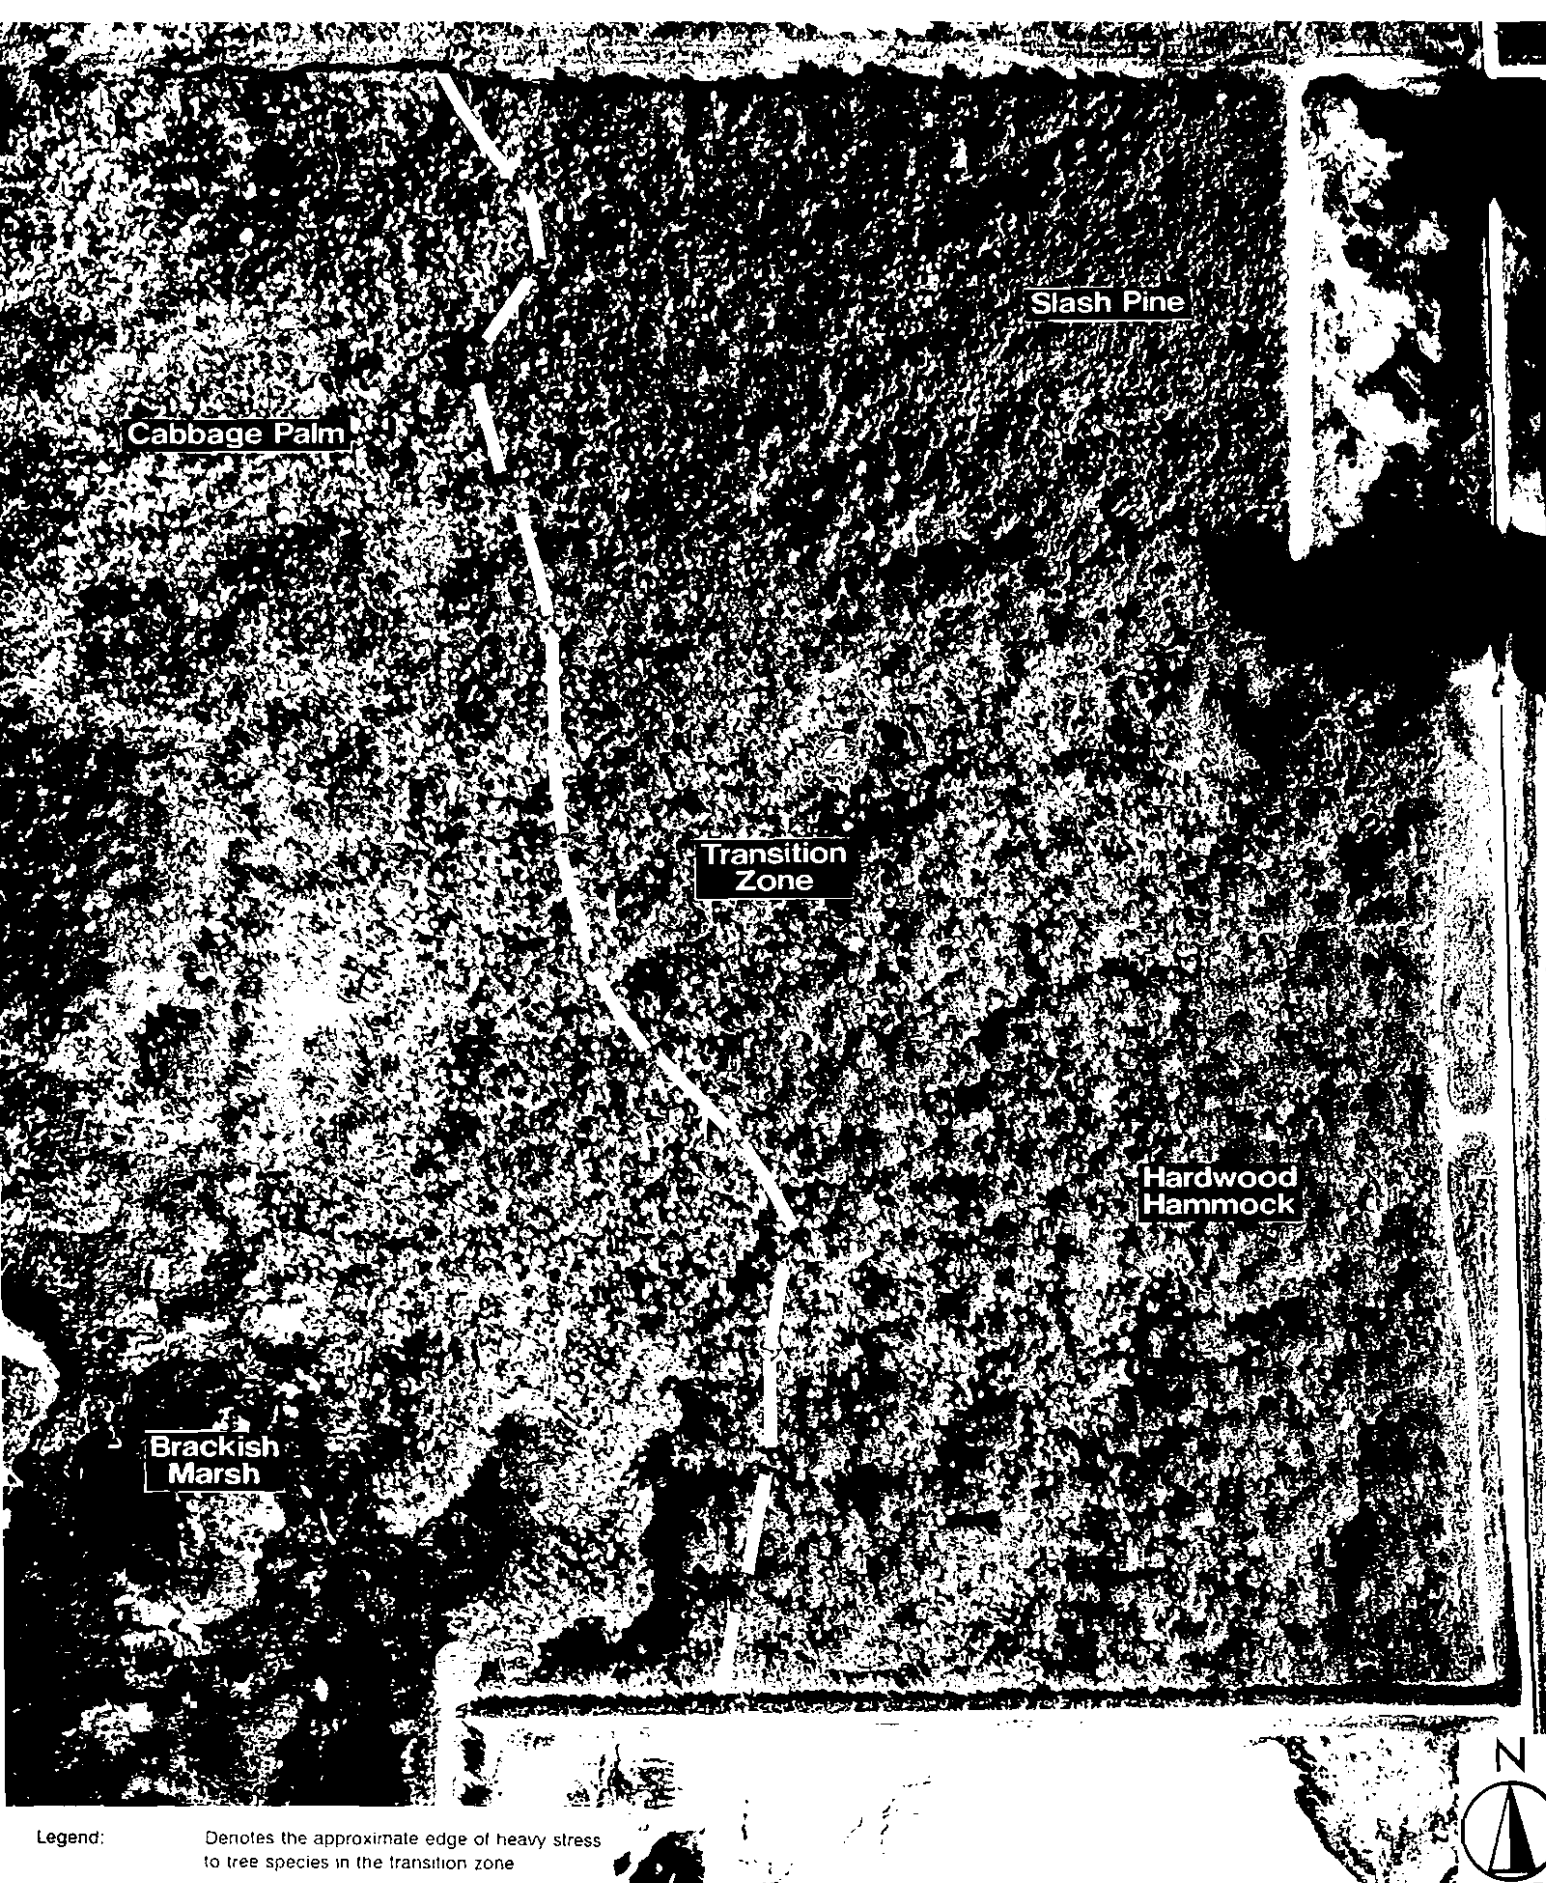
Broad areas of interest in portions of the study area are encompassed in the mid-altitude coverage taken in the fall 1995 mission. Figure 2 is such an area of interest, located to the west of the Natural Draft Cooling Towers. The forested communities transition from pine (*Pinus* sp.) flatwoods and mixed hardwood hammocks into the lower, wetter zones adjacent to the large brackish marshes. A significant portion of this area has experienced a moderate to high amount of stress or mortality to the woody species over the last several years. This stress is mainly observed in the areas of low elevation, however there appears to be a trend for expansion into the edges of upland communities such as pine and live oaks (*Quercus virginiana*). Changes in hydrologic conditions are suspected.

Legend: Denotes the approximate edge of heavy stress to tree species in the transition zone

Figure 2. Areas of Interest Immediately West of the Natural Draft Cooling Towers, Fall 1995.

Observations and data accumulated during the monitoring year indicate that the overall conditions of vegetative communities (in terms of health and vitality) at the Crystal River plant are very good. This includes the upland forested and herbaceous communities, wet prairies and shallow marshes, freshwater forested wetlands, and brackish marsh along the coastline. The continued exception to this assessment is the stressed condition of (primarily) two or three woody species along the brackish marsh/forested transition zone, extending to the north and south of the power plant site. Large-scale changes in the hydrologic conditions (water levels) are suspected as a cause of this condition.

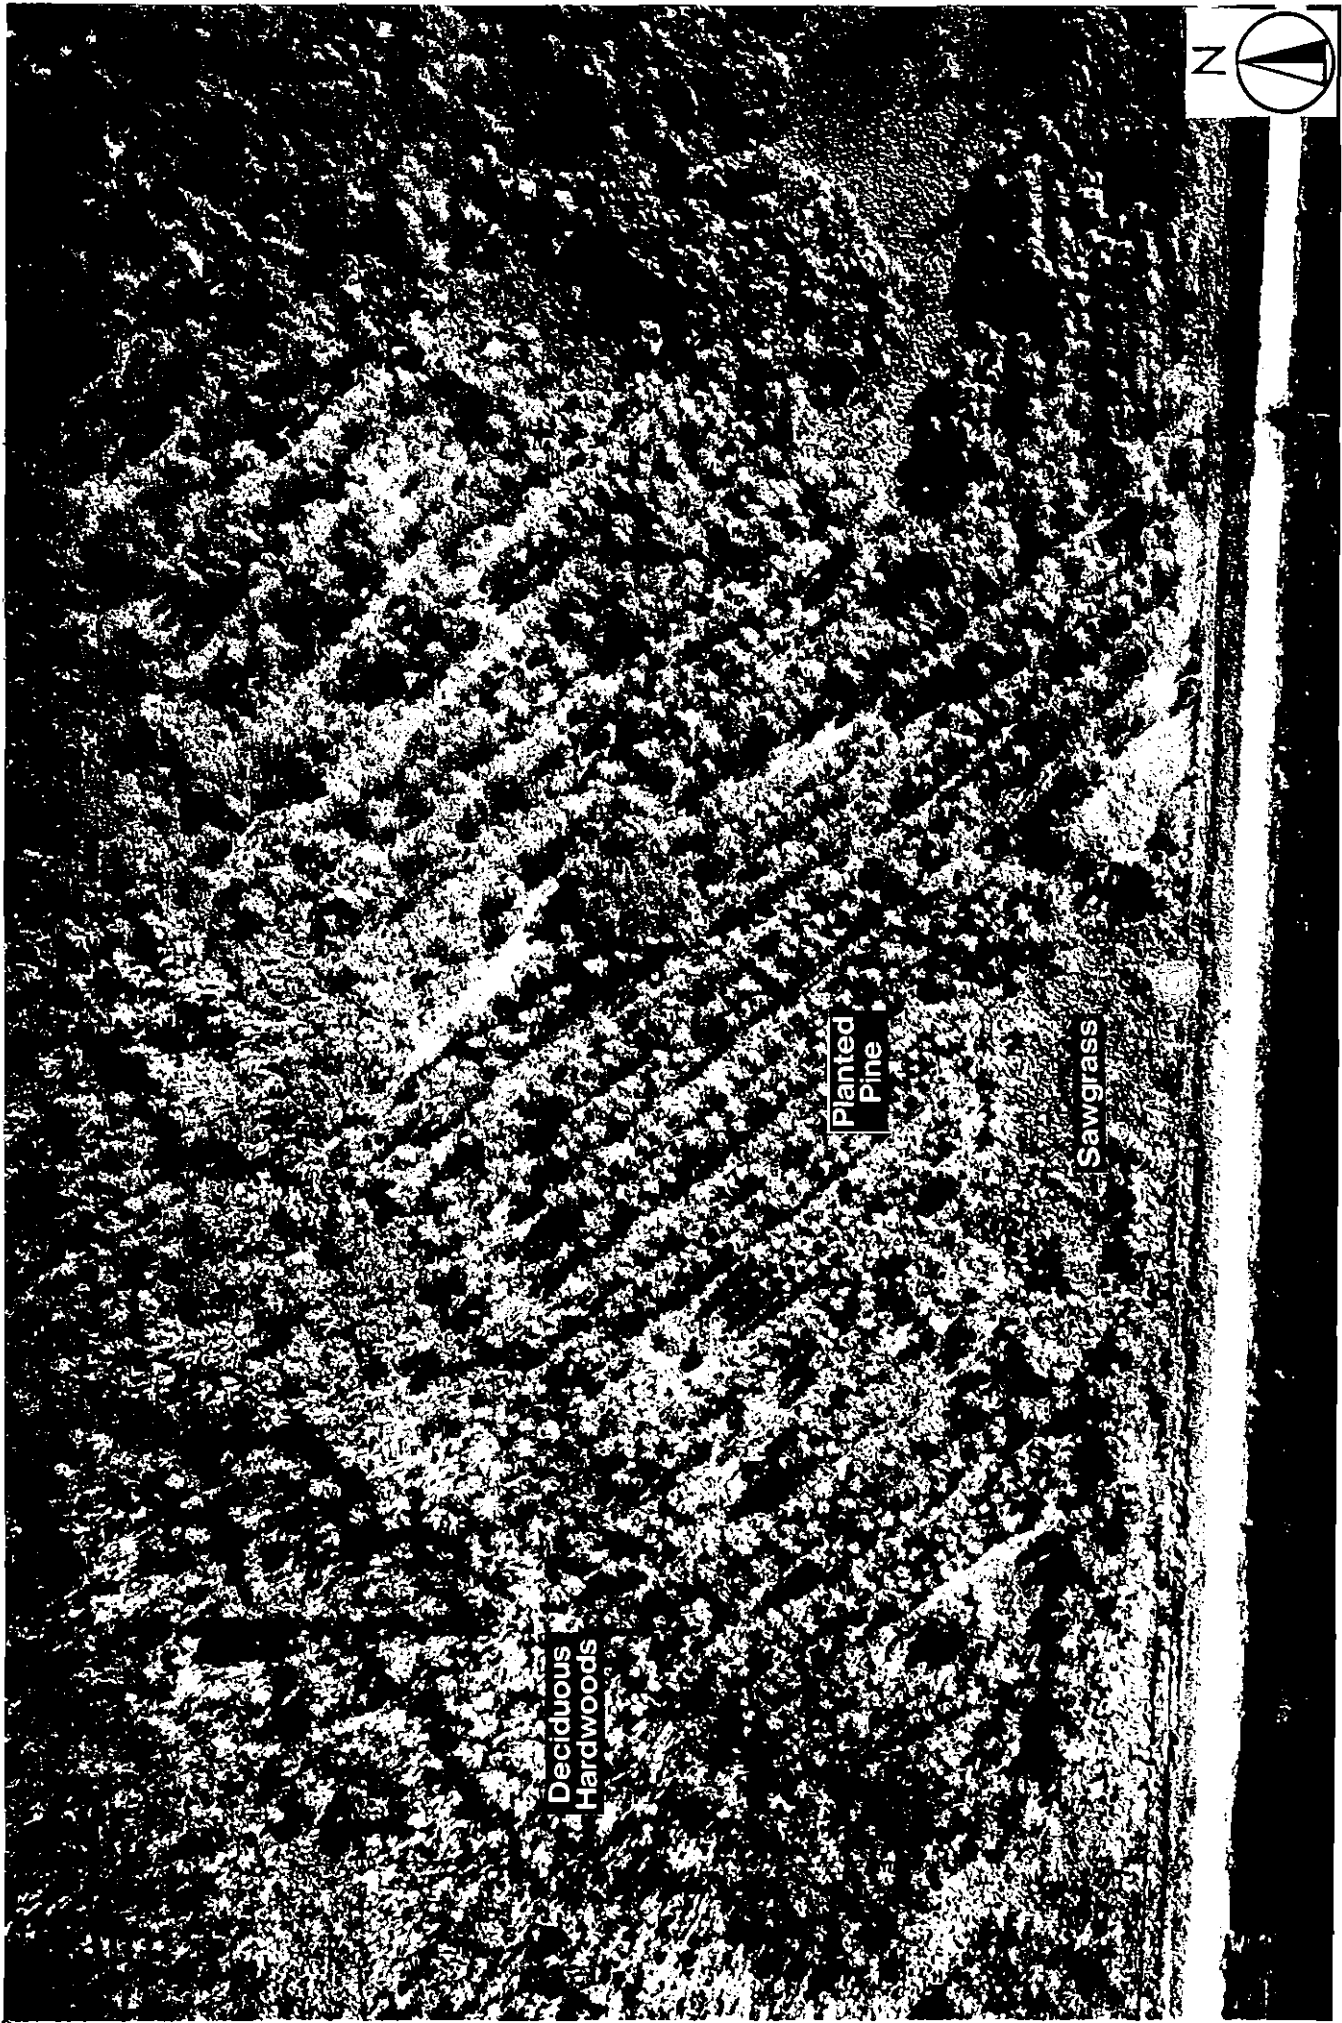
In contrast, other isolated depressional areas and transition edges further to the east do not appear to have symptoms of large-scale stress; this can be seen, for instance, in the vicinity of the Northeast Open Test site (Figure 3) and the North Open Pine site (Figure 4). Although occasional stressed or dead individual trees have been observed in these areas, there has been no evidence of increasing numbers of stressed vegetation.

Figure 3. Low-Altitude Coverage of the Northeast Open Test Site, Fall 1995.

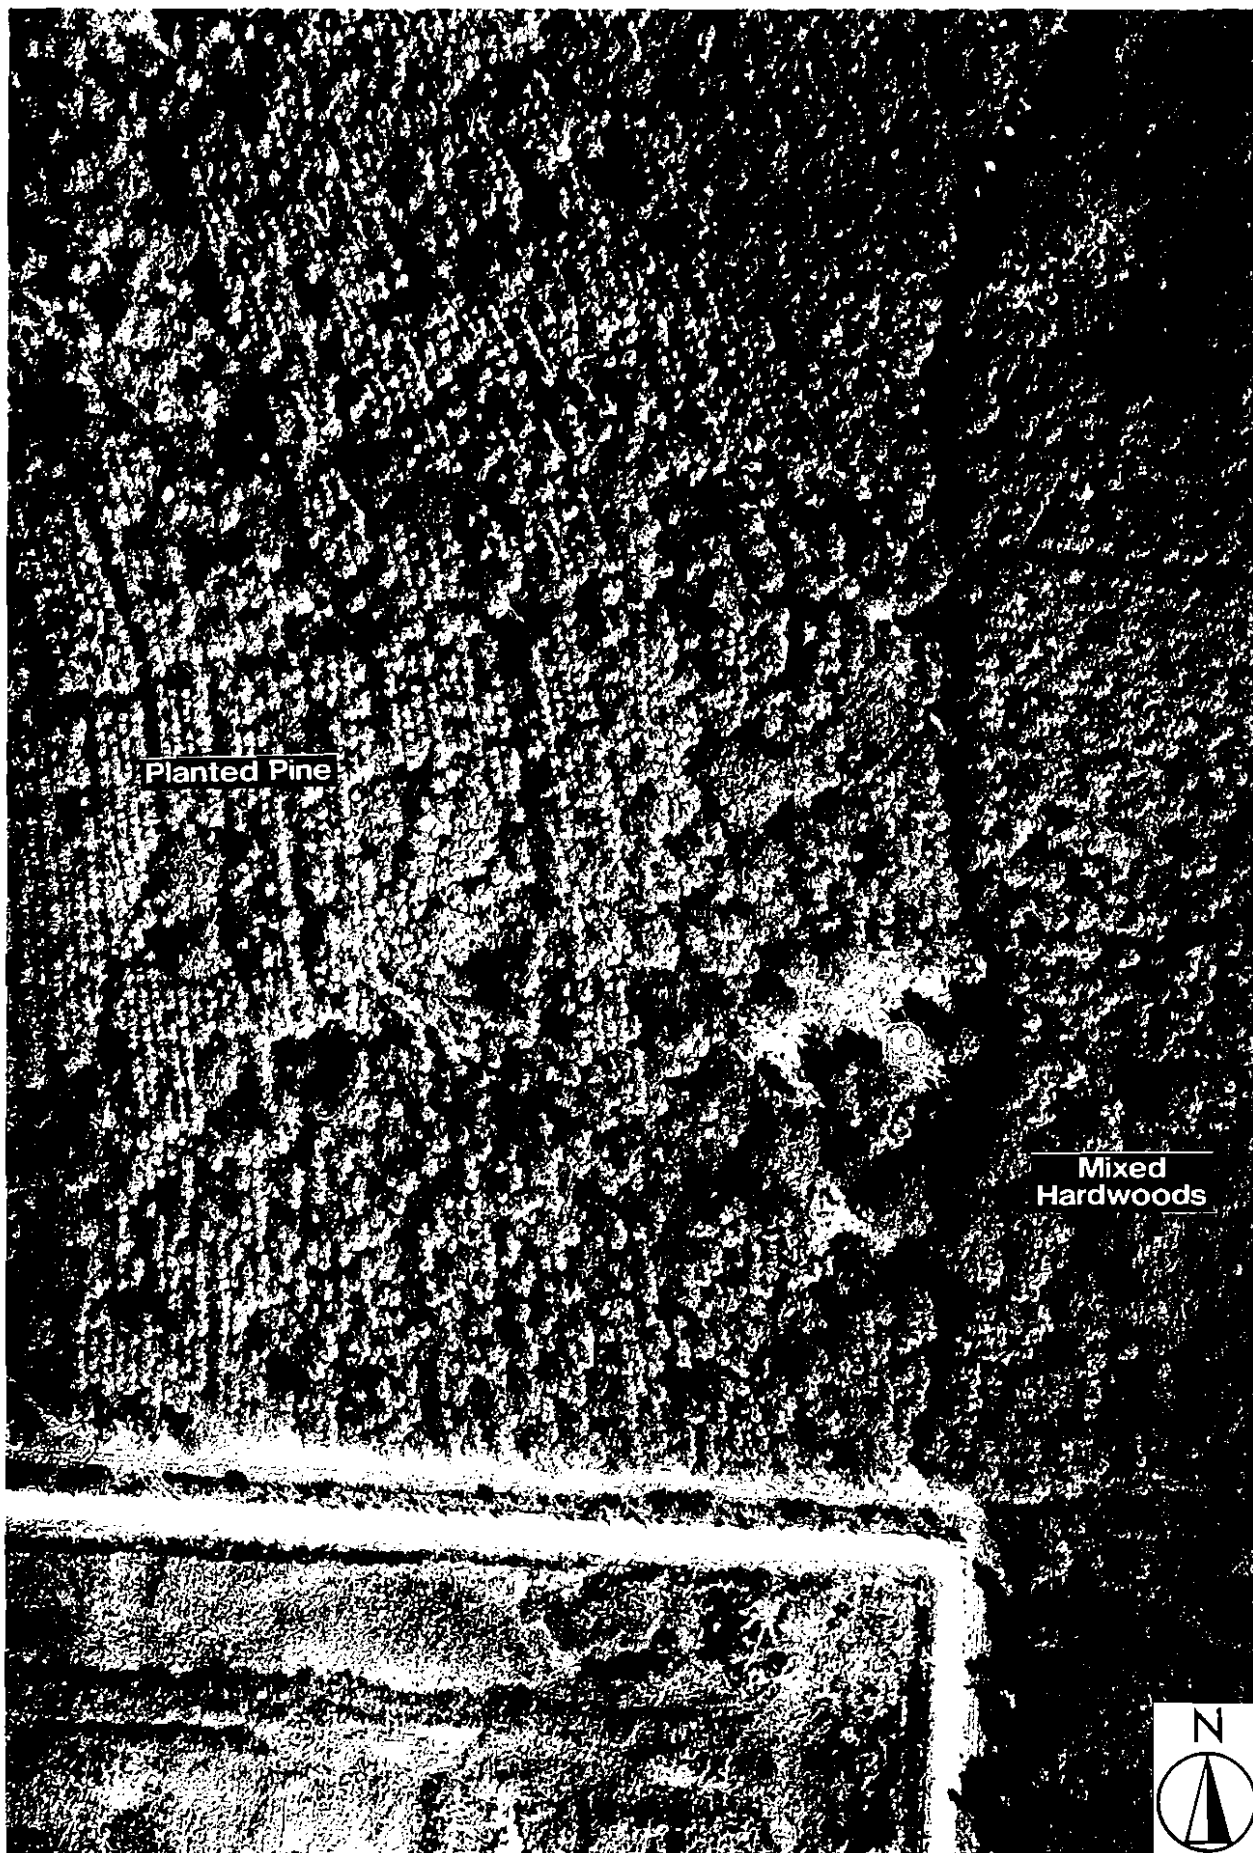
The upland pine and hardwood communities to the north and east of the power plant are in overall good health, as seen in Figures 5 and 6. Foliage conditions of the canopy species and the understory have appeared consistently good in the early part of the growing season, and loss of foliage with the onset of fall leaf senescence is seen to be similar to the previous years of observation.

Figure 5. Low-Altitude Coverage of the Northeast Open Pine Site, Fall 1995.

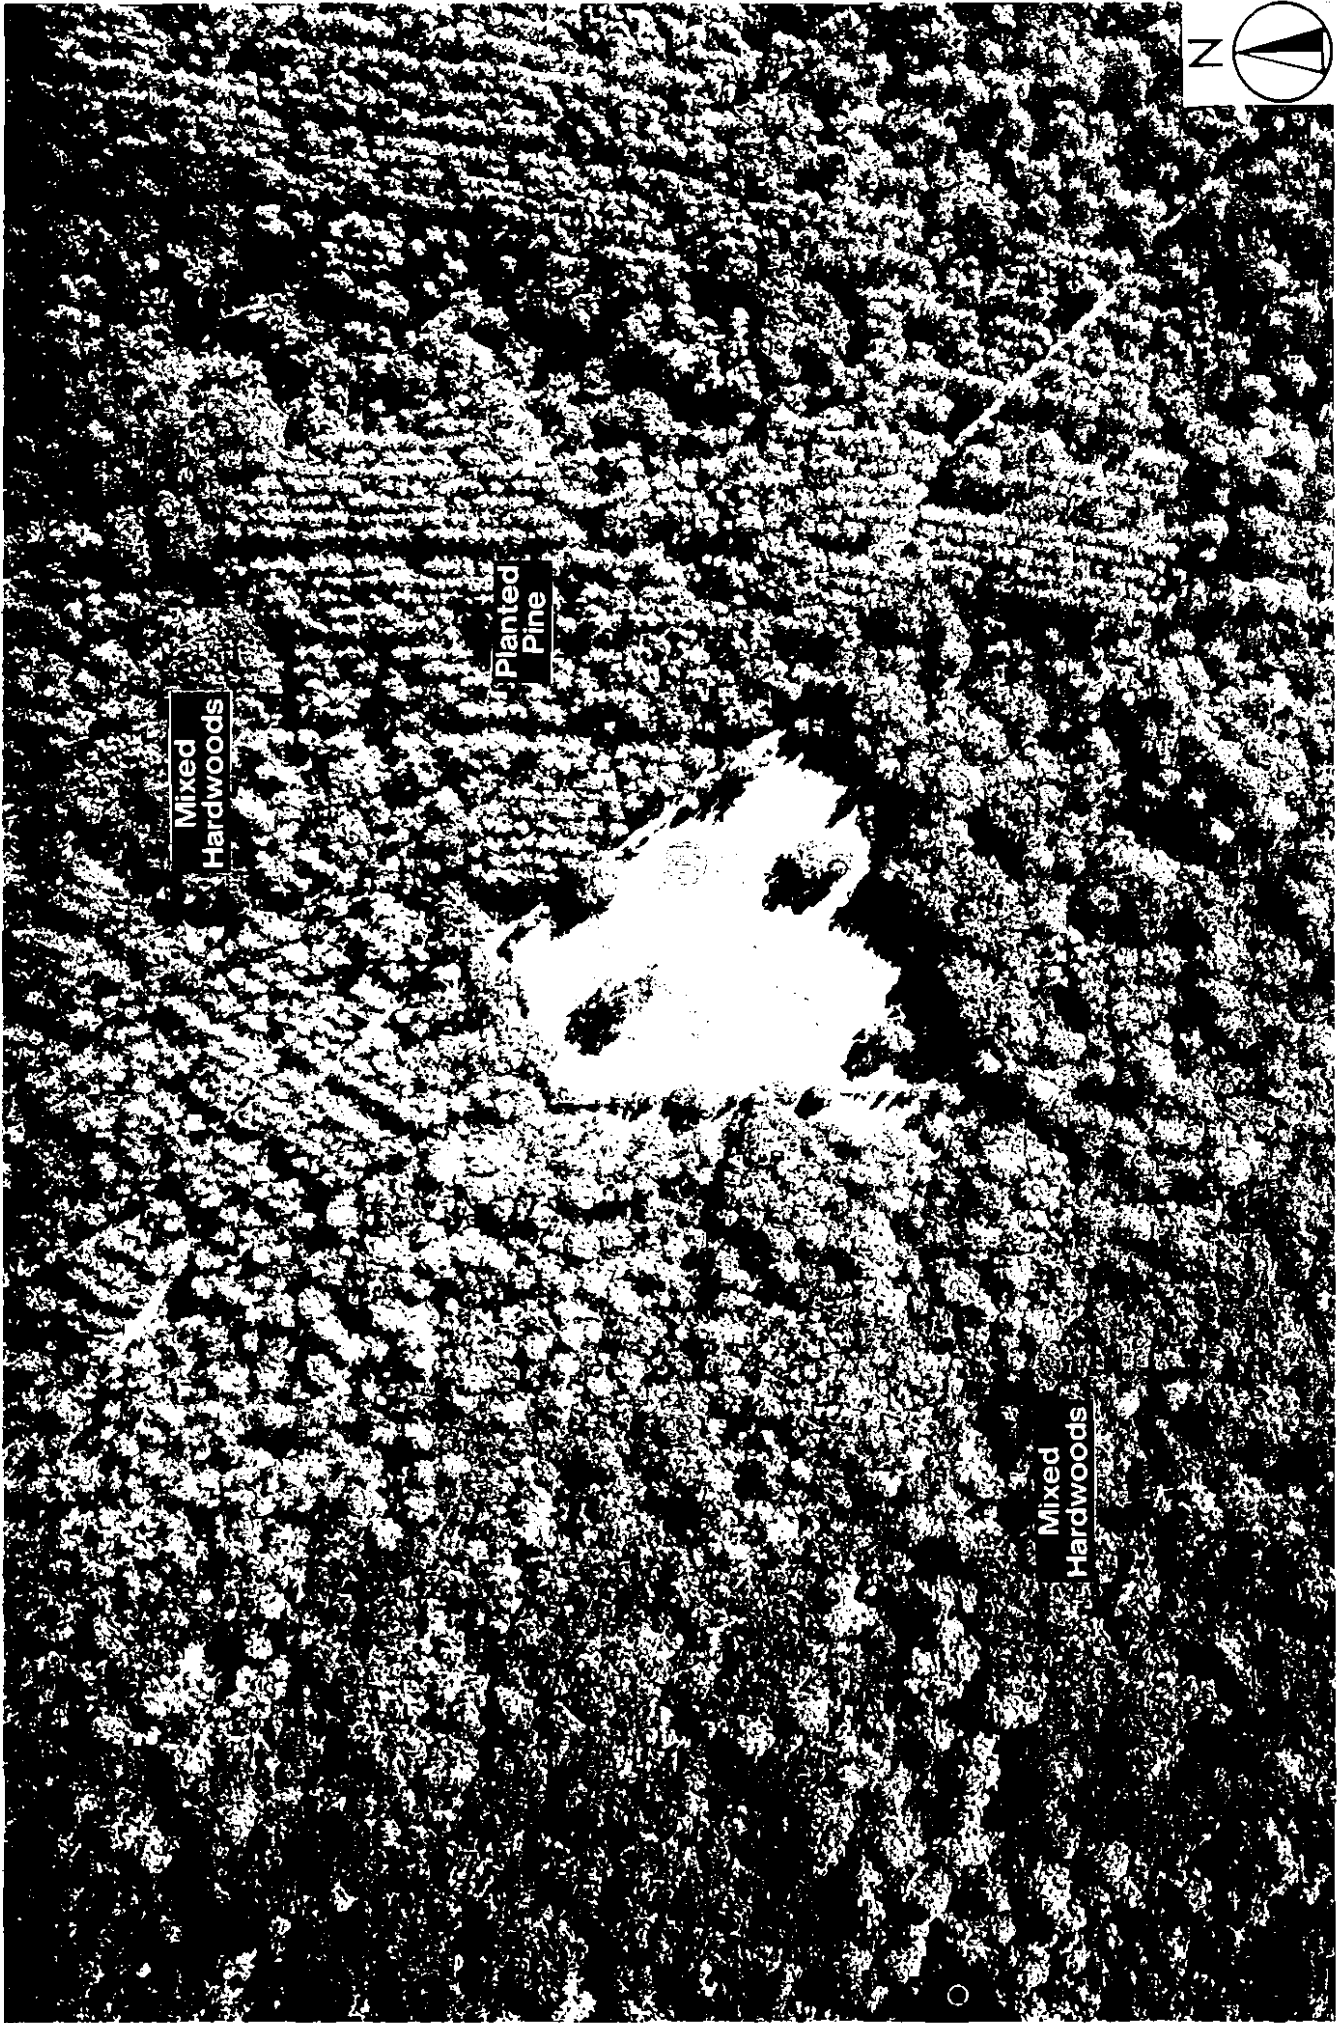
Figure 6. Low-Altitude Coverage of the East Open Pine Site, Fall 1995.

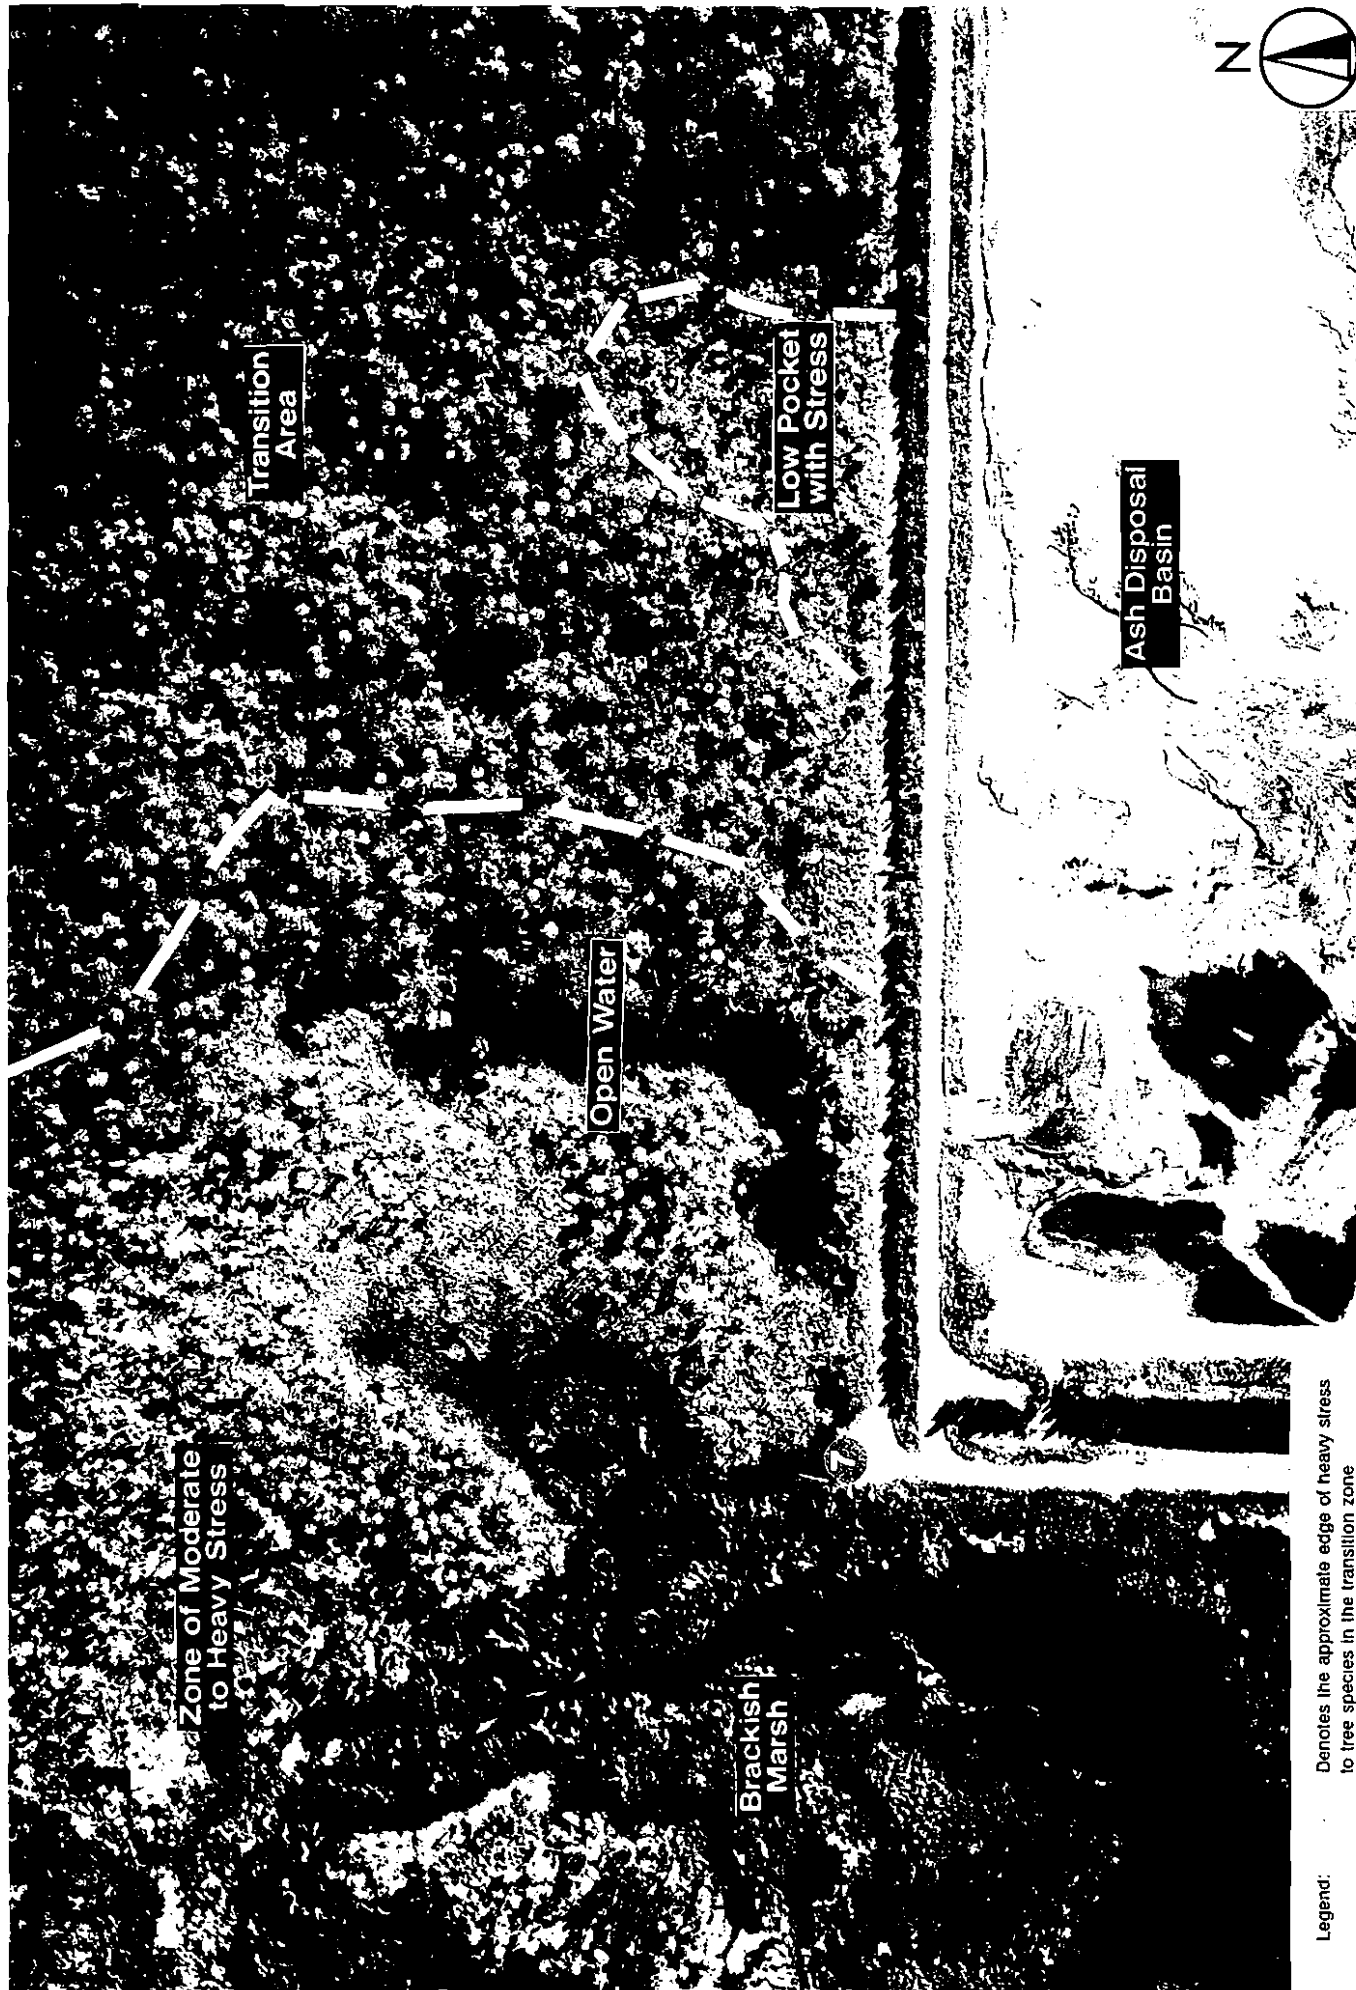
Figures 7 through 10 are a combination of aerial photography and ground photography which document the conditions of the plant communities in the coastal transition zone near the Southwest Open Hammock site, southwest of the Natural Draft Cooling Towers. These photographs clearly demonstrate the conditions of stress to the common woody species that have historically established along this zone; specifically, cabbage palm (*Sabal palmetto*), southern red cedar (*Juniperus silicicola*), and live oak. Although some regeneration is evident in many of the red cedars that have experienced partial or total loss of foliage, there seems to be a gradual, continued loss of a large number of these trees along the transition zone. This trend is much more pronounced in areas of lower elevations.

**Figure 7. Low-Altitude Coverage in Vicinity of the Southwest Open Hammock Site, Fall 1995.**

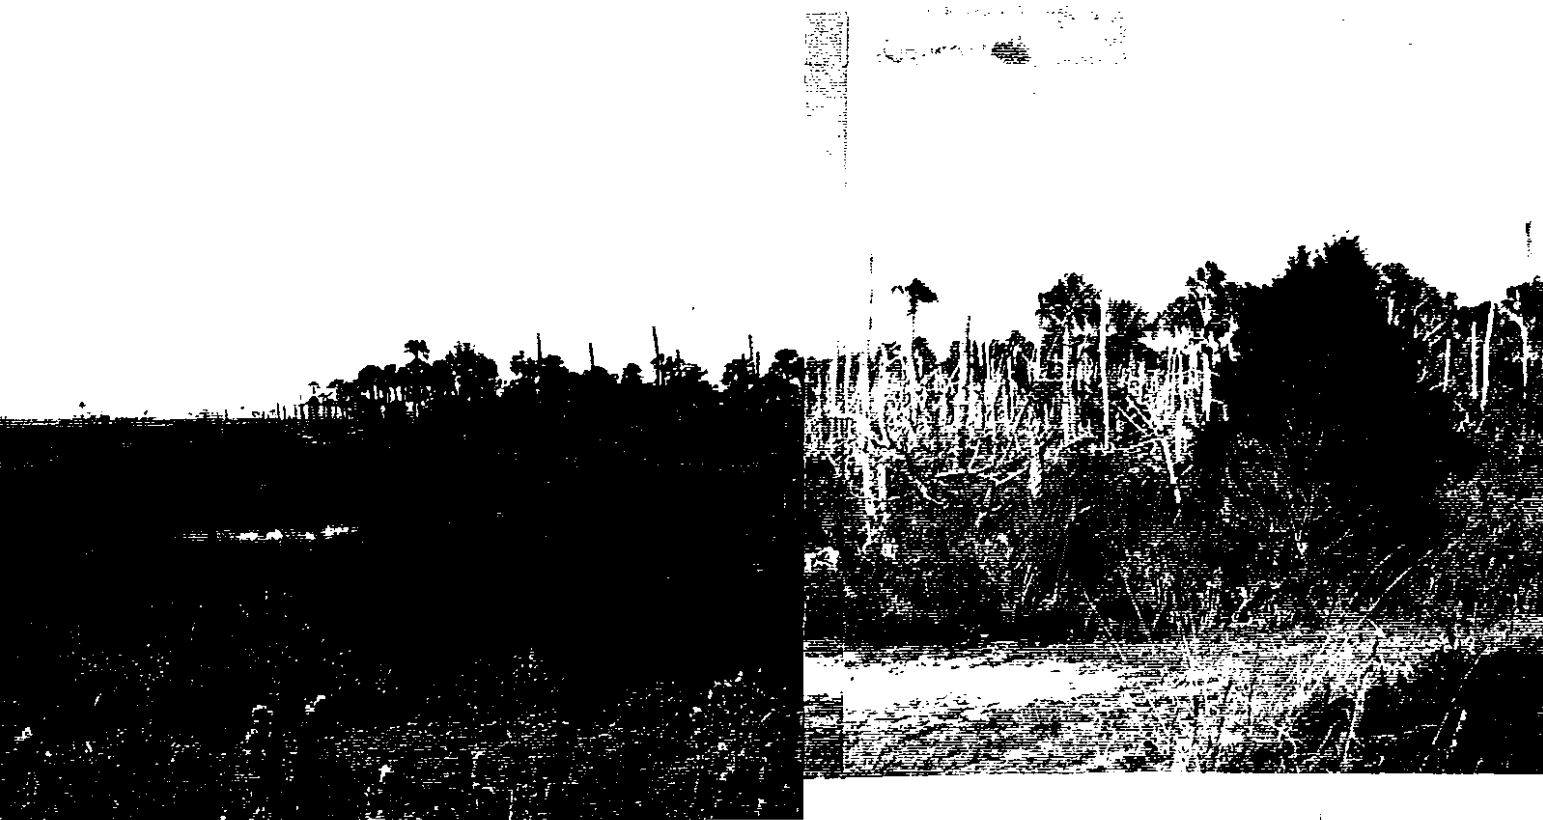
**Figure 8. Panoramic Hammock Site, Fall 1995.**

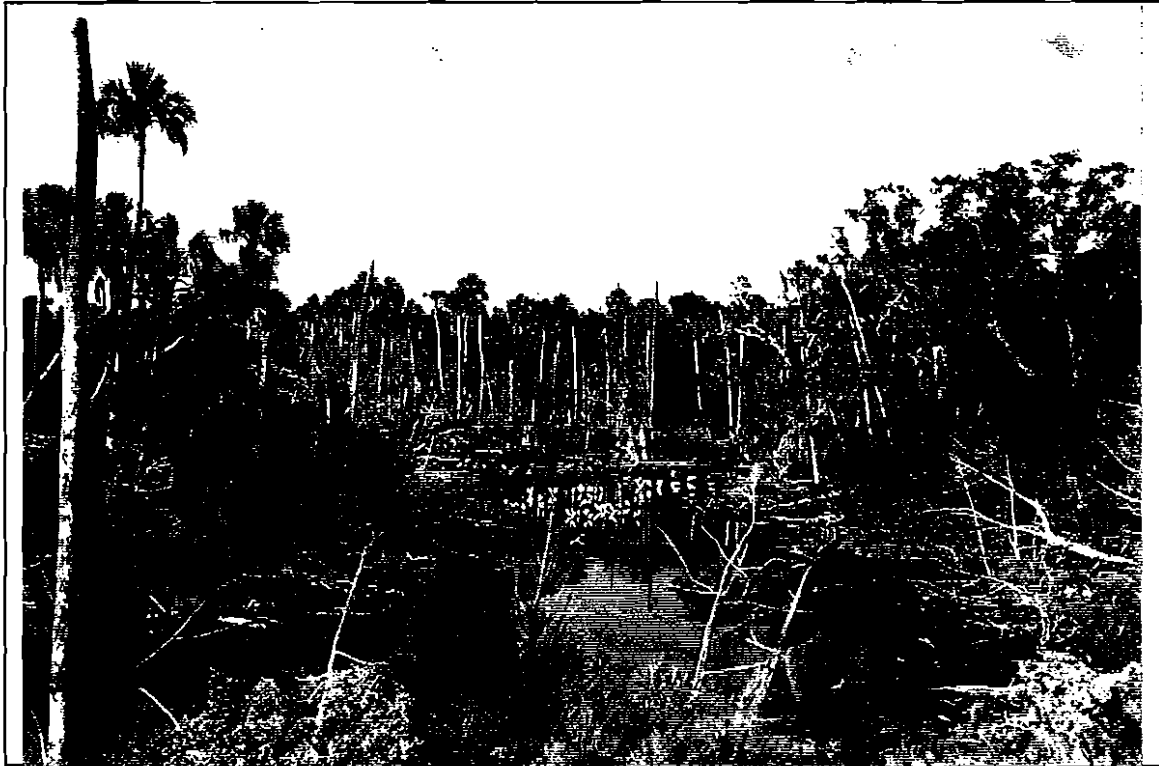
**Figure 9. Open Water Area Just East of the Southwest Open Hammock Site; Showing Stressed and Dead Cabbage Palm, Cedar, Live Oak, Fall 1995.**

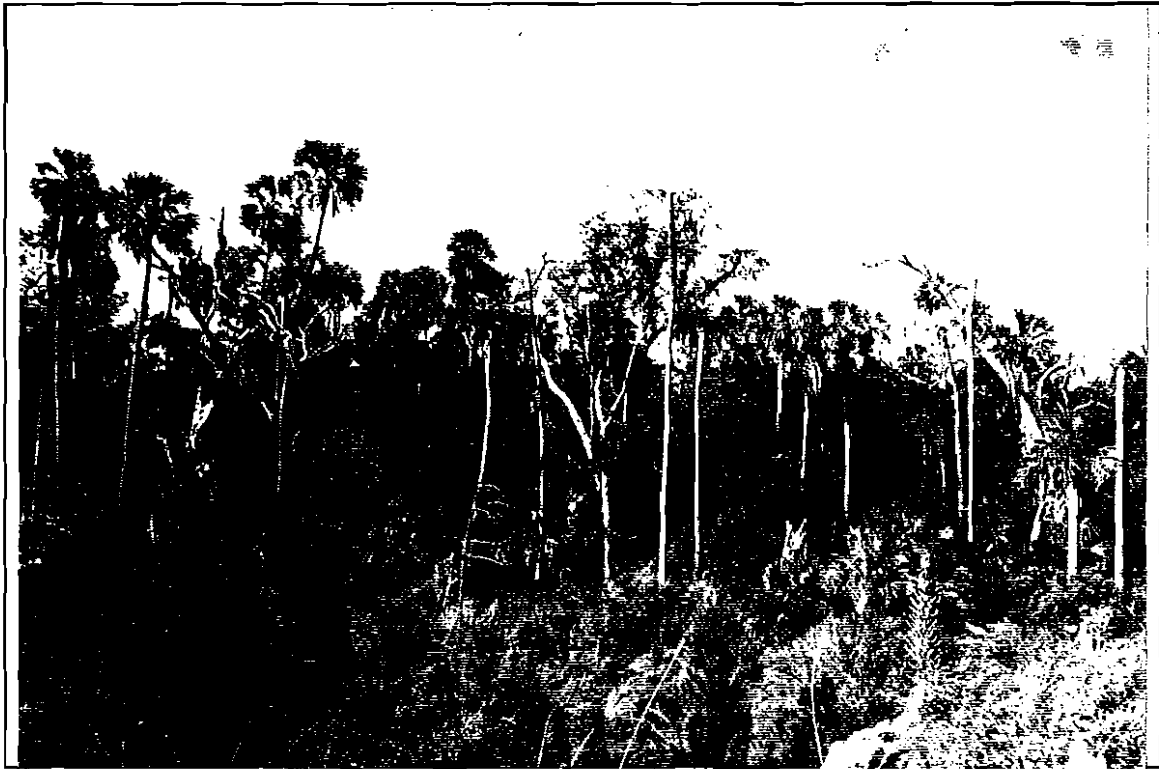
**Figure 10. Oak/Cabbage Palm/Cedar Hammock Area, Just East of the Southwest Open Hammock Site; Showing Some Dead or Stressed Trees Along Edge of Dense Canopy 17.**

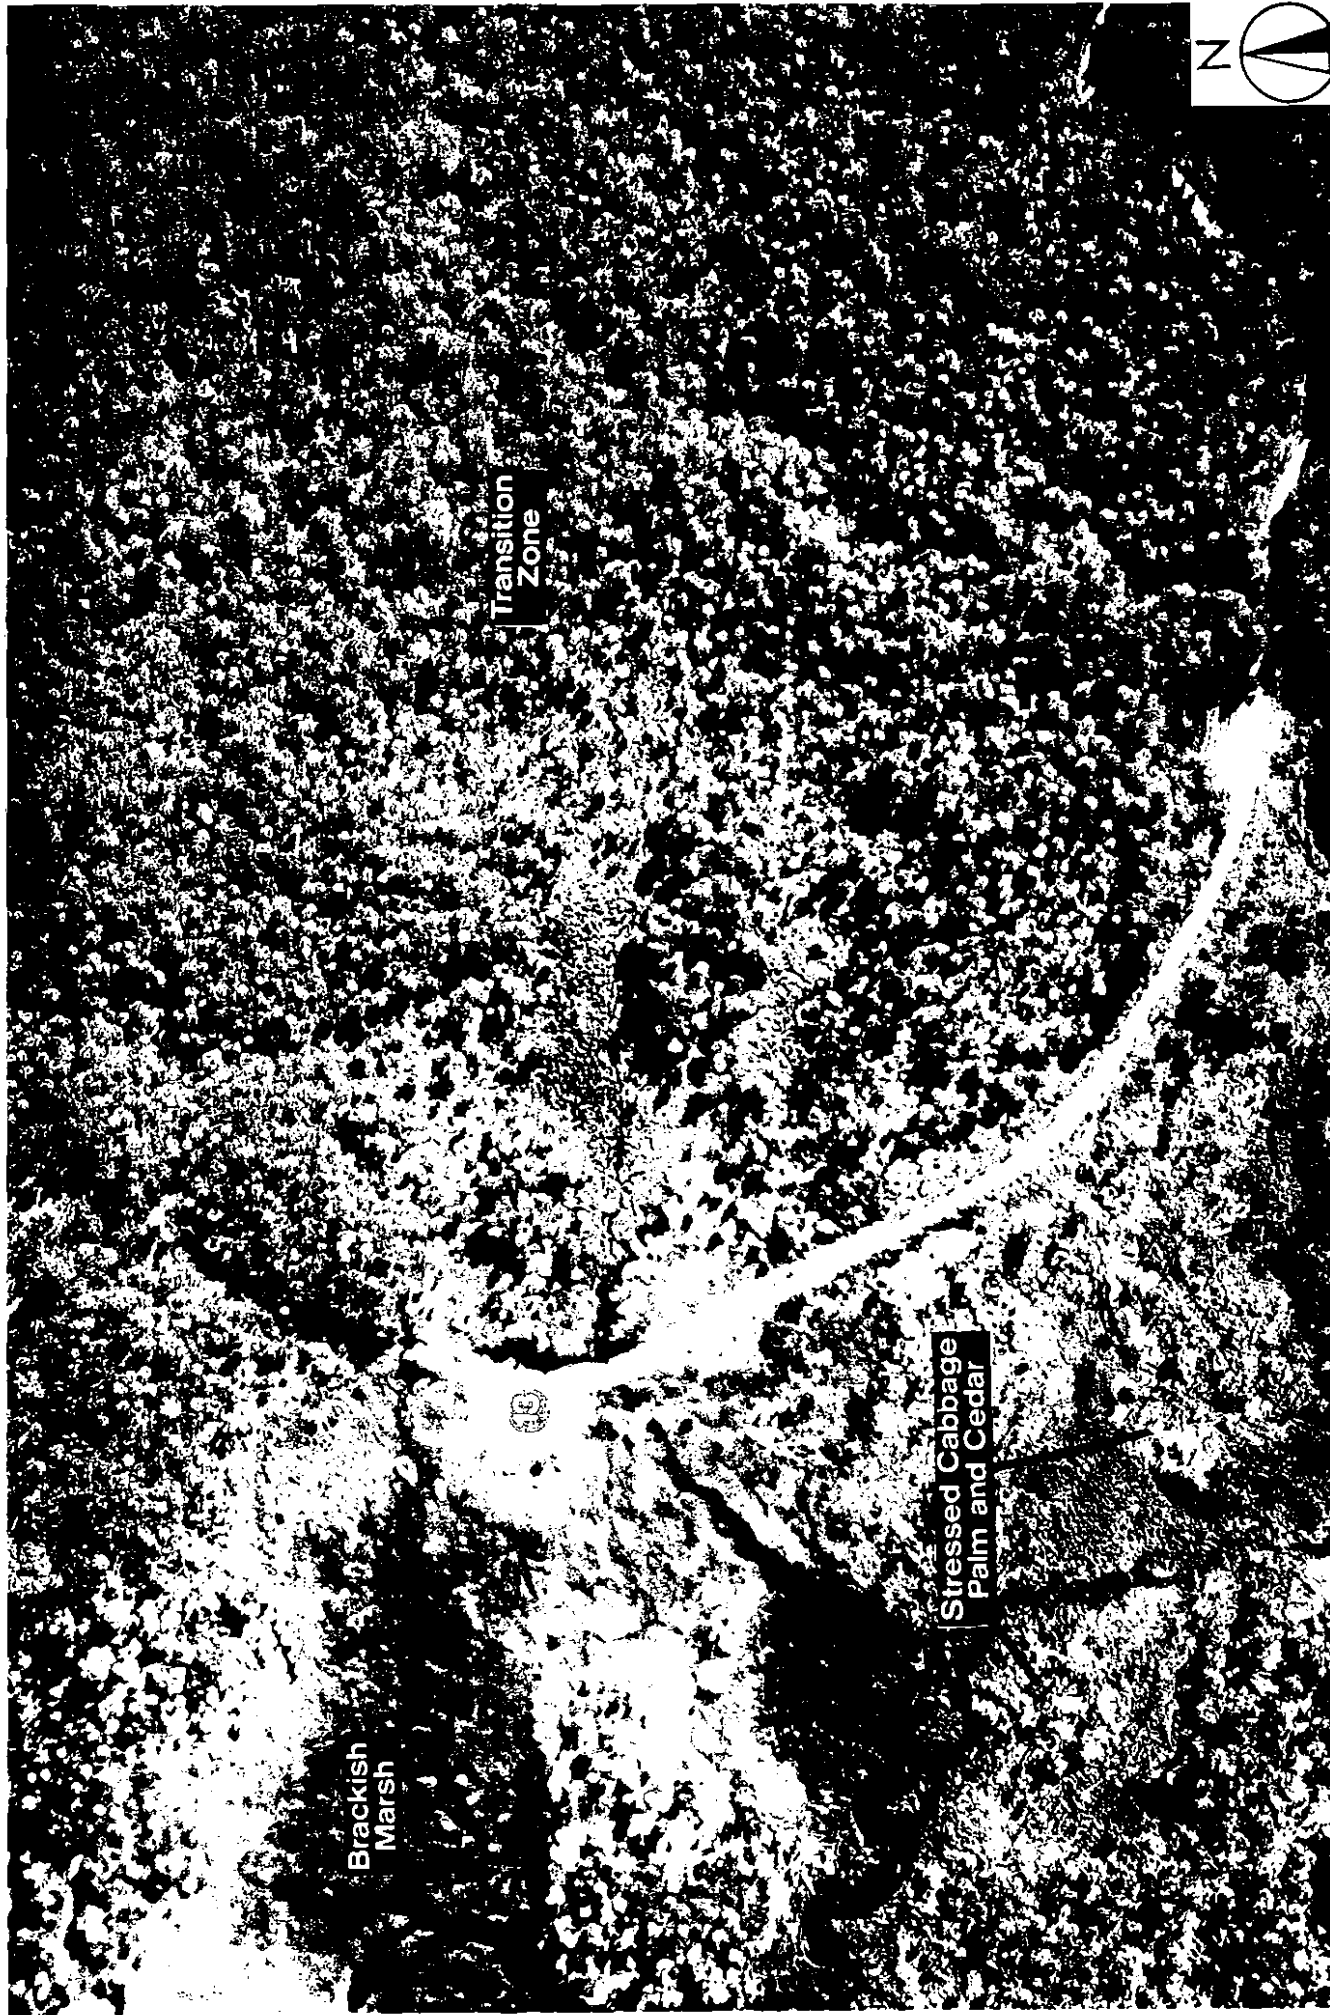
The Coastal Control site shows a similar pattern of stress; however, the transition edge between upland communities at higher elevations and the brackish marsh seems to be much sharper,

resulting in comparatively smaller areas and densities of stress or mortality. Affected cabbage palm and cedar can be observed as somewhat isolated specimens or small clusters. Figures 11 and 12 demonstrate this pattern. A nearby upland oak (*Quercus* sp.) and pine community, shown in Figure 13, shows no signs of stress as are apparent in the lower edges of the coastal transition zone where these same species occur.

Figure 11. Low-Altitude Coverage in Vicinity of the Coastal Control Site, Fall 1995.

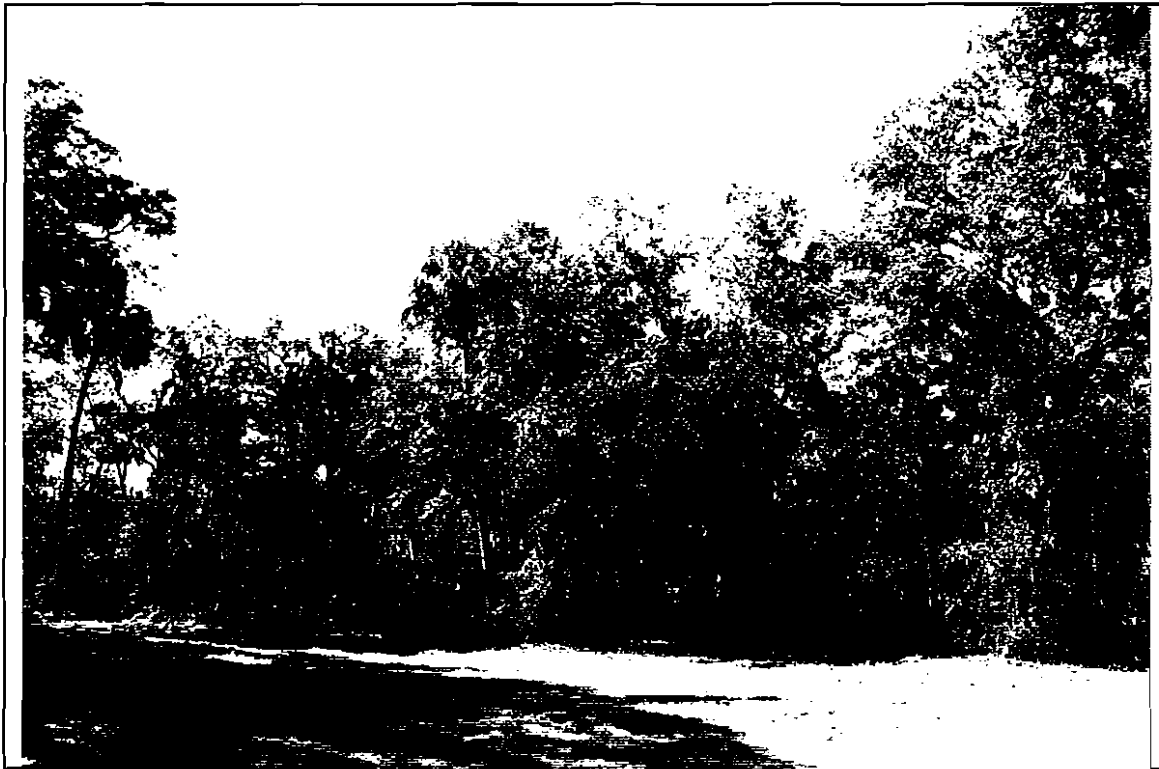
**Figure 13. Live Oak/Pine Community North of the Coastal Control Site, Fall 1995.**

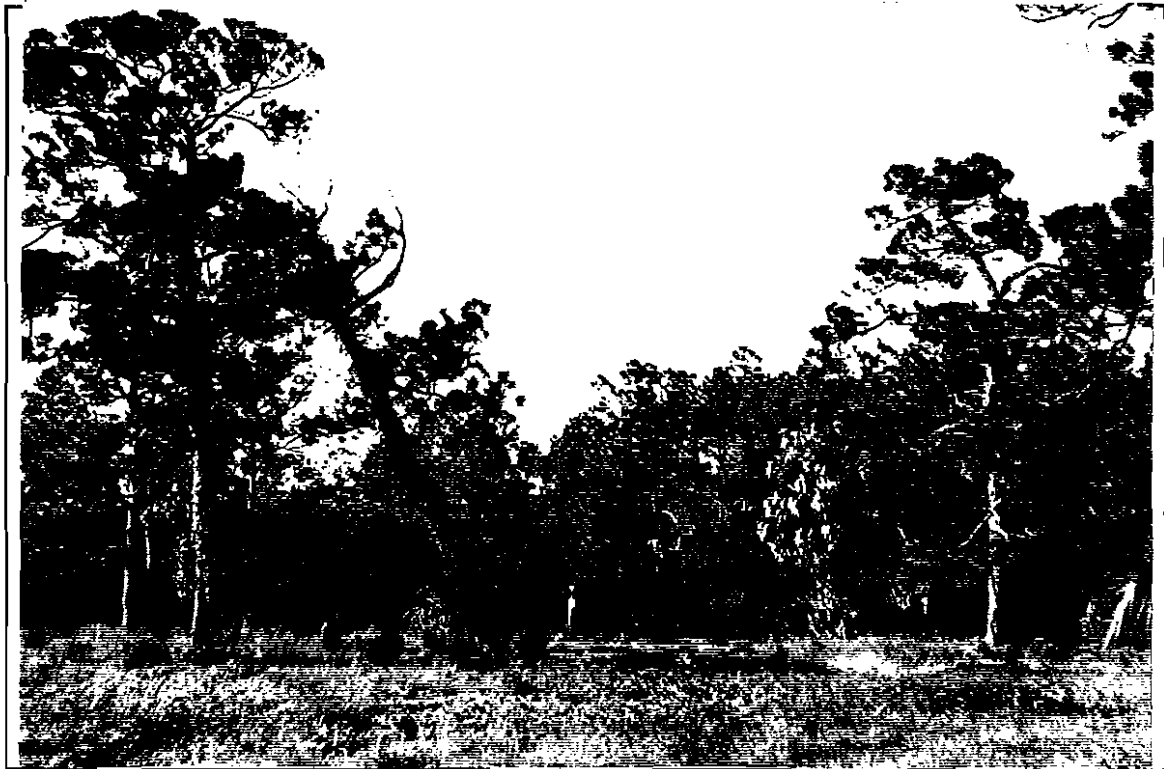
**Figure B-5. Northwest Open Pine Site and Adjacent Forested Area, Showing Pine-Dominant Community.**

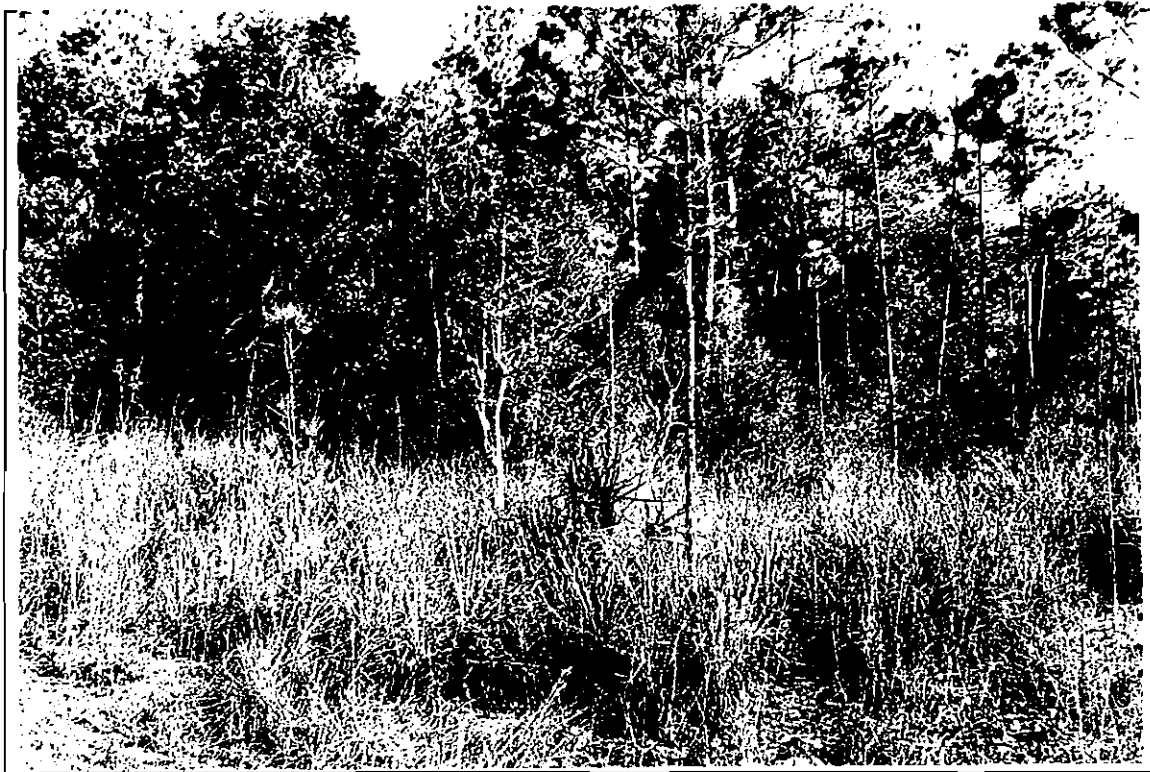
**Figure B-6. Wet Transition Edge of Sawgrass Marsh to the East of the Northwest Open Pine Site, Fall 1995.**
