**93046-30.4**

**AERIAL PHOTOGRAPHIC MONITORING,  
FLORIDA POWER CORPORATION,  
CRYSTAL RIVER POWER PLANT  
SALT DRIFT STUDY**

**FINAL REPORT 1995 AERIAL PHOTOGRAPHY**

January 18, 1996

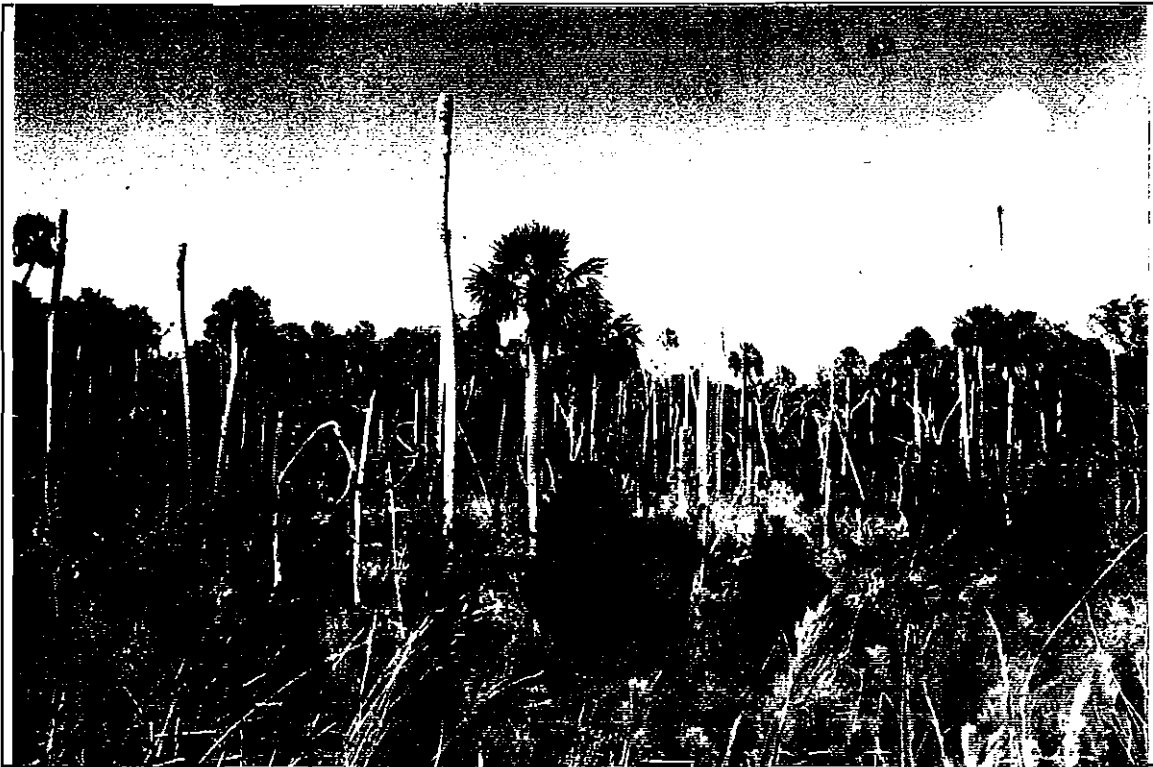
**Figure B-8. Current Conditions of Areas to the East of the Southwest Open Hammock Site.**

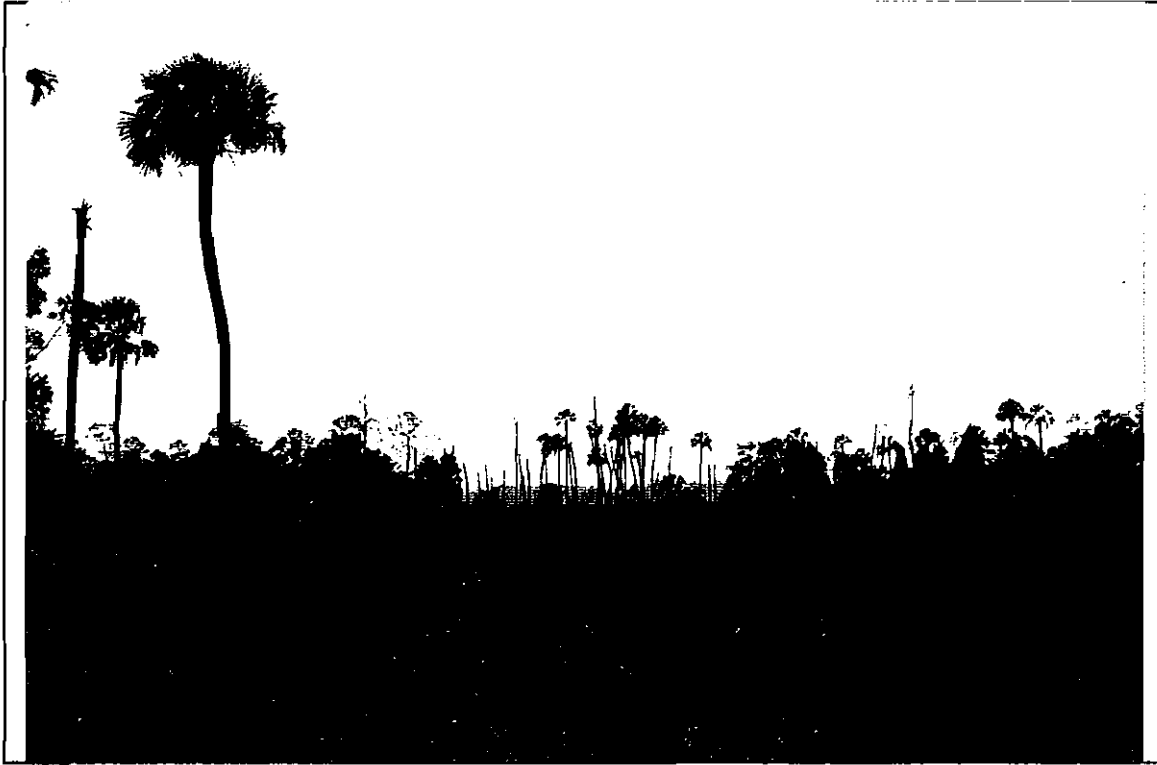
**Figure B-10.      Brackish Marsh and Transition Edge to the South of the Coastal Control Site, Fall 1995.**
