# Assessment and Recommendations for Improving the Performance of Waste Containment Systems

Rudolph Bonaparte, Ph.D., P.E.  
GeoSyntec Consultants  
Atlanta, GA 30342

EPA Cooperative Agreement Number  
CR-821448-01-0

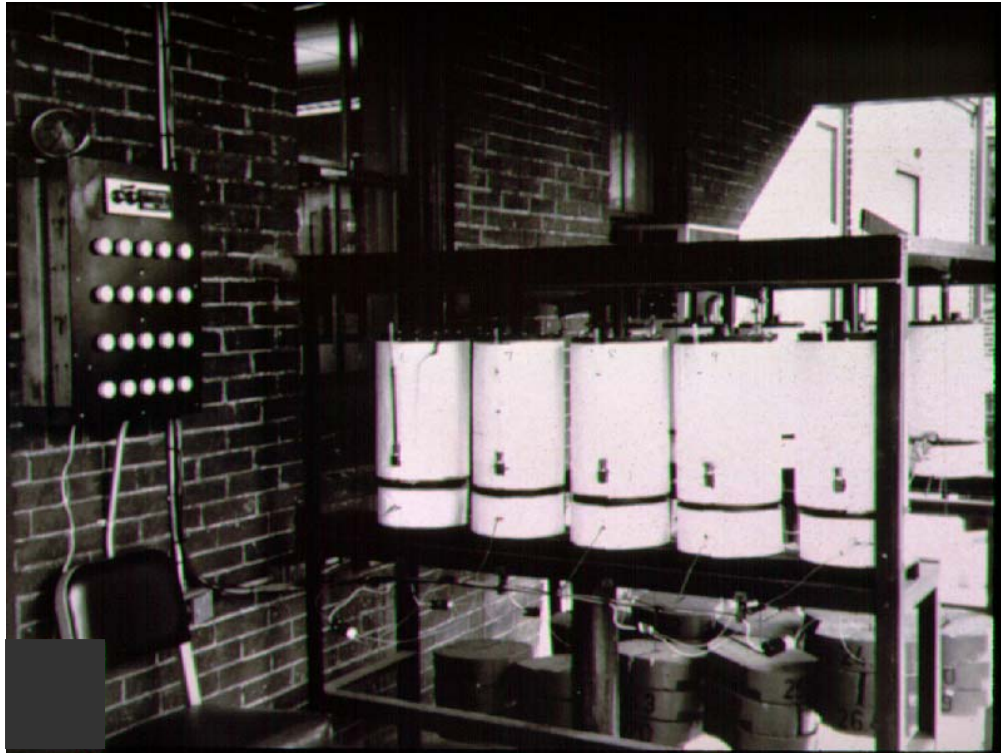
**Figure 2-18. Photograph and schematic diagram of a typical compression column for incubation Series No. III.**

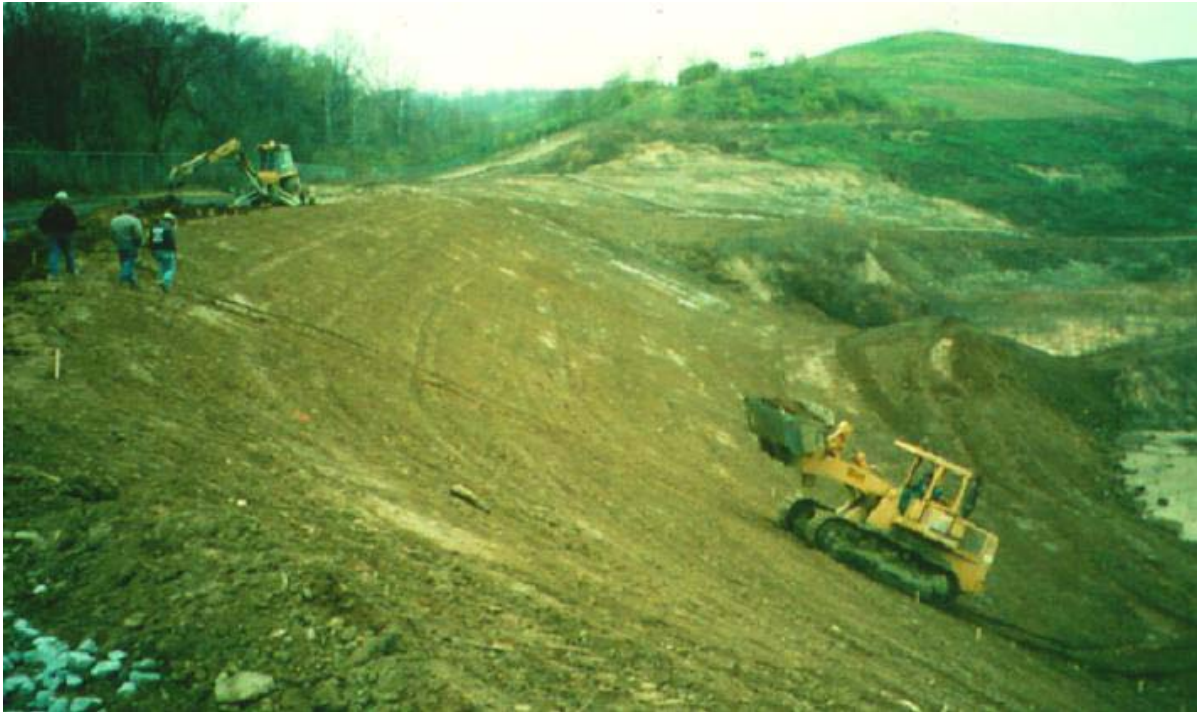
**Figure 3-11. Prepared surface on which 2H:1V test plots were constructed.**

The test plots were first graded to provide a smooth subgrade, as shown in Figure 3-11. Next, geosynthetics were installed by pulling them down from the crest of the slope (Figure 3-12). Cover soil was placed by starting at the bottom of the slope and working upslope (Figure 3-13). All test plots, except plot M, were then covered with an erosion control material. The 3H:1V test plots are shown in Figure 3-14, and the 2H:1V test plots are shown in Figure 3-15.

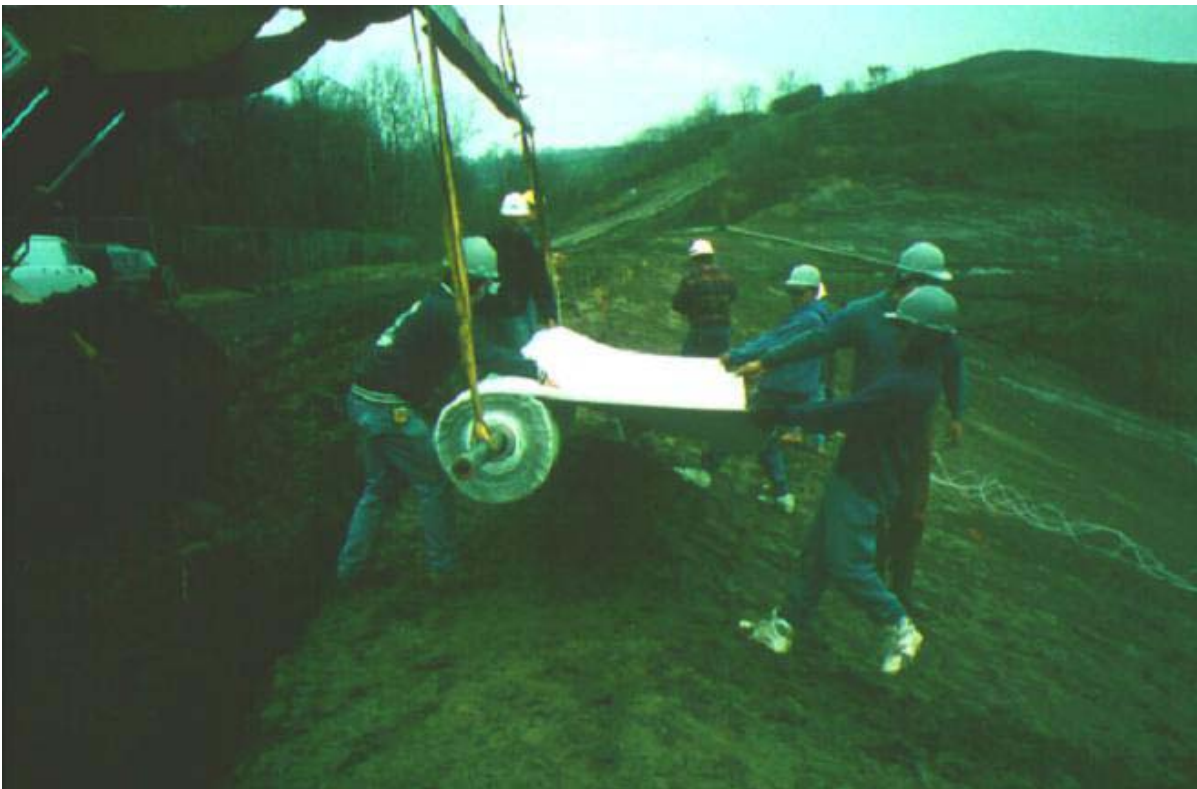
**Figure 3-12. Typical installation of geosynthetics.**

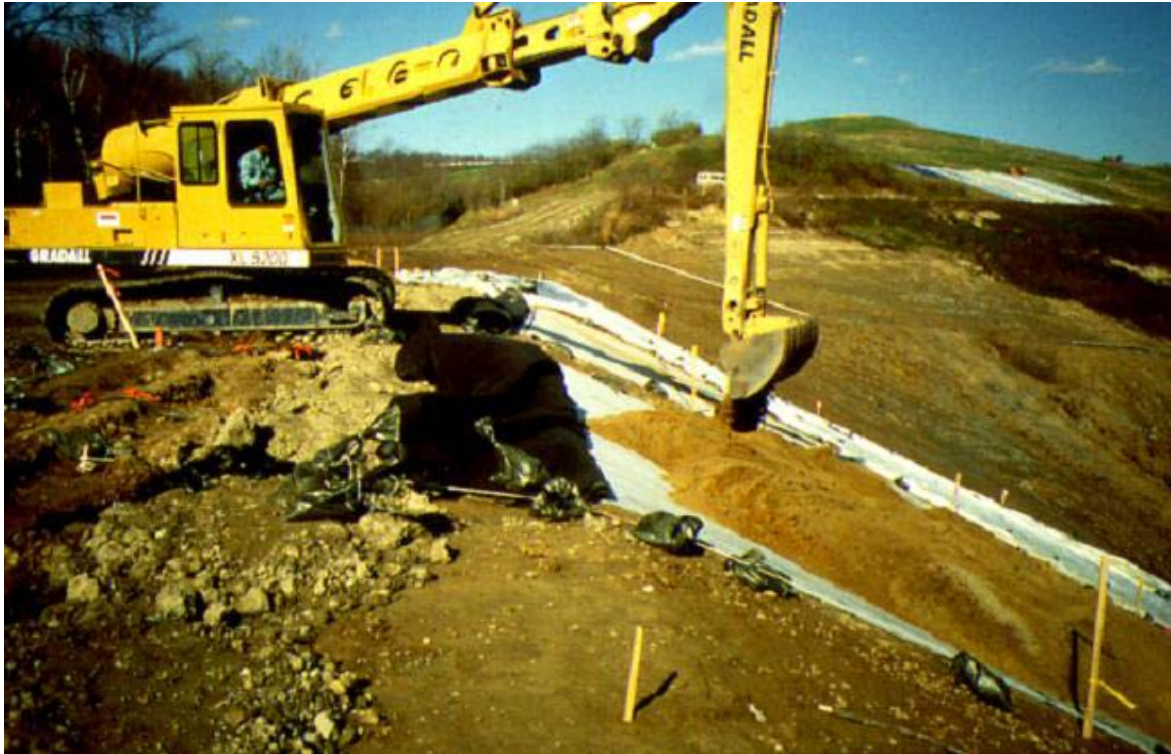
**Figure 3-13. Placement of cover soil near top of slope.**

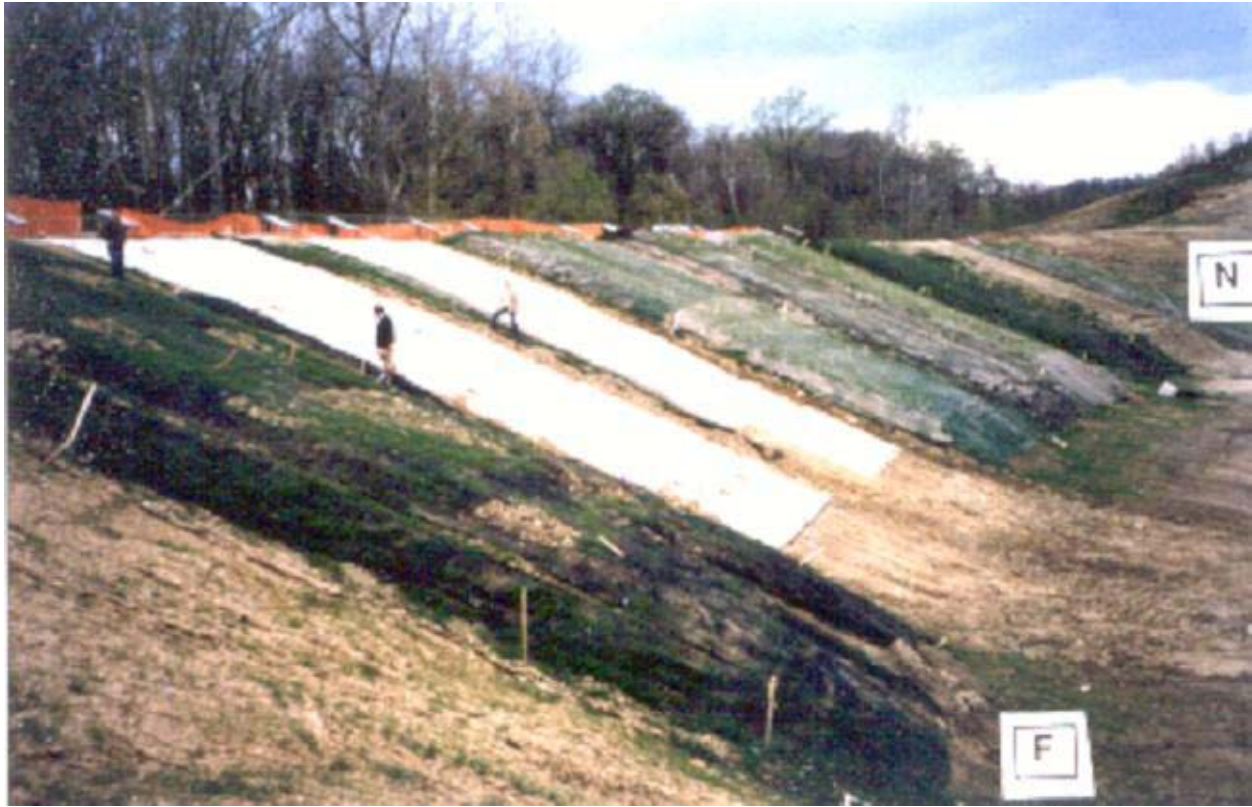
**Figure 3-15. View of 2H:1V test plots.**

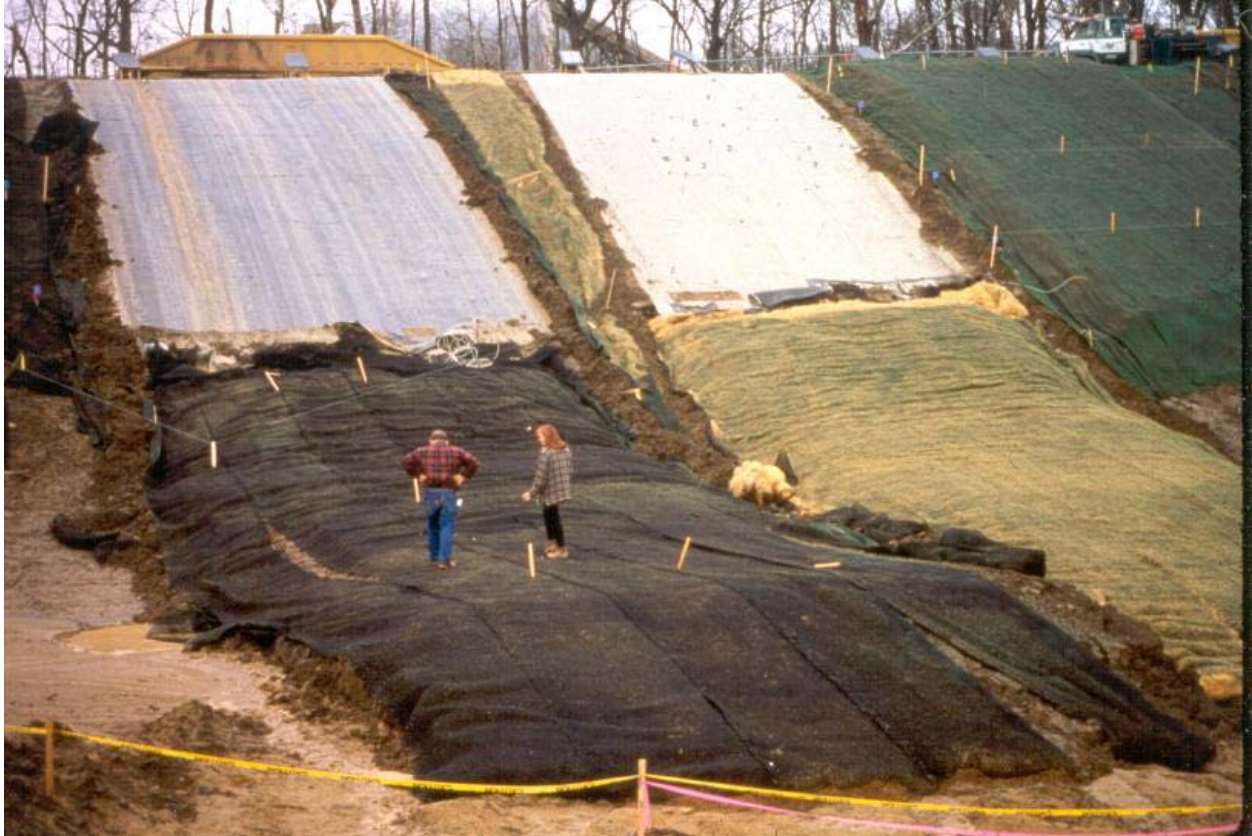
**Figure 3-23. Photograph of slides in plot G (left) and H (right) taken approximately 2 months after construction and several days after the slide in plot G.**

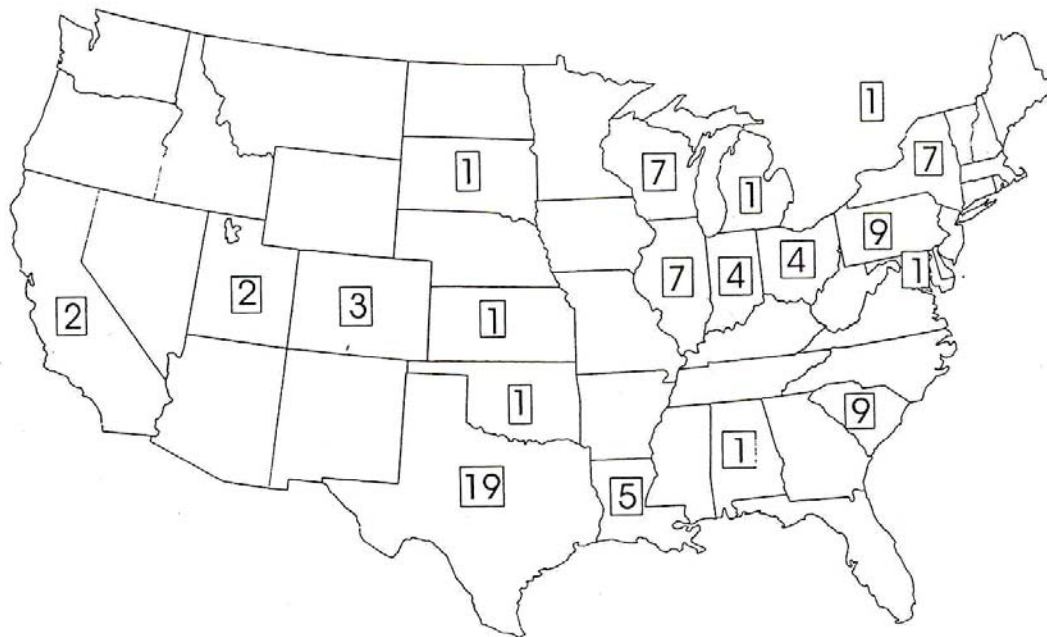
**Figure 4-1. Locations of sites in database for clay liners constructed of natural clay material.**

The database consists of 89 CCLs. Of the 89 CCLs in the database, 8 are actual in-service liners for landfills and 81 are test pads. The geographic distribution of CCLs in the database is shown in Figure 4-1. Data for the 89 CCLs are compiled in four tables presented in Appendix C. Specific site locations are not provided due to potential sensitivities for some sites.

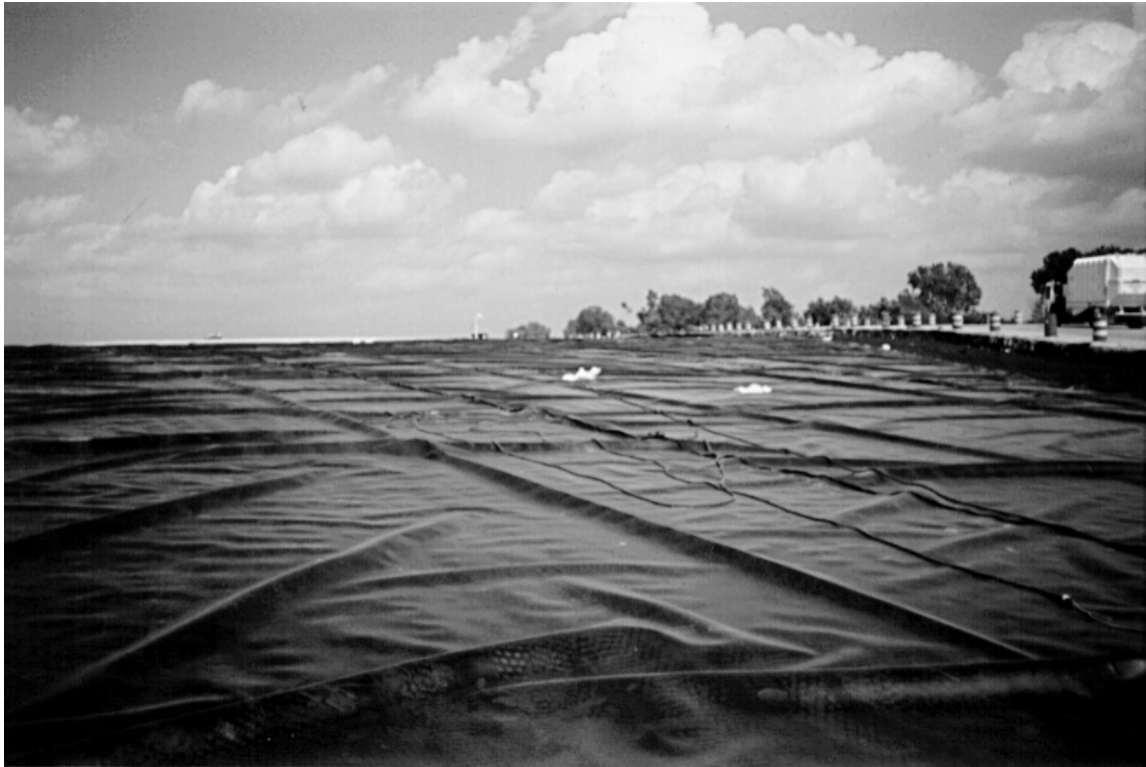
**Figure A-2. Relatively large waves, or wrinkles, in a field deployed GM.**

Geomembranes (GMs) form the essential material component in many liner systems which require a liquid or vapor barrier. Such applications are landfill liners, landfill covers, liquid impoundment liners, and other waste pile liners. The usual assumption in the placement of such liners is that they lay flat on the subgrade beneath them, e.g., on the underlying compacted clay liner, geosynthetic clay liner, etc. This is sometimes not the case. Waves, or wrinkles, of different sizes can occur in the as-placed and seamed GMs, see Figures A-1 and A-2. These waves have given design engineers a certain amount of concern as to the behavior of GMs after soil backfilling or covering. The research study described in this appendix was developed to shed insight into the issue of GM wrinkles.

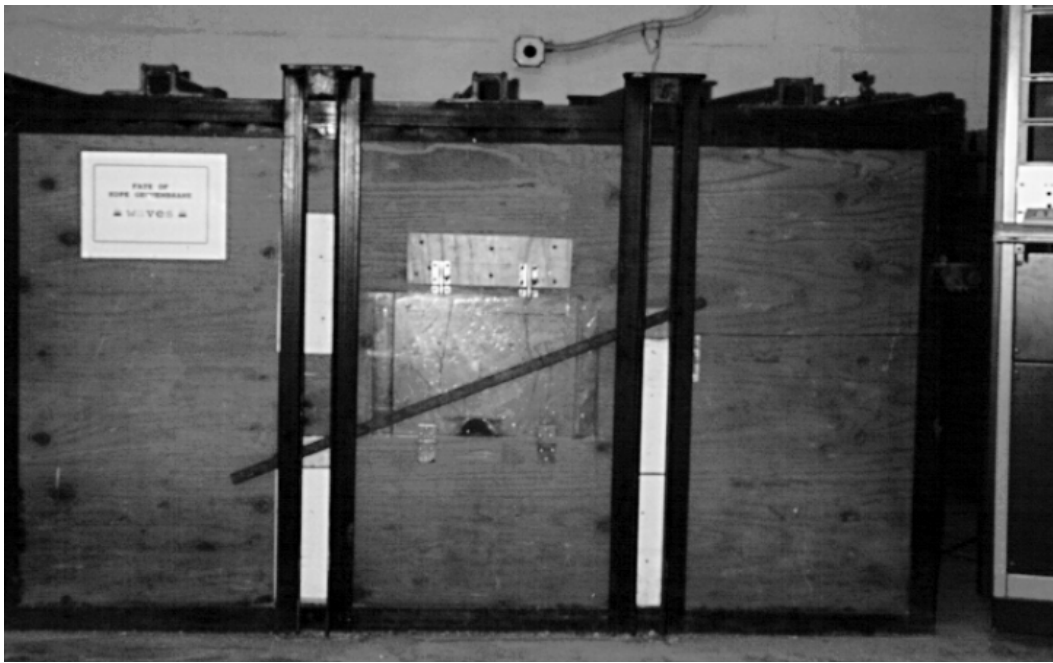
**Figure A-6. Photograph and schematic illustration of the large-scale experimental test box used in this study.**

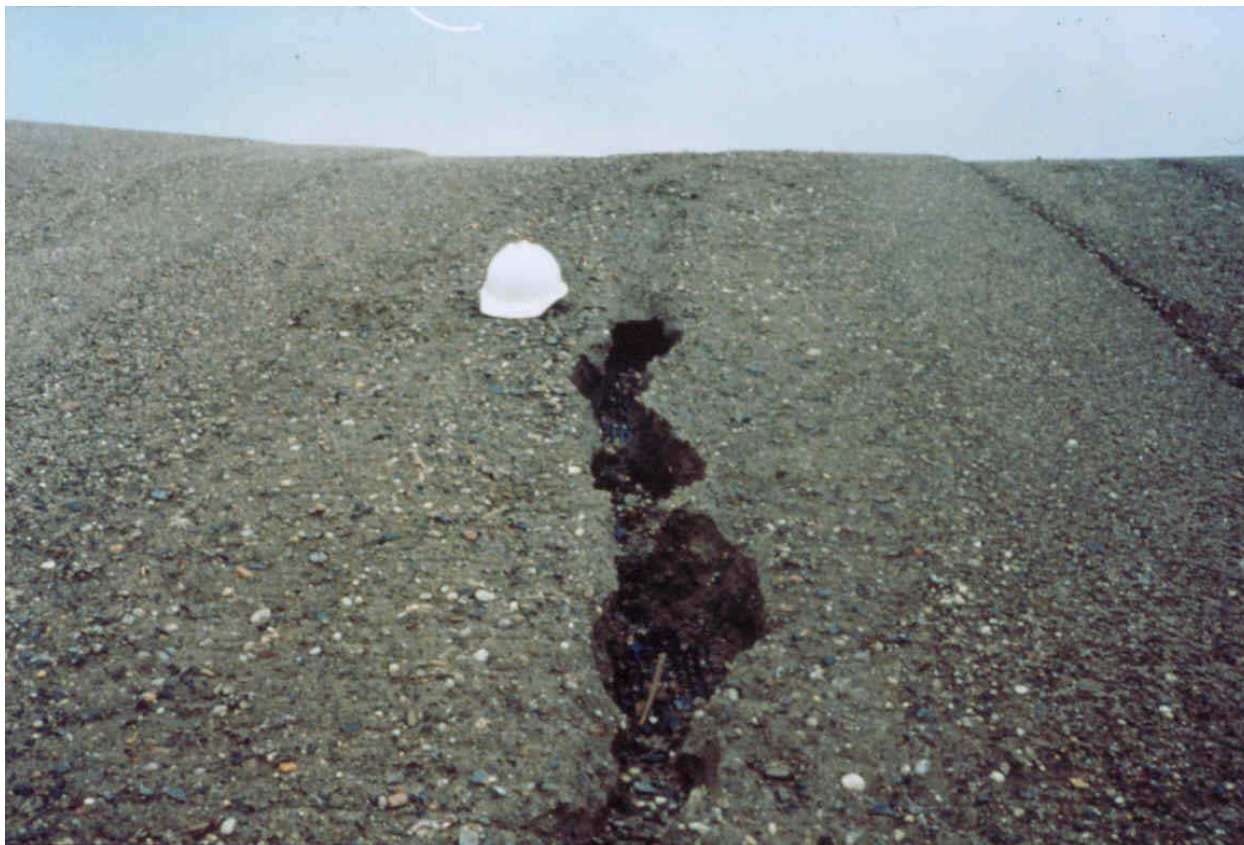
**Figure F-A.2.1. Construction debris in a CCL with an initially smooth surface protruded from the CCL after the CCL was left exposed and subsequently eroded.**

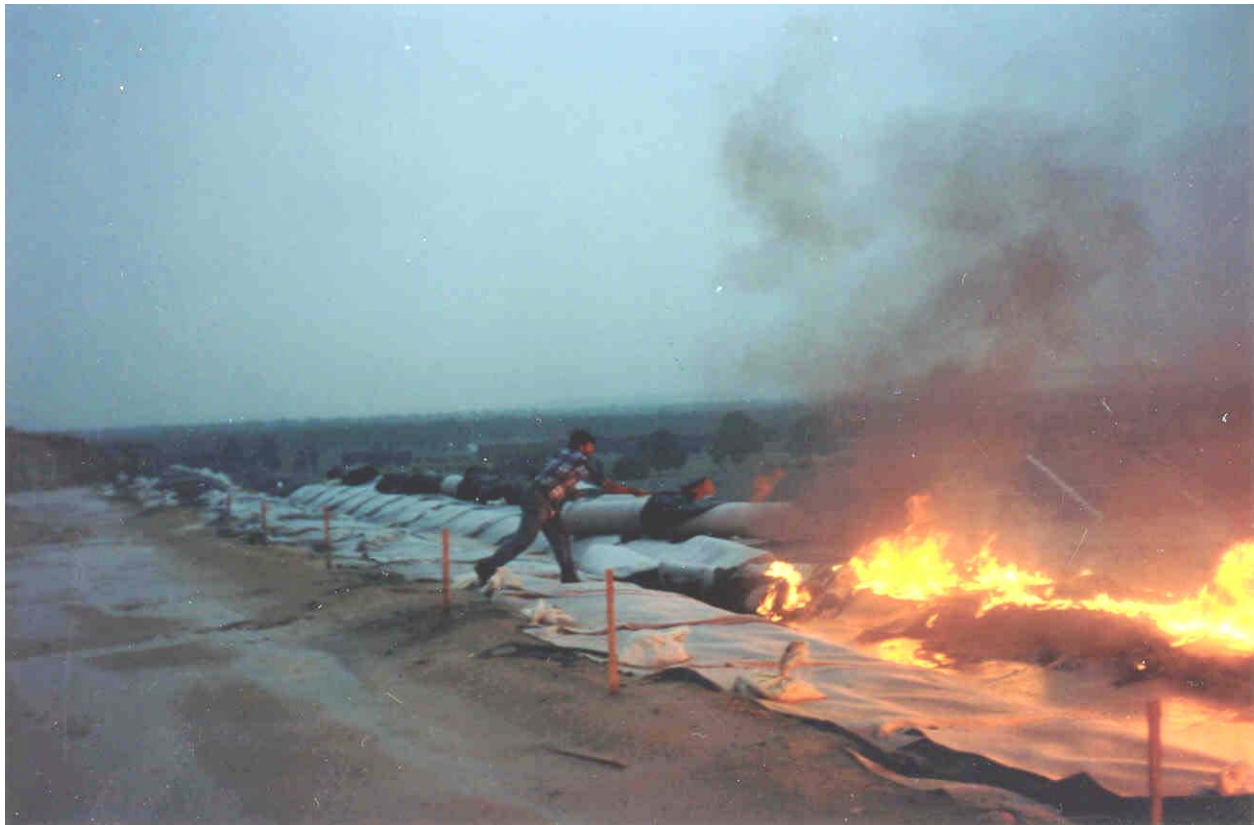
**Figure F-A.3.1. GC rolls at the top of a liner system side slope caught fire (potentially due to a lightning strike) and damaged the underlying GM.**

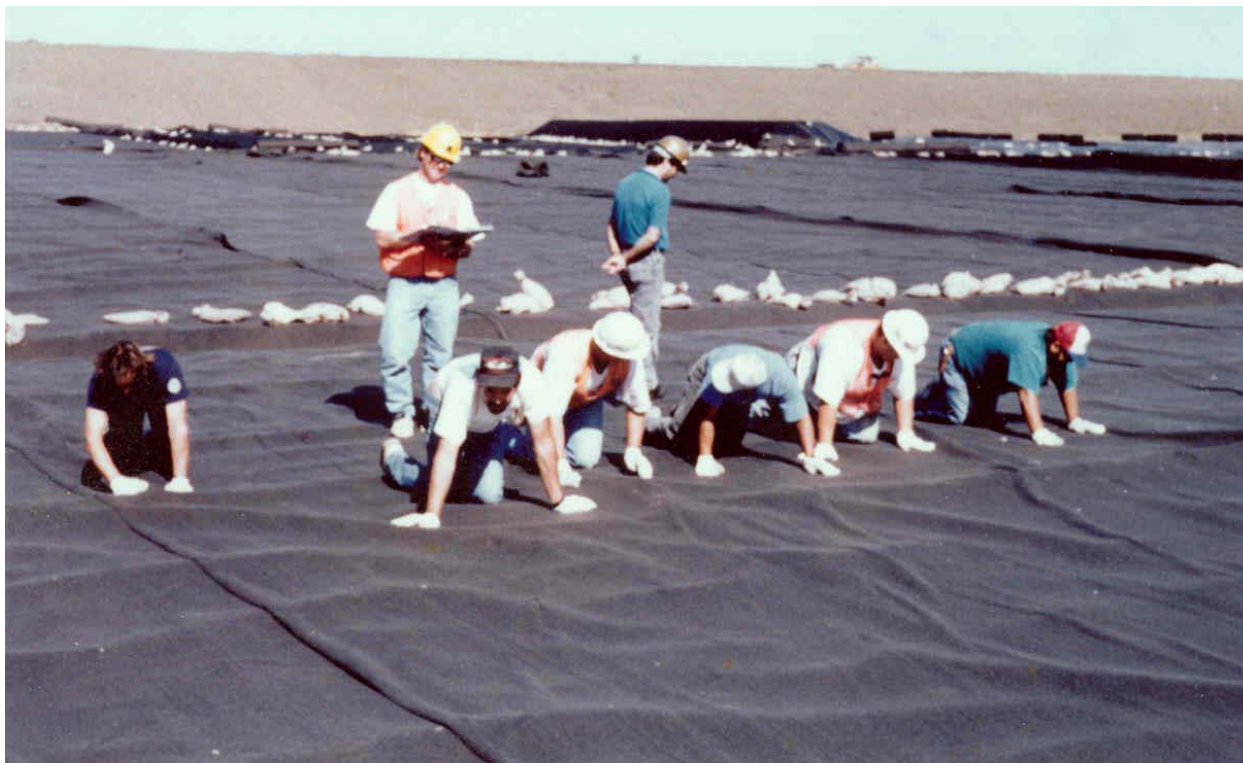
**Figure F-A.4.1. Manually searching for needle fragments in an installed GT.**

- Project specifications for needlepunched nonwoven GTs should require that the GTs be needle-free and should require a certification from the manufacturer attesting to this.
- The CQA Plan should require that deployed GTs near GMs be inspected for needles before the GTs are covered with overlying materials.
- Even with excessive needles in the GT, if the GM is separated from the GT by a GN, few needles are expected to puncture the GM.

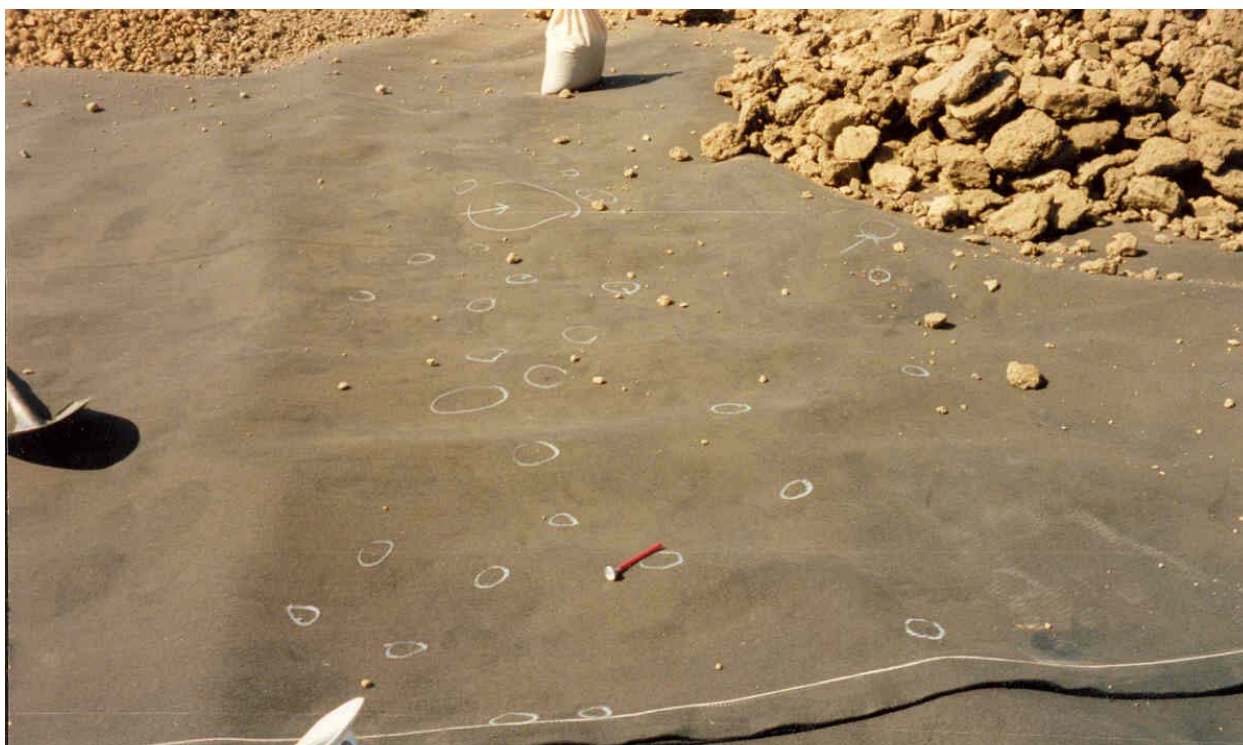
**Figure F-A.4.2. Many needle fragments were found in the deployed GT.**

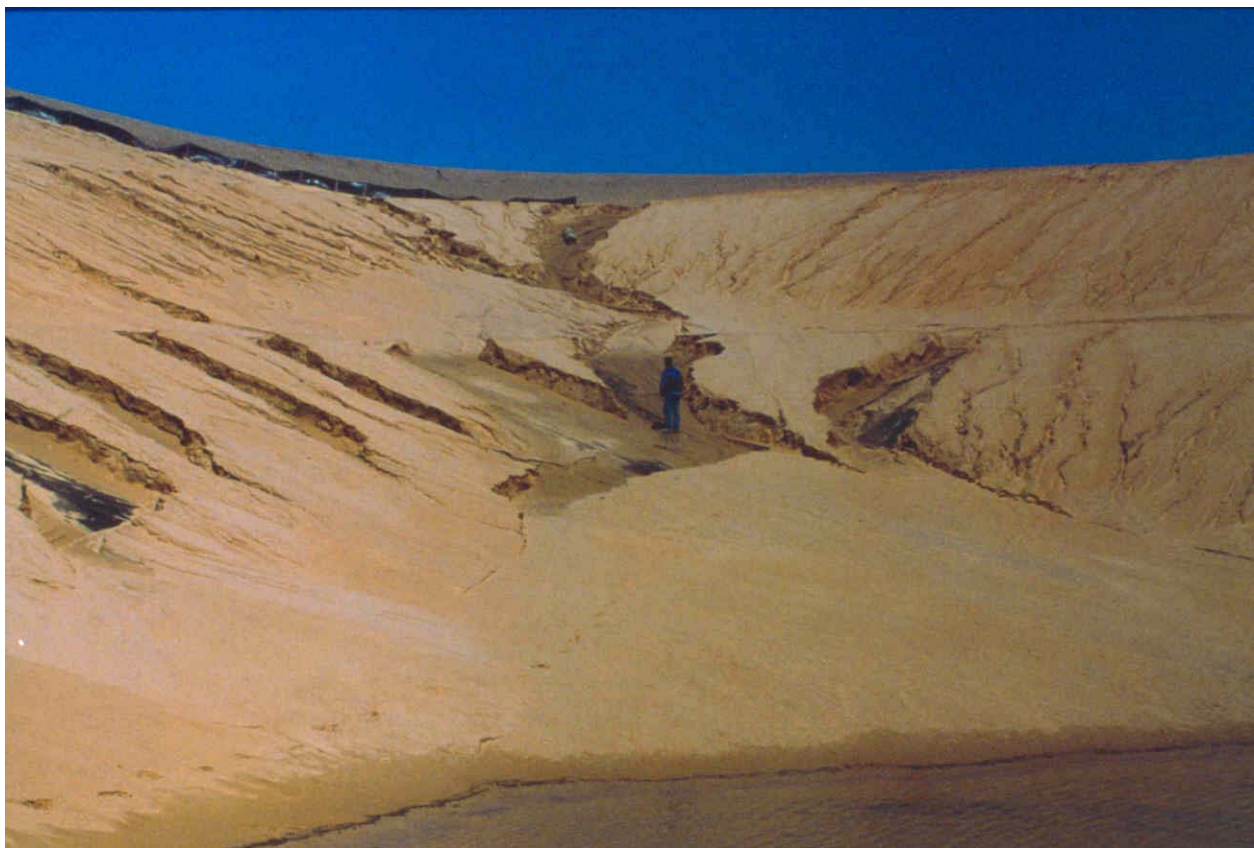
**Figure F-A.5.1. Erosion of sand protection layer on liner system sideslopes.**

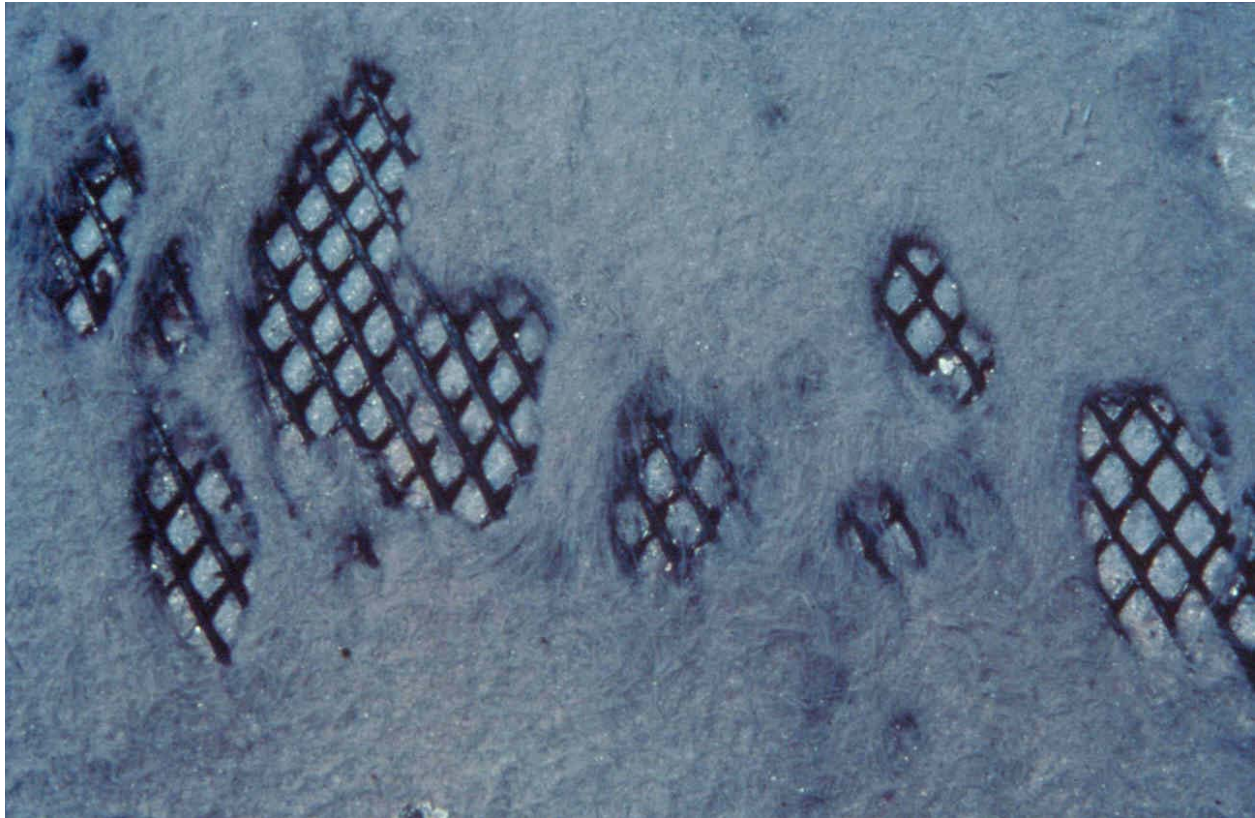
**Figure F-A.5.2. Holes developed in a polypropylene GT at the side slope crest after 6.5 months of exposure to the environment.**

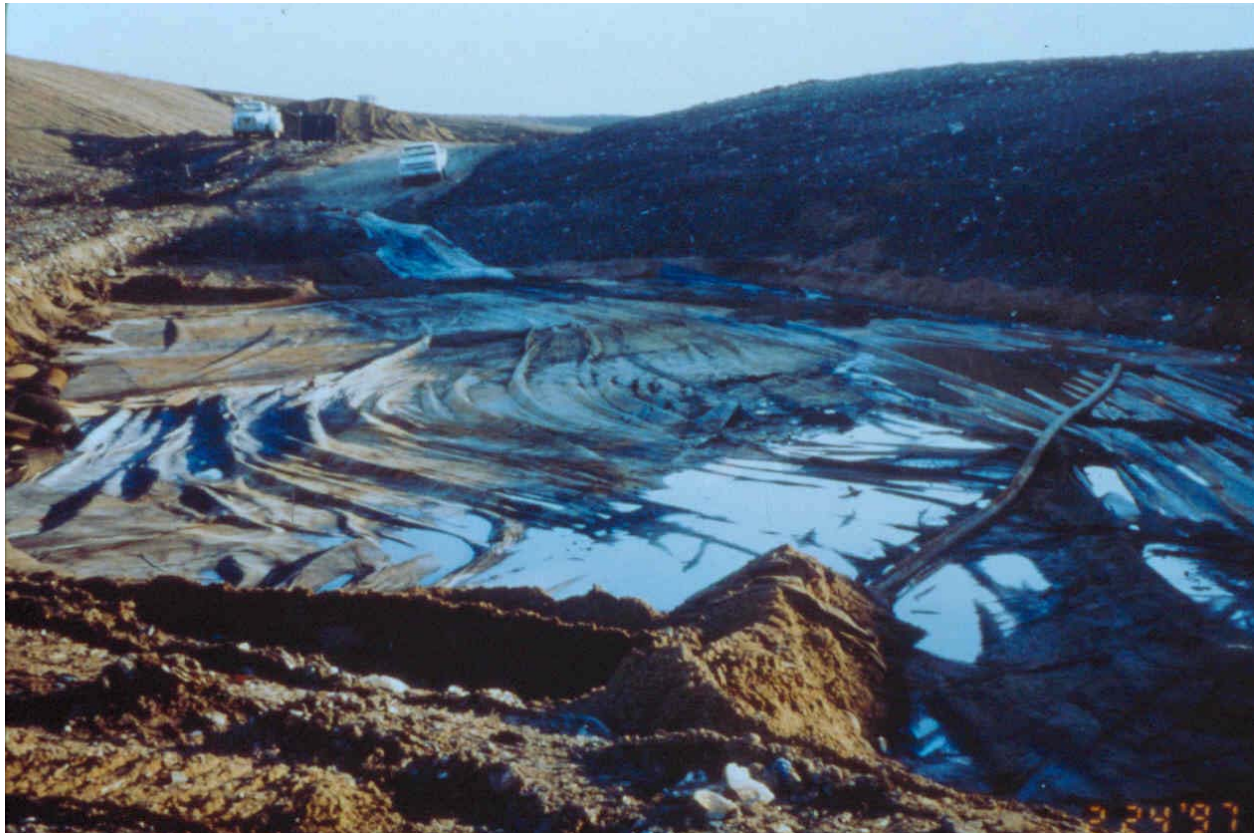
**Figure F-A.8.1.** When waste was excavated from the failure zone, large wrinkles in the GCL were evident.

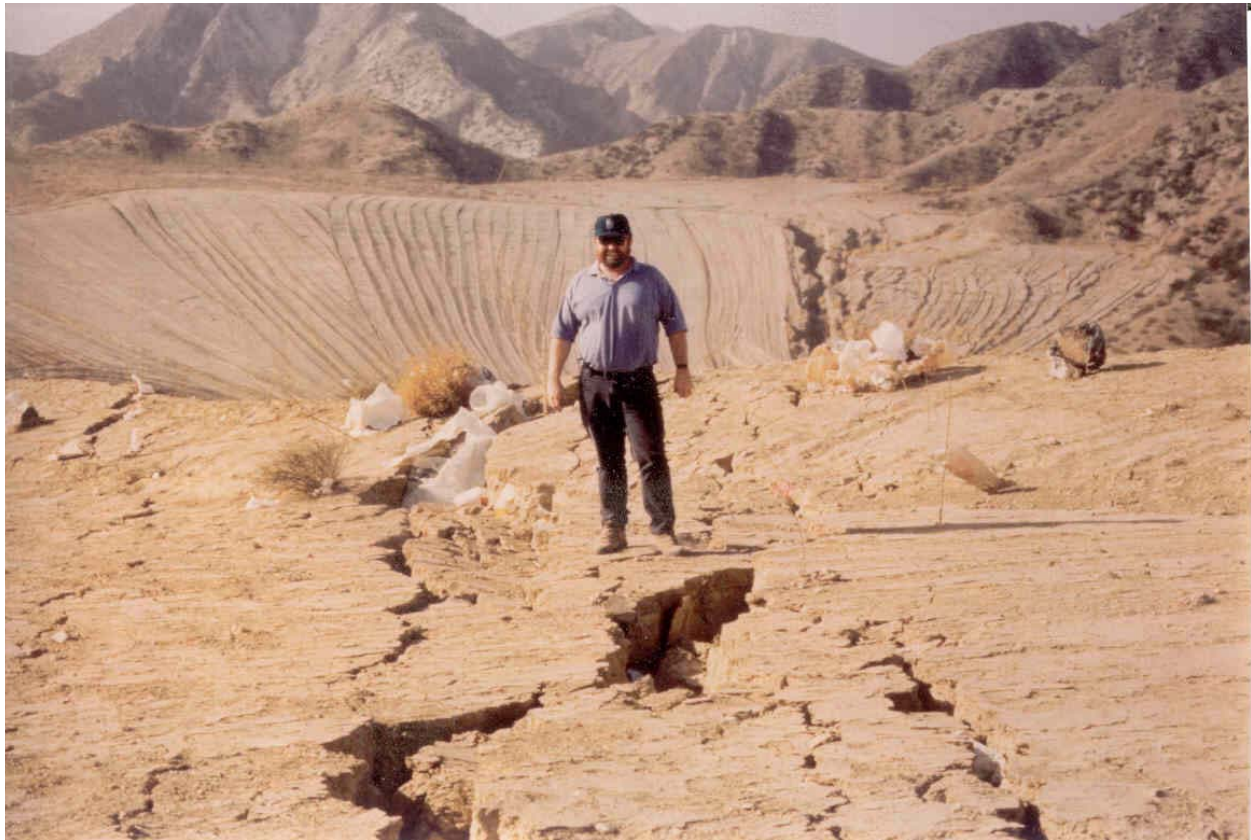
**Figure F-A.8.2. Longitudinal cracks in soil intermediate cover at Chiquita Canyon Landfill after the Northridge earthquake.**

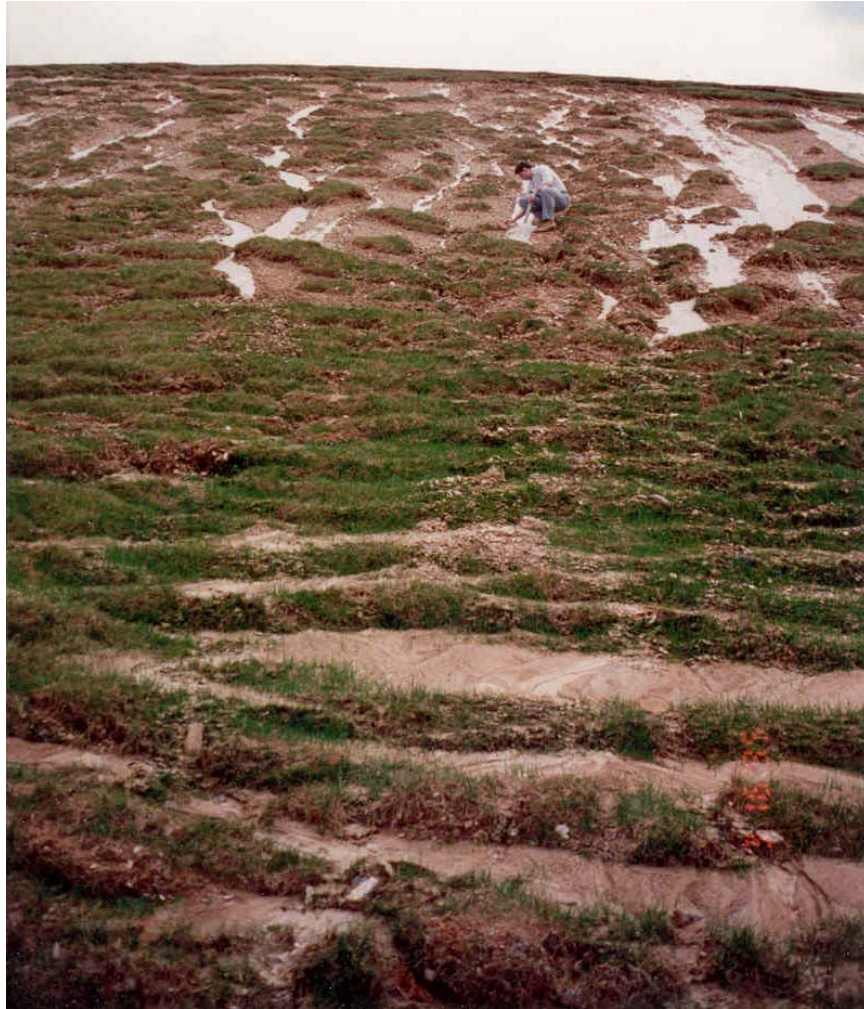
**Figure F-A.12.1. Cover system at the end of the second sliding episode.**
